Re: **Construction Documentation Report**  
**Portions of Parcels 06-806-00739-05 and 06-806-00739-00**  
**2929 Halvor Lane**  
**Superior, Wisconsin**  
**BRRTS#: 07-16-583046**  
**BBJ Group Project No. R2413652**

# CONSTRUCTION DOCUMENTATION REPORT

**FedEx Facility  
2929 Halvor Lane  
Superior, Wisconsin  
BRRTS#: 07-16-583046**

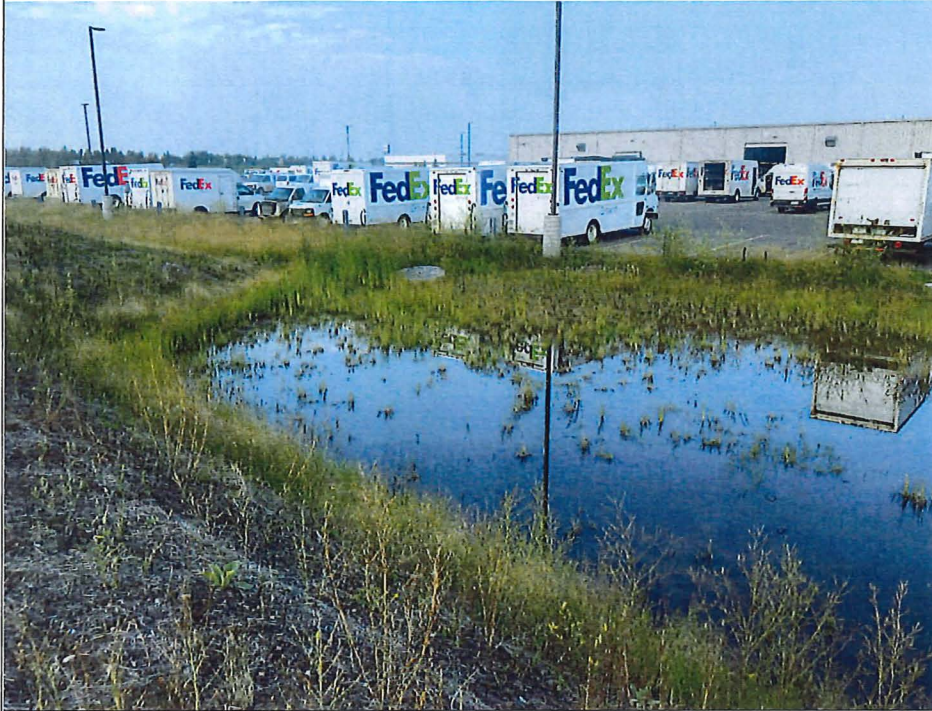
Title: South half of storm water pond viewing southwest. Note outflow structure in center at end of pond.

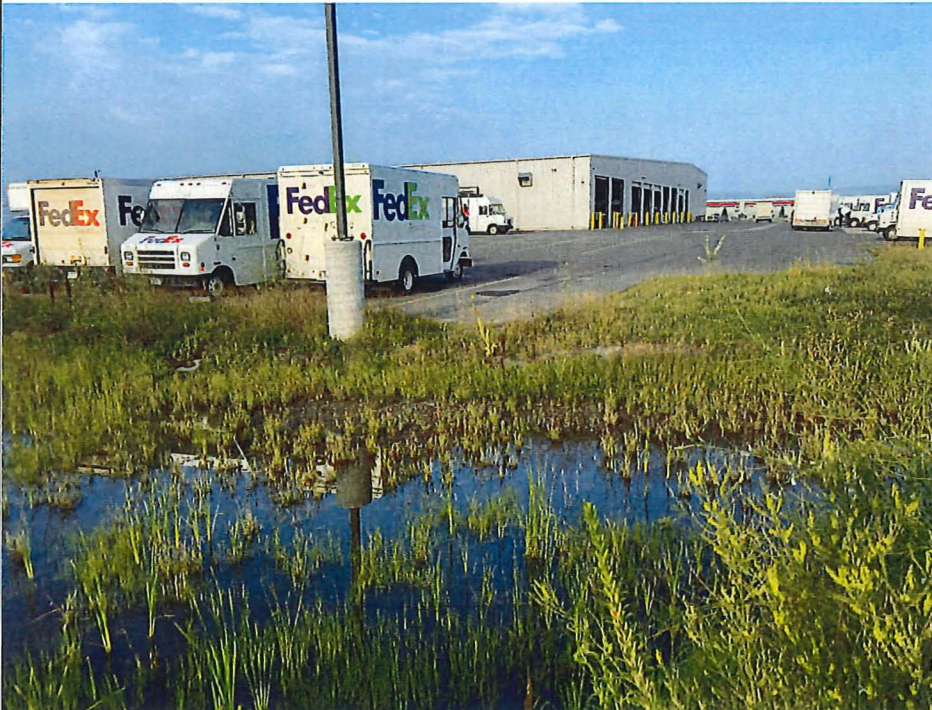
Title: North end of storm water pond viewing wes. Note asphalt parking lot in background which also serves as cap/cover.
