MEMORANDUM

DATE : June 17, 2023

FROM : Pratap Singh, Ph.D., PE / KSingh

SUBJECT : Weekly Progress Report for Week Ending 06/17/2023
Community Within the Corridor - East Block

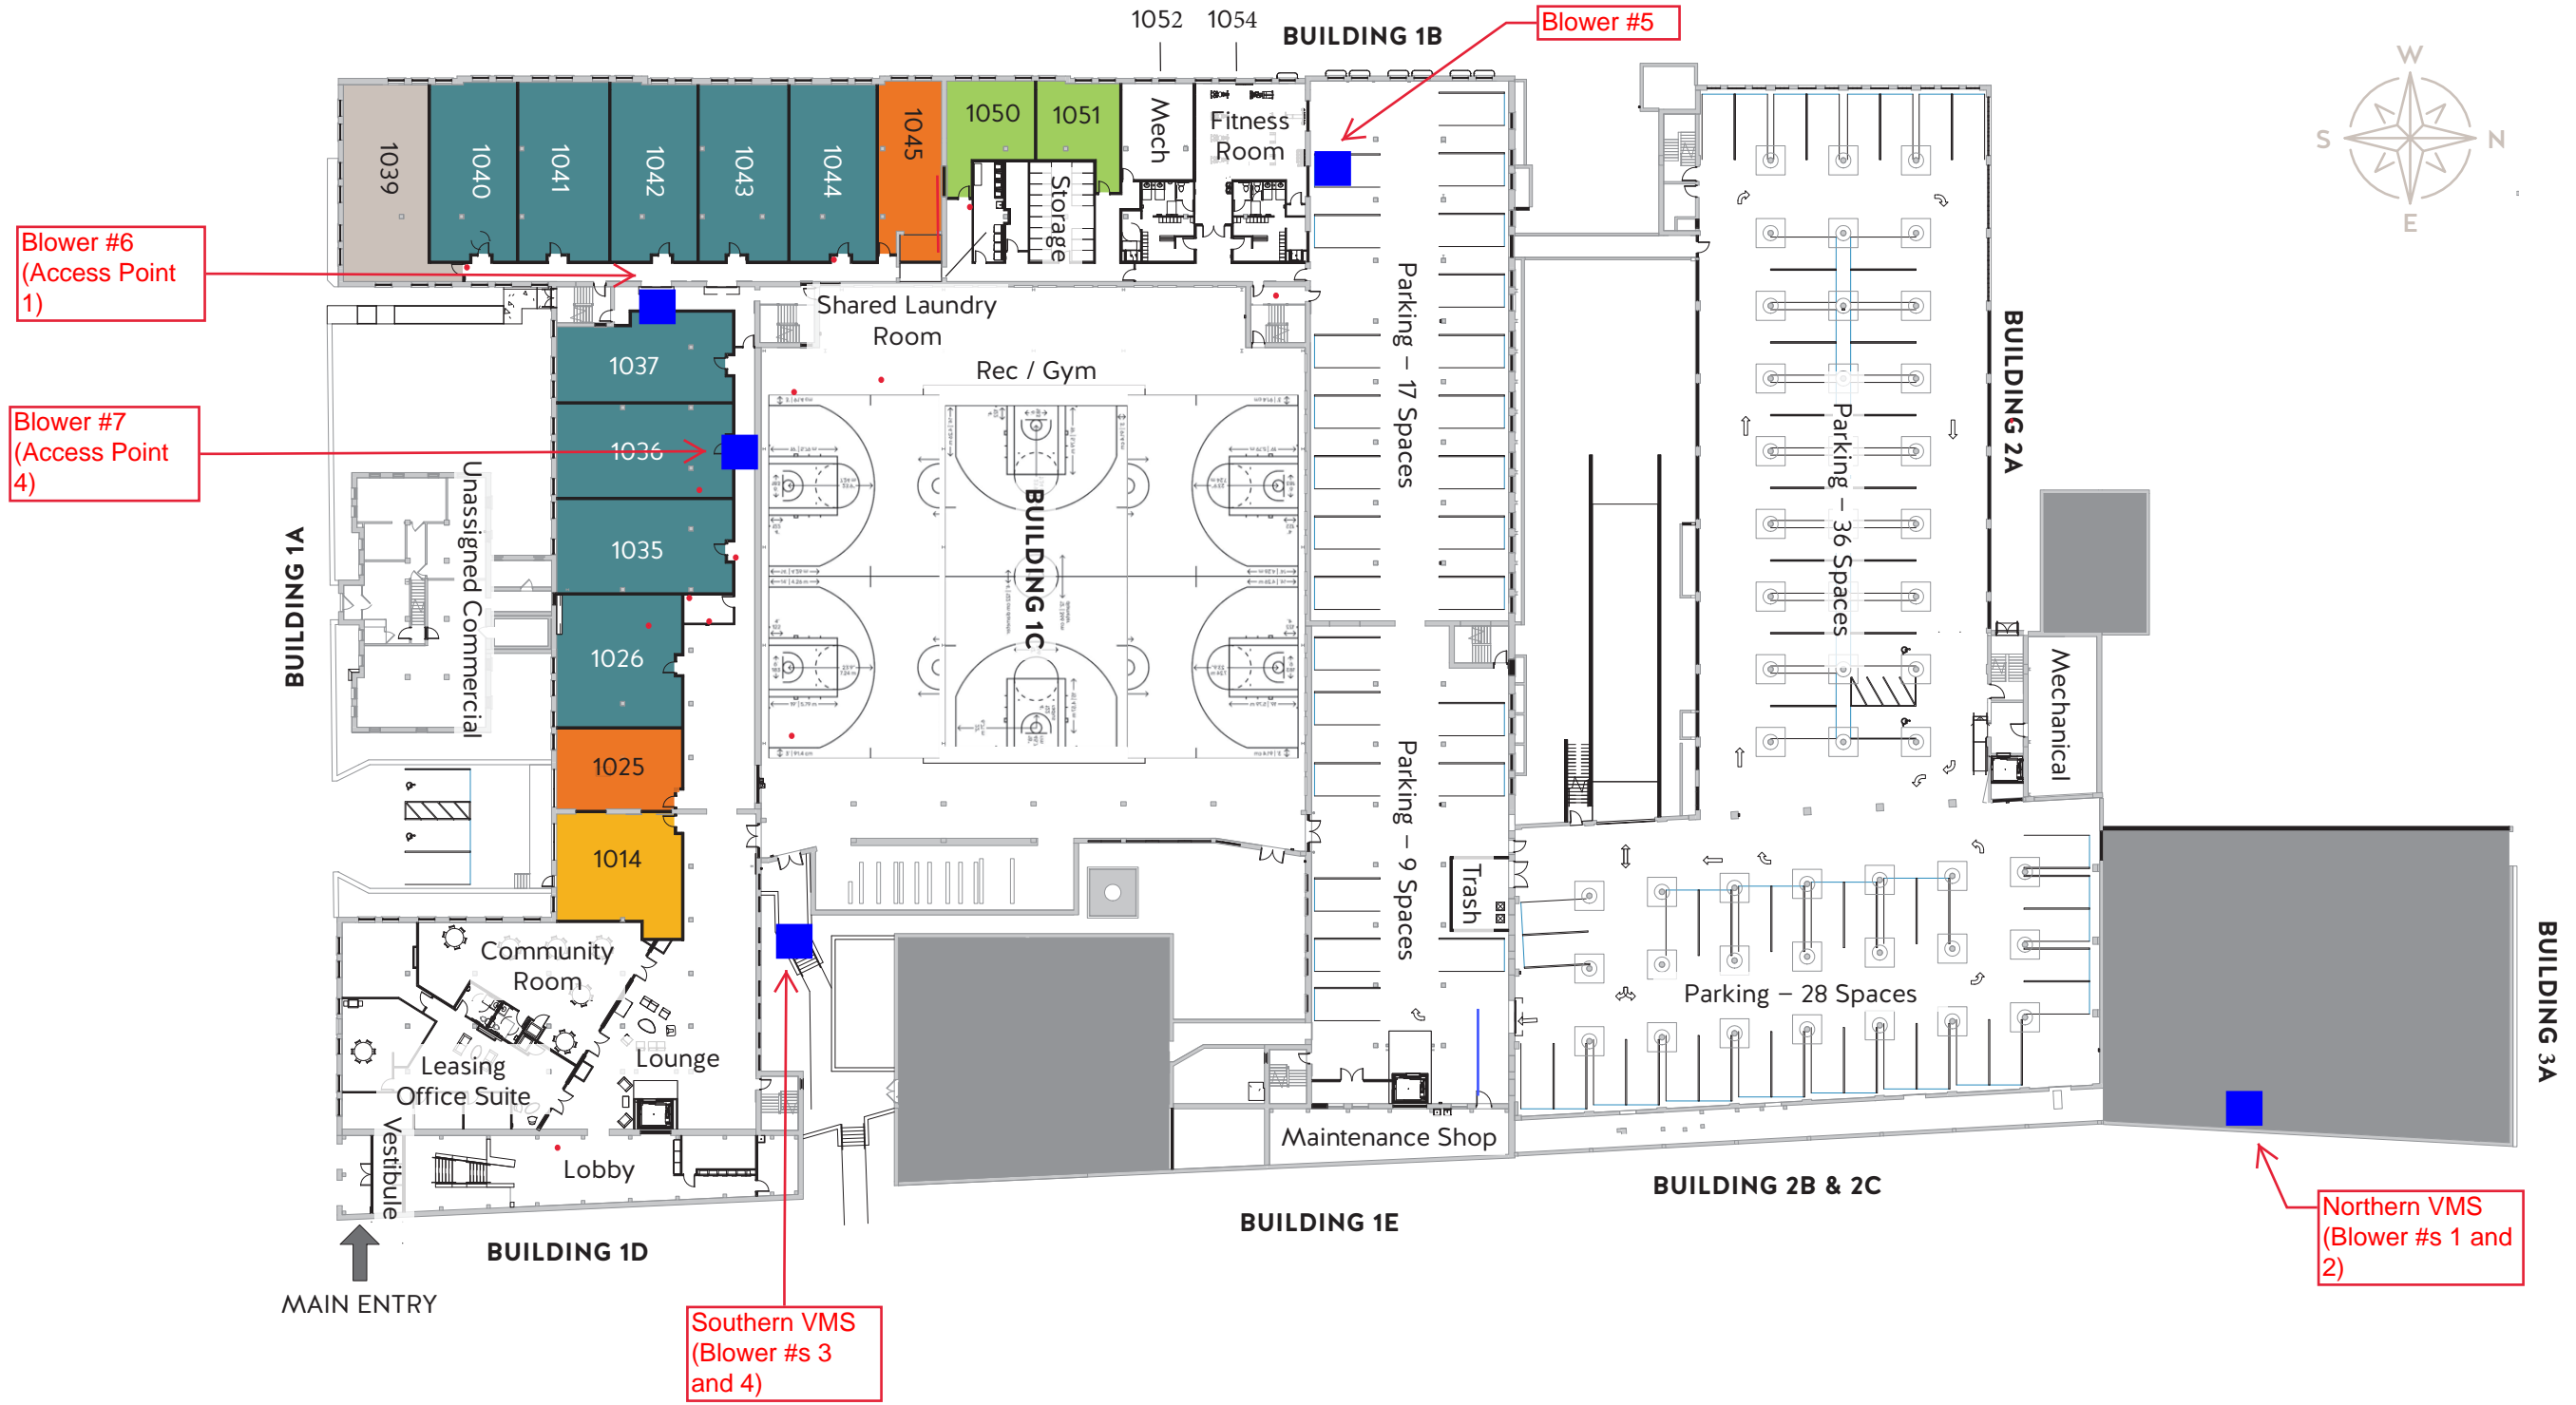
Figure 1 - CWC EB Level 1 Map and Blower Locations

- High vacuum was observed in the Fitness Center (1054) and the Mechanical Room (1052) while the Units in the Building 1B-SW had little to no vacuum.
