MEMORANDUM

SUBJECT : Weekly Progress Report for Week Ending 07/15/2023
Community Within the Corridor - East Block

COPY TO : Que El-Amin / Scott Crawford, Inc., Robert Reineke, PE, Robert Fedorchak, PE
Project #40441B

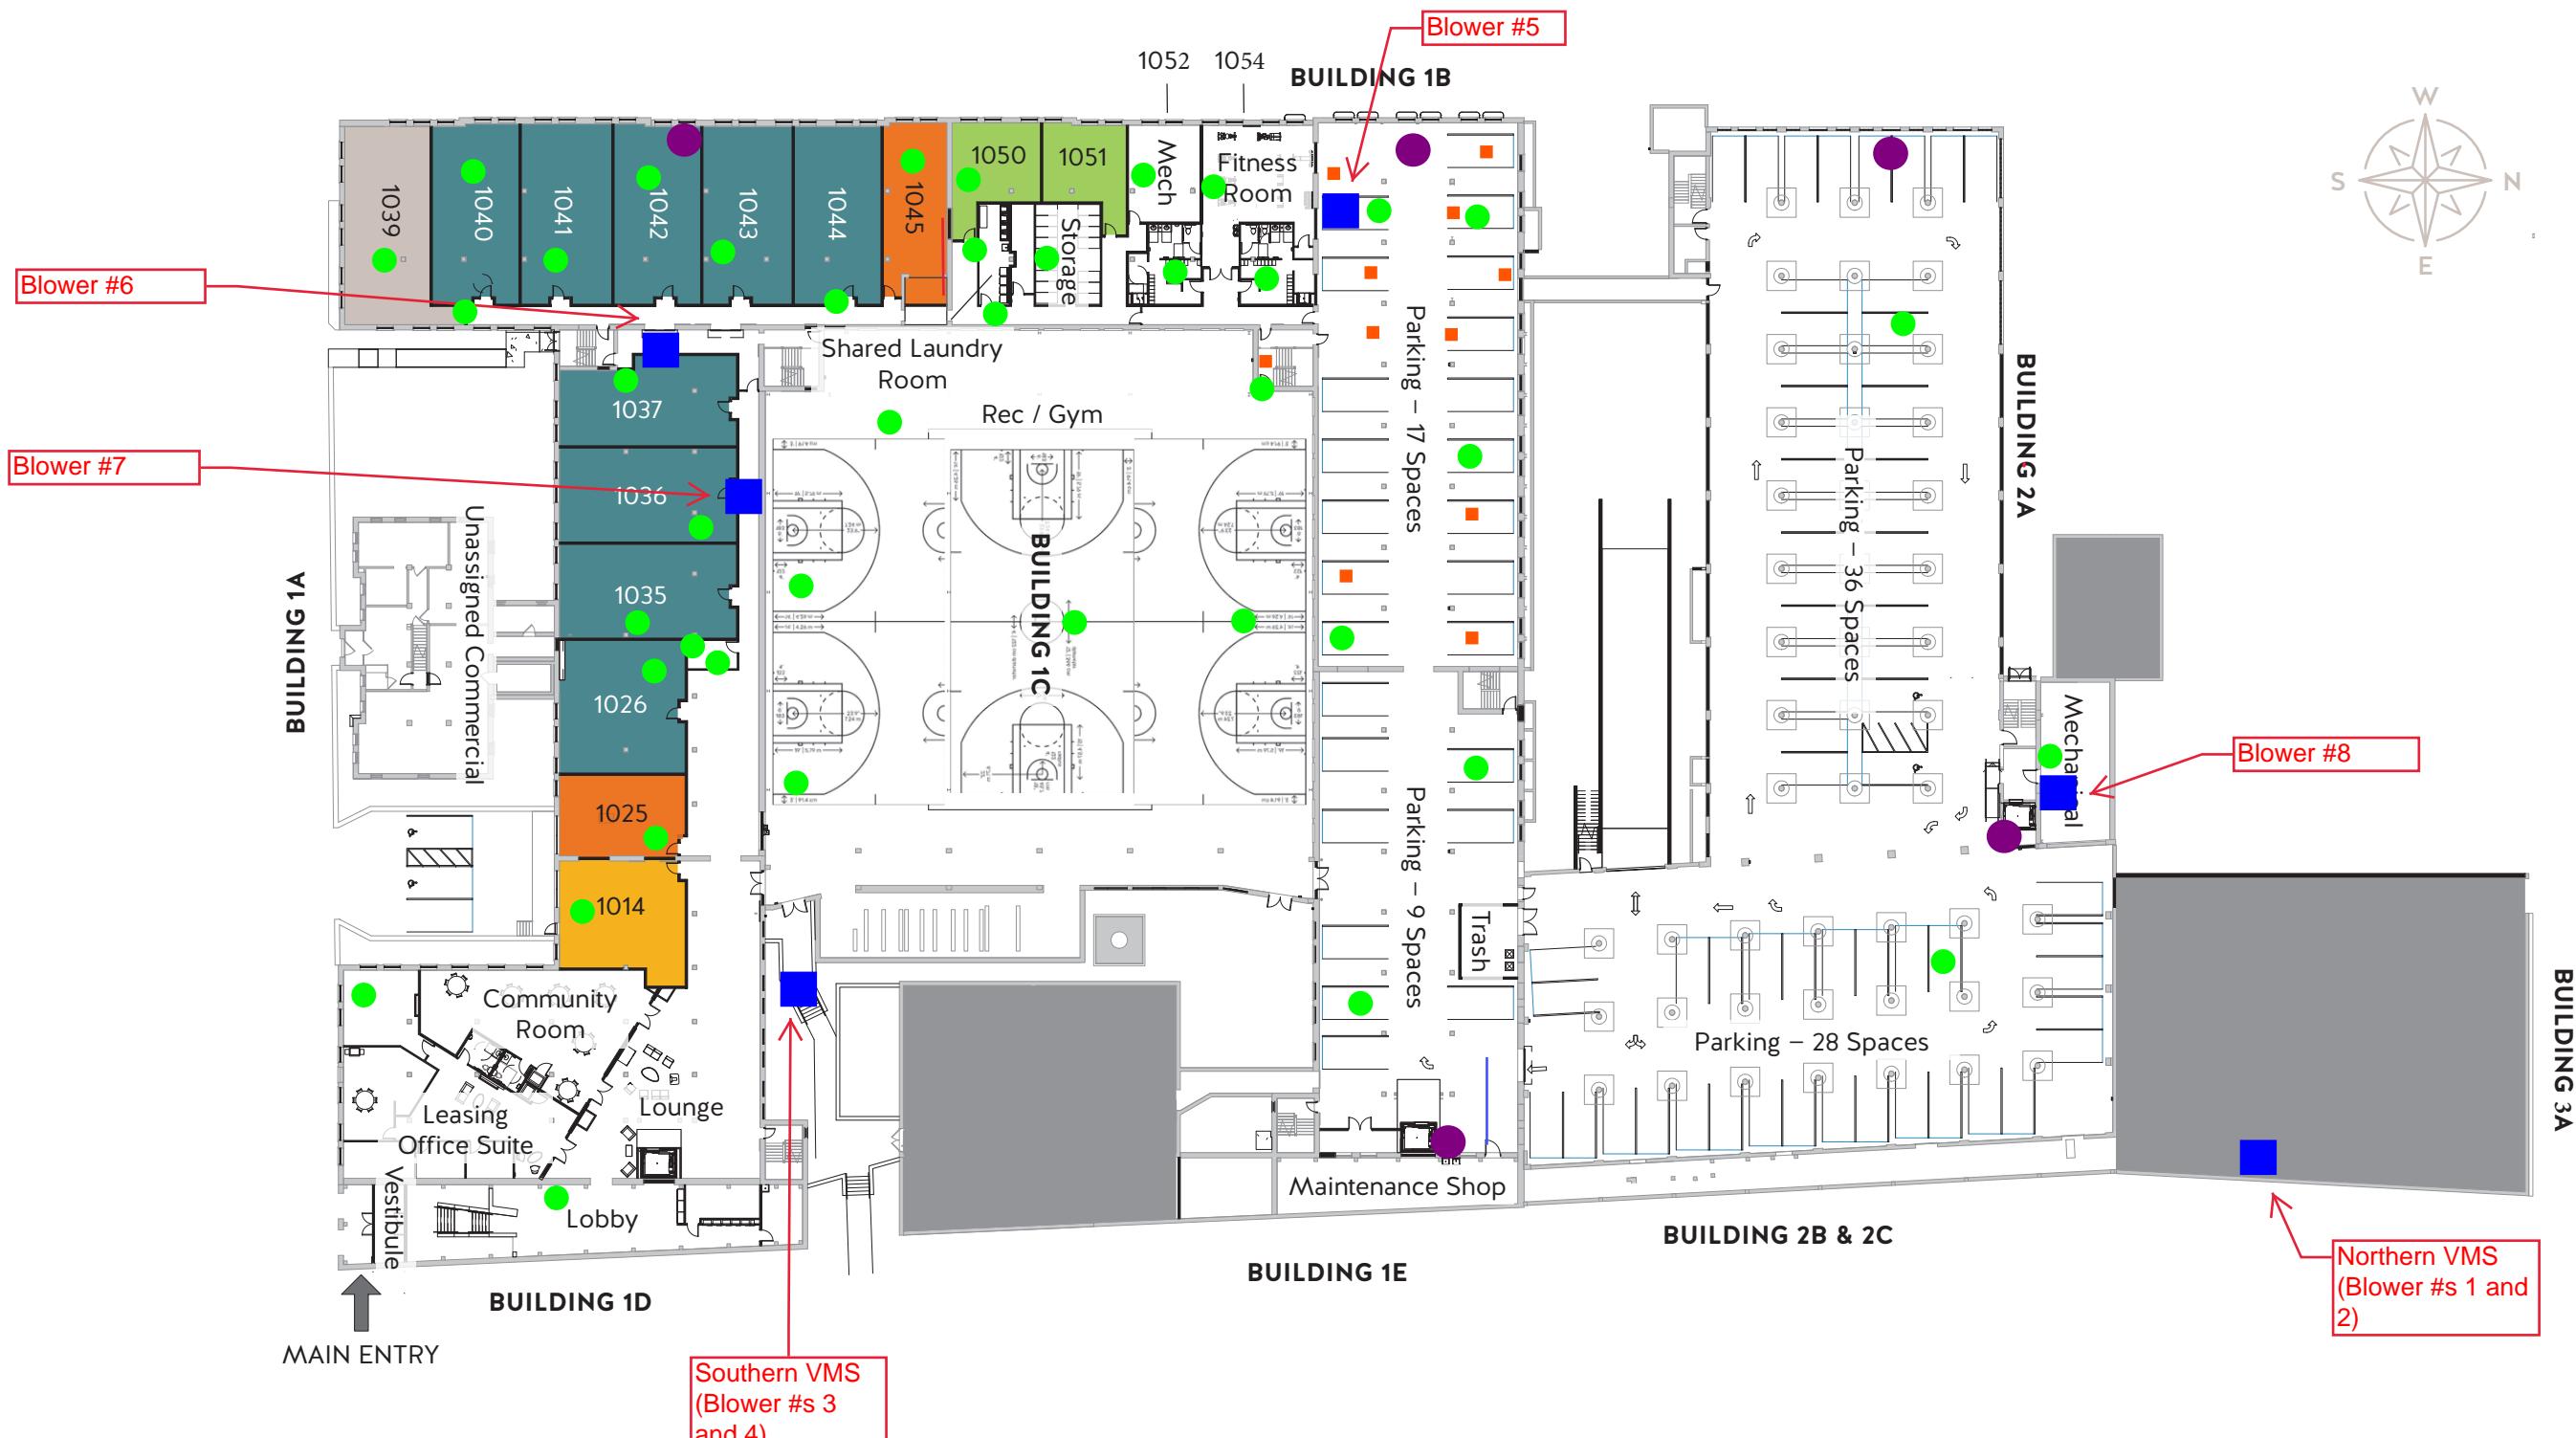
Figure 1 - CWC EB Level 1 Map with Blower, Vapor Pin, Sump, and Soil Boring Locations

- The values of sub-slab TCE can be observed in Appendix D (Table 8). A major hotspot can be observed in the areas between Units 1043 – 1050, extending to the Laundry and Storage Room, which will require additional action.

1. Submit work plan for additional remediation to WDNR. The plan includes a combination of source removal, Biochar application, and supplemental radon fan installation.
2. Monitor and complete pilot study on additional sealing of wooden columns using a biochar-alginate compound mix.
3. Conduct soil borings in SW garage to evaluate the plume delineation.
4. Coordinate with Horner Plumbing, Roman Electric, and OBAR for installation of replacement GBR fans.
5. Conduct discrete sampling for units being vacated by residents.
6. Continue discrete sampling in various units and common areas and add results to comprehensive data table.
7. Continue continuous sampling of Units 1045 and 1050.
8. Conduct vacuum measurements at strategic locations within the buildings daily.
9. Continue to measure sub-slab TCE concentrations on a weekly basis to evaluate the performance of the VMS.

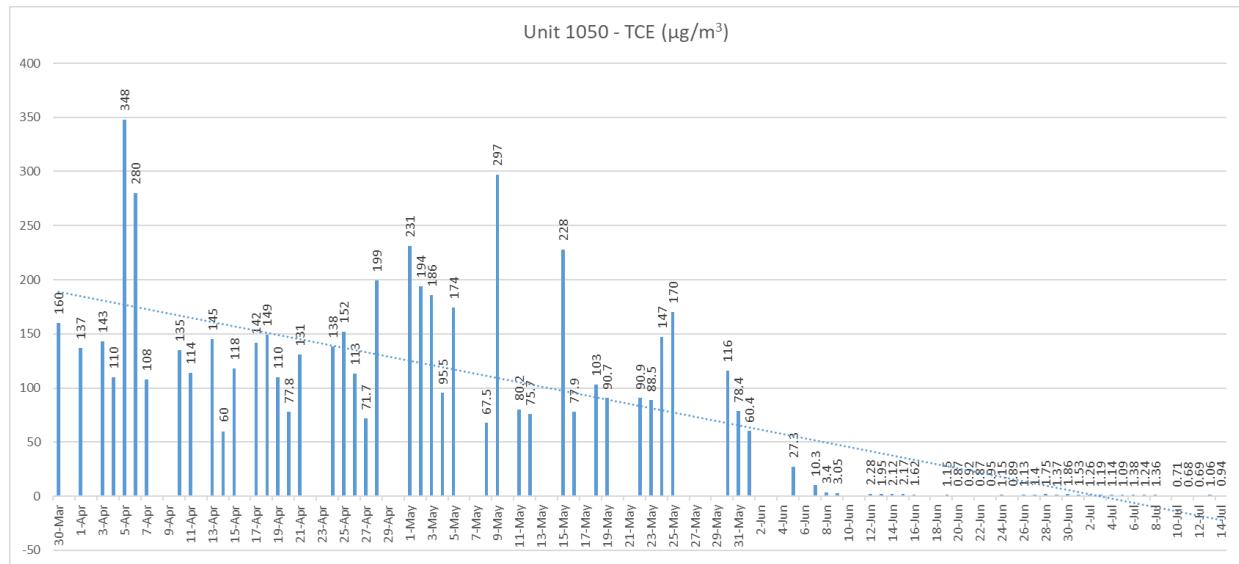
Figure 4 – YTD Data of TCE Concentration in Unit 1050

- Continuous monitoring results in Units 1045 and 1050 are displayed in Figure 3. The continuous monitoring data shows a direct correlation with the barometric pressure and ambient temperature with the values of TCE.
