# ANALYSIS OF SITE CONDITIONS AND PROJECT RECOMMENDATION FOR MILJALA TRIBUTARY

October 2022 Revised November 2022

**Rock Lake Improvement Association**

Resource Engineering Associates, Inc. 3510 Parmenter St., Suite 100 Middleton, Wisconsin, 53562

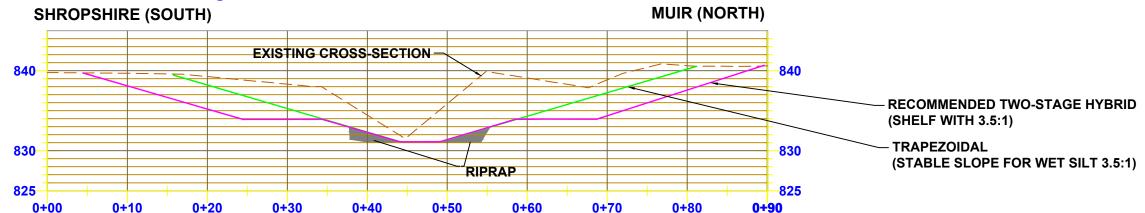
**Cross Section at Alignment - B**

- 4. Installing riprap at the toe of the banks in the farthest west region (cross section A to cross section B; Muir and Shropshire property) for additional stability to areas prone to erosion. The amount and specifications of the riprap should be considered during the final design stage of the project.
- 5. Construct the project during the cold season (late fall/winter) to minimize downstream erosion. Partially frozen ground will reduce the likelihood of construction runoff and be easier for the equipment to move on compared to wet muck. Construction equipment and crews have higher availability in the winter. We anticipate the project would take between one week and a month.
