**Re: Clam River Hydroelectric Project FERC #9185
Flambeau Hydro, LLC
Article 401 (b) (M) – Final 2014 Purple Loosetrife Inventory Report**

2014 Purple Loosestrife Inventory Report
(Per License Article 401 (b) (M))

Clam River Hydroelectric Project
FERC Project # 9185
Flambeau Hydro, LLC

Clam River Project Purple Loosestrife Inventory
August 18 and August 19, 2014
FERC Project # 9185 Article 401(b)(M)

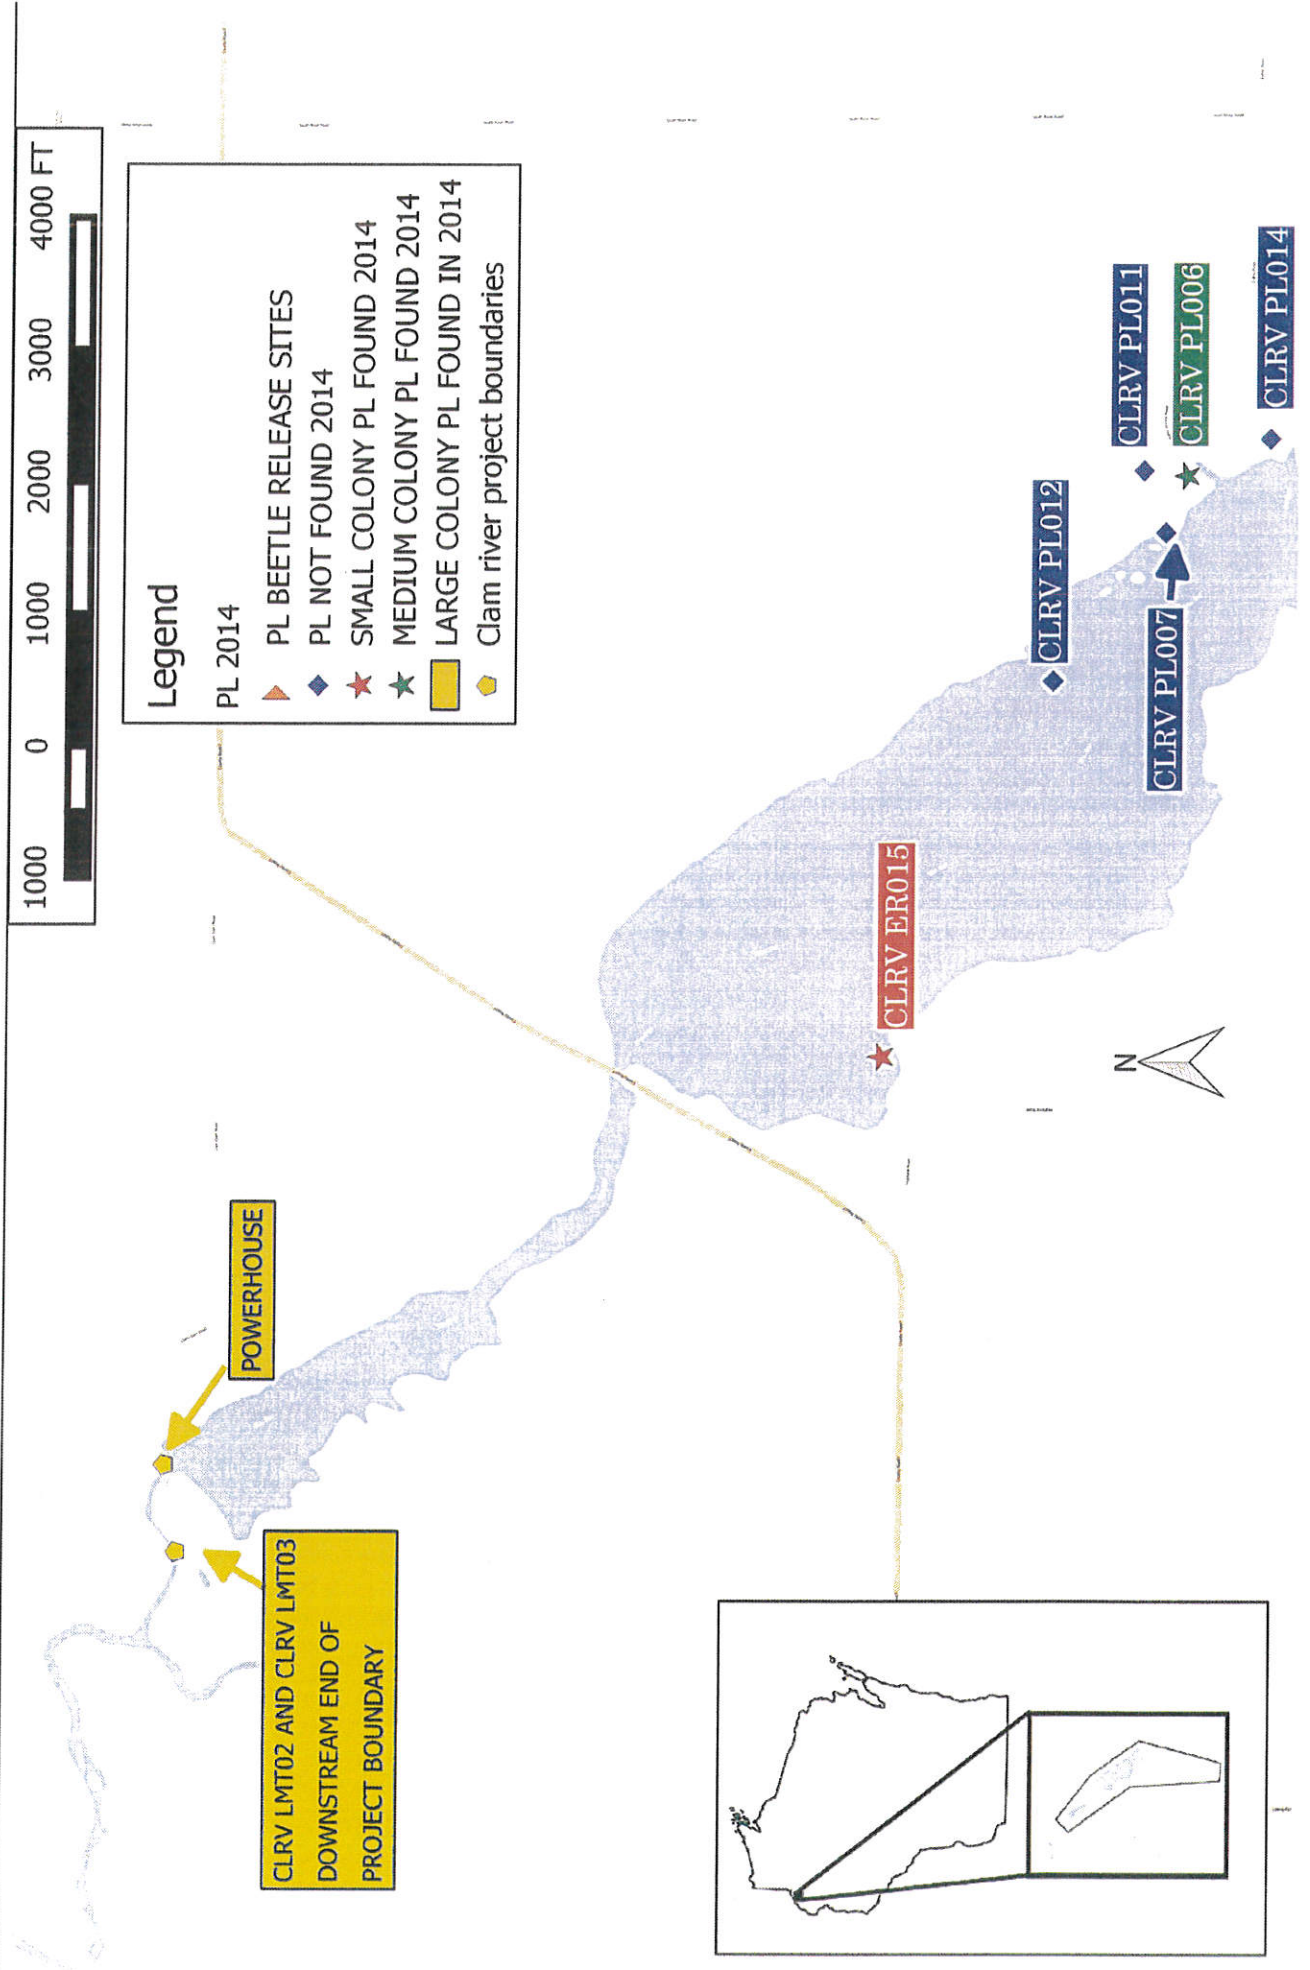
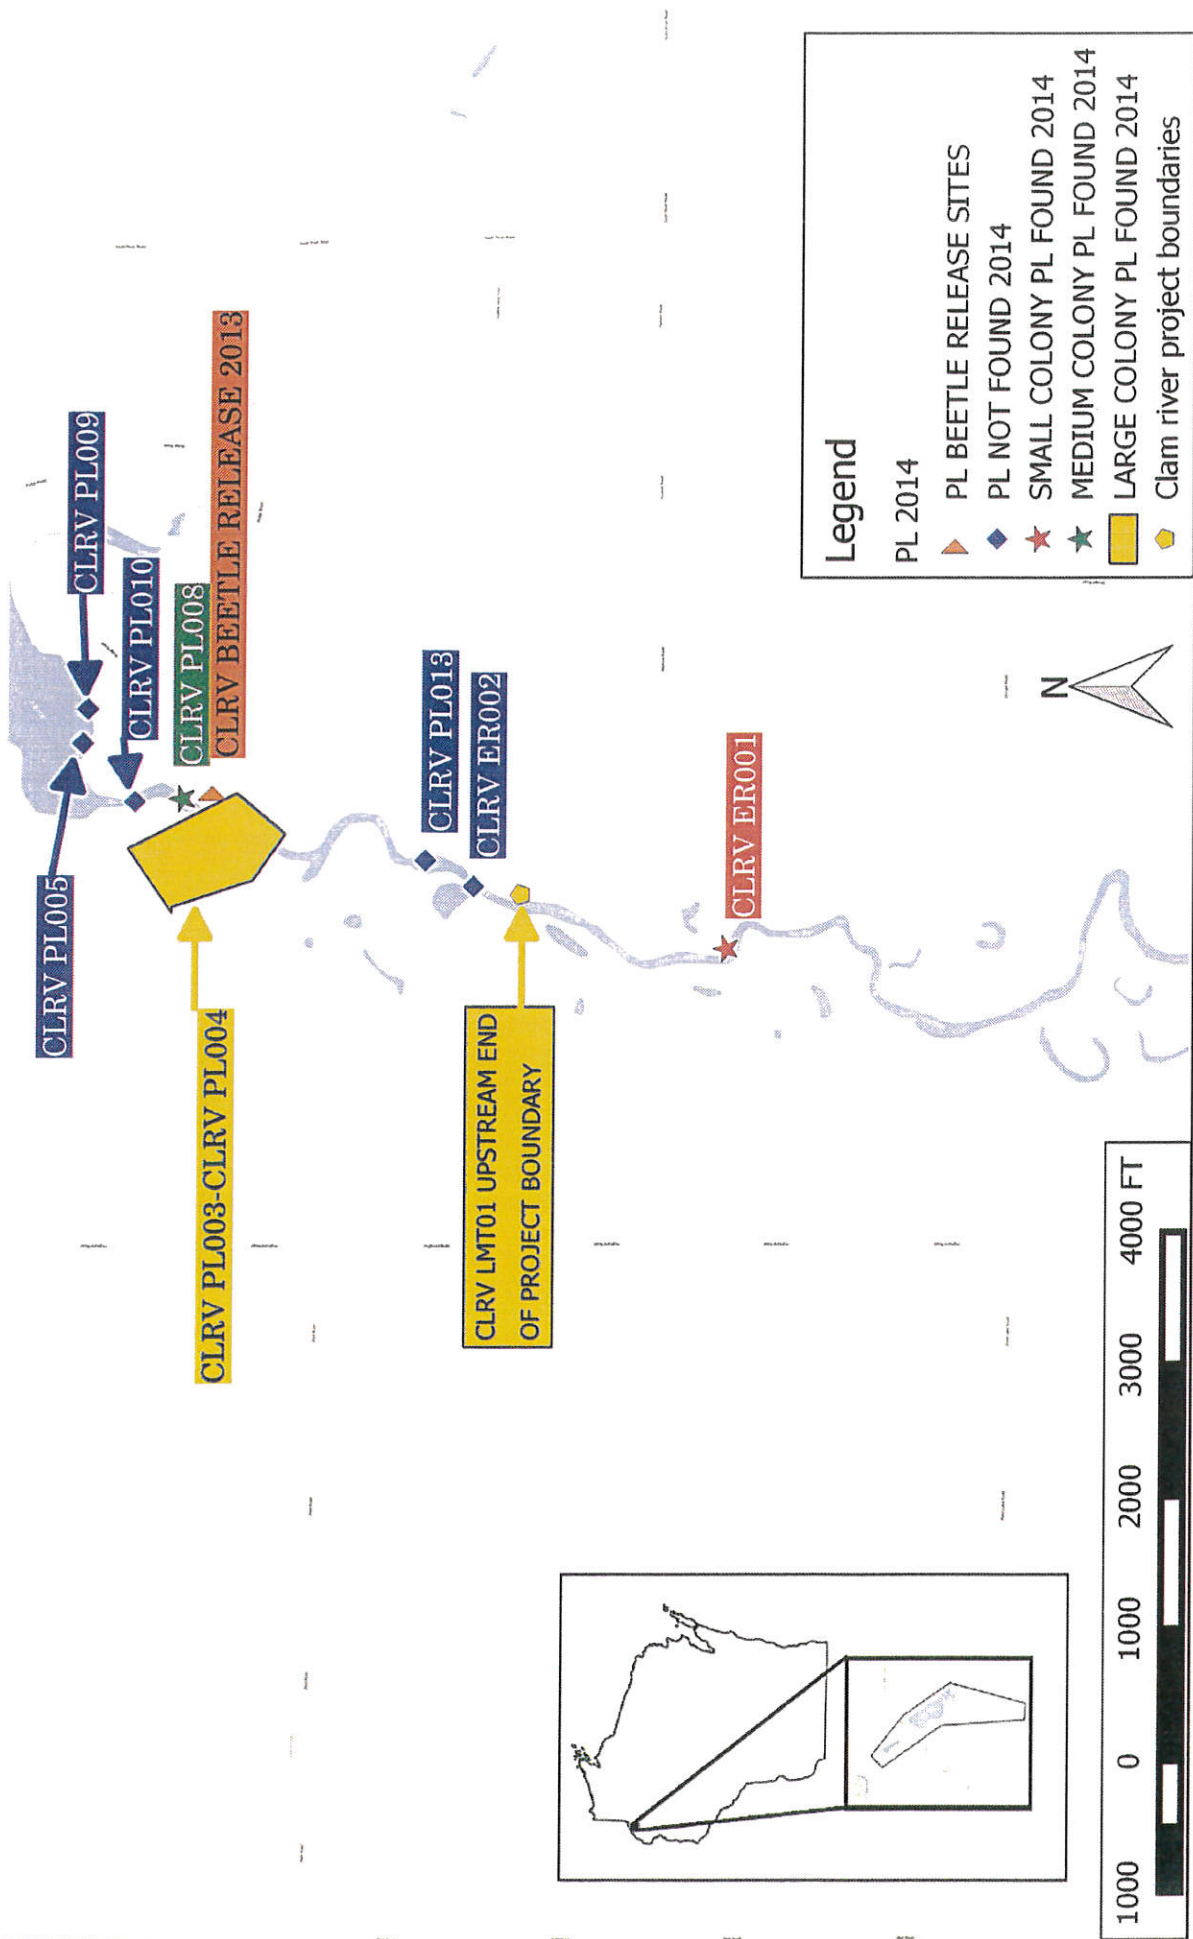
CLAM RIVER PURPLE LOOSESTRIPE LOCATION MAP 2014

On August 18th the *impoundment* was surveyed by canoe. Six areas of purple loosestrife plants were observed in 2014.

At sites CLRVPL002, CLRVPL005, CLRVPL007, CLRVPL009, CLRVPL010, CLRVPL011, CLRVPL012, CLRVPL013, and CLRVPL014 no purple loosestrife was observed during 2014.
