DATE: November 19, 2002

SUBJECT: Drummond S. D. - Surface Water Classification & Designated Use Review

Drummond Sanitary District Wastewater Treatment Plant

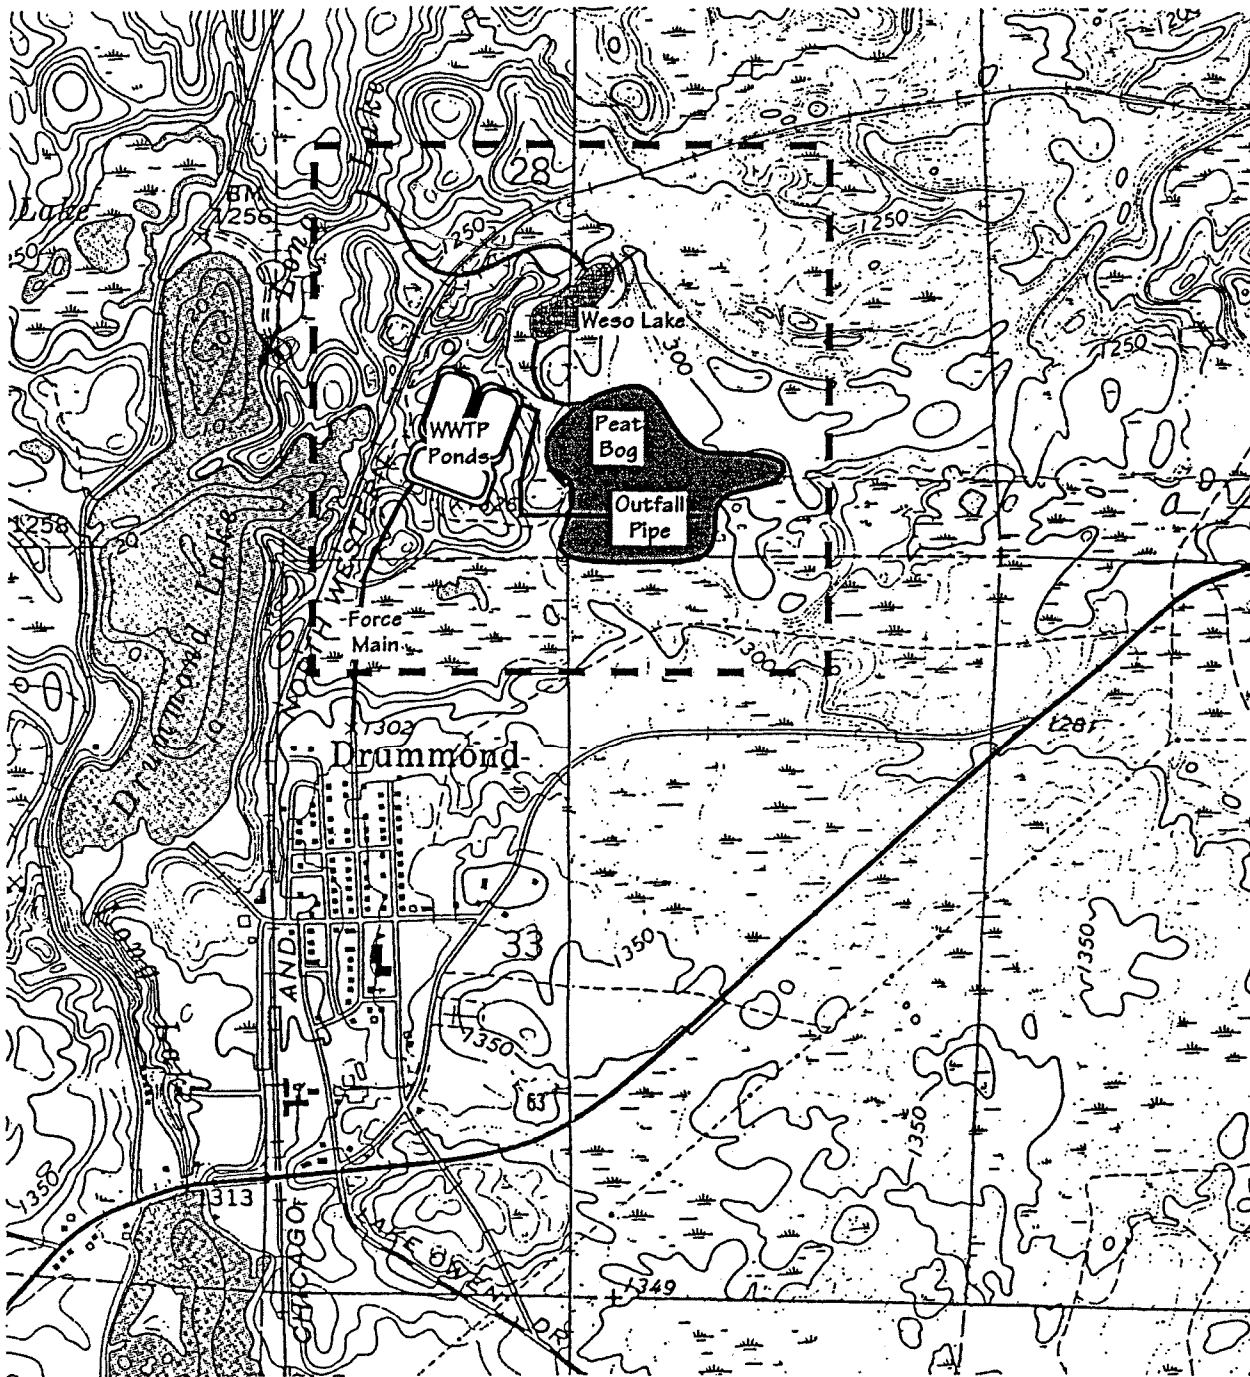
Figure 1
WI-0031615-5

The Drummond S. D. wastewater treatment facility in Bayfield County includes one primary and two secondary cells (Figure 1). Treated wastewater is discharged from the northeast pond through a dispersal pipe located in a bog wetland east of the lagoons (Figure 2). An unnamed, intermittent tributary to the Long Lake Branch of the White River begins at a weir outlet at the northwestern end of the bog (Figure 3). This tributary stream, which does not consistently exhibit defined bed and bank, continues for approximately 350 m, and then it diffuses just before a wetland that surrounds Weso Lake (Figures 4 and 5). The lack of stream connectivity and substrate habitat limits potential fish and aquatic macroinvertebrate communities in the intermittent stream.
