Lake Grant Report: Identifying Restorable Wetlands in the Watersheds of Horicon Marsh & Lake Sinissippi

A project of the Rock River Coalition, Inc.

(Wisconsin Department of Natural Resources Lake Grant #SPL-322-14.1)

Submitted by:
Scott Taylor, Member
Patricia Cicero, President
Rock River Coalition, Inc.
April 2015

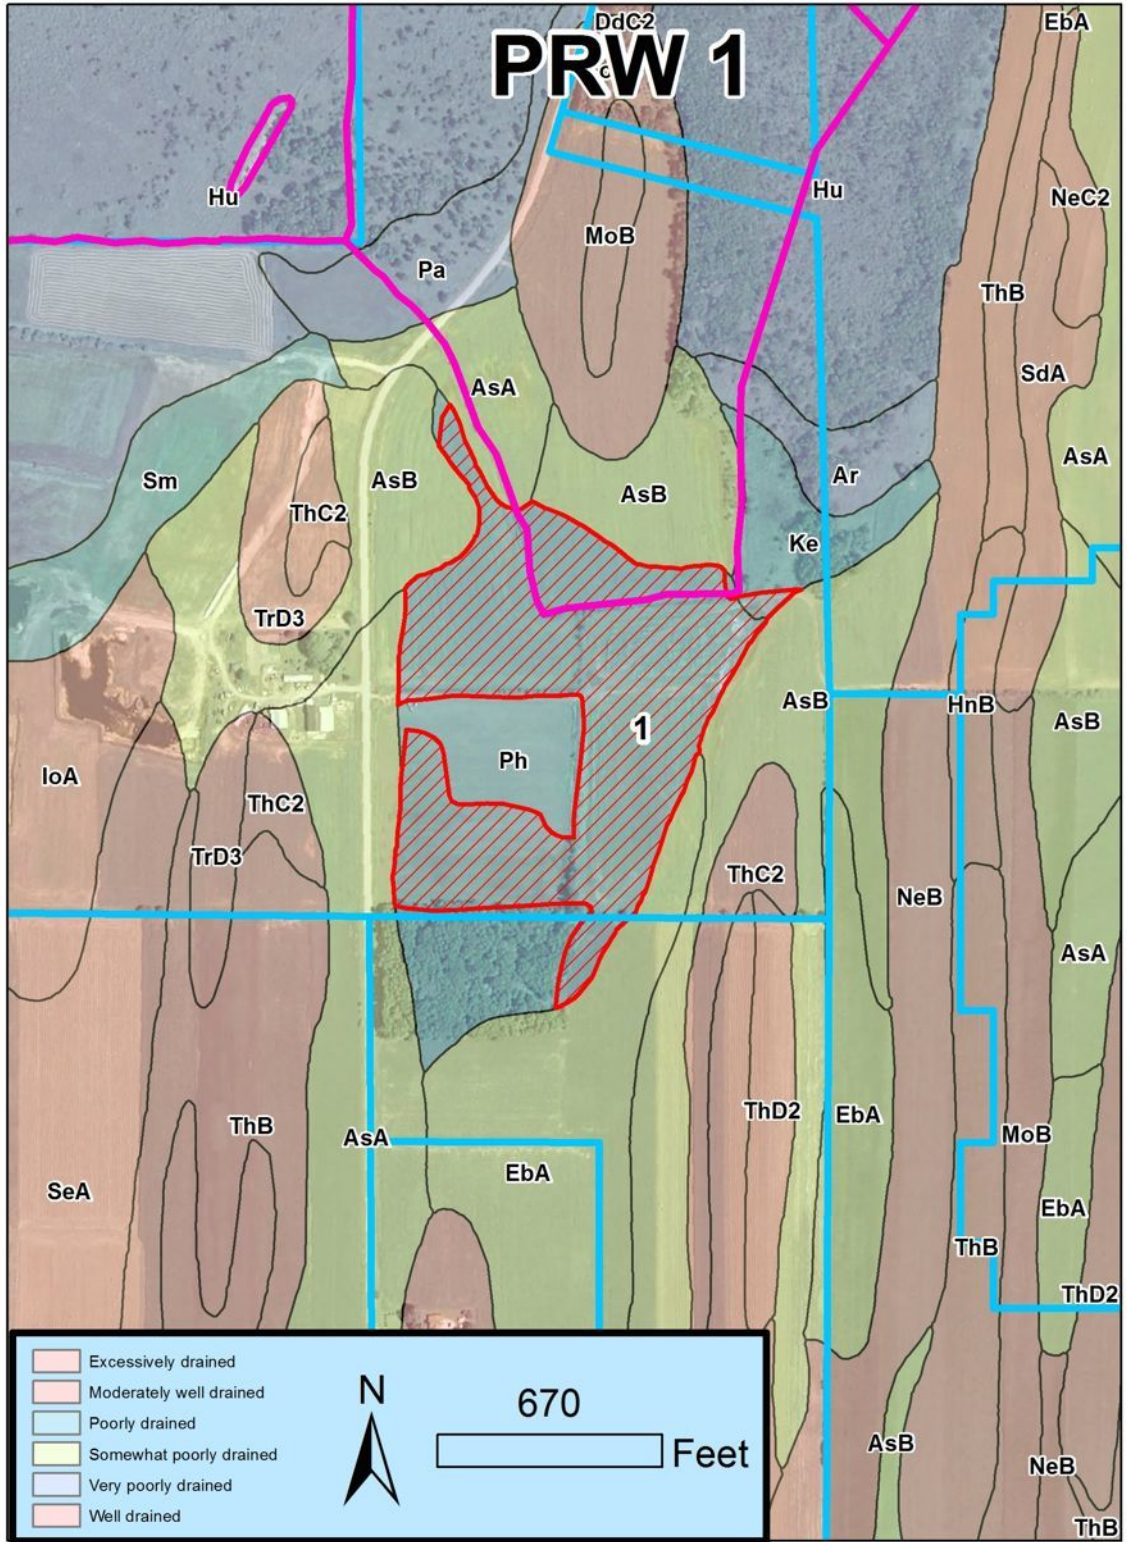
PRW 1

Flat area near woods shows signs of flooding, no crop survival, ruts in field, looks like muck. If tiles present and ditch can be filled, then decent restoration potential. A ditch along north edge of woods was recently cleaned. The woods are ash-dominated.

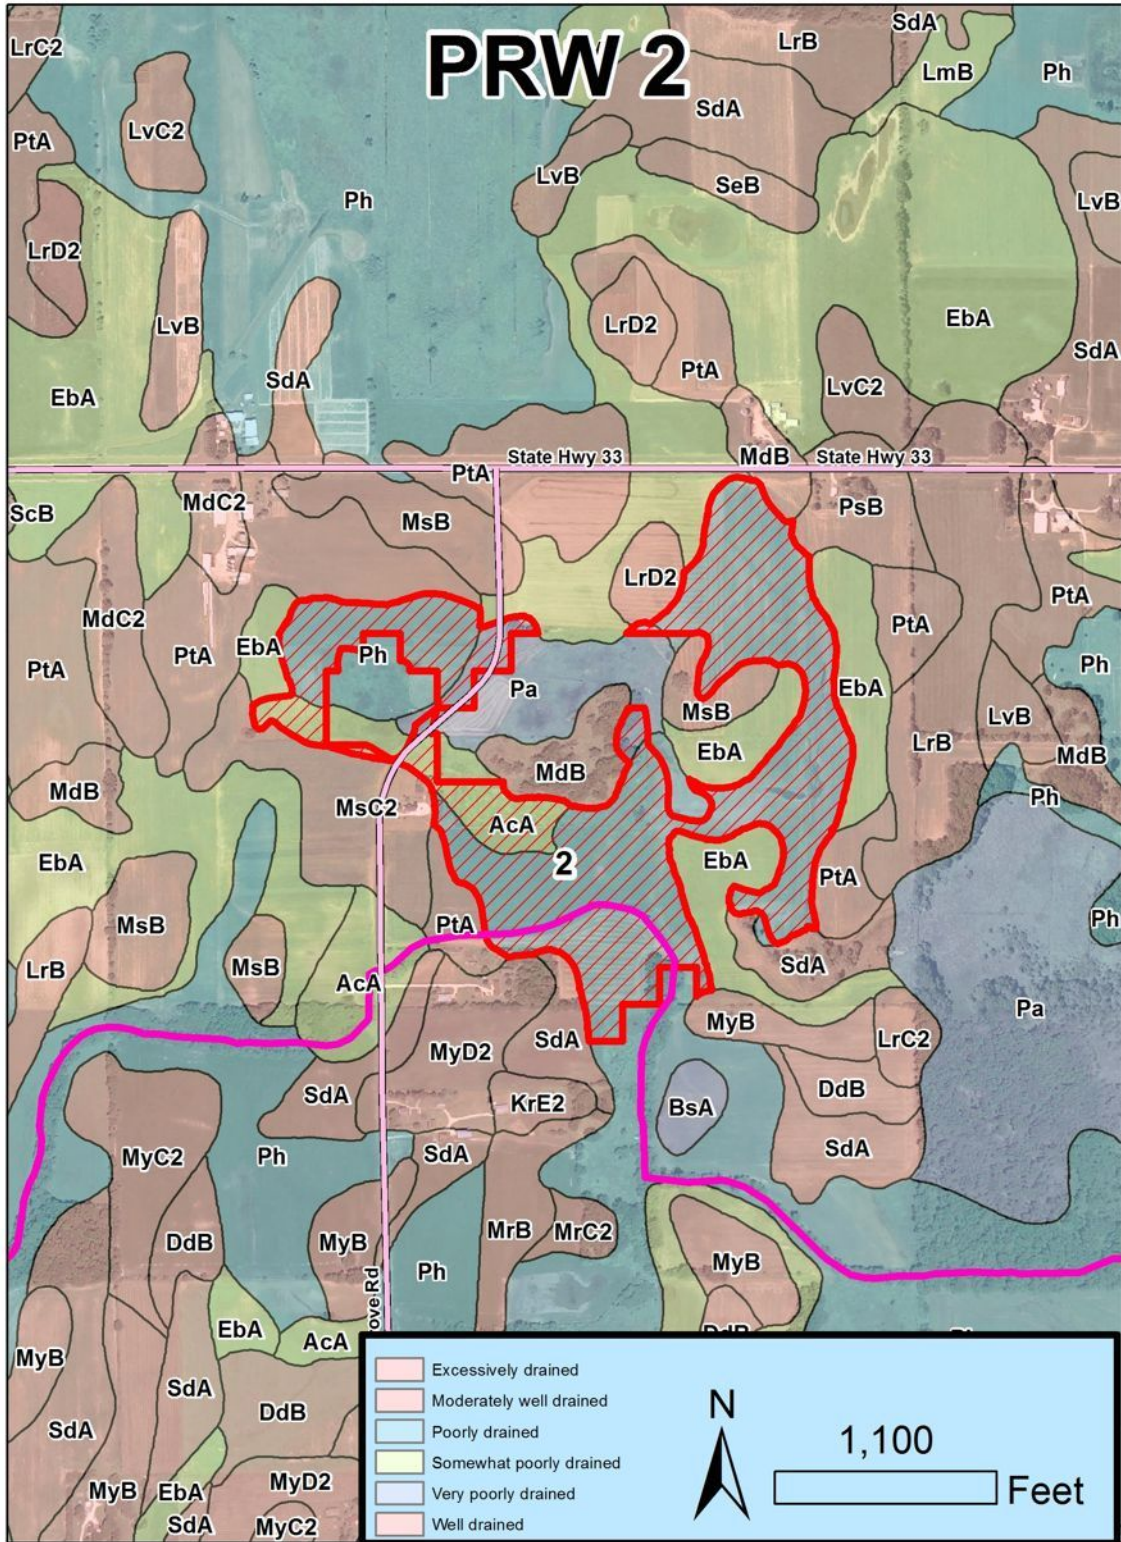
PRW 2

West Segment: Probable tile system, could be disabled. Can't manipulate main creek channel.

East Segment: Restorable by blocking ditch under N. Grove Rd.

South Segment: Same as 9a, possible tile system.

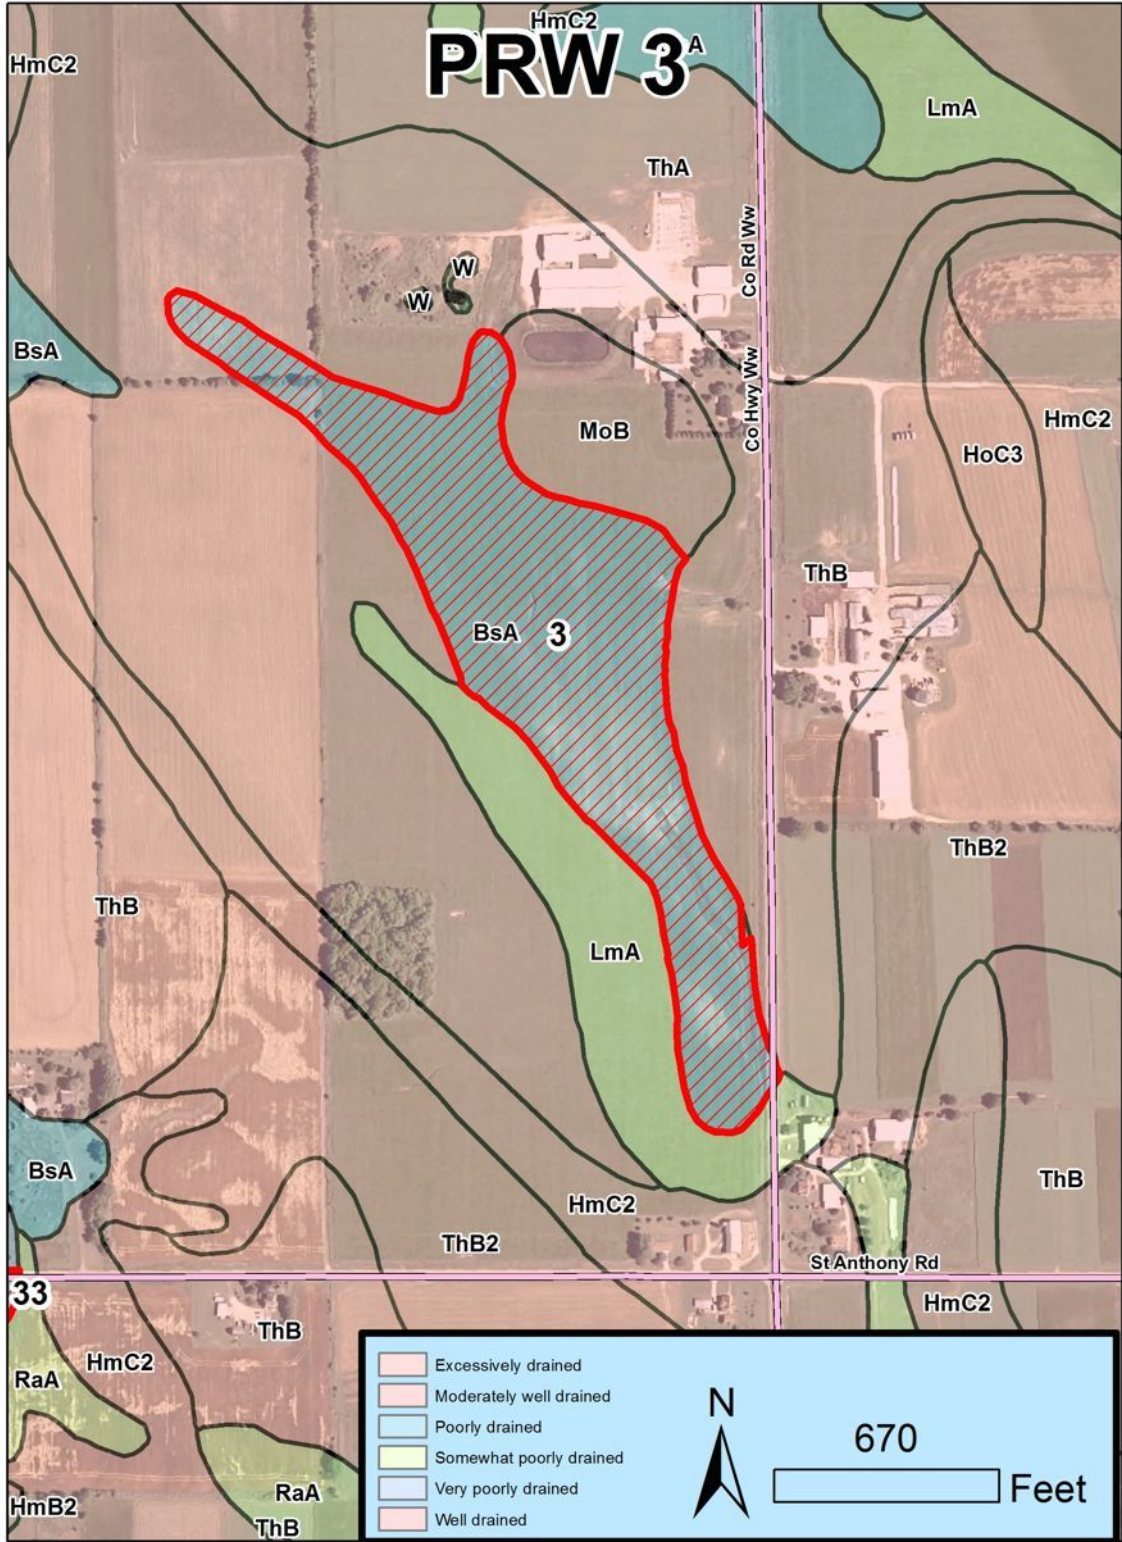
PRW-3

Waterway runs south. Tile riser in middle of field (tile lines present). Gently sloping south, no big flat area. Ditch runs east across road. Some potential for restoration.

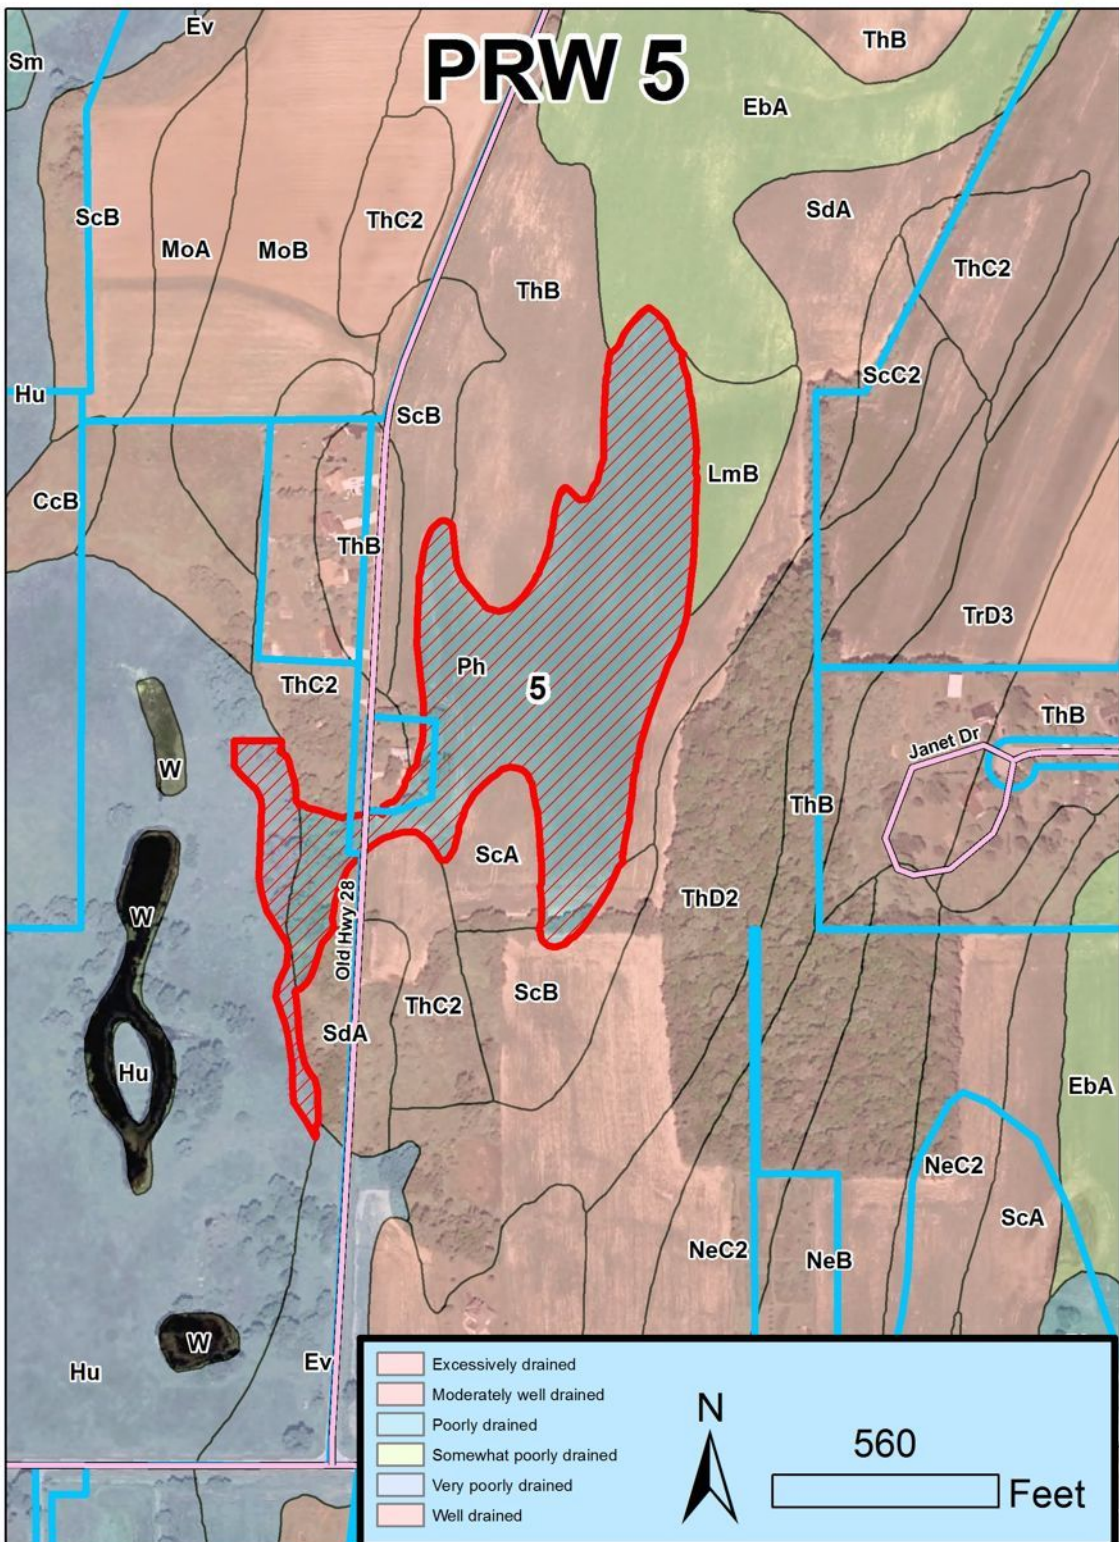
PRW 5

Possible tile outlet in southwest area by road. PRW supported corn in 2014 but pockets of crop stress. Neighbor to north just installed tile, likely connection to this site. Possible restoration if tiles exist.

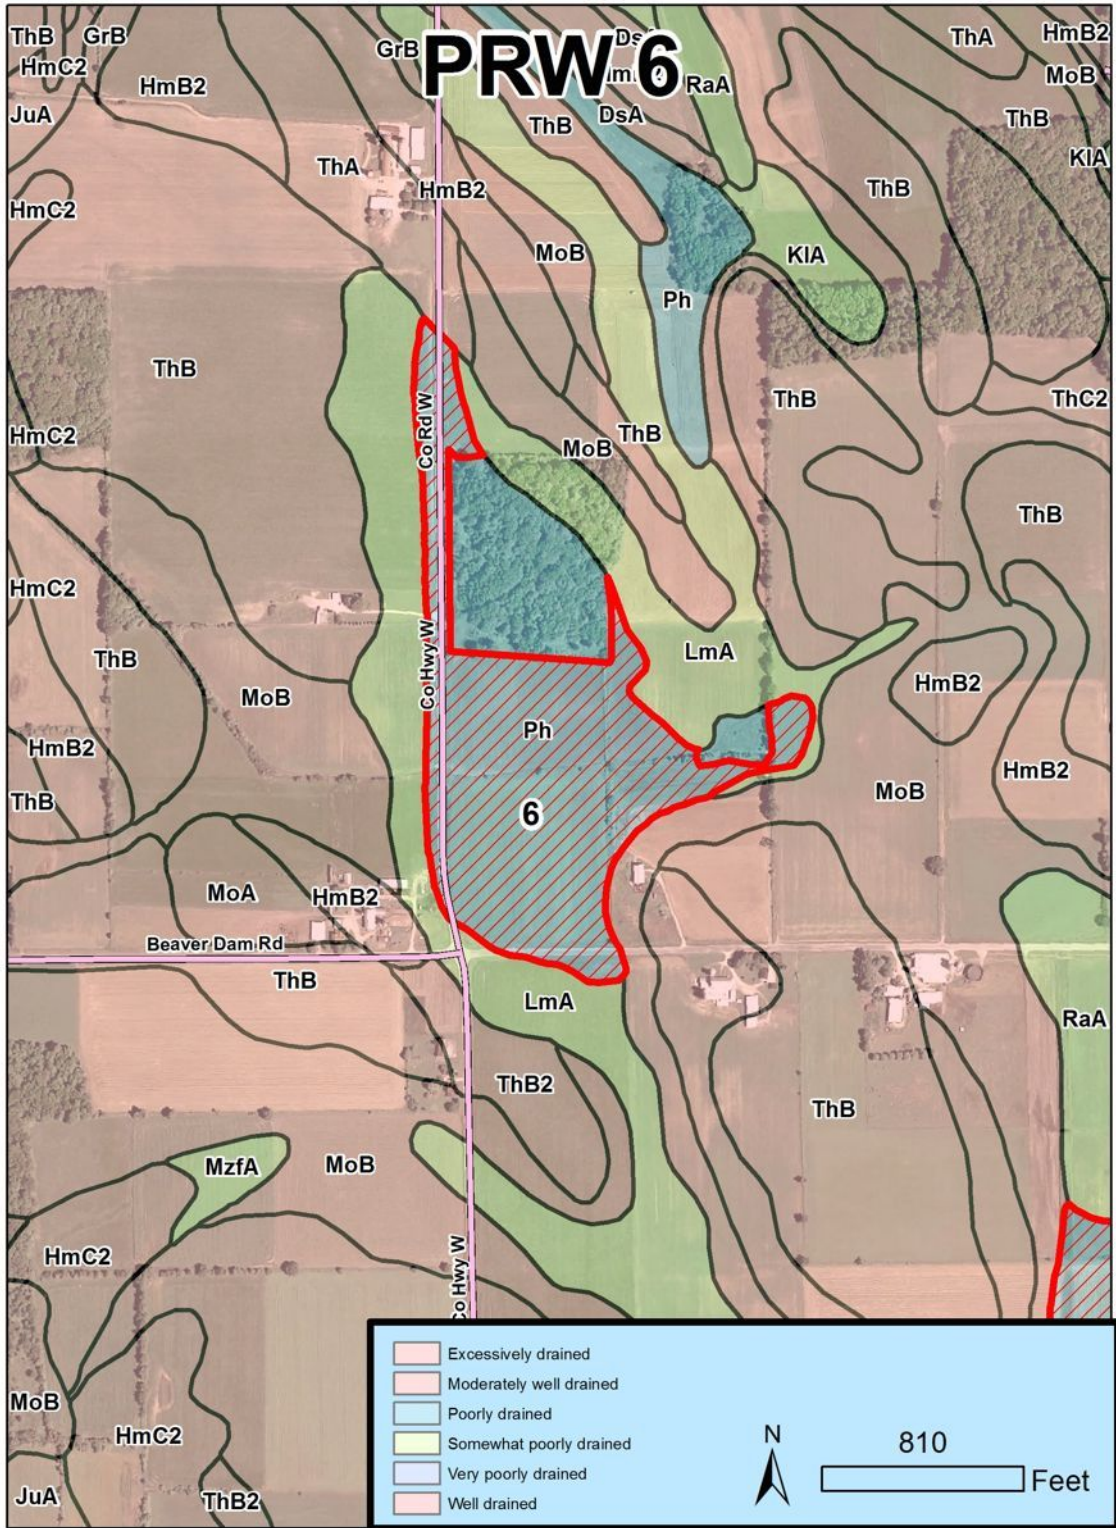
PRW 6

Isolated small ditches. No flow. Large flat landscape. No observable ditch outlet. Nearby woodlot dominated by ash trees. Low potential restoration but could be restored to hardwood swamp.

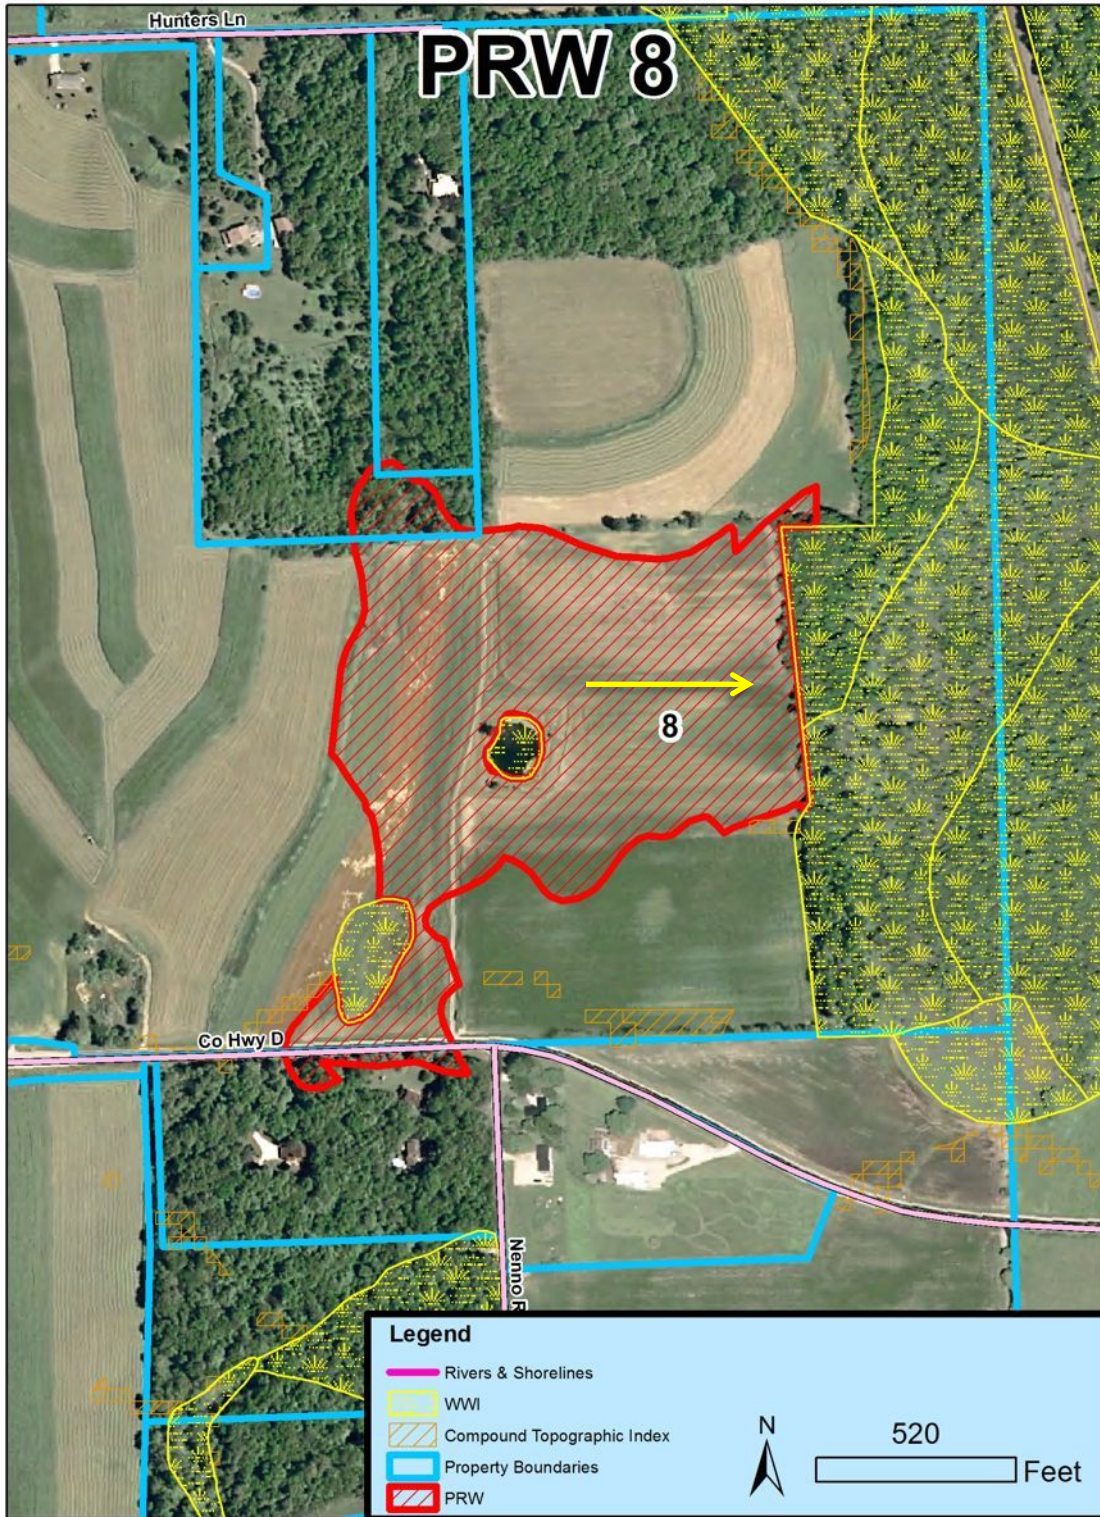
Pond in middle. Ditch (swales) along access road funneling water to pond area. Indications of tile present. Ditch or waterway in middle running east. Good restoration potential.
