**RE: Winter Hydroelectric Project, FERC Project #2064
Flambeau Hydro LLC
Final Report 2017 Land & Wildlife Management Report**

2017 LAND & WILDLIFE MANAGEMENT FINAL REPORT

Winter Hydroelectric Project FERC Project #2064 Flambeau Hydro, LLC

Final Report – December 2017

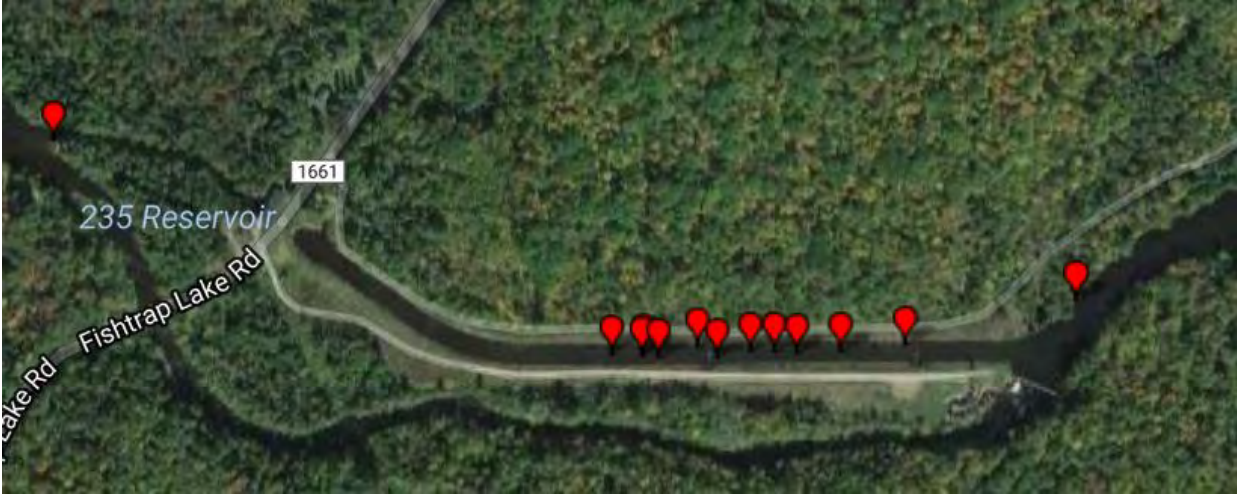
Figure 20. Zoomed out photo of Winter 2017 erosion sites.

The *bypass reach* had fifteen new erosion sites due to the heavy rain events in 2016 (WNTR ER004 to WNTR ER014) (Figure 20). The erosion survey took place on June 14, 2017 and photos were taken. The erosion sites are summarized in Table 2 and photos follow.

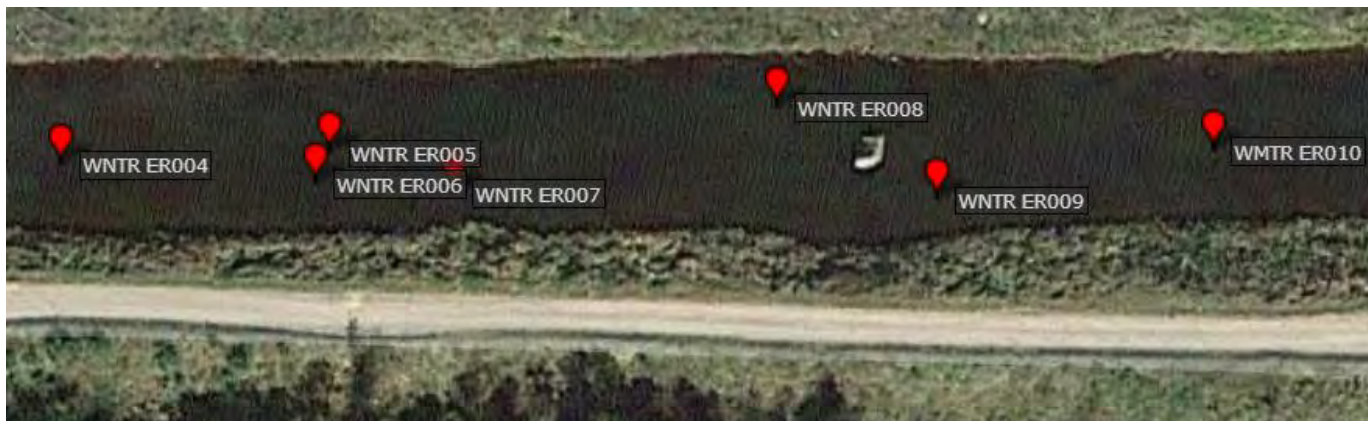
Figure 22. Bypass reach erosion sites 2017.

WNTR ER004 was first observed in 2017 along the left bank facing upstream (Figure 22). It is Moderate in condition. Slumping of the bank due to weathering was the cause of this erosion and grasses are present (Figure 9).

WNTR ER005 was first observed in 2017 along the left bank facing upstream (Figure 22). It is Severe in condition. Slumping of the bank due to weathering was the cause of this erosion (Figure 10). The entire site is bare soil.

WNTR ER006 was first observed in 2017 along the left bank facing upstream (Figure 22). It is Moderate in condition. Slumping of the bank due to weathering was the cause of this erosion and grasses are present (Figure 11).

WNTR ER007 was first observed in 2017 along the left bank facing upstream (Figure 22). It is Moderate in condition. Slumping of the bank due to weathering was the cause of this erosion and grasses are present (Figure 12).

WNTR ER008 was first observed in 2017 along the left bank facing upstream (Figure 22). It is Moderate in condition. Slumping of the bank due to weathering was the cause of this erosion and grasses and many rocks are present (Figure 13).

WNTR ER009 was first observed in 2017 along the right bank and left bank (ER009b) facing upstream (Figure 22). All three sites are Moderate in condition. Slumping of the bank due to weathering was the cause of this erosion and grasses are present (Figure 14, 14a, and 14b).

WNTR ER010 was first observed in 2017 along the left bank facing upstream (Figure 22). It is Minor (ER010) and Severe (ER010a) in condition. Slumping of the bank due to weathering was the cause of this erosion and grasses are present (Figure 15 and 15a).

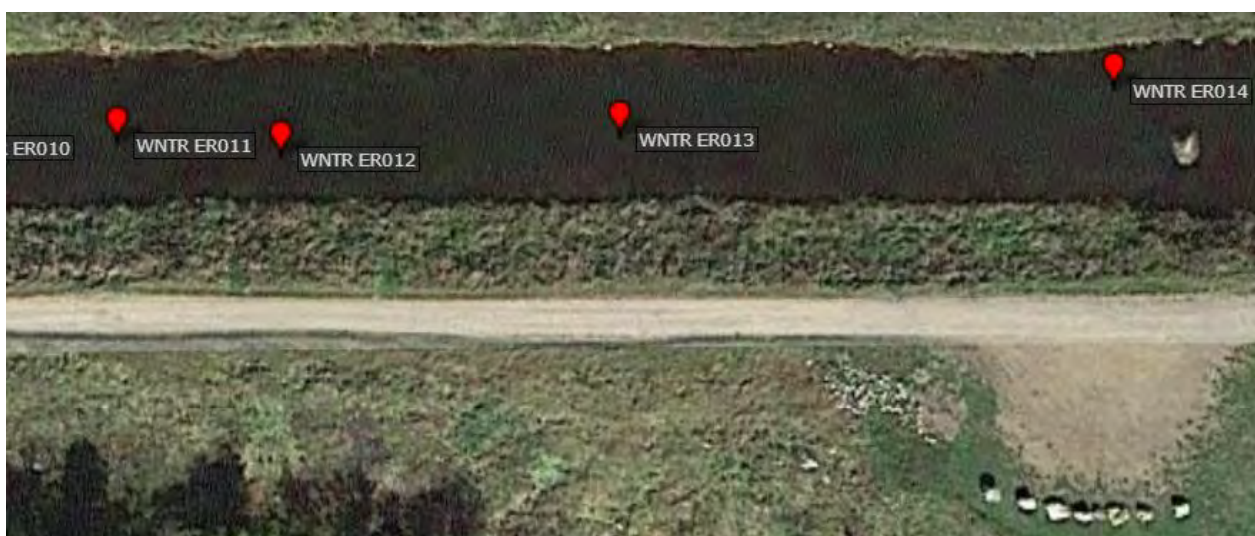
Figure 23. Bypass reach erosion sites 2017.

WNTR ER011 was first observed in 2017 along the left bank facing upstream (Figure 23). It is Moderate in condition. Slumping of the bank due to weathering was the cause of this erosion and grasses are present (Figure 16).

WNTR ER012 was first observed in 2017 along the left bank facing upstream (Figure 23). It is Moderate in condition. Slumping of the bank due to weathering was the cause of this erosion and grasses are present (Figure 17).

WNTR ER013 was first observed in 2017 along the left bank facing upstream (Figure 23). Both sites are Moderate in condition. Slumping of the bank due to weathering was the cause of this erosion and grasses are present (Figure 18).

WNTR ER014 was first observed in 2017 along the right bank facing upstream (Figure 23). Both sites are Moderate in condition. Slumping of the bank due to weathering was the cause of this erosion and grasses are present (Figure 19).

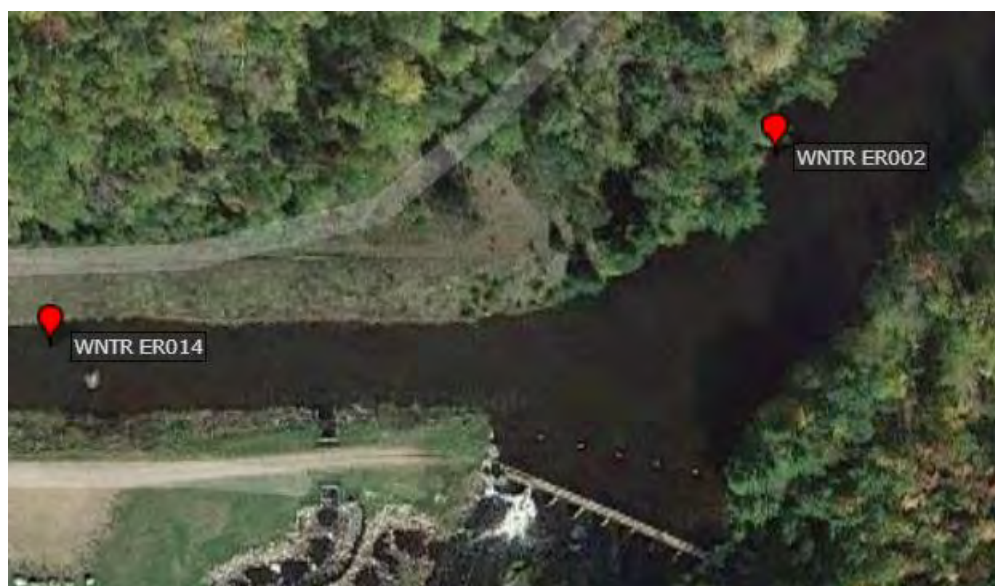
Figure 24. Impoundment erosion site 2017.

WNTR ER002 is located on the right side of the river near the spillway about 0.43 miles upstream from the powerhouse (Figure 24). This site is not located on FHLLC property. It is considered a Minor site due to the small size and stability of the toe (Figure 7). The entire toe is established with rock and gravel and has been growing more grasses during the last 4 years. No noticeable erosion has been evident during the monitoring period of 2011 through 2017. It is unlikely to contribute noticeable sediment to the river in its current condition. No other unusual erosion sites were observed in the impoundment.
