Pioneer Lake 2019 Lake Assessment Report

Prepared by
Vilas County Land & Water Conservation

November 16, 2020

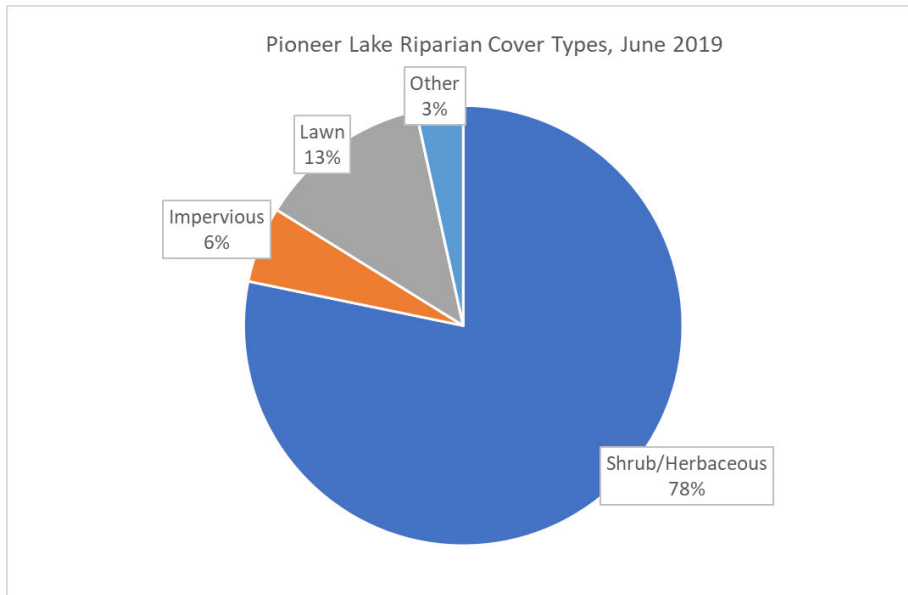
The shoreline of Pioneer Lake consists of 80 privately owned parcels. Within the 35 ft. buffer zone, 61% of the area was covered by a canopy (trees taller than 16 ft.). In many cases, parcels with lower canopy

Figure 7. Ground cover type in Riparian Buffer Area (35 ft. inland from shore) on Pioneer Lake, 2019.

percentages correlated with higher percentages of lawn, however; the wetland area at the Twin River outlet naturally has very little canopy. See Figure 37 for a map of percent canopy cover.

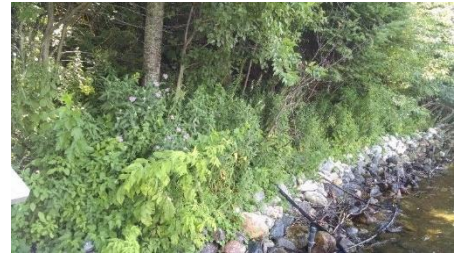
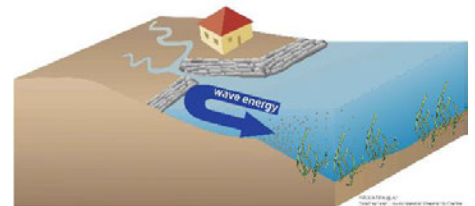
Within the Bank Zone, several parcels had human modifications of riprap, other erosion control structures, or artificial beaches. 465 ft. of artificial beaches was documented. Some parcels had bank erosion with a greater than 1 ft. face (more than 1 foot vertical face of bank is eroded for a certain length of shoreline). Shoreland length of these human modifications and bank erosion appear in Figure 17. Notice that over 2,700 ft. (over 12%) of the shoreline of Pioneer Lake is rock riprapped. While riprap can protect shorelines from erosion resulting from wave and wake energy, some energy will be transferred to the edges of the non-riprapped areas and lake bottom, resulting in possible erosion on adjacent shorelines and lake bottom (Basco). See Figures 10 and 11.

Riprap

Waves bounce back from the surface with higher energy, stirring up mud and clouding the water.

Figure 10. Top: Rock riprap photo. Bottom: Wave energy is “bounced” or transferred from riprap to adjacent shoreline and lake bottom. While the armored section is protected, the adjacent shoreline and lake bottom are now the target of higher wave energy, making them further susceptible to erosion. Kristen Minogue, Smithsonian Environmental Research Center.

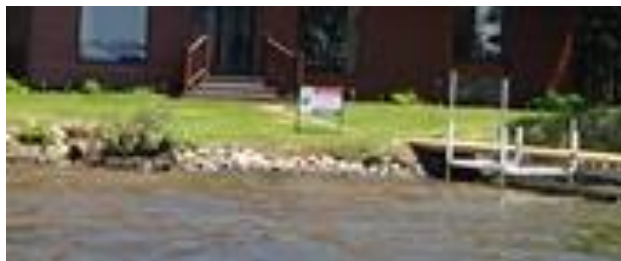
It seemed several lake properties had “For Sale” signs. As properties change hands, more education about lake living may be needed.

Figure 20. Property for sale on Pioneer Lake.

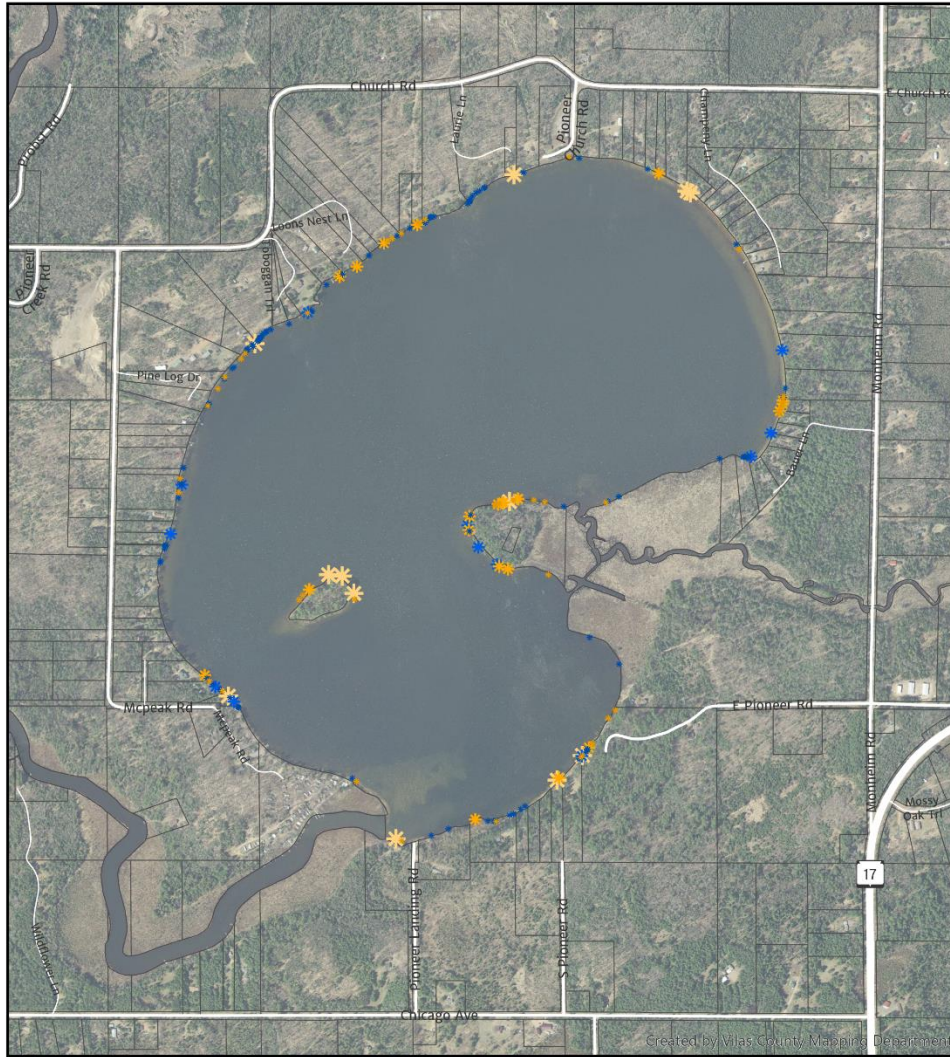
The rate of 46.49 logs/miles is considered low. Riparians that are interested in increasing wood in the lake should work with either Vilas County Land & Water Conservation or the DNR Fisheries Biologist for recommendations.

Coarse Woody Habitat Shoreland Survey 2019 - Pioneer Lake (1623400)

Coarse Woody Habitat Location and Coverage	
Does Not Cross OHWM	Crosses OHWM
Full Tree Crown (0)	Full Tree Crown (12)
A Few Branches (13)	A Few Branches (22)
No Branches (102)	No Branches (43)

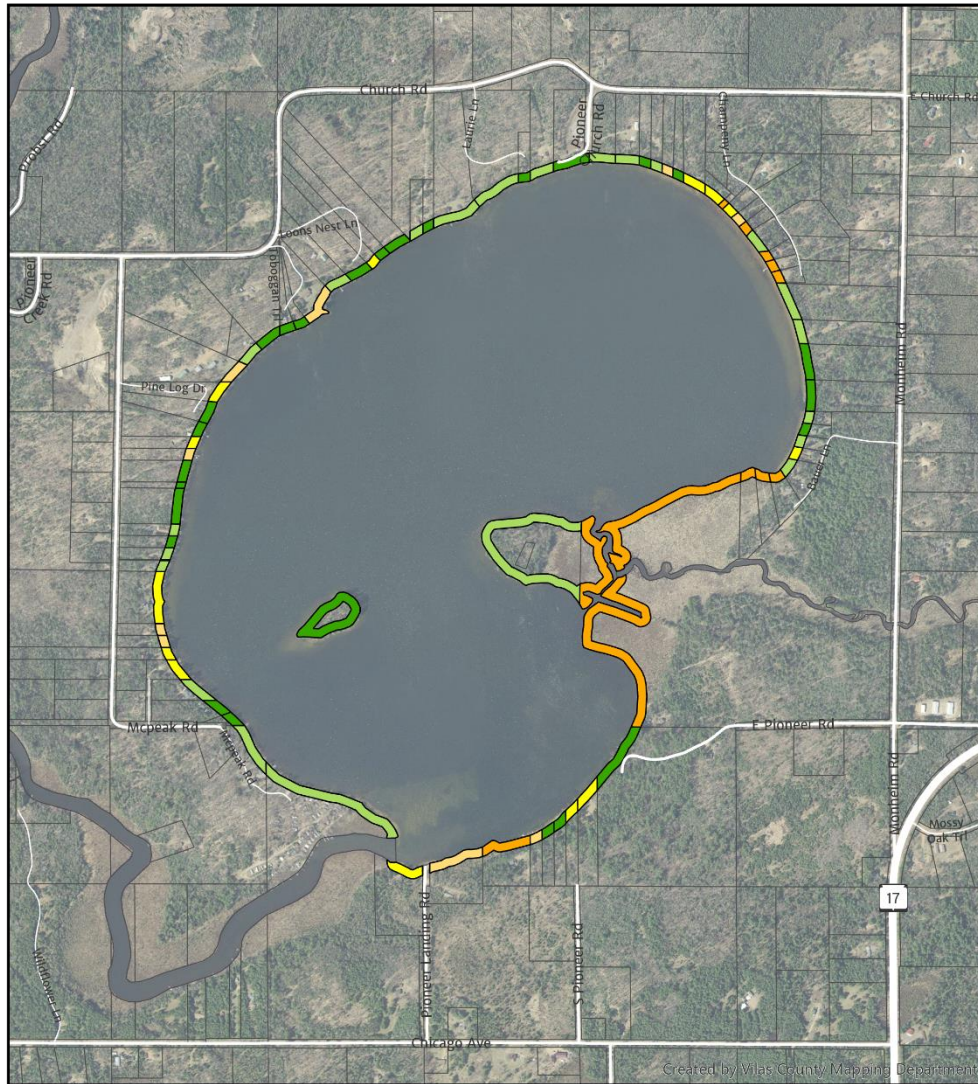
Figure 37. Canopy cover percent per parcel within 35 ft buffer area on Pioneer Lake 2019.

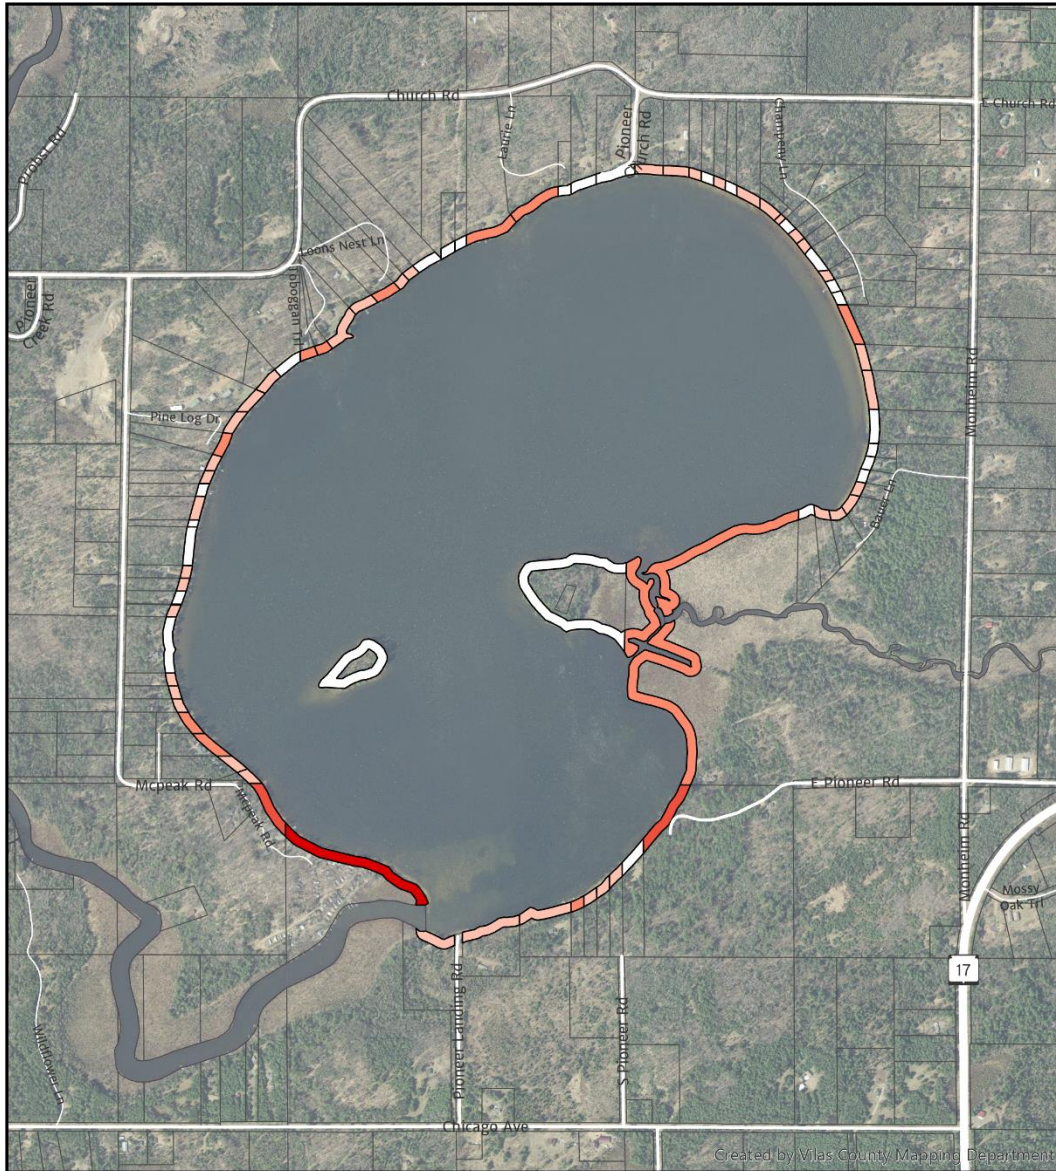
Because of their ecological importance, these areas are typically protected by County Zoning and DNR regulations and permits are often required to modify or place new structures in these areas. In Pioneer Lake, piers were the most common structure. Ten docks or less per kilometer (16 docks/mile) of shoreline, as a reflection of shoreline development, has been shown to be a threshold of maintaining high quality fish diversity in Minnesota (Jacobsen et. al). Pioneer Lake's pier density was 25.20 docks/mile of shoreline, much more than the suggested threshold. Additional littoral

Number of Piers

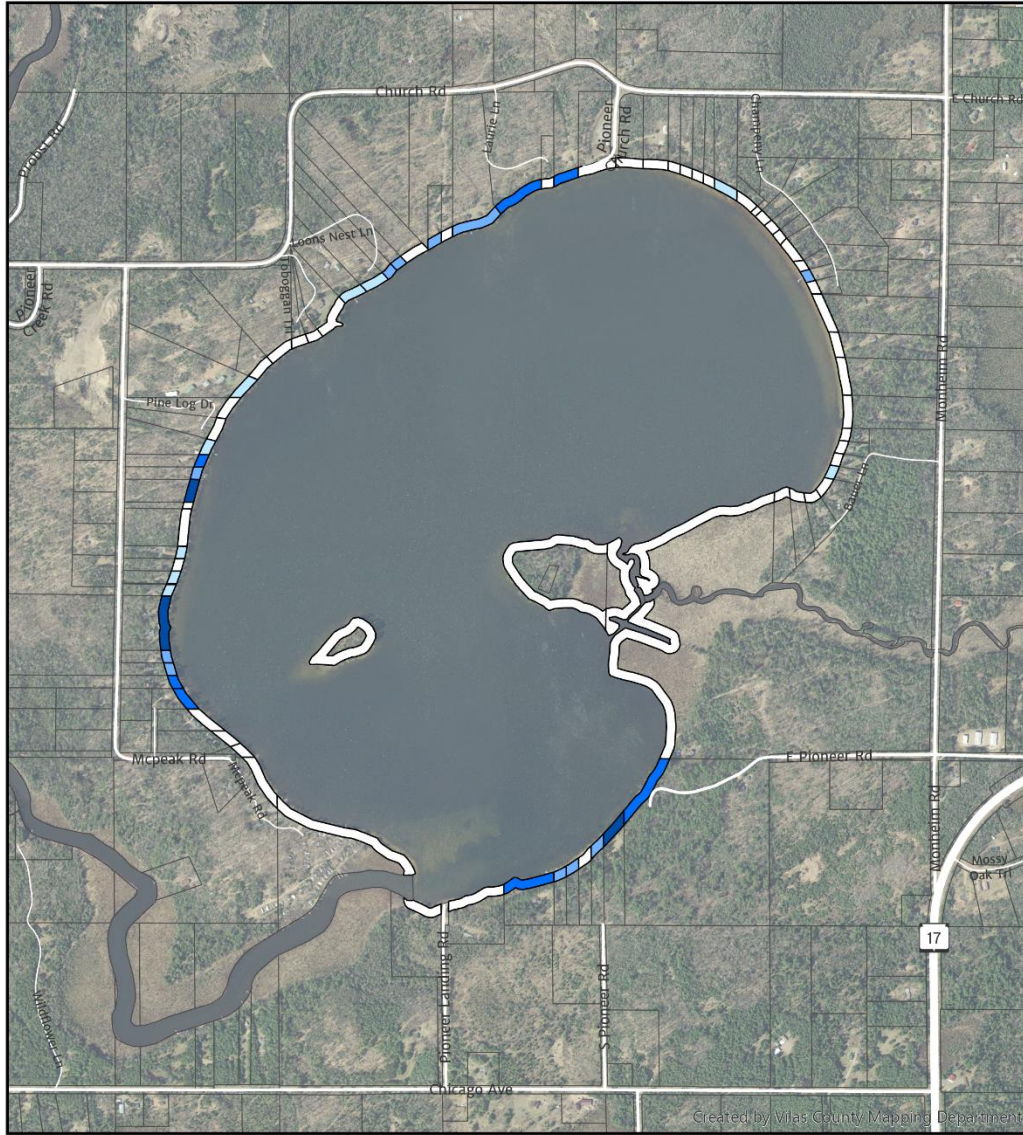
Feet of Rip Rap

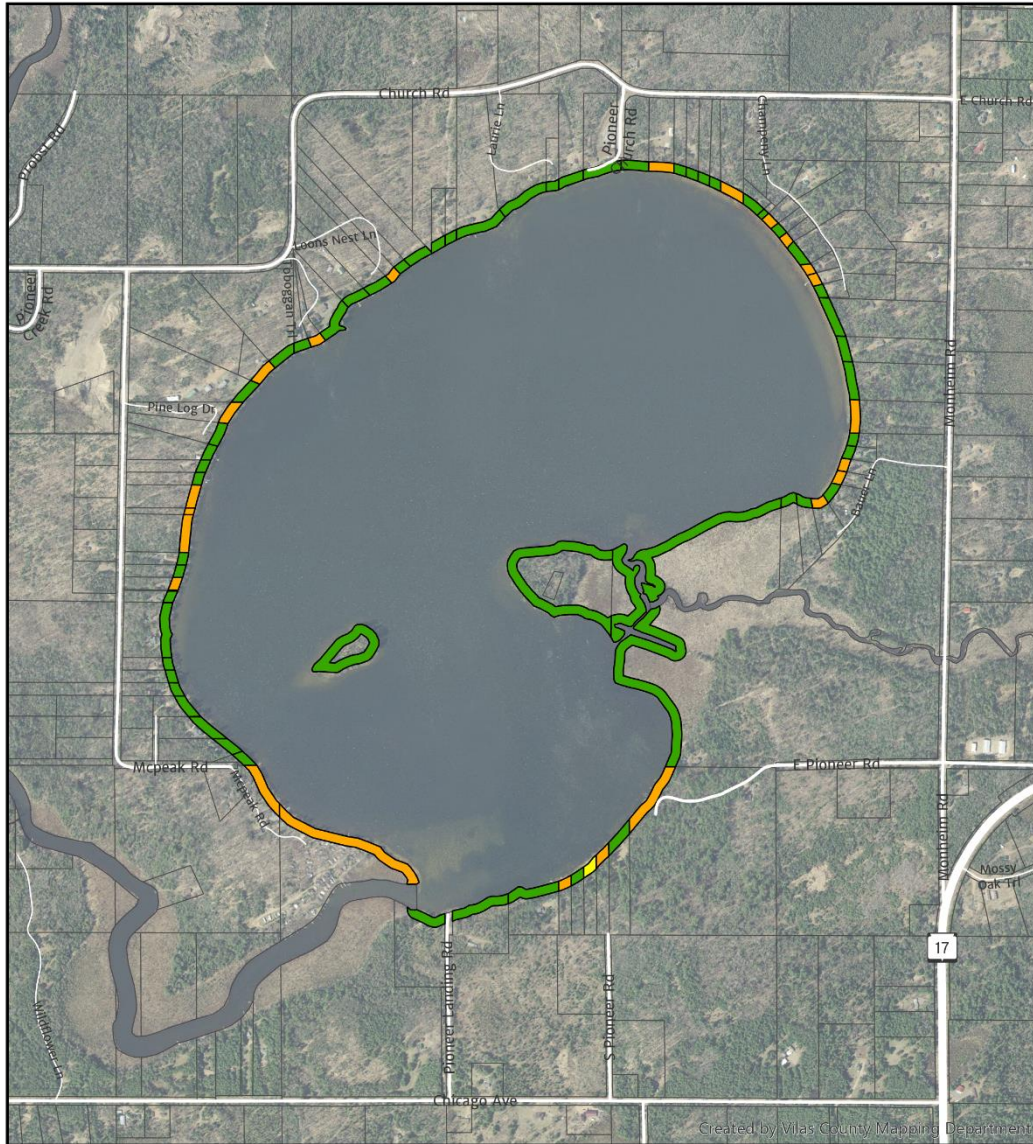
Several runoff and erosion concerns were documented within the riparian area: 36 parcels had areas of lawn or soil sloping to the lake; 34 parcels had a straight stairs/trail/road to the lake; 24 parcels had bare soil (not sloping); and 2 parcels contained a point source (pipe draining directly into the lake). See Figure 13 for Number of Parcels with Erosion or Runoff Concerns.

Bare Soil Presence

- **Address runoff and erosion concerns:**
 - Areas of bare soil in the riparian zone and bank erosion should be restored as they can add extra phosphorus into the water. Staff from Vilas County Land & Water Conservation are able to do site visits, recommend solutions, and in certain instances offer grant fund reimbursement for installing best practices. Contact Cathy Higley from Vilas County Land & Water Conservation 715-479-3738 or cahigl@vilascountywi.gov for assistance, questions, or possible funding.

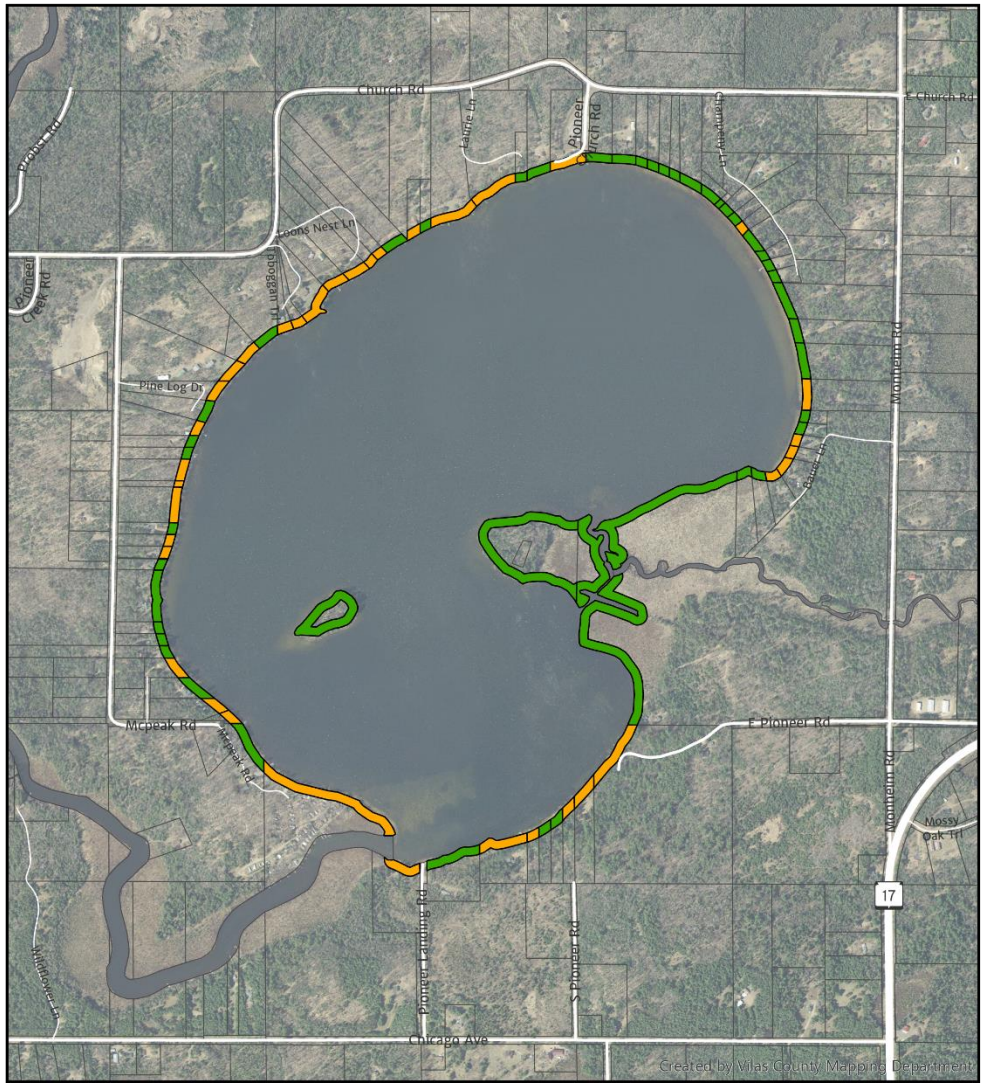
Lawn/Soil Sloping to Lake
■ Absent ■ Present In Riparian Zone

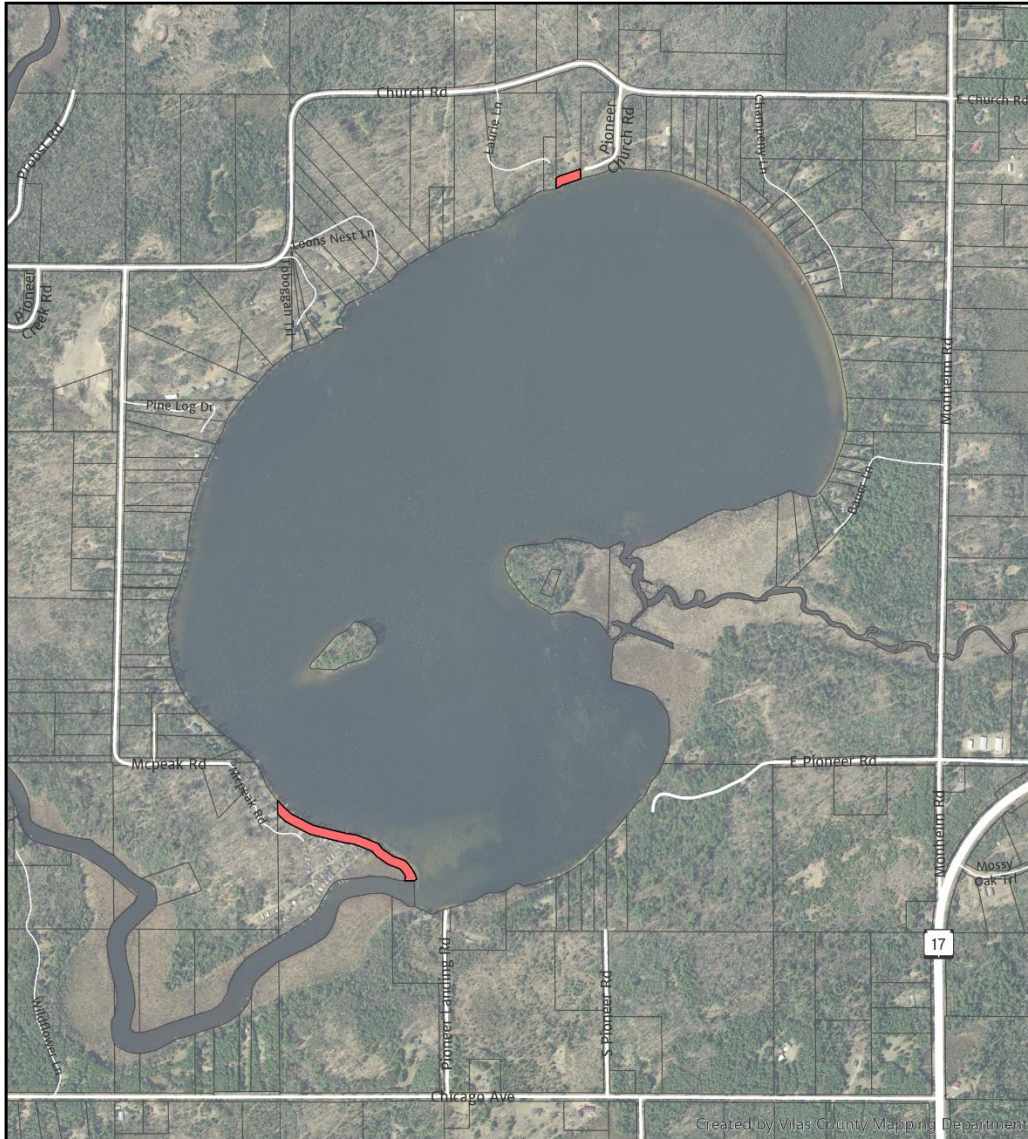
Point Source/Active Erosion

Active Erosion
Point Source

- **Address point source sites:**
 - Follow up on the two point source discharges found for potential pollutants. If necessary/appropriate, encourage landowners to consider alternate ways to deal with their storm/waste water. Contact Melissa Yarrington of the WI DNR for assistance at 715-359-0192 or Melissa.yarrington@wisconsin.gov.

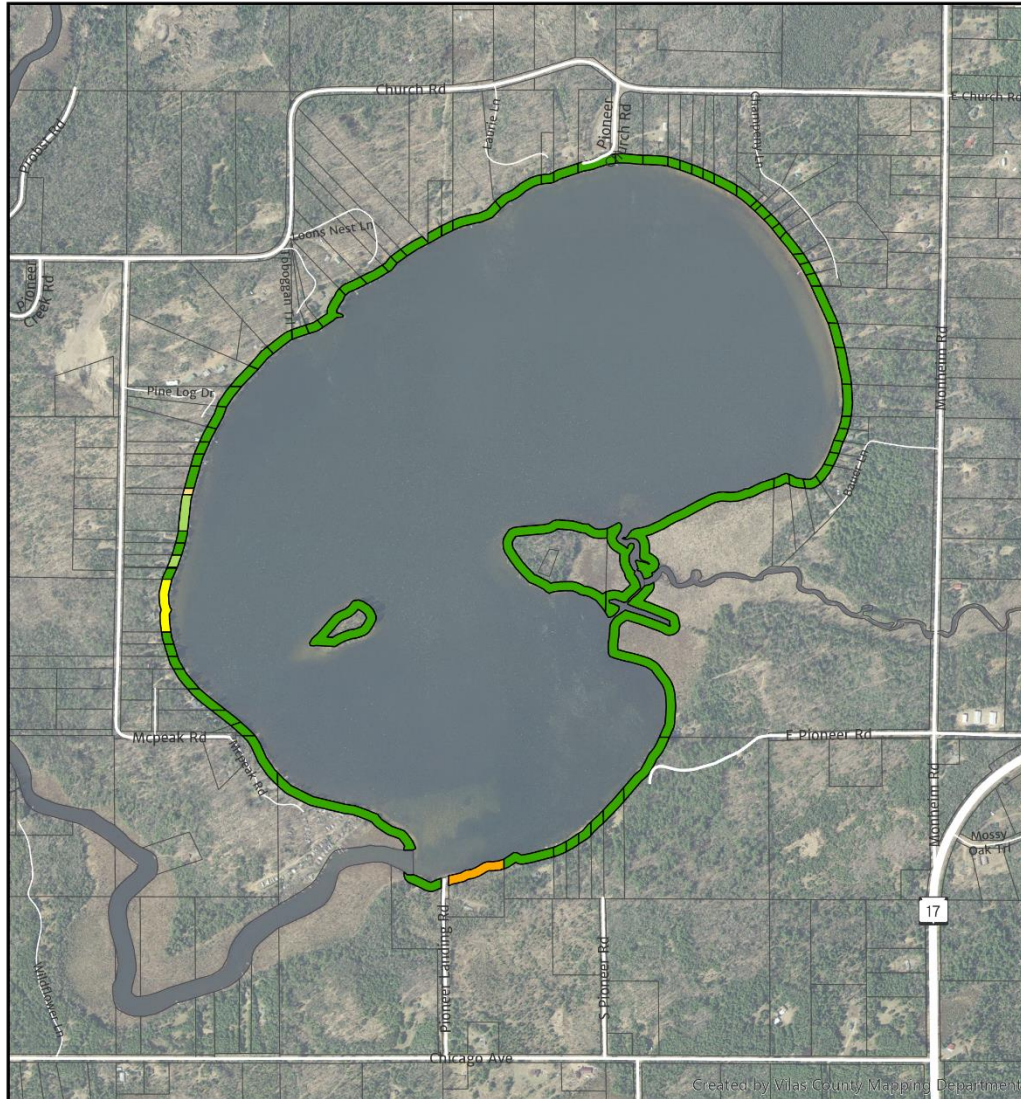
Bank Erosion with >1ft Face

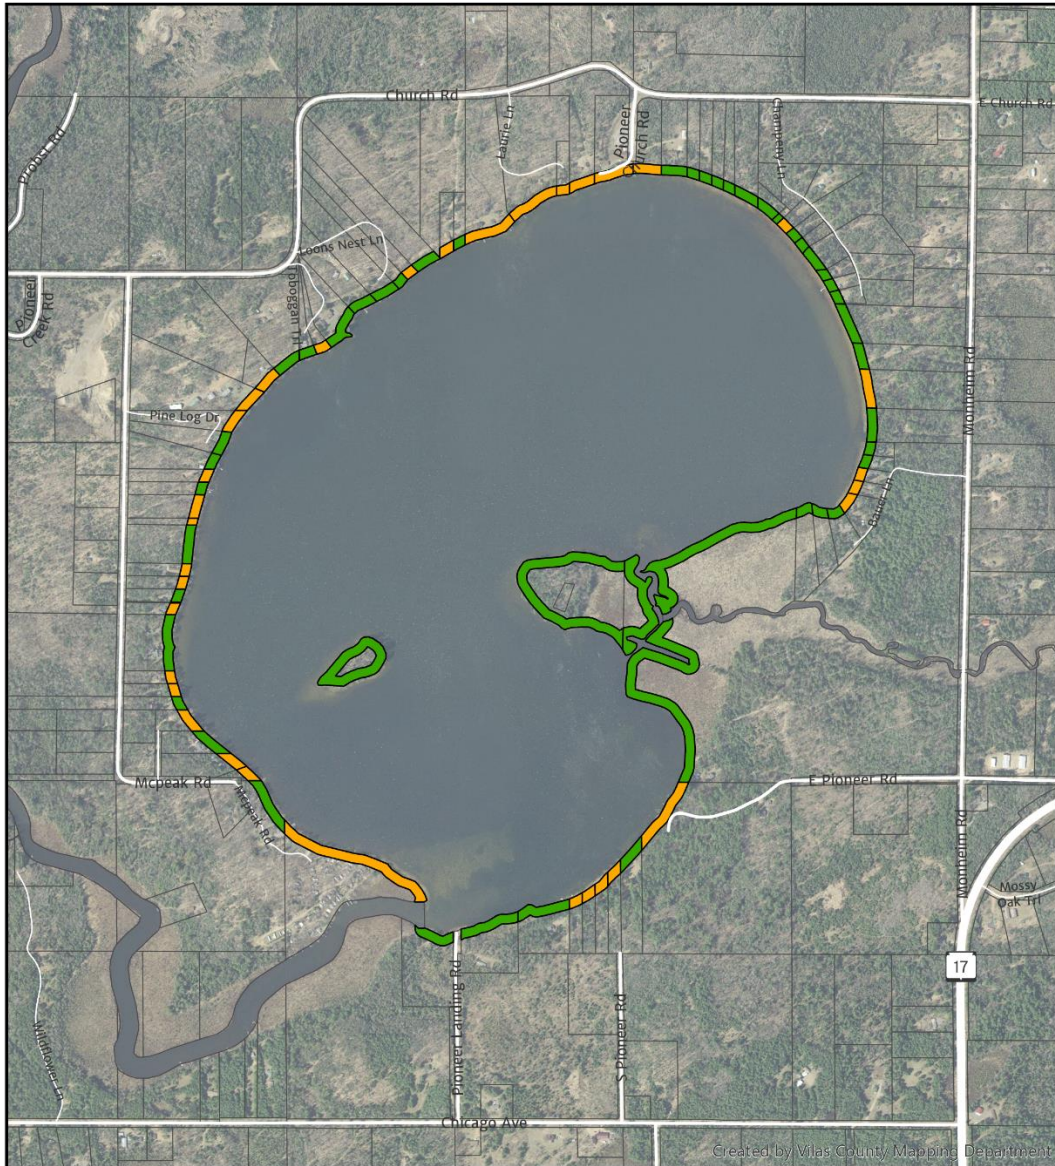
Straight Stair/Trail/Road to Lake
Green Absent Orange Present in Riparian Zone

- Where lake access trails/driveways slope down to the lake, encourage riparian owners to curve their access trails across the slope rather than going straight down to the lake. This switchback approach will allow stormwater to infiltrate into the soil (vs. becoming runoff) better than a straight trail would. Landowners should be mindful when curving or meandering an access path to comply with Zoning regulations on allowable access area width. See Figure 14 as an example. For assistance with properly placing this type of lake access with the viewing corridor contact the Vilas County Zoning at 715-479-3620.

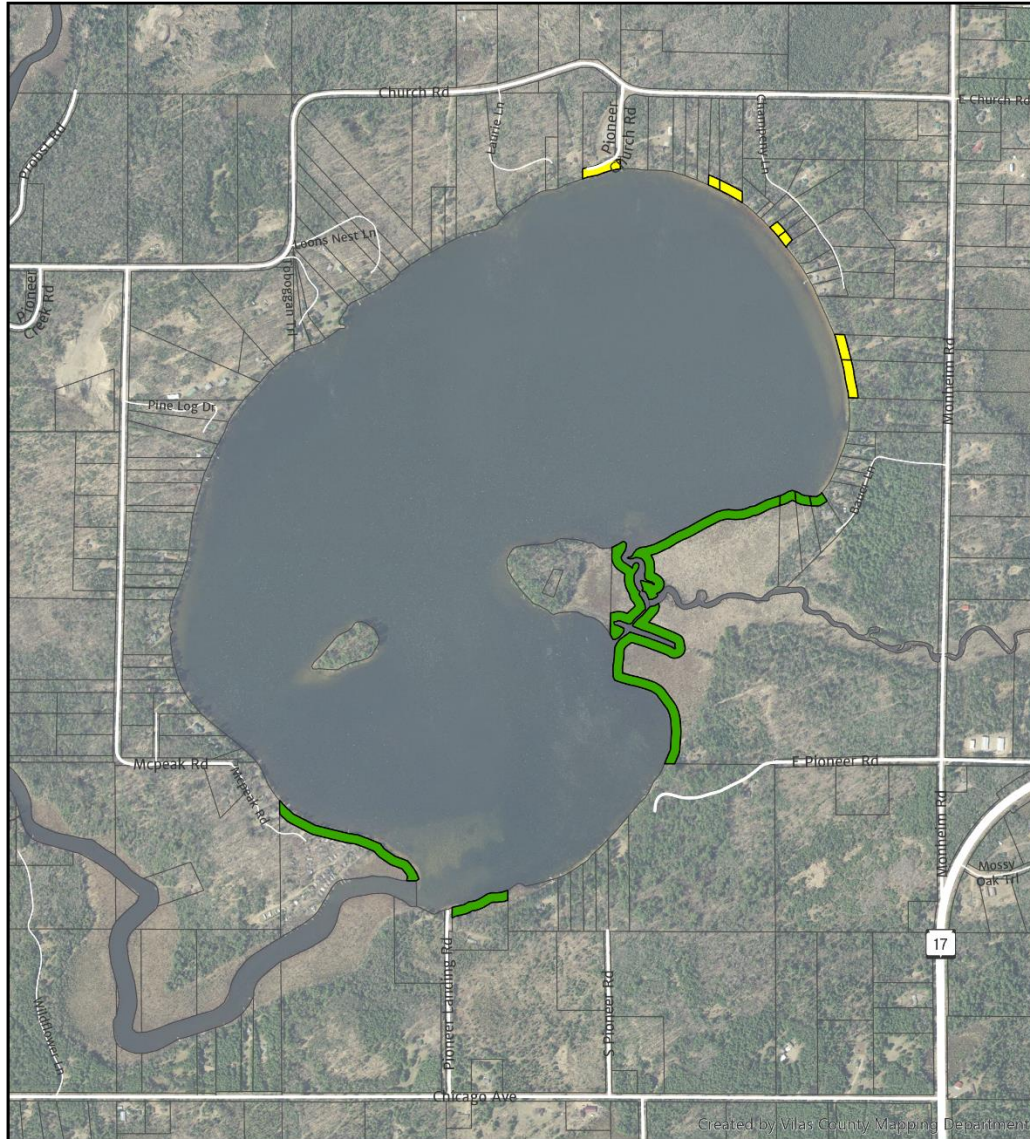
Emergent or floating plants were observed in the littoral zone adjacent to 13 of the 80 parcels. There was no evidence of aquatic plant removal on Pioneer Lake.

Figure 48. Parcels where emergent or emergent and floating plants were observed on Pioneer Lake 2019. No plant removal was observed.
