DATE: 4-25-2024 FILE REF: NA

SUBJECT: Puris Proteins, Unnamed Tributary to S. Branch Beaver Brook (WBIC 2624400), Barron County

Summary of recommendations

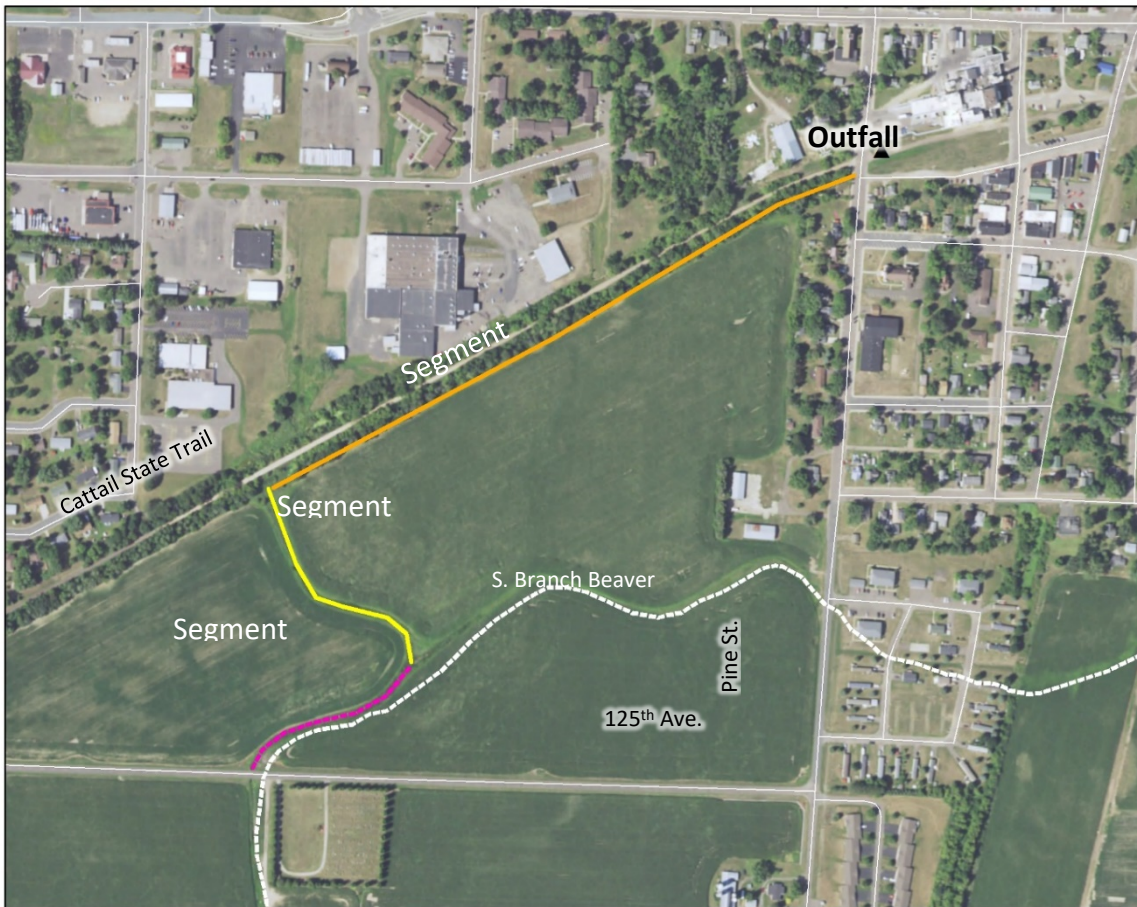
Figure 1. Site map of Puris Proteins outfall (black triangle), unnamed tributary (no WBIC, segment 1 & 2), and South Branch of Beaver Brook (segment 3, WBIC 2624400). Fish survey was done from the downstream end of Segment 1 to 100m upstream.

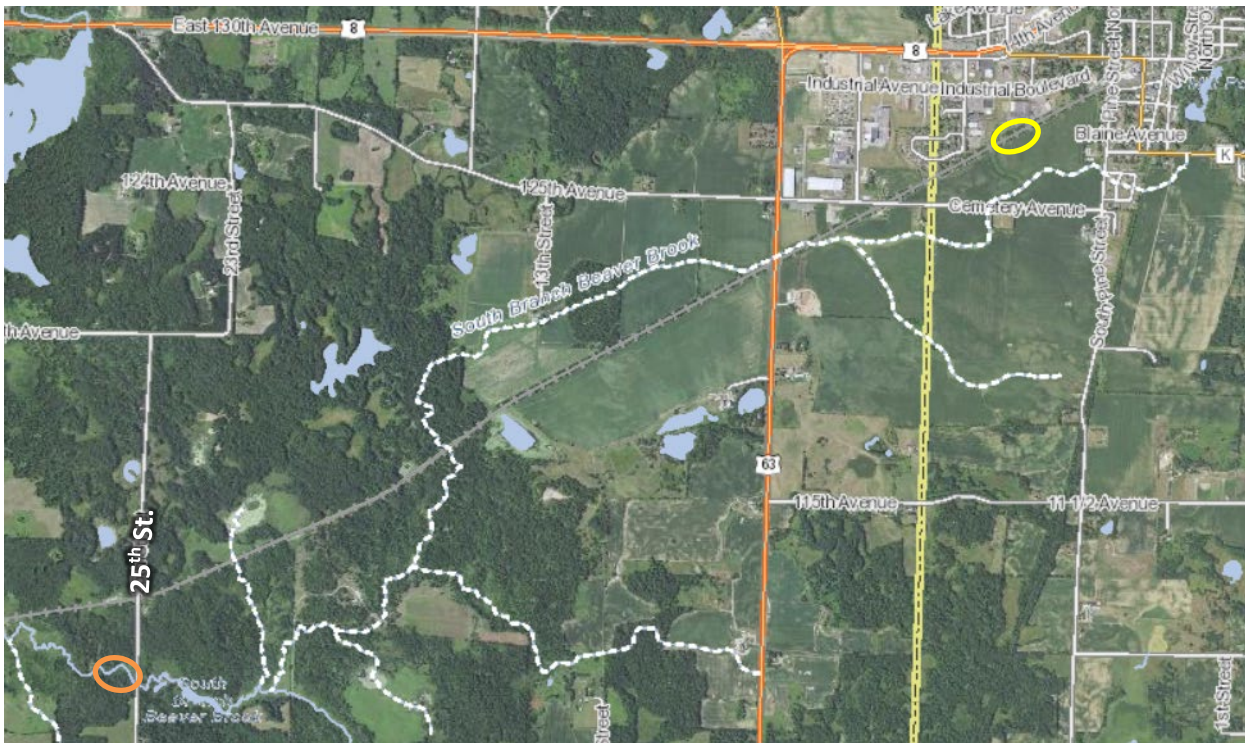
Figure 2. Fish and habitat survey sites: On Segment 1, the general fish survey extent is indicated with a yellow circle. A survey farther downstream was done on S. Br. Beaver Brook, downstream from 25th Street, indicated with an orange circle.

Fish and qualitative habitat surveys were done on August 8, 2023 (see Fig. 2 for locations). Water levels changed significantly from the initial site check, which affected where surveys could occur. The facility was not discharging on this date.

- **Segment 1: Ditch running parallel to Cattail Tail from outfall to confluence with stormwater input**
A fish survey was conducted in the water present from the confluence with the intermittent stream to 100m upstream (Table 1). Ten central mudminnows were captured. Capture was impeded by thick aquatic plants, so more fish could be present than were captured. Abundant macroinvertebrates were observed. The ditch was wide and depth varied along its length with an average depth of 0.5 - 1 foot. The habitat was monotonous and substrate was fine sediments (Table 2). The aquatic plants provided cover for fish and there was some woody debris. Qualitative habitat score was 20.
