DATE: 8-23-2023 FILE REF: NA

SUBJECT: Clover Sanitary District Permit Reissuance, Tributary (no WBIC) to L. Superior, Bayfield Co.

Overview of issue

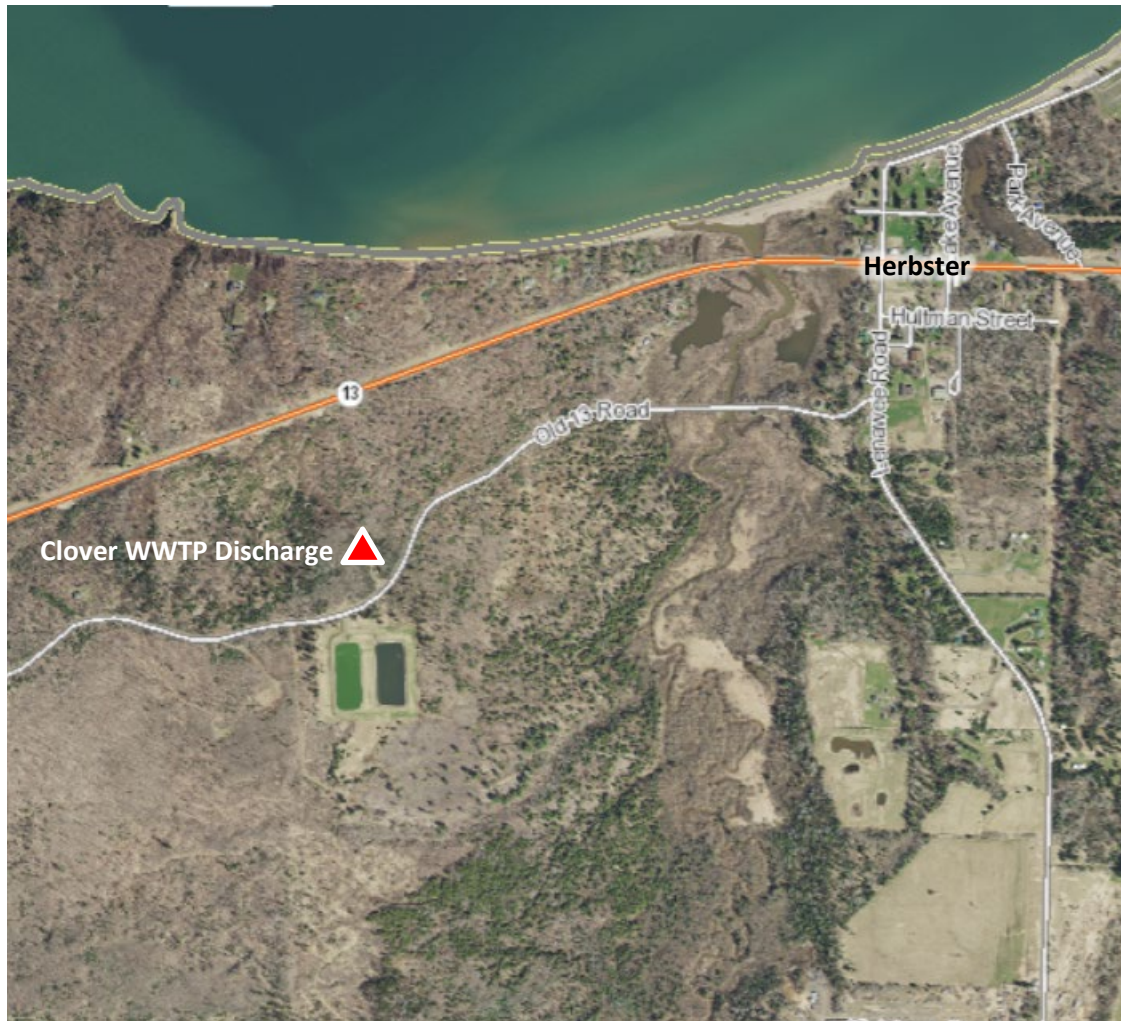
Map 1. Clover discharge location and surrounding area from Surface Water Data Viewer. The tributary is not shown as a waterbody on the Surface Water Data Viewer. See Map 2 for the discharge path.
