Natural
Resource
Technology, Inc.

RE: **Operation, Maintenance and Monitoring Status Report No. 9 and Request for Shutdown of VOC System 001**
Reporting Period - July 1, 1997 to December 31, 1997
Praefke Brake and Supply, 133 Oak Street, West Bend, Wisconsin
FID #267083740

Praefke Brake and Supply
Reporting period: 7/1/97 - 12/31/97
Status Report No. 9

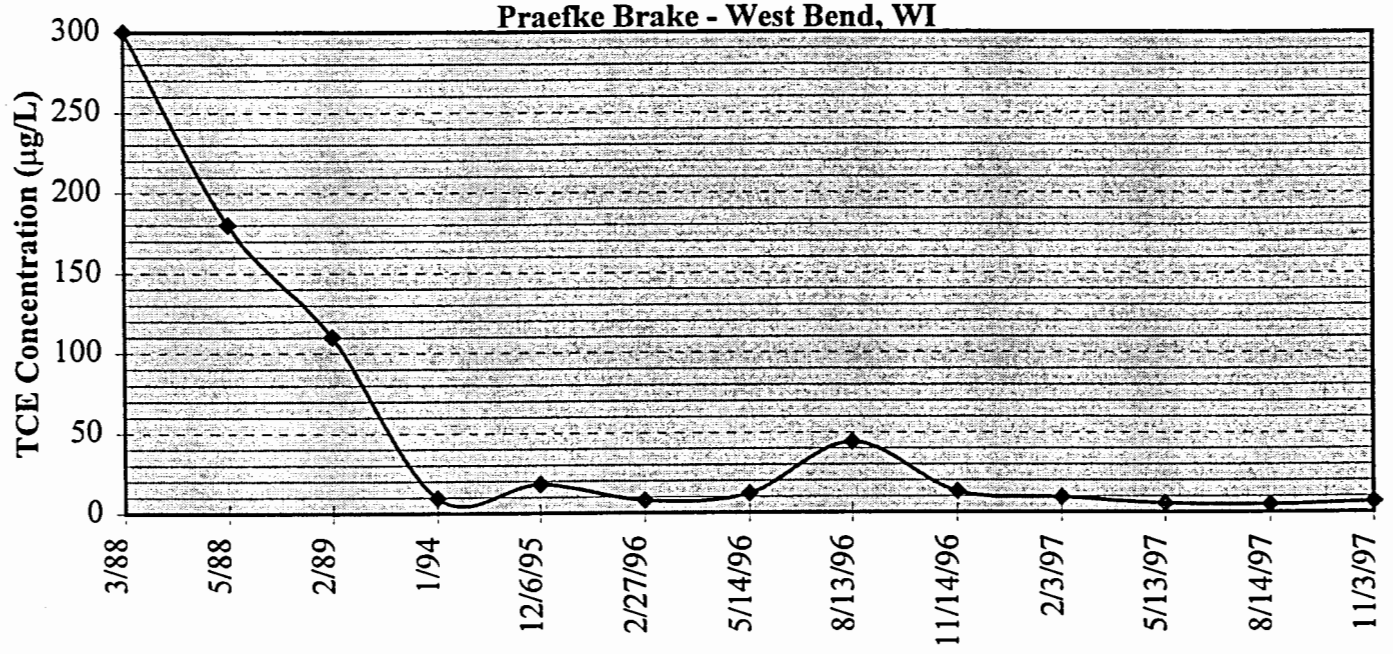
MW-A: TCE Concentration vs. Time

1. Is a contaminated groundwater plume fully contained in the capture zone? (Y/N) If no, explain: Substantially, PAL exceedance at MW-A outside capture zone
