RE: Work Plan for the Property Located at 5923 W. Lincoln Avenue in West Allis, Wisconsin — EDS Project No. 091203; Commerce No. 53219-2109-23-A

Site Description

Project Background

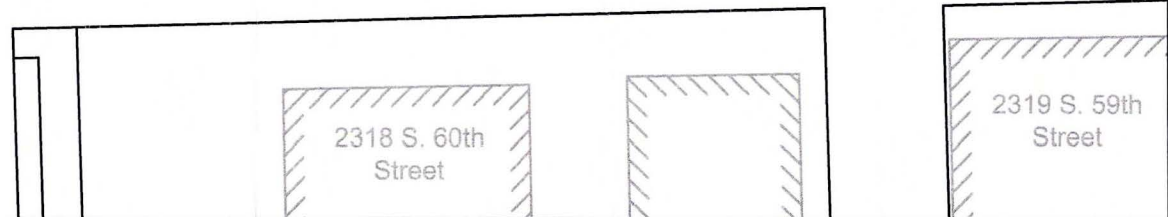
existing w.o. UST

Site Features and Sample Locations Diagram
 Former D&M Motors Property
 5923 W. Lincoln Avenue
 West Allis, Wisconsin
