State of Wisconsin Substance Release Notification Form

Subject: No Further Action, Diesel Spill, Weyerhaeuser Company, 200 Grand Avenue, Rothschild, Wisconsin

Re: Request for No Further Response Action - Final Report, Diesel Fuel Spill, Weyerhaeuser Company, Rothschild, Wisconsin -- STS Project No. 4-27045XA

WEYERHAEUSER
DIESEL FUEL OIL SPILL AREA
ROTHSCHILD, WISCONSIN

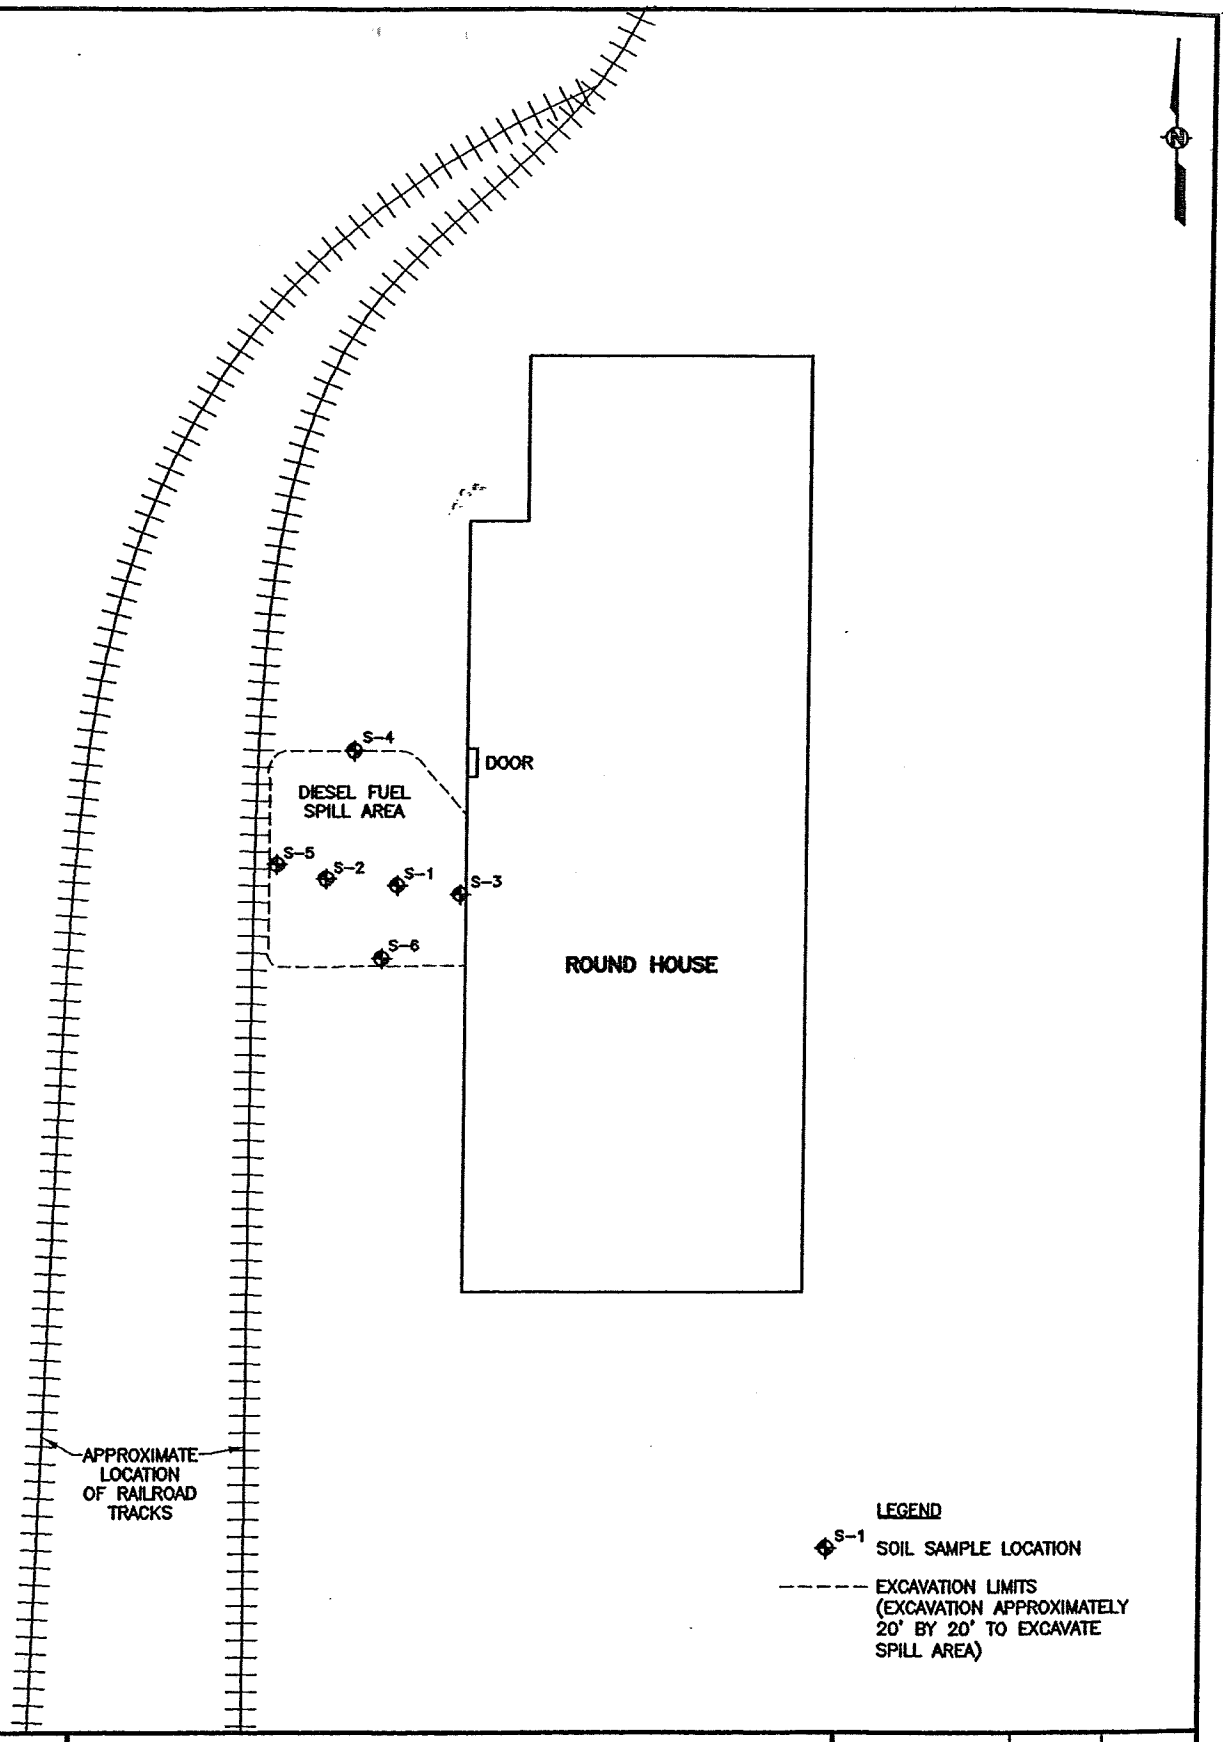
DESIGNED BY	JCP	1-2-01
DRAWN BY	ACS	1-2-01
APPROVED BY	JCP	1-2-01
CADFILE 427045XA001.dwg	SCALE NTS	
STS PROJECT NO. 27045XA	FIGURE NO. 1

An STS representative was on site October 3, 2001 to monitor existing conditions and collect soil samples from the base and sidewalls of the excavation. The spill occurred on a compacted driveway area. The excavation limits were approximately 20 by 20 feet with a depth of 2.5 feet (Figure 1). During the excavation the soils were screened using a flame ionization detector (FID). The excavation extended horizontally and vertically, until field screening indicated that contamination was no longer present or the proximity of the railbeds prevented further excavation. Groundwater was not encountered during the excavation. The excavated soil was stockpiled on plastic for future disposal. On October 17 and 18, 2001, 52.25 tons of petroleum-impacted soil was transported to the Cranberry Creek Landfill in Wisconsin Rapids, Wisconsin. The disposal weight ticket summary is attached.

On October 3, 2001, five (5) confirmatory soil samples were collected from the excavation base and sidewalls and submitted to U.S. Filter/Enviroscan in Rothschild, Wisconsin, for laboratory testing to document soil conditions. Soil sample locations are identified on Figure 1. Based on discussions between the WDNR and Weyerhaeuser, the soil samples were analyzed for petroleum-volatile organic compounds (PVOCs) and diesel range organics (DRO).

PVOC concentrations were below the Chapter NR 720 groundwater pathway generic residual contaminant levels (RCLs). In addition, PVOC concentrations were not detected above Chapter NR 746 direct contact concentration for benzene. The DRO concentrations were at or below the NR 720 RCL. Table 1 summarizes the laboratory analytical results. Copies of the laboratory analytical data sheets are attached.
