**RE: Additional Documentation for Post-Closure Modification Request**  
**709-733 East Capitol Drive**  
**City of Milwaukee, Milwaukee County, Wisconsin 53212**  
**FID #241975140**  
**BRRTS #02-41-200169**

- Soil Management Plan (Revised), dated April 14, 2017;
- Draft Site-Wide Cap Maintenance Plan, dated April 14, 2017; and
- Draft Operation, Maintenance and Monitoring Plan (Vapor Collection and Vapor Barrier System), dated April 14, 2017.

Figure 2-1 Vapor Barrier System Plan .....3

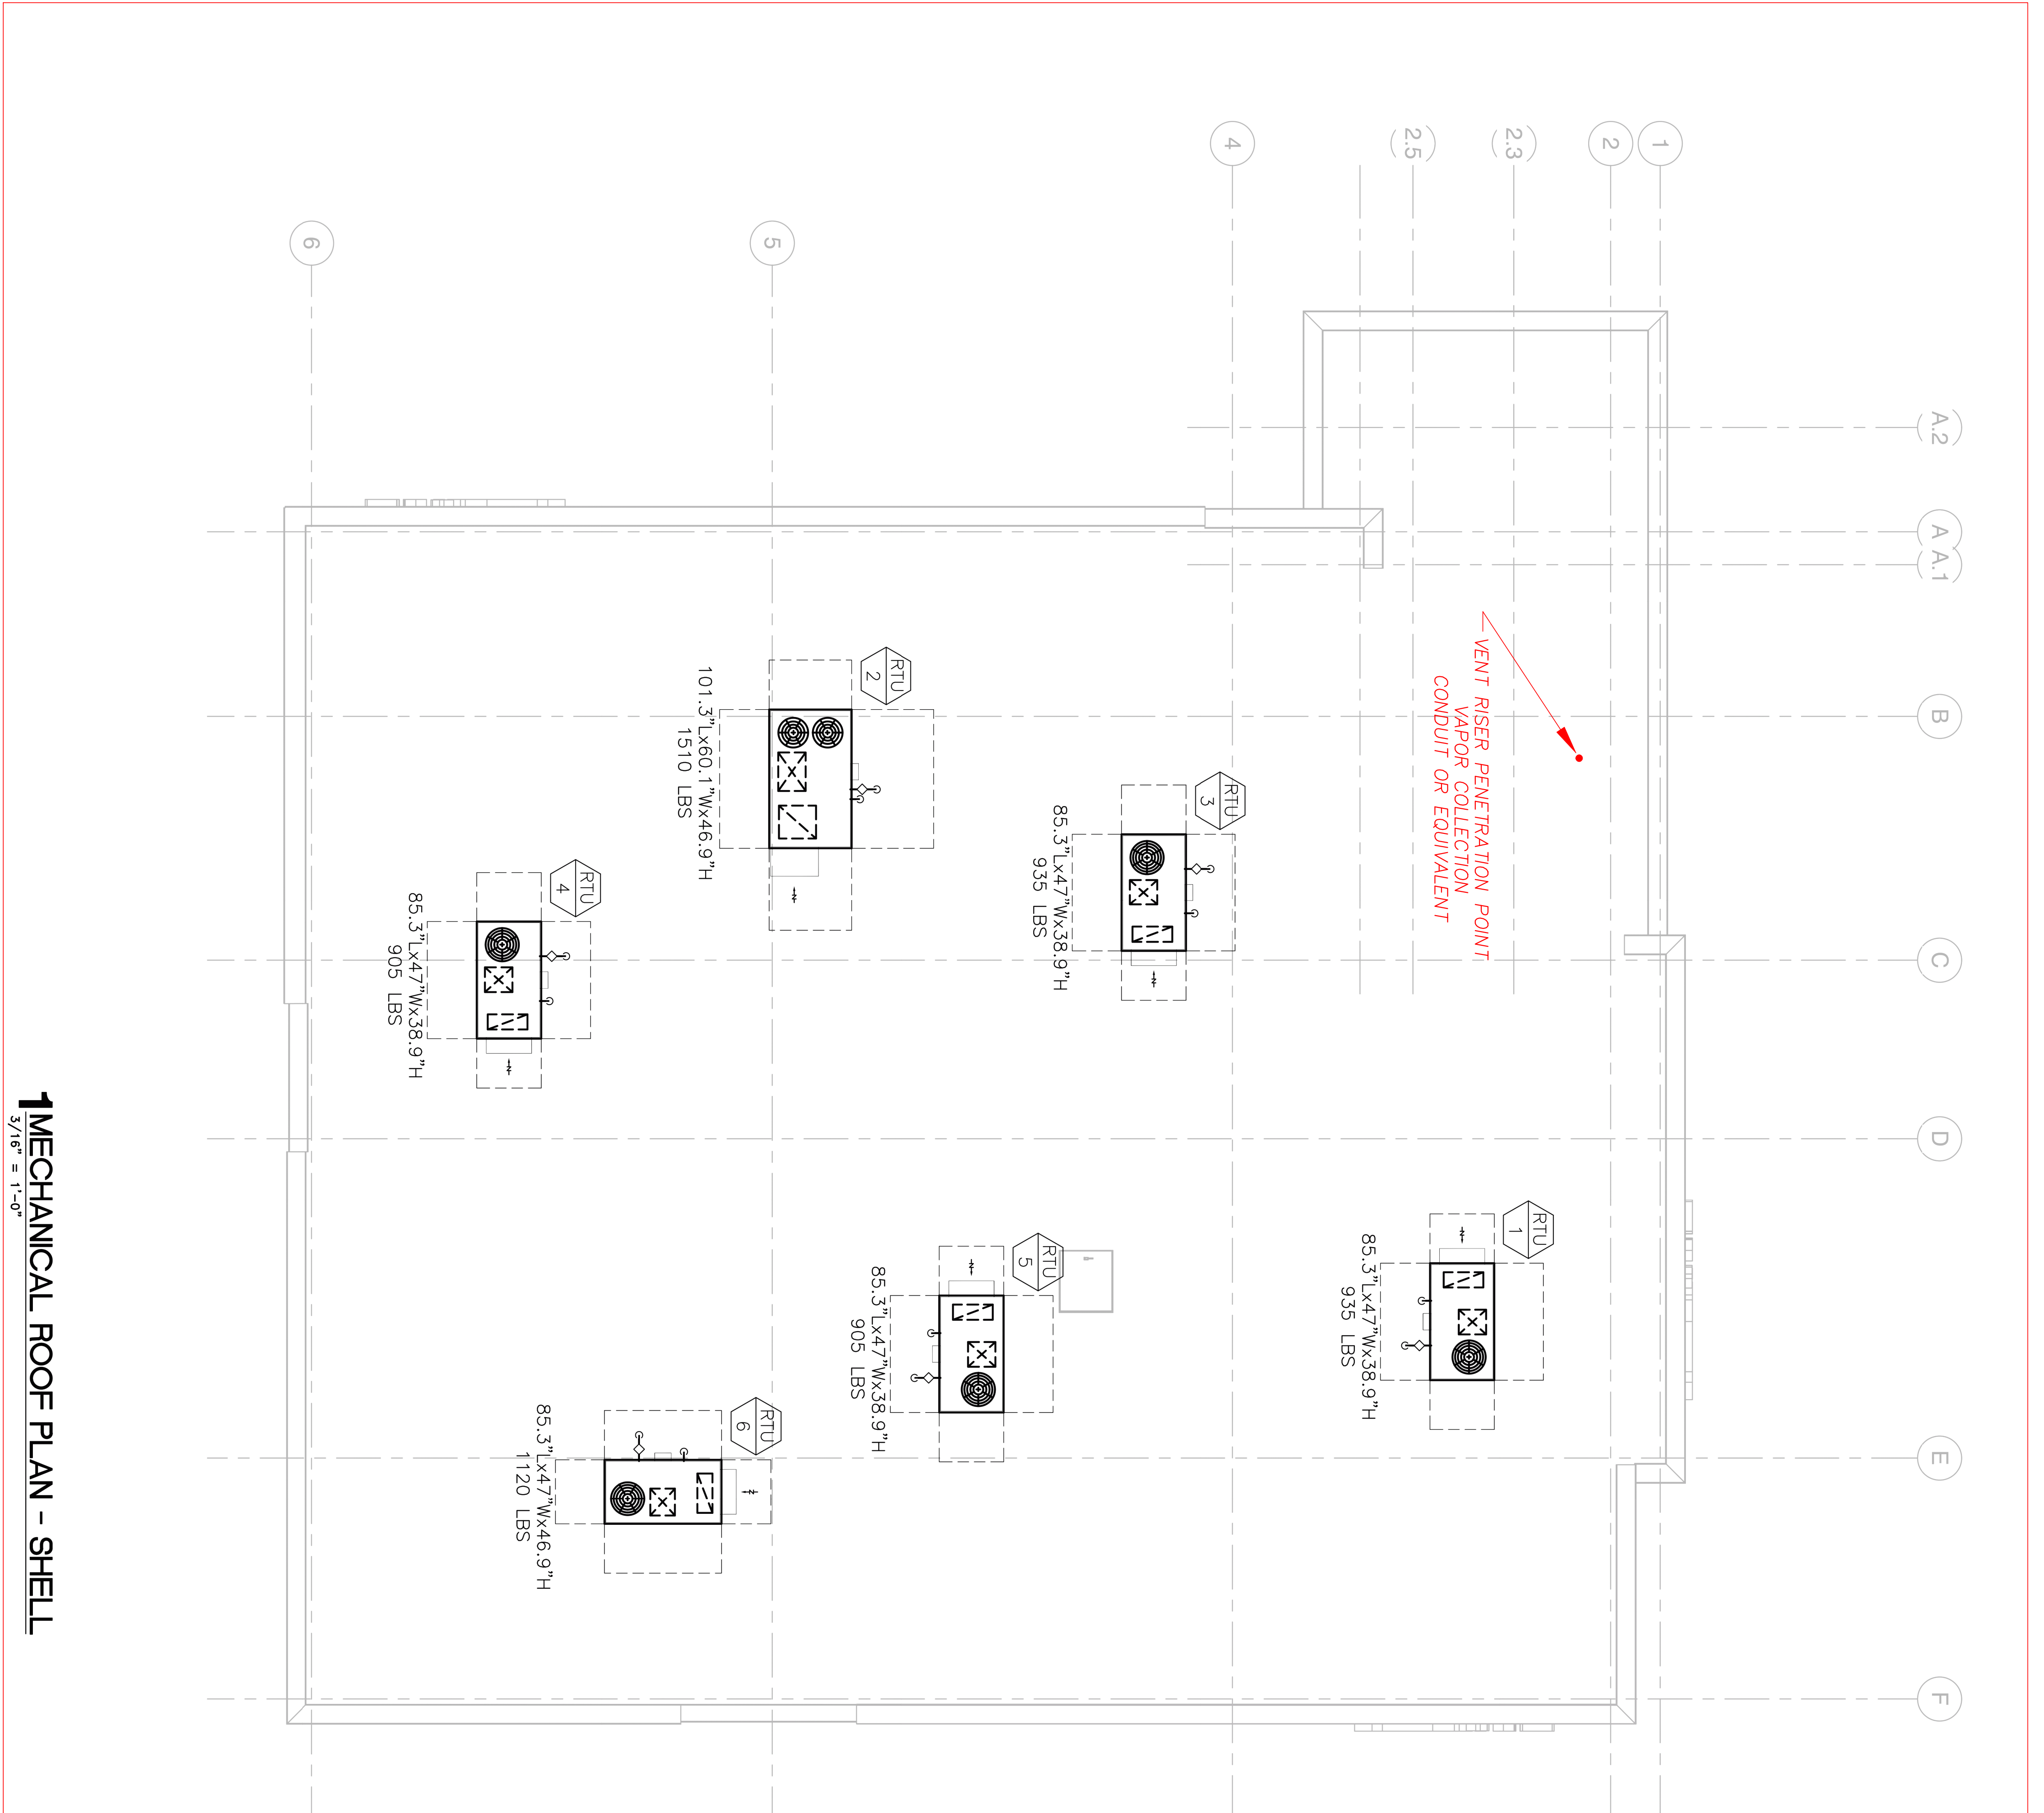
**MECHANICAL ROOF PLAN - SHELL**  
 3/16" = 1'-0"

Soil vapor samples will be collected from the two (2) vapor sampling ports installed in the building. If the soil gas sample laboratory analytical results are below applicable Vapor Risk Screening Levels (“VRSLs”), then the vapor mitigation system installed in the building becomes voluntary and this OMM plan will not be required. If the soil gas sample laboratory analytical results are reported above VRSLs, then performance verification testing of the passive (or active) vapor collection and vapor barrier system will be completed. If necessary, the installed passive vapor mitigation system will become an active vapor mitigation system through the use of the one (1) RP265 Series in-line induction fan unit installed outside on top of the 4-inch diameter PVC riser piping above the roof.
