From: [Madden, Peter](#)
To: [Joslin, Richard R - DNR](#)
Cc: [Brotz, Adam](#); [Meyer, Todd](#)
Subject: Request Using BRRTS to record resolution of soil contamination-Plastics Engineering Co., Sheboygan
Date: Friday, November 18, 2016 9:18:54 AM

From: [Beggs, Tauren R - DNR](#)
To: [Joslin, Richard R - DNR](#)
Subject: NAR Concurrence for Plenco site, 2732 N 15th St, Sheboygan
Date: Friday, November 11, 2016 2:45:19 PM
Attachments: [image001.gif](#)
[image002.gif](#)
[image003.gif](#)
[image004.gif](#)
[image005.gif](#)
[image006.gif](#)

Project Name PLENCO ELEVATOR PIT
Project # 20048-001

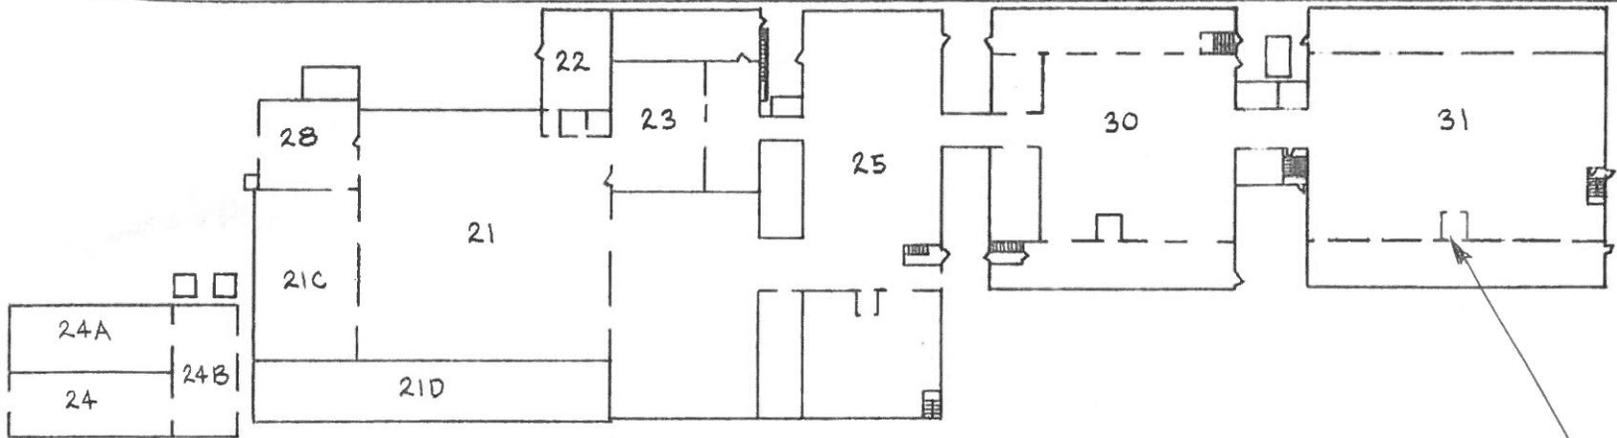
FIRST FLOOR PLAN

Attached is a floor plan of our facility with the location of the elevator marked. Building 31 is a three story building. The DRO results are also attached. The samples are identified as drums #2 through #7. The higher the drum number, the deeper the depth at which the sample was collected. These results represent soil removed from the jack shaft. As expected, the samples closer to the surface have higher DRO concentrations than those collected deeper. As explained, the process used to remove the soil cause some mixing of the soil column, so some of the DRO detected at lower levels was likely introduced into the samples from soil above. As noted in my preliminary report to you, a sample of soil from the bottom of the boring had a DRO concentration of 50.6 mg/kg. I believe these data support the position that contaminated soil has been substantially removed. The attached results will be used to profile the soil for proper disposal.

location of
Elevator 5
