State of Wisconsin DEPARTMENT OF NATURAL RESOURCES Waukesha Service Center 141 NW Barstow St Waukesha WI 53188

Final Case Closure with Continuing Obligations

Quick Cleaners (Former) 530 Franklin, Oconomowo, WI 532

DNR BRRTS Activity #02-68-280310 FID #268169680

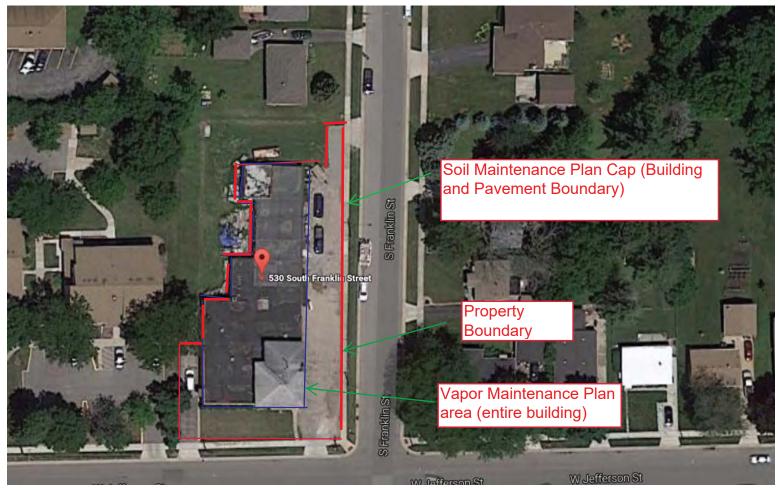
D1 Soil Maintenance Plan Map

530 S Franklin St

In the event the paved surfaces overlying the contaminated soil are removed or replaced, the replacement barrier must be equally impervious. Any replacement barrier will be subject to the same maintenance and inspection guidelines as outlined in this Maintenance Plan unless indicated otherwise by the WDNR or its successor.

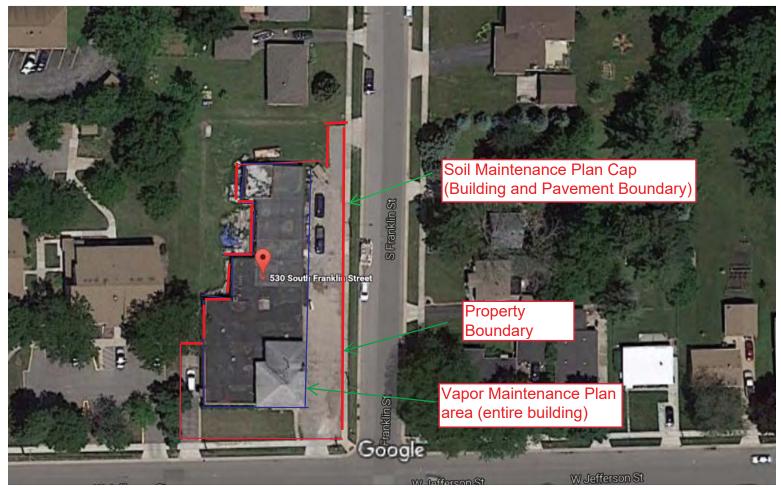
D1.1 Vapor Maintenance Plan Map

530 S Franklin St

The vapor mitigation systems as depicted in Exhibit D-1.2 will be inspected once a year, to verify the fans are working properly and a negative pressure is observed on the pressure gauge within the building. The warranty of the fan is estimated to be 5 years. The inspections will be performed by the property owner or owner's representative to evaluate damage due to increasing age and other factors.

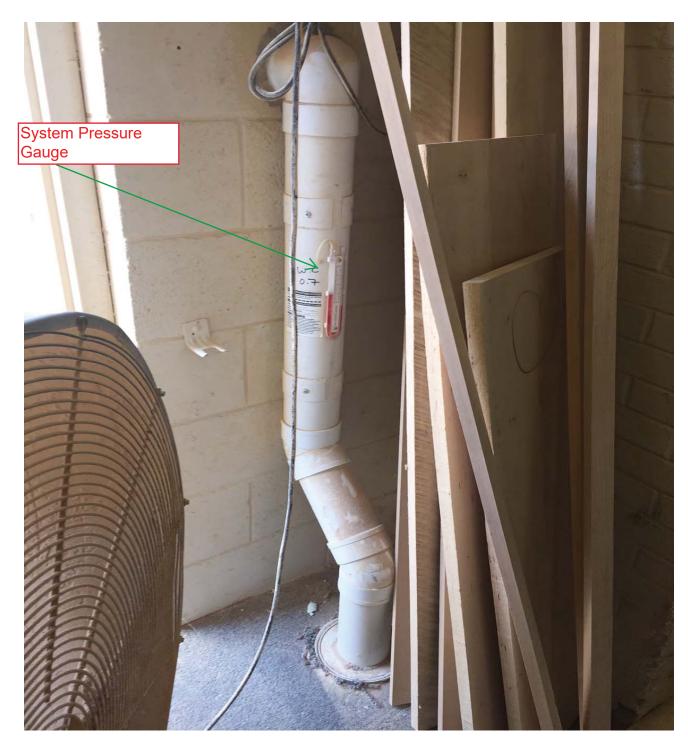
East vapor extraction system interior piping showing the piping going into the sub slab and venting outside of the building.

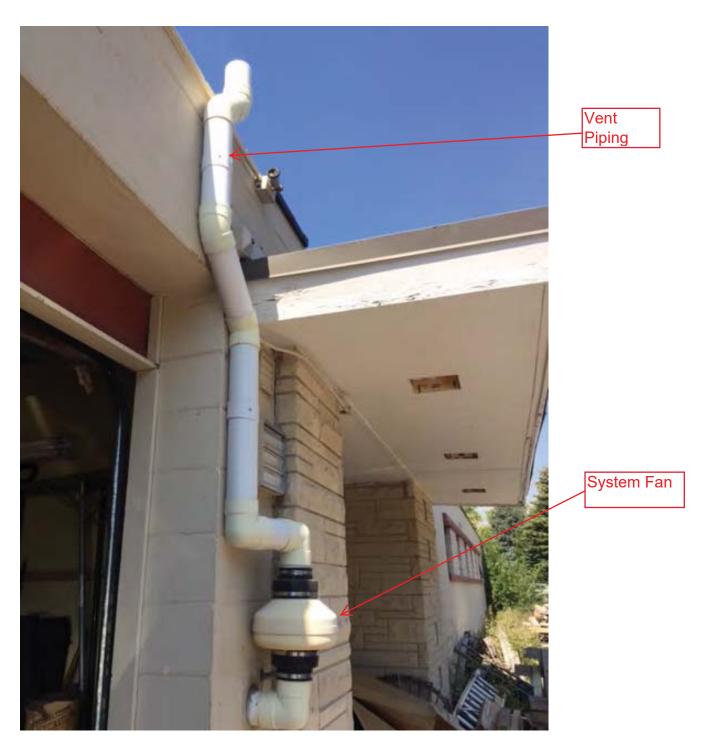
Vapor system located on the east side of the building showing the vent piping going up to the roof line of building.

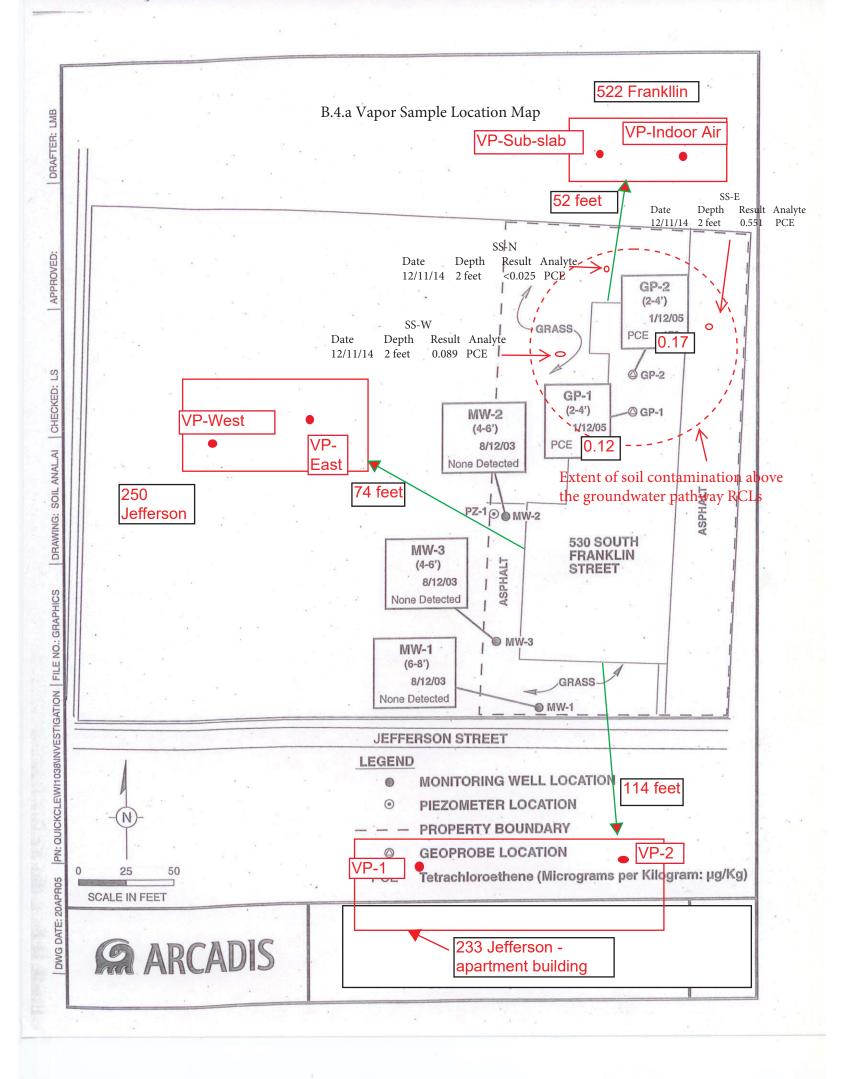
B.4.a.1Vapor Testing Sample Locations233 Jefferson Street, Oconomowoc, WI

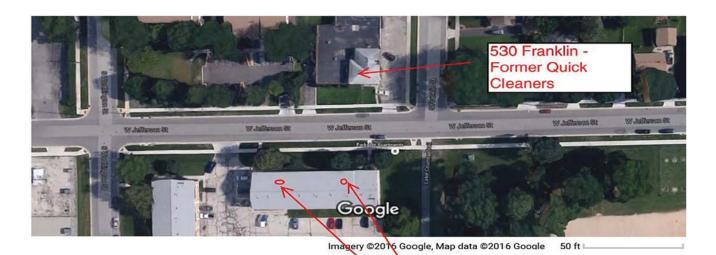
Vapor sub-slab samples - 233 Jefferson Street

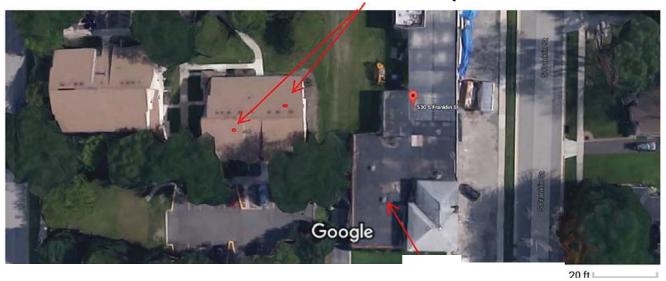
B.4.a.2 Vapor Sample Locations 250 Jefferson Street

Indoor air in crawlspace.

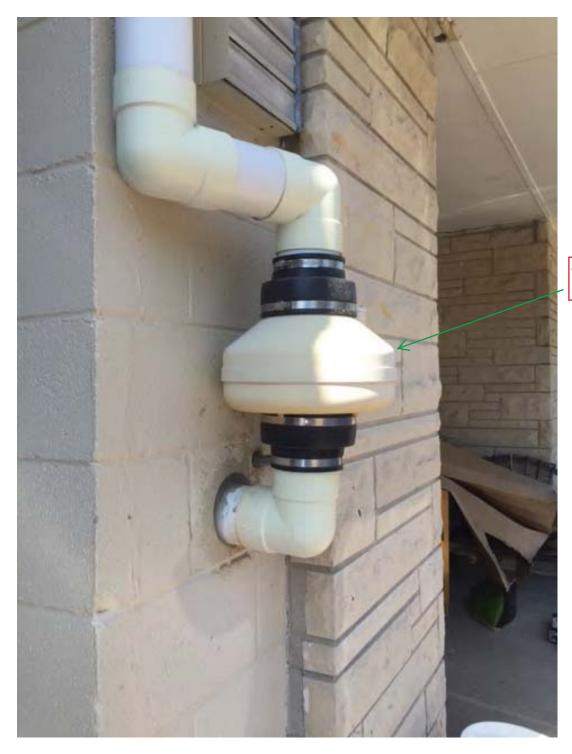
Vapor system located on the east side of the building.

Sy□ŧm □an

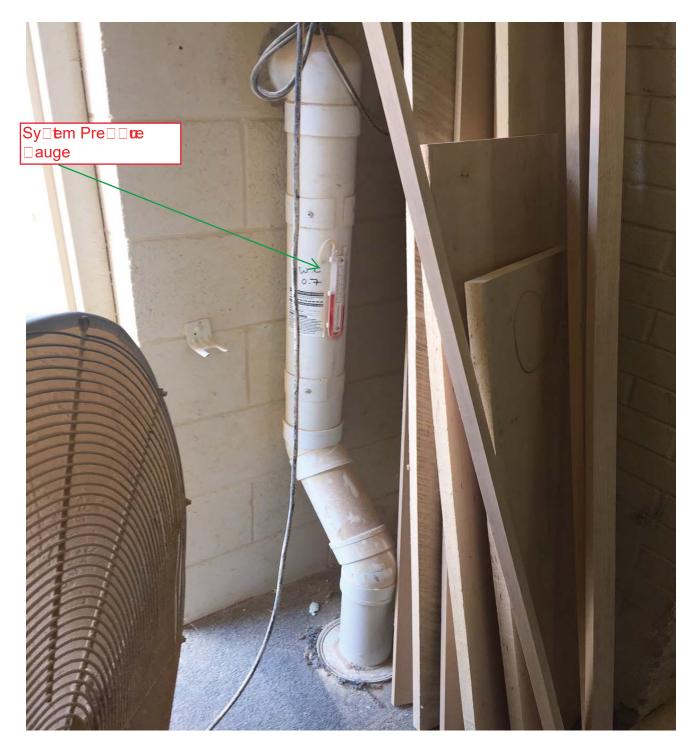
East vapor extraction system interior piping showing the piping going into the sub slab and venting outside of the building.

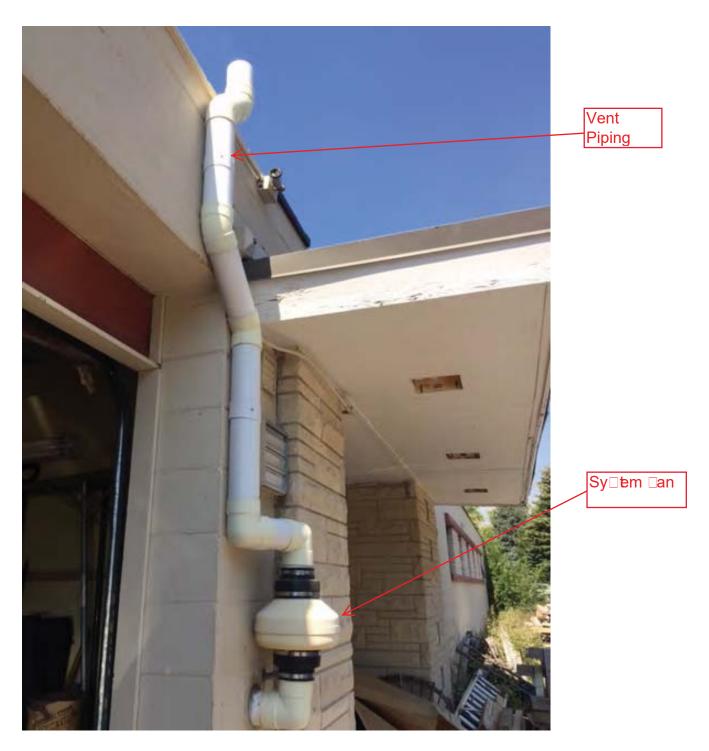
Vapor system located on the east side of the building showing the vent piping going up to the roof line of building.

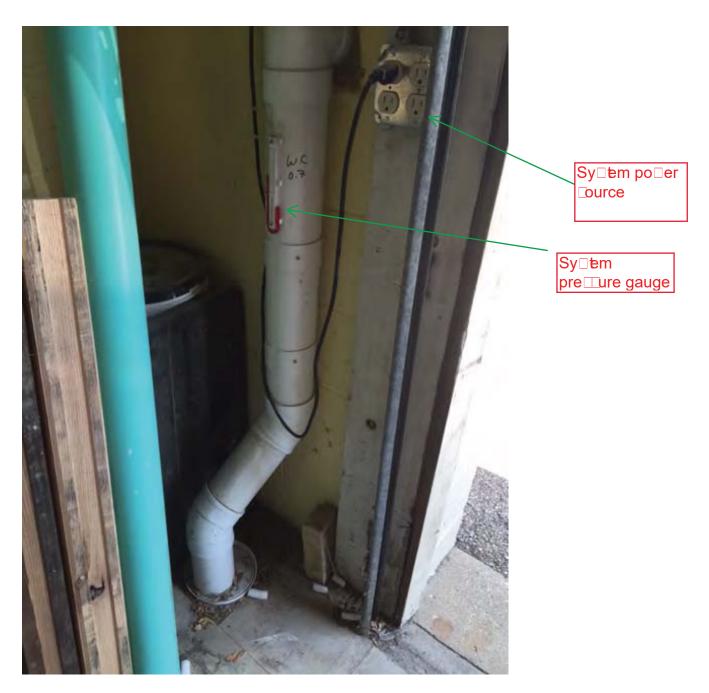
Vapor extraction system on the west side of the building. Interior piping showing the piping going into the sub slab and venting outside of the building.

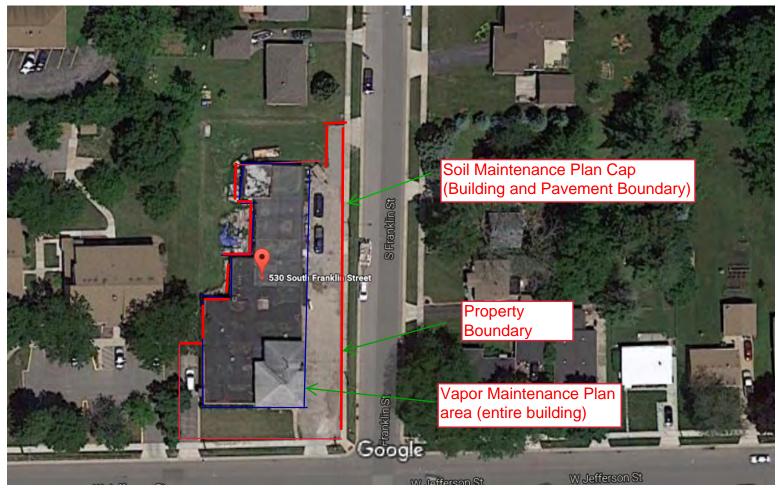
D1.1 Vapor Maintenance Plan Map

530 S Franklin St

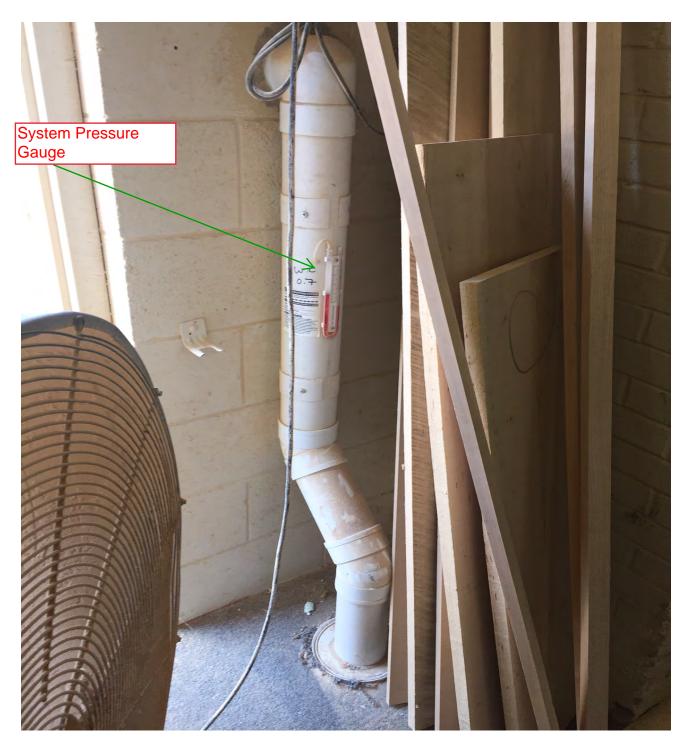
East vapor extraction system interior piping showing the piping going into the sub slab and venting outside of the building.

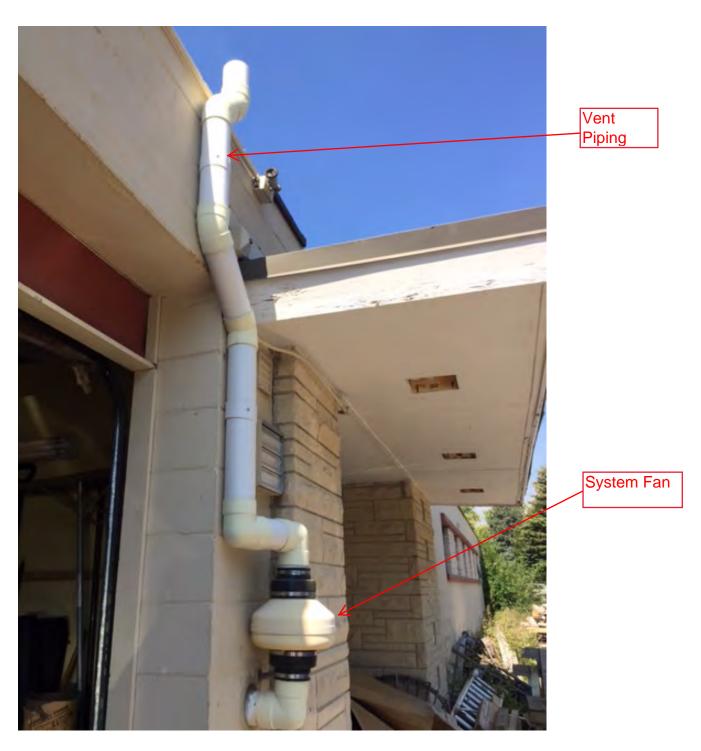
Vapor system located on the east side of the building showing the vent piping going up to the roof line of building.

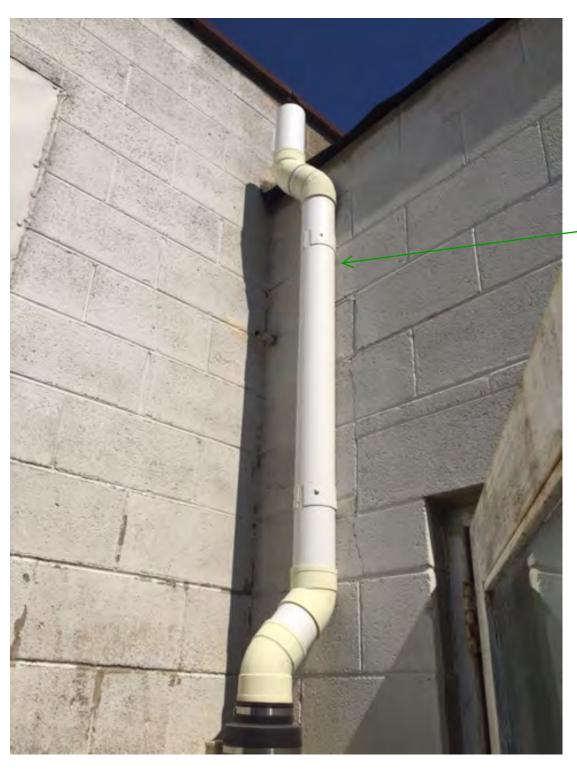
Vent piping

Vapor system located on the west side of the building showing the vent piping going up to the roof line of building.

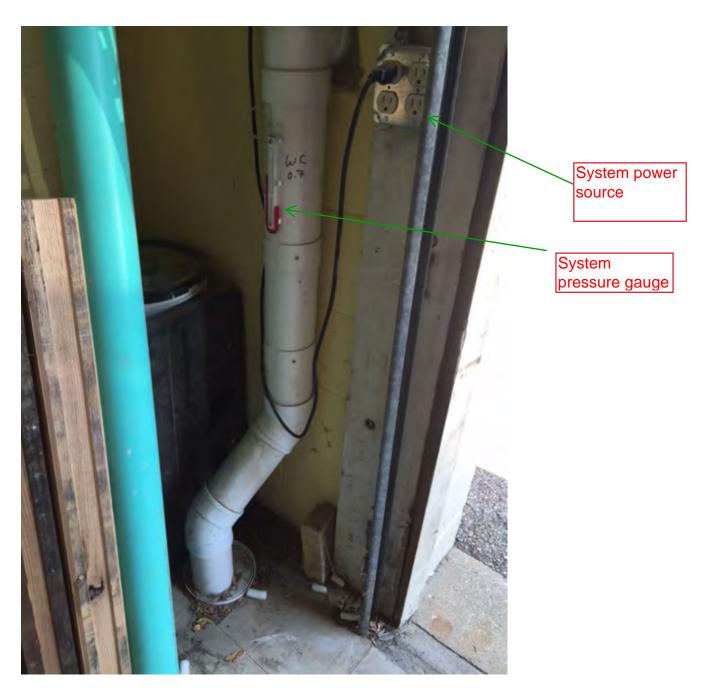
Vapor extraction system on the west side of the building. Interior piping showing the piping going into the sub slab and venting outside of the building.

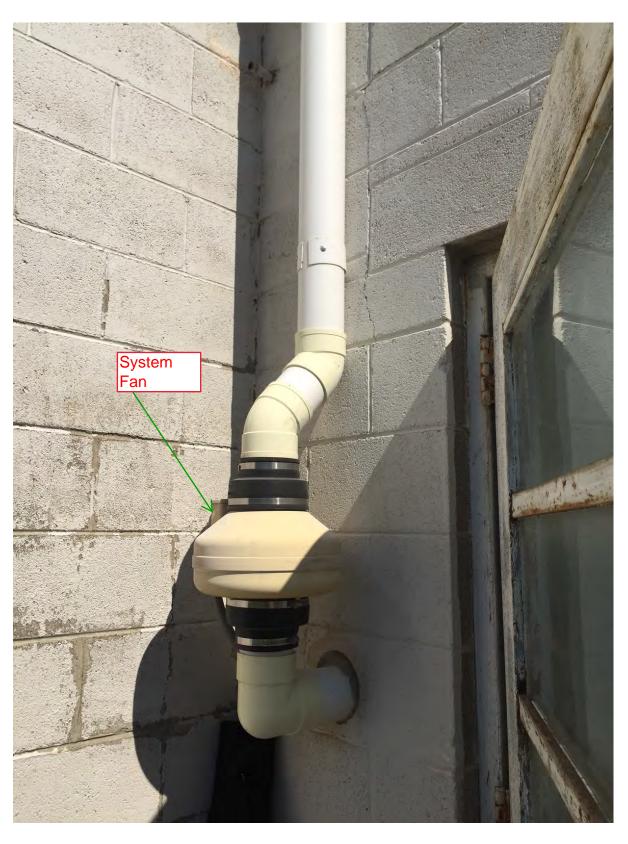
Vapor system located on the west side of the building showing the fan and vent piping going up to the roof line of building.
