SUBJECT: Final Case Closure with Continuing Obligations
McGettigan Property, 2803-2809 University Ave., Madison WI
DNR BRRTS Activity #: 02-13-321347

The Department of Natural Resources (DNR) considers the McGettigan Property closed, with continuing obligations. The closure applies to chlorinated volatile organic compounds in soil, groundwater, and sub-slab soil vapor. No further investigation or remediation is required at this time. However, you, future property owners, and occupants of the property must comply with the continuing obligations as explained in the conditions of closure in this letter.

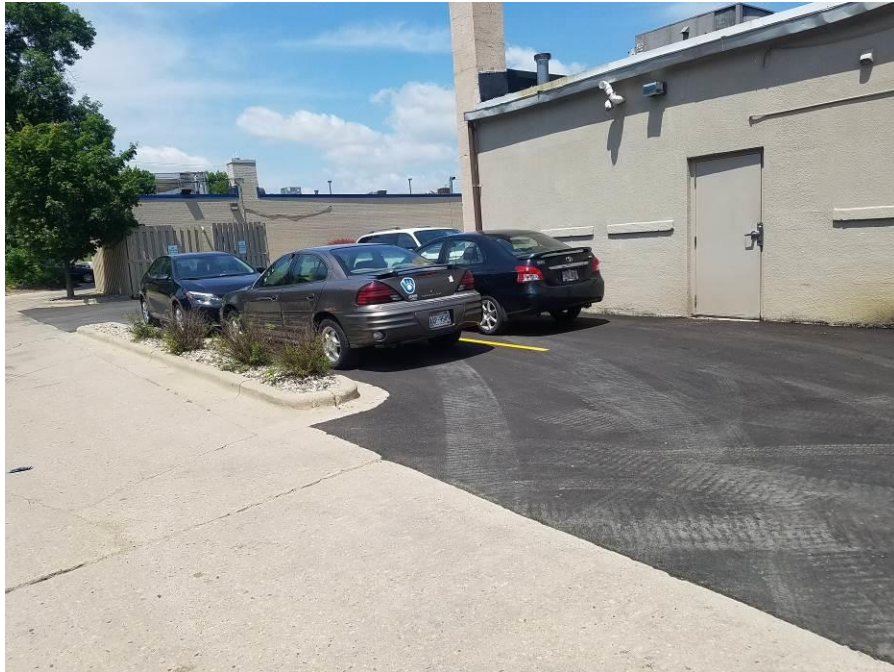
Photo 1: Looking northwest at pavement and buildings on June 7, 2018.

The caps consist of building foundation and asphalt pavement. The caps are located on the southwest side of the property as shown on **Figure D.2**.

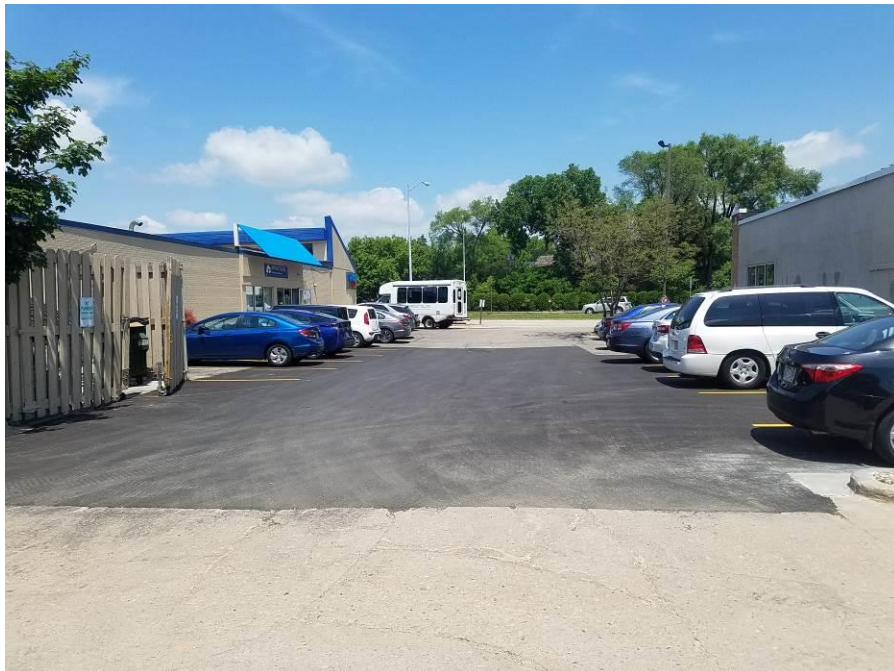
Photo 2: Looking north at pavement and buildings on June 7, 2018.

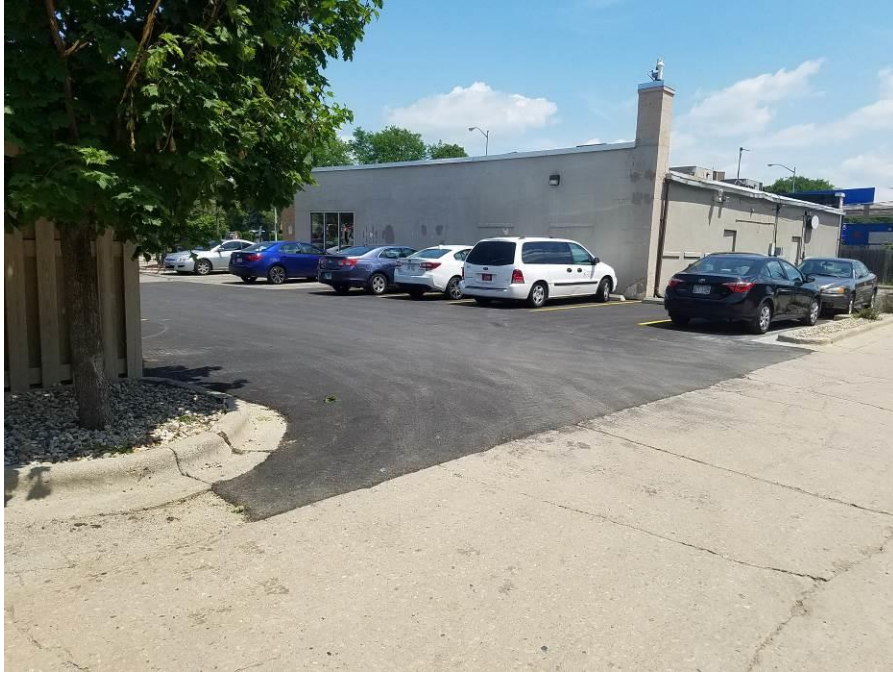
Photo 3: Looking northeast at pavement from south side of the property on June 7, 2018.

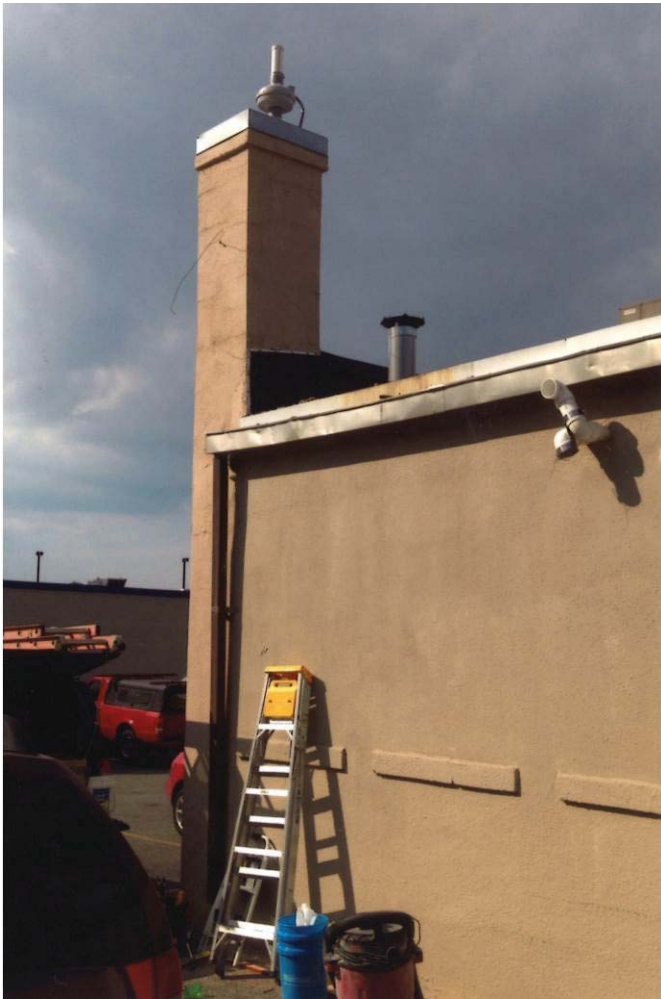
Photo 1: View looking northwest at southwest corner of 2803-2807 University Avenue building showing mitigation system fan and exhaust point.

Photographs of the VMS are included in **Attachment B**. The VMS includes four vacuum pickup points. Each pickup point was constructed with 3-inch-diameter schedule 40 PVC pipe set in the sub-slab material. The PVC pipes were sealed into the floor to prevent leakage and extended through the interior walls, columns, or other existing structures for support. The pickup points were plumbed together to a 3-inch-diameter PVC pipe which was extended above the roof line of the building through an un-used chimney.

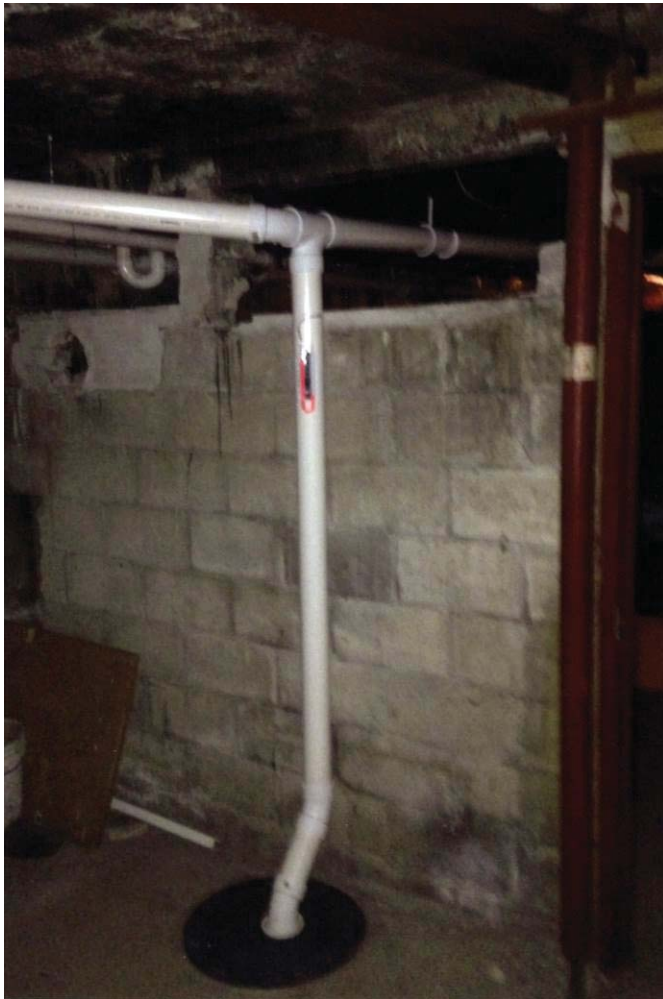
Photo 2: View looking northwest at mitigation system Pickup Point #1 (PU-1) in basement of 2803-2807 University Avenue.

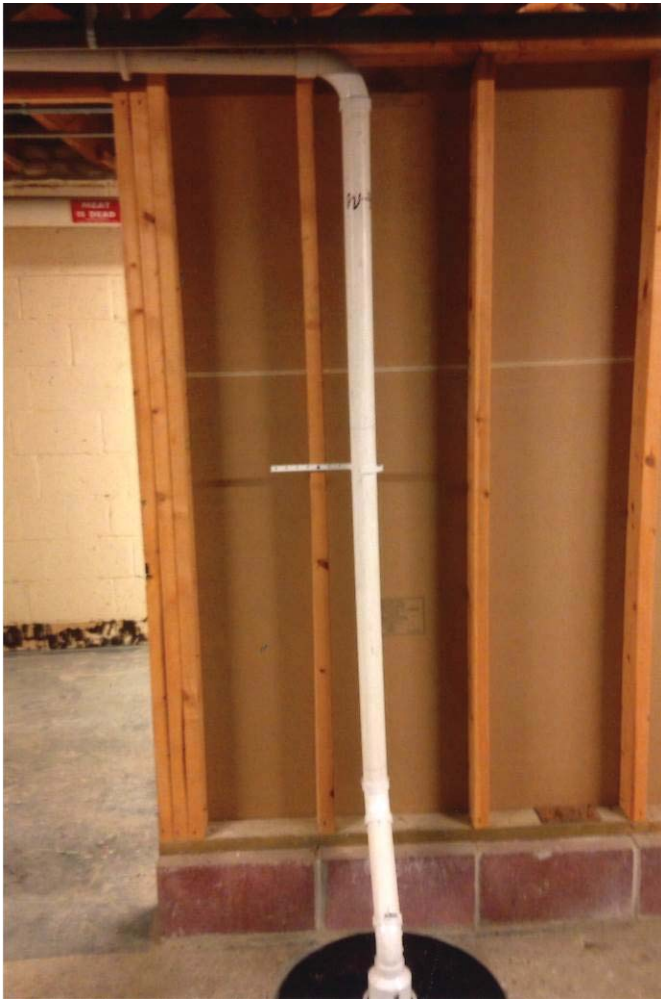
Photo 5: View looking west at mitigation system Pickup Point #4 (PU-4) in basement of 2803-2807 University Avenue.
