GIS REGISTRY INFORMATION

SITE NAME: Hales Corners Service Center
 BRRTS #: 03-41-005080 FID # (if appropriate): 241105040
 COMMERCE # (if appropriate): 53130-133403
 CLOSURE DATE: 2-15-2007
 STREET ADDRESS: 5403 S. 108th St.
 CITY: Hales Corners

Subject: Conditional Case Closure - Hales Corners Service Center
5403 South 108th Street, Hales Corners, WI, 53130
FID #: 241105040; BRRTs#: 03-41-005080

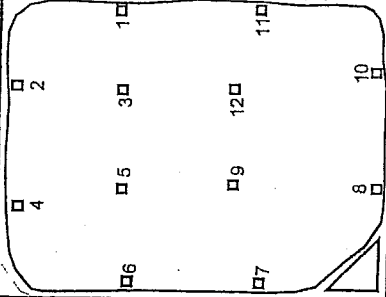
#1162 3/28/00 FIGURE 7

MORaine ENVIRONMENTAL, INC.
REMEDIAL EXCAVATION EXTENT
HALES CORNERS SERVICE CENTER
5403 SOUTH 108th STREET, HALES CORNERS

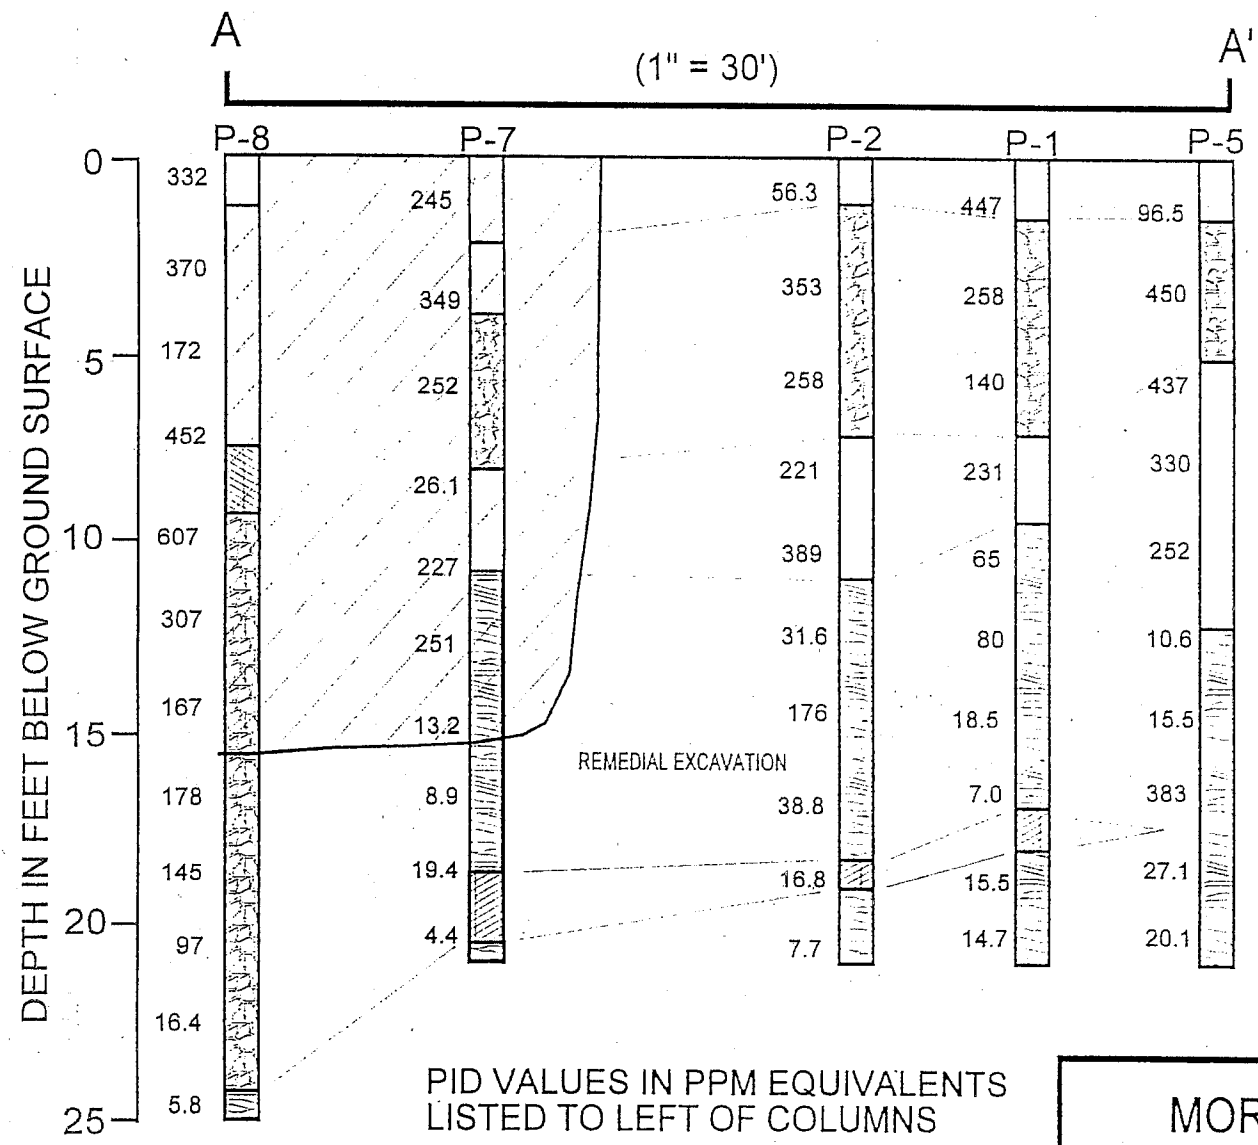
-   CLAYEY SAND AND GRAVEL FILL
-   SILTY FINE TO MEDIUM SAND
-   BROWN SILT WITH TRACE CLAY AND SAND
-   GREY CLAY TO SILTY CLAY
-   GREY SILT WITH TRACE CLAY AND SAND
-   BROWN NON-PLASTIC SILTY CLAY

PID VALUES IN PPM EQUIVALENTS LISTED TO LEFT OF COLUMNS
