Five Year Review

Third Five-Year Review Report for Better Brite Plating Co. Zinc and Chrome Shops Superfund Site De Pere, Brown County, Wisconsin

Wisconsin Department of Natural Resources
Northeast Region
Green Bay, Wisconsin

U.S. Environmental Protection Agency
Region 5
Chicago, Illinois

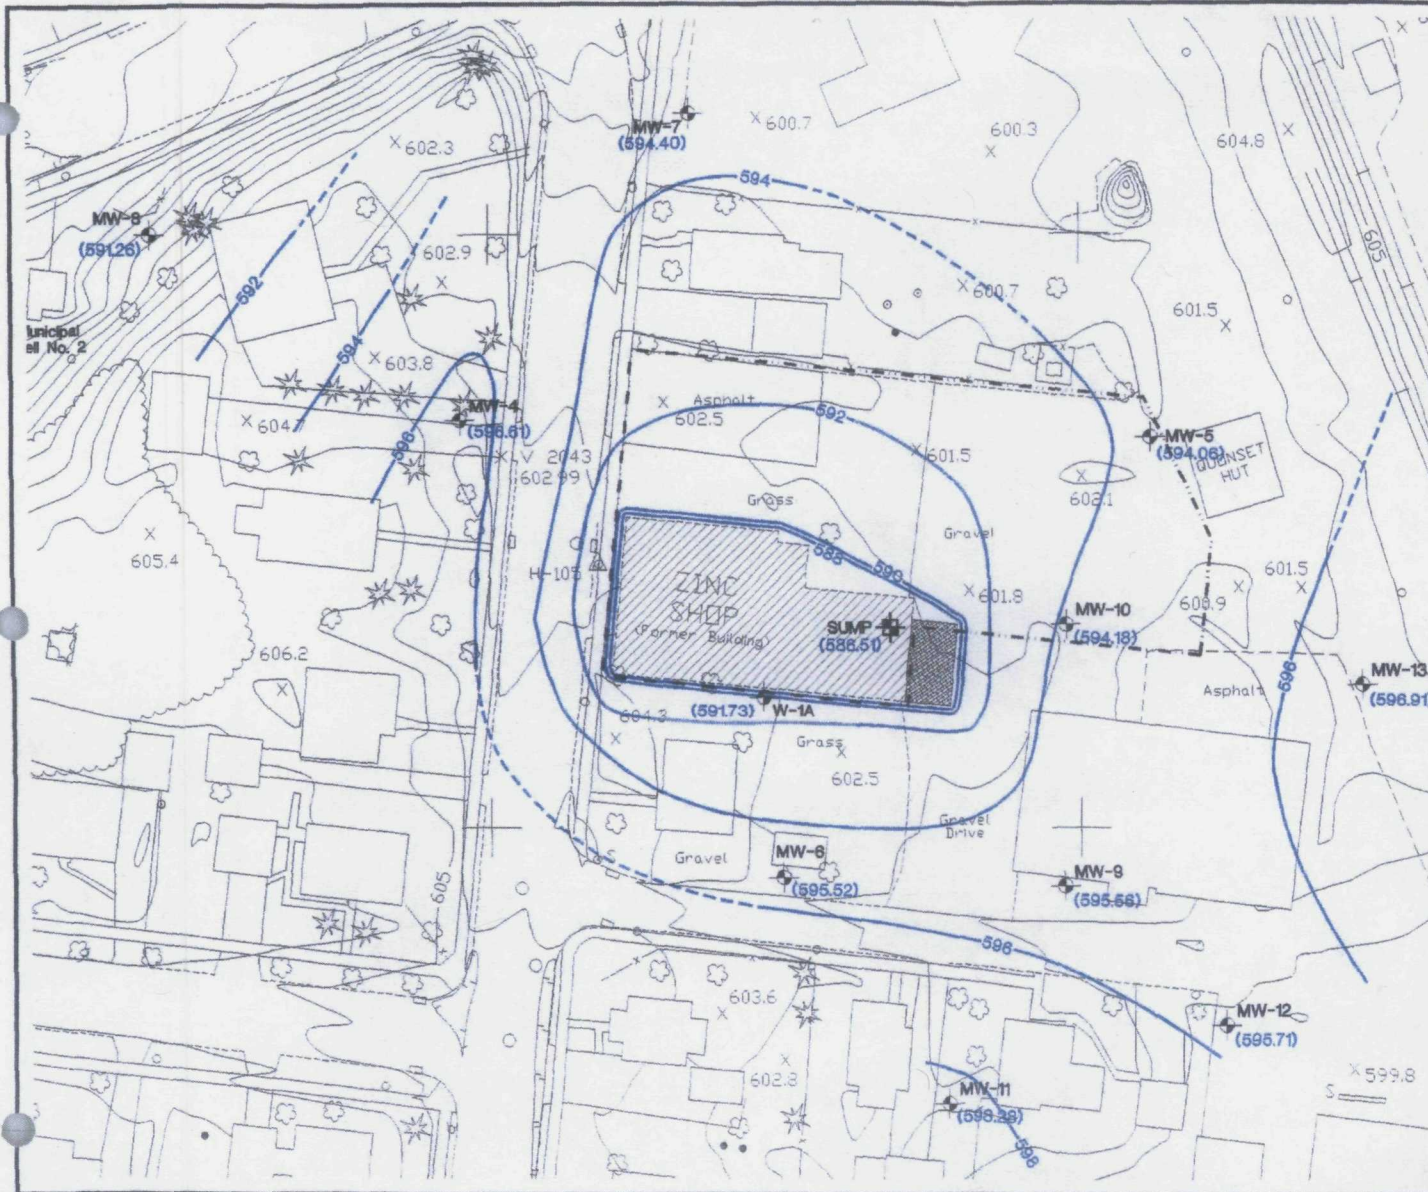
- MW-9 MONITOR WELL LOCATION AND DESIGNATION
- SUMP SUMP ACCESS LOCATION AND DESIGNATION
- GROUND WATER COLLECTION SYSTEM EXCAVATION COMPLETED IN 1993
- GROUND WATER COLLECTION SUMP EXCAVATION COMPLETED IN 1990
- (595.56) GROUND WATER ELEVATION (ft. msl)
- 594 — GROUND WATER CONTOUR (Dashed where inferred)
- - - - - PROPERTY LINE
- - - - - SUMP BOUNDARY
