Re: Koppers Inc. Wood-Treating Facility, Superior, Wisconsin

Beazer East, Inc.
Koppers Inc. Facility – Superior, WI
Recommended Corrective Actions for Off-Property Areas

BEAZER EAST, INC. KOPPERS INC. FACILITY SUPERIOR, WISCONSIN	
SITE PLAN	
 	FIGURE 1

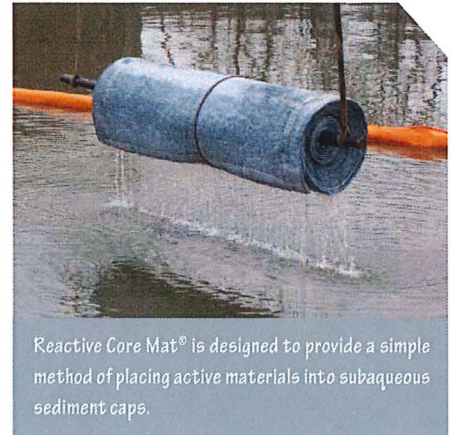
Reactive Core Mat® is designed to provide a simple method of placing active materials into subaqueous sediment caps.
