RE: Responses to USEPA Comments Based from the July 24, 1992, Letter

On behalf of CCP, enclosed are responses to the USEPA comments from the July 24, 1992, letter. This information is provided to clarify the scope of work for the outstanding work items from the 1987 Consent Order and additional work requested by USEPA.

- **Figure 1–Potential Sources of Groundwater Contamination**
- **Groundwater Collection System–Freeman Chemical Corporation, Saukville, Wisconsin**

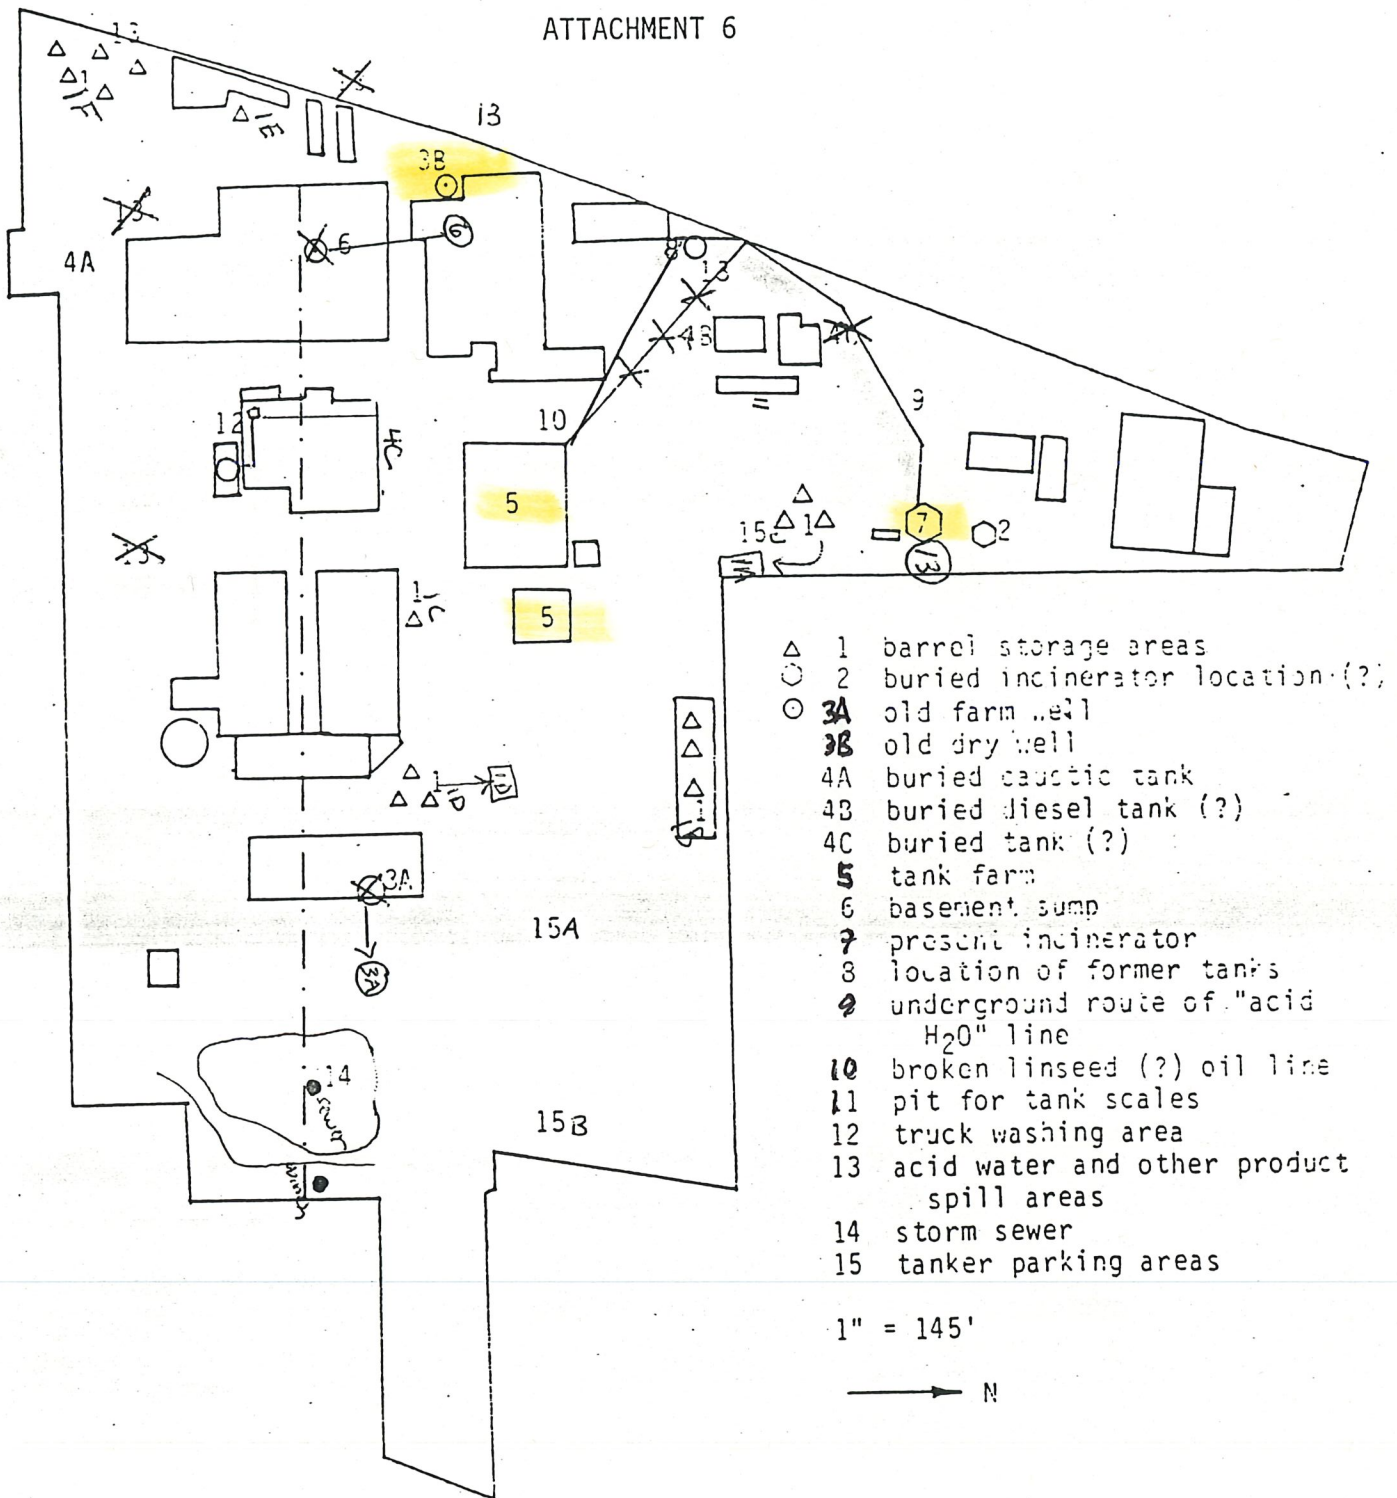
FIGURE 1 - Potential Sources of Groundwater Contamination

- △ 1 barrel storage areas
- 2 buried incinerator location (?)
- 3A old farm well
- 3B old dry well
- 4A buried caustic tank
- 4B buried diesel tank (?)
- 4C buried tank (?)
- 5 tank farm
- 6 basement sump
- 7 present incinerator
- 8 location of former tanks
- 9 underground route of "acid H₂O" line
- 10 broken linseed (?) oil line
- 11 pit for tank scales
- 12 truck washing area
- 13 acid water and other product spill areas
- 14 storm sewer
- 15 tanker parking areas

1" = 145'

USEPA COMMENTS	RESPONSES
<p>TASK 2 - POTENTIAL SOURCES OF GROUNDWATER CONTAMINATION</p> <p>Figure 1, <u>Potential Sources of Groundwater Contamination</u>, of the Corrective Action Order on Consent (CAO) identifies 18 Hazardous Waste Management Units (HWMUs), Solid Waste Management Units (SWMUs) and/or Areas of Concern (AOC). Several have been addressed prior to the CAO and the method of remediation has been documented in Task 1 of the CAO. The remedial actions taken prior to the CAO are considered by U.S. EPA to be "interim measures" and not final solutions. Review of Task 1, Annual Reports (Task 5), and quarterly groundwater monitoring reports supports the need for further work that will determine the final solution to each of these 18 units. Each unit in Figure 1 of the CAO is listed and described below in the order found in Figure 1, which is reproduced as Attachment 6.</p> <p>Each unit must be described as it presently exists. Task 1 included only those units that had been addressed in pre-CAO remediation. In every case, there was a brief description and little post-remedial information is available. For example, much of the site is paved over which may include some of the old HWMUs, SWMUs, and AOCs listed in Figure 1 of the CAO. This may be an influencing factor in the investigation of the site and potential remediation of the sources of contamination. This factor must be addressed in the workplan.</p> <p>CCP shall conduct an investigation, sampling for Appendix IX compounds, to characterize the contamination of the soil and rock units above the water table in the vicinity of the known or suspected contaminant releases listed in Figure 1 of the CAO. The investigation shall include, but not be limited to, the following information for each unit that requires additional work:</p> <ol style="list-style-type: none"> a. A description of the vertical and horizontal extent of contamination in the soil; b. A description of contaminant and soil chemical properties within the contaminant source area and plume. This includes contaminant solubility, speciation, adsorption, leachability, exchange capacity, biodegradability, hydrolysis, photolysis, oxidation, and other factors that might affect contaminant migration and transformation; c. Specific contaminant concentrations; d. The velocity and direction of contaminant movement; e. An extrapolation of future contaminant movement; 	<p>As discussed at the September 9, 1992, meeting, three major on-site sources exist that may be contributing contaminants to groundwater. These areas include the following:</p> <ul style="list-style-type: none"> • Former dry well • Former hazardous waste incinerator/urethane laboratory area • Former tank farm storage area <p>The remainder of the areas of concern may be characterized as nonexistent or nonsignificant areas of concern. Each area is discussed in more detail (see past waste disposal practices which follows). The proper locations of the 18 areas of concern are illustrated on Figure 1 of the AOC (see Attachment A).</p> <p>CCP is proposing an alternative soil investigation approach (refer to Workplan outline). The objectives are the following:</p> <ul style="list-style-type: none"> • To collect data necessary to adequately characterize the site for purposes of determining whether or not additional corrective measures are necessary to remediate remaining on-site sources of groundwater contamination. • To quantify the risk to public health posed by off-site sources which originated from CCP operations.

USEPA COMMENTS	RESPONSES
<p>13) "Acid Water and Other Product Spill Areas": A minimum of five areas were defined as spill areas on Figure 1. No spill area was specifically addressed in the pre-CAO remediation as outlined in Task 1.</p> <p>○ Each area in Figure 1 and any other area identified by CCP must be included in the workplan. Each area where contamination is found must be included in the CMS Work Plan.</p>	<p>13) <u>Acid Water and Other Product Spill Areas</u> The locations for some of the spill areas are incorrect (see Figure 1). No product or raw material was spilled at two areas identified on the map.</p> <p>Products that do not contain hazardous constituents need not be addressed under this corrective action.</p> <p>In years past, approximately from 1965-1972, an acid water tankwagon was parked by the old dry well. Spills of acid water occurred when the tankwagon overfilled, which may have impacted the area immediately west of the dry well.</p> <p>There were no reaction water lines at this time to carry the reaction water from production areas to the incinerator area. Thus, the reaction water was trucked up to the incinerator area and transferred into the storage tank. Spills of acid water occurred at the former hazardous waste incinerator area.</p> <p>Spills did not occur at the south end of the facility. This area was used primarily for employee parking. Field-screening results for soils excavated during placement of the storm sewer line clearly indicate that these soils were not impacted (see Attachment C).</p> <p>On rare occasions, employees recollected hose leaks from phthalic and maleic tanks located near the old dry well. Phthalic and maleic materials solidify at ambient temperatures. This area is now paved and is not an area of concern for groundwater contamination.</p>

USEPA COMMENTS	RESPONSES
<p>16) "Contamination plume in the glacial aquifer as defined by wells 43 and 44, 1987": This is not listed in Figure 1 of the CAO and may be a newly defined Area of Concern which could be associated with the tank farm immediately north of the plume area (area 5 above). This area indicated a third major hot spot in the facility's groundwater as seen in 1986 and/or 1987 groundwater sampling data. When wells 43 and 44 were no longer producing water samples due to the drought, this plume disappeared off of isocontour maps produced for the annual report (Task 5). (The Trend Analysis of the 1991 Annual Report shows well 43 as being dry between summer 1987 and summer 1989 with samples being taken until summer 1991 and well 43 became dry afterwards. Approximate contamination is 150,000 ppb.) The soils are likely to be contaminated in this location and must be investigated as source of contamination to the groundwater. If contamination is found, this area must be included in the CMS Work Plan.</p>	<p>The VOCs detected at wells W-43 and W-44 are likely a result of the upgradient tank farm storage area. Employees do not recollect disposal practices at these well locations that would constitute a separate source area.</p>

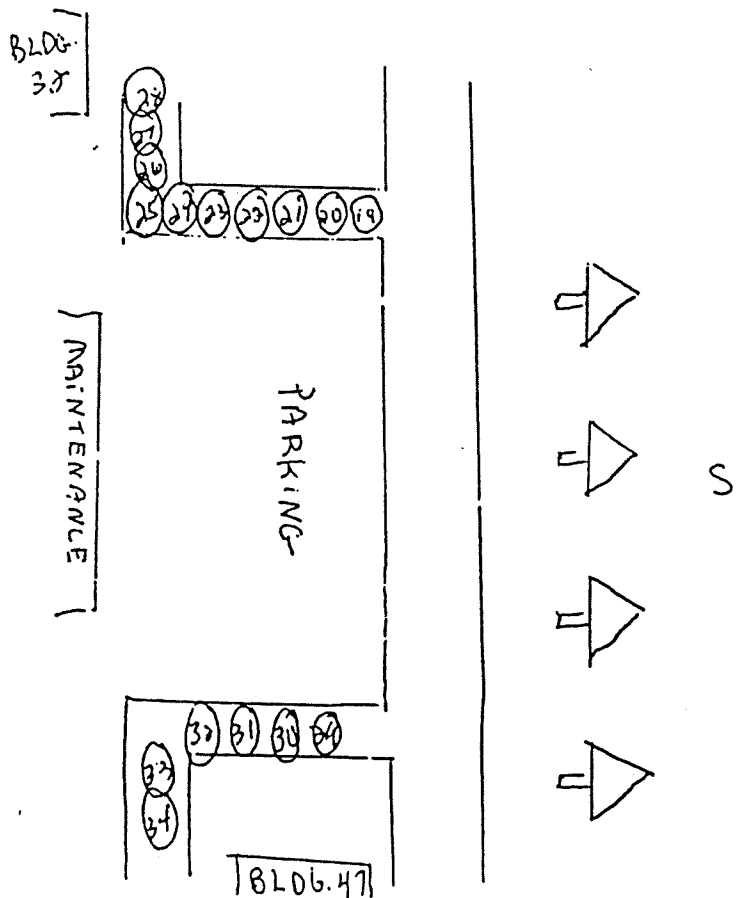
Sample readings and results:

- #19 0 ppm
- #20 0 ppm
- #21 0 ppm
- #22 0 ppm
- #23 0 ppm
- #24 0 ppm
- #25 0 ppm
- #26 0 ppm
- #27 0 ppm
- #28 0 ppm
- #29 0 ppm
- #30 0 ppm
- #31 0 ppm
- #32 0 ppm
- #33 0 ppm
- #34 0 ppm

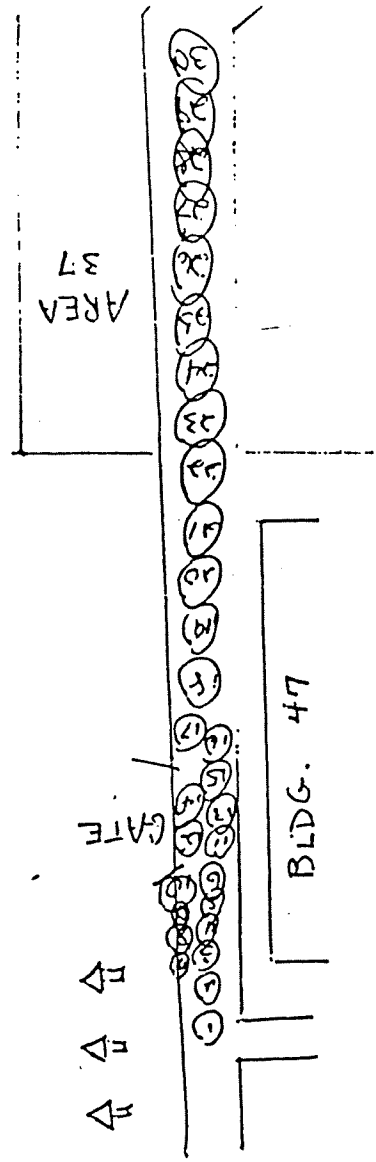
Sample readings and results:

#1	0 ppm	(0)
#2	0 ppm	(0)
#3	0 ppm	(2)
#4	0 ppm	(3)
#5	0 ppm	(0)
#6	0 ppm	(1)
#7	0 ppm	(2)
#8	0 ppm	(0)
#9	0 ppm	(0)
#10	0 ppm	(0)
#11	0 ppm	(2)
#12	0 ppm	(2)
#13	0 ppm	(2)
#14	0 ppm	(2)
#15	0 ppm	(3)
#16	0 ppm	(4)
#17	0 ppm	(1)
#18	0 ppm	(2)
#19	0 ppm	(0)
#20	0 ppm	(0)
#21	0 ppm	(0)
#22	0 ppm	(0)
#23	0 ppm	(0)
#24	0 ppm	(0)
#25	0 ppm	(0)
#26	0 ppm	(0)
#27	0 ppm	(0)
#28	0 ppm	(0)
#29	0 ppm	(0)
#30	0 ppm	(0)

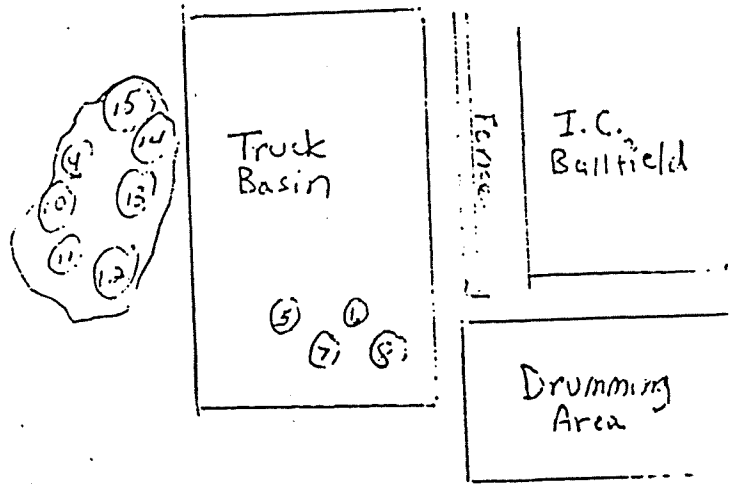
Soil readings and results:

- #5 0 ppm
- #6 0 ppm
- #7 0 ppm
- #8 0 ppm
- #9 0 ppm
- #10 0 ppm
- #11 0 ppm
- #12 0 ppm
- #13 0 ppm
- #14 0 ppm
- #15 0 ppm

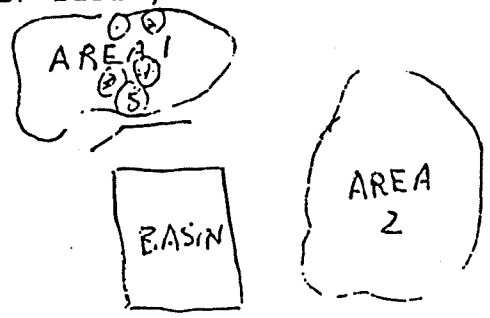
Soil was also tested on concrete to be removed by Tillmann and sent to off-site landfill. Soil was scraped from cement blocks that had been moved to area a (north of basin, but south of drive).

Readings for soil were as follows:

- #1 0 ppm
- #2 0 ppm
- #3 0 ppm
- #4 0 ppm
- #5 0 ppm

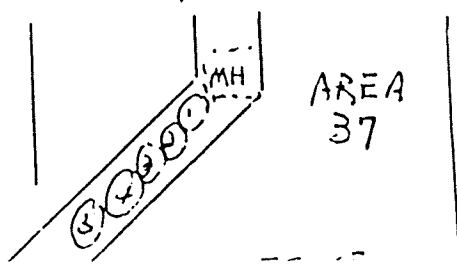
Soil was also tested as it was excavated in area 37. Only a few samples were taken as most of sewer line was tested prior to this.

Results of PID readings:

- #1 0 ppm
- #2 0 ppm
- #3 0 ppm
- #4 0 ppm
