**Subject:** Gunderson Neenah (Goodwill Store) Report

Attached is the requested reevaluation of the remedial options, with recommendations for two main tasks:

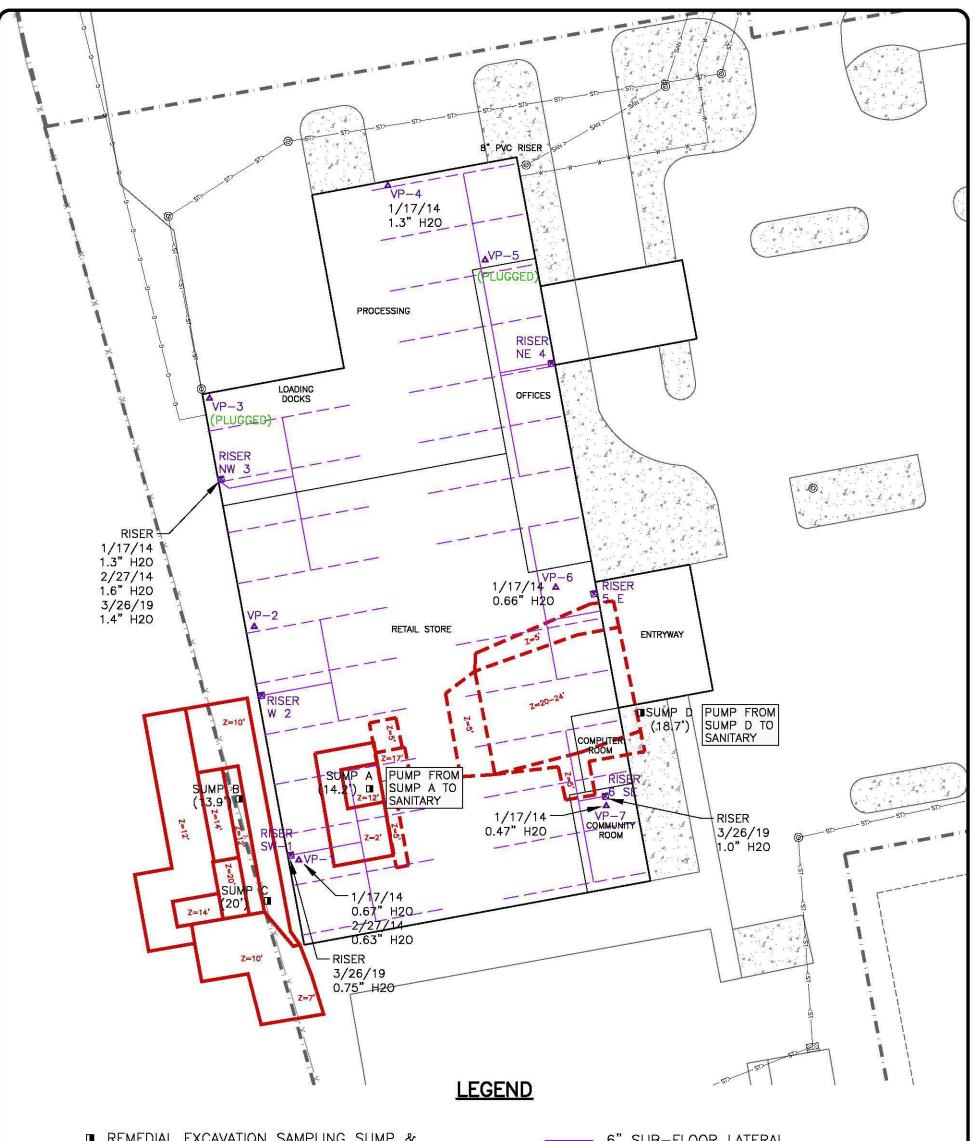
- REMEDIAL EXCAVATION SAMPLING SUMP &
- ▲ SUB-SLAB VAPOR SAMPLING POINT
- EXTRACTION SYSTEM VERTICAL RISER TO ROOF MOUNTED FAN
- 6" SUB-FLOOR LATERAL
- --- 4" PERFORATED PIPE BEDDED IN STONE
- 2009 EXCAVATION OUTLINE & DEPTH
- [Z=1] 2013 EXCAVATION OUTLINE & DEPTH

Prior to testing, the operating subslab vapor mitigation system should be shut down for 24 to 48 hours so conditions can equilibrate. Four subslab vapor samples are proposed for
