Source Property Information

CLOSURE DATE: 12/19/2013

STEVE PLATER FAC (ONE HOUR MARTINIZING)

6914 N Teutonia Ave

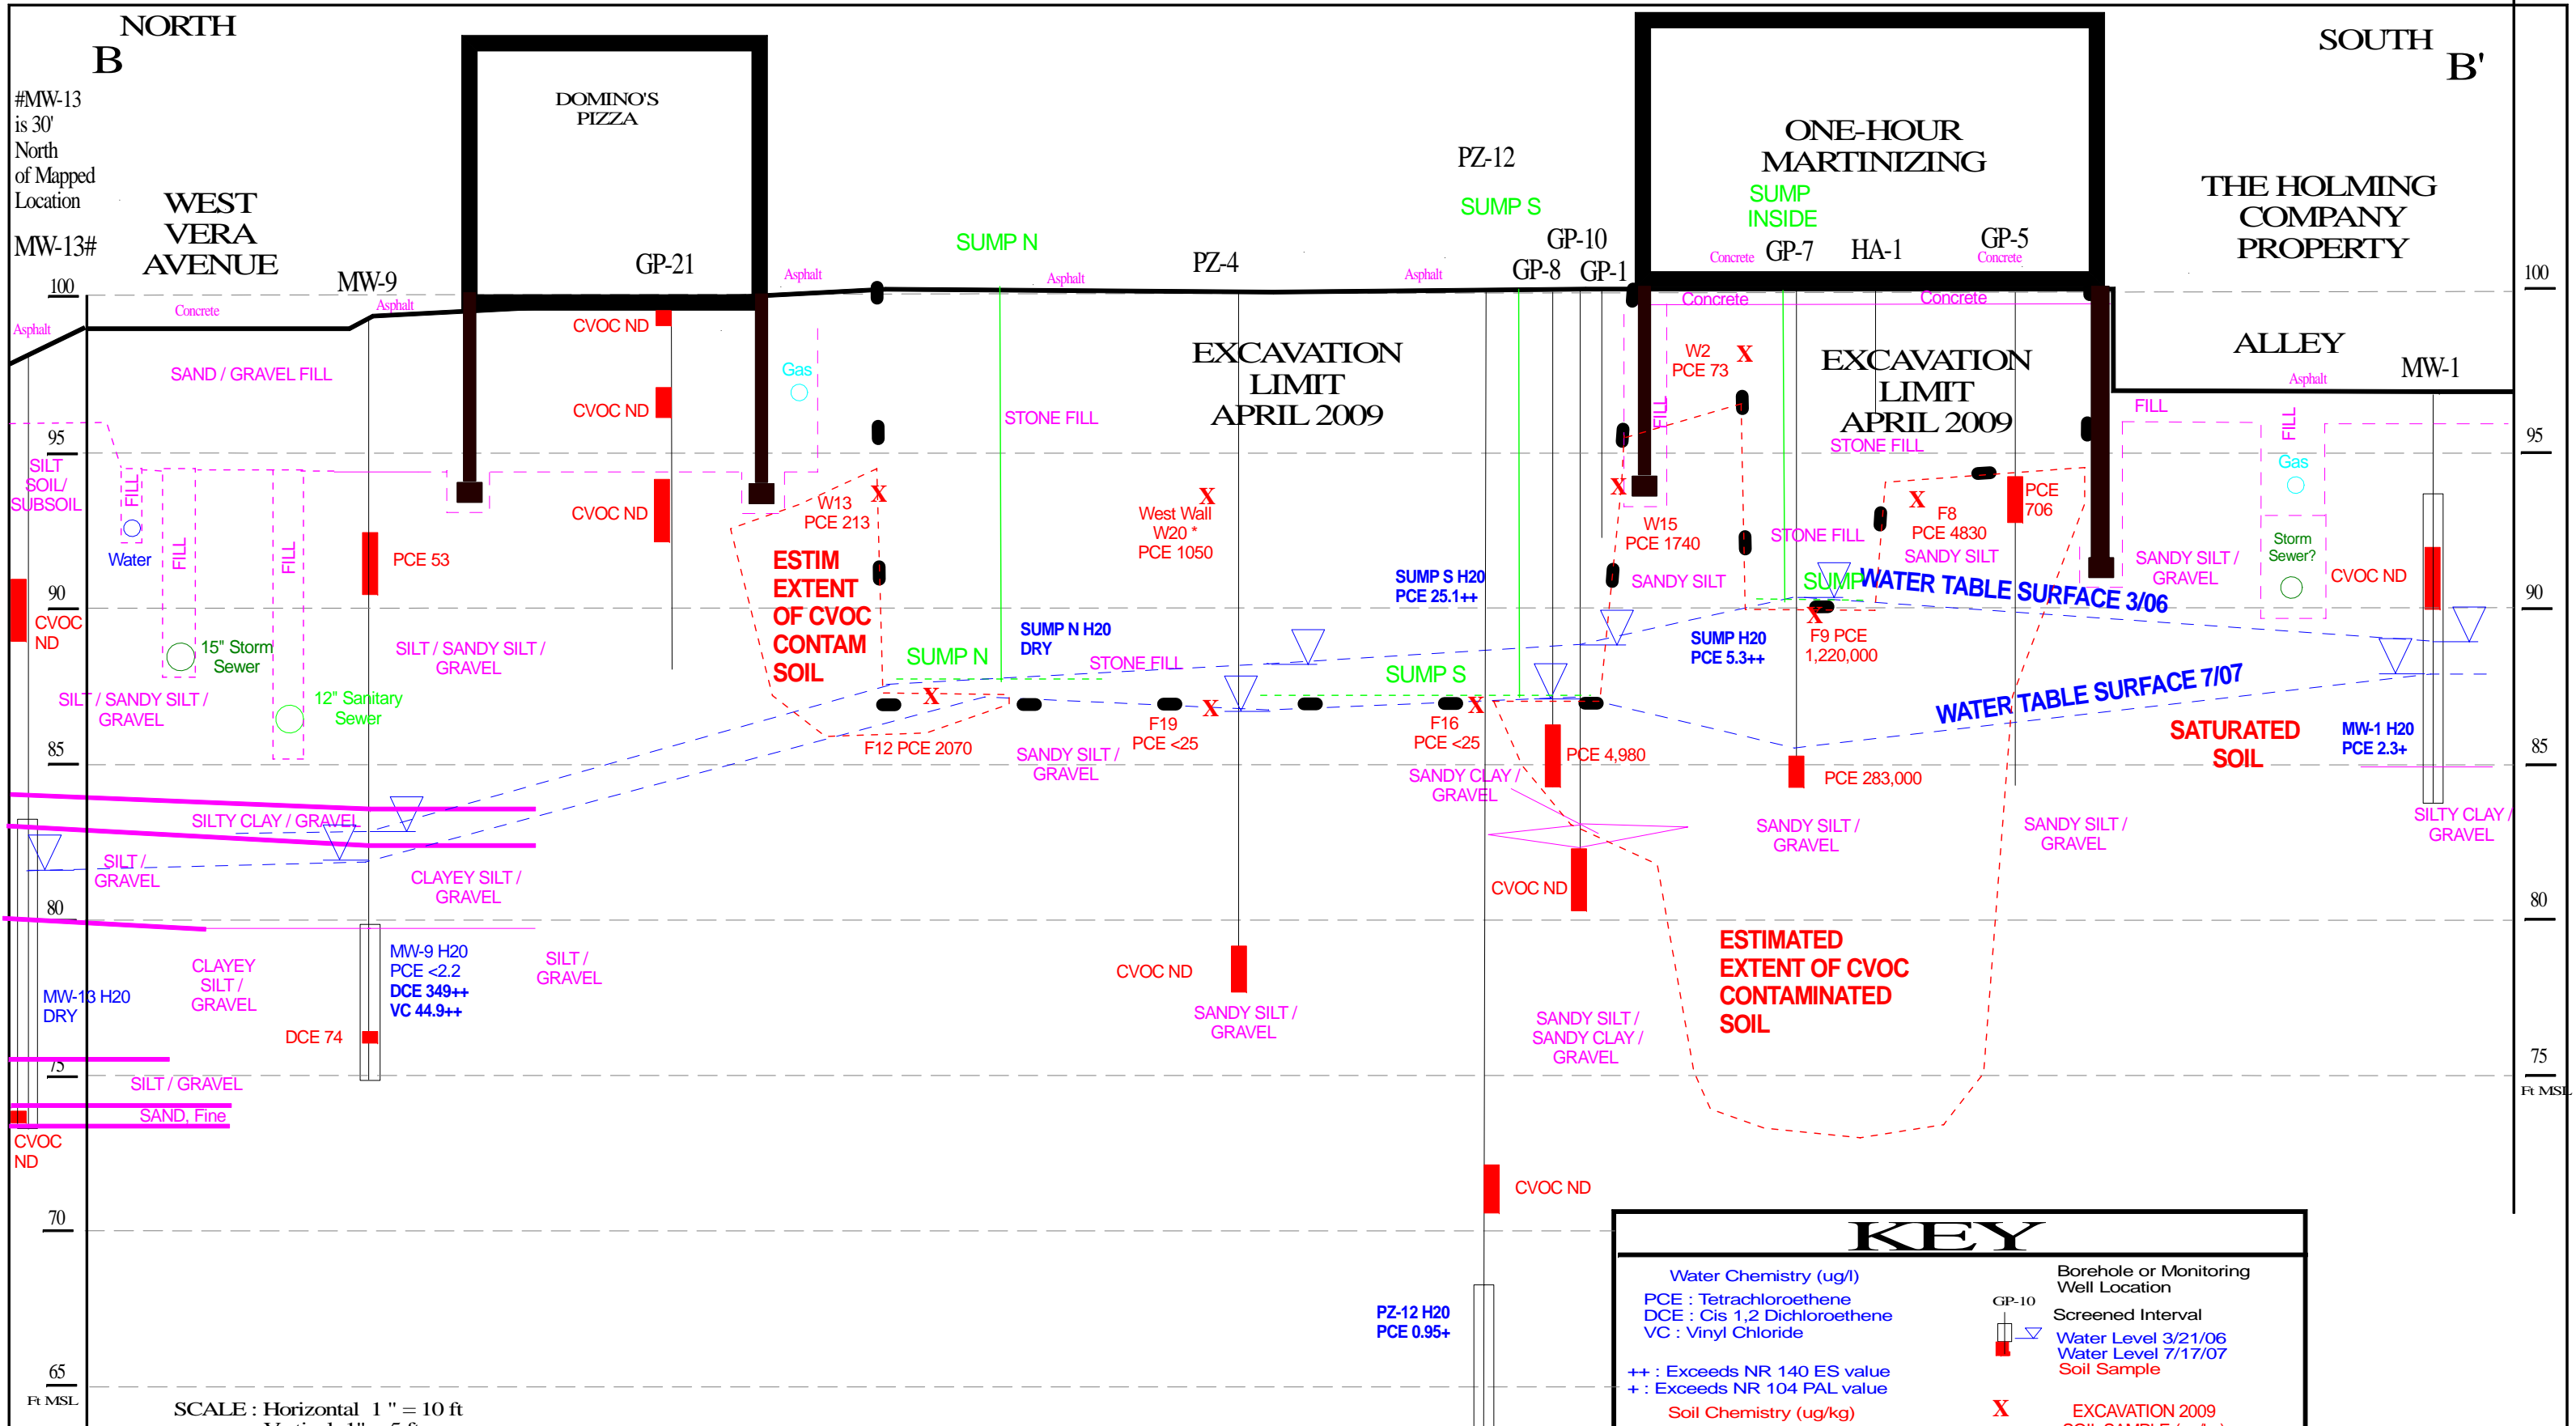
NORTH / SOUTH CROSS SECTION B-B'

Project: FORMER OHM, PLATER, MILWAUKEE, WI
 Client: PLATCO, INC.

<p>Water Chemistry (ug/l) PCE : Tetrachloroethene DCE : Cis 1,2 Dichloroethene VC : Vinyl Chloride</p> <p>++ : Exceeds NR 140 ES value + : Exceeds NR 104 PAL value</p> <p>Soil Chemistry (ug/kg) PCE : Tetrachloroethene TCE : Trichloroethene DCE : Cis 1,2 Dichloroethene</p> <p>— GEOLOGIC CONTACT, ESTIMATED - - - GEOLOGIC CONTACT, INFERRED</p> <p>Groundwater chemistry from July 2009 Only detected compounds shown CVOC ND = No detect for Chlorinated VOC's</p>	<p>Borehole or Monitoring Well Location</p> <p>Screened Interval</p> <p>Water Level 3/21/06 Water Level 7/17/07 Soil Sample</p> <p>X EXCAVATION 2009 SOIL SAMPLE (ug/kg)</p> <p>F8 PCE 4830</p>
--	--

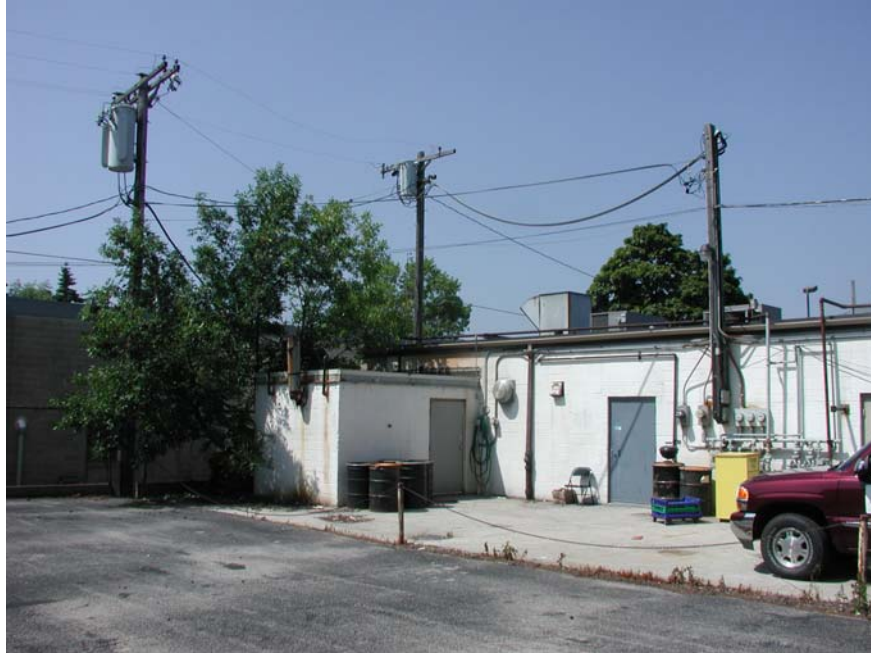
One-Hour Martinizing - N. Teutonia Ave.
South view of asphalt cap

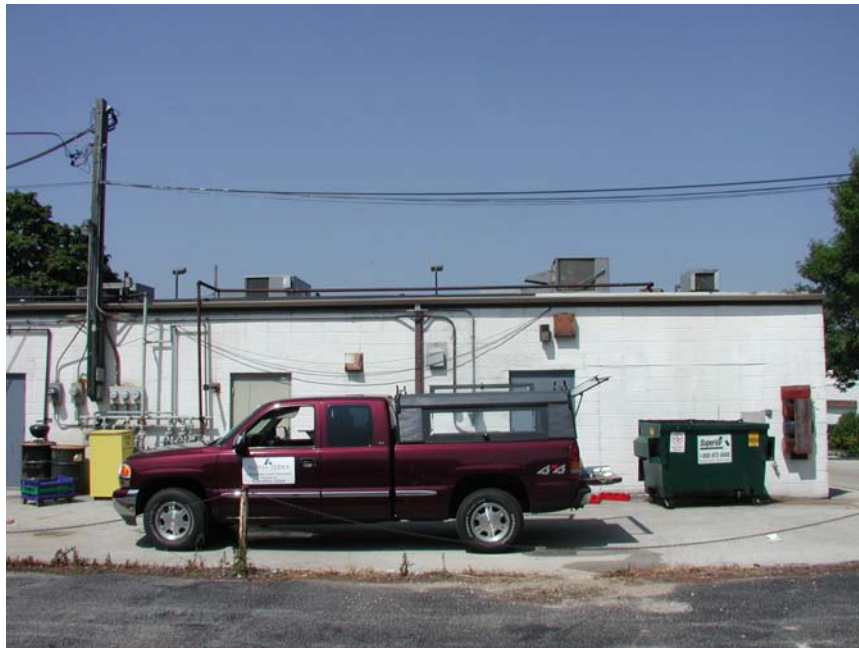
One-Hour Martinizing - N. Teutonia Ave.
North view of asphalt cap

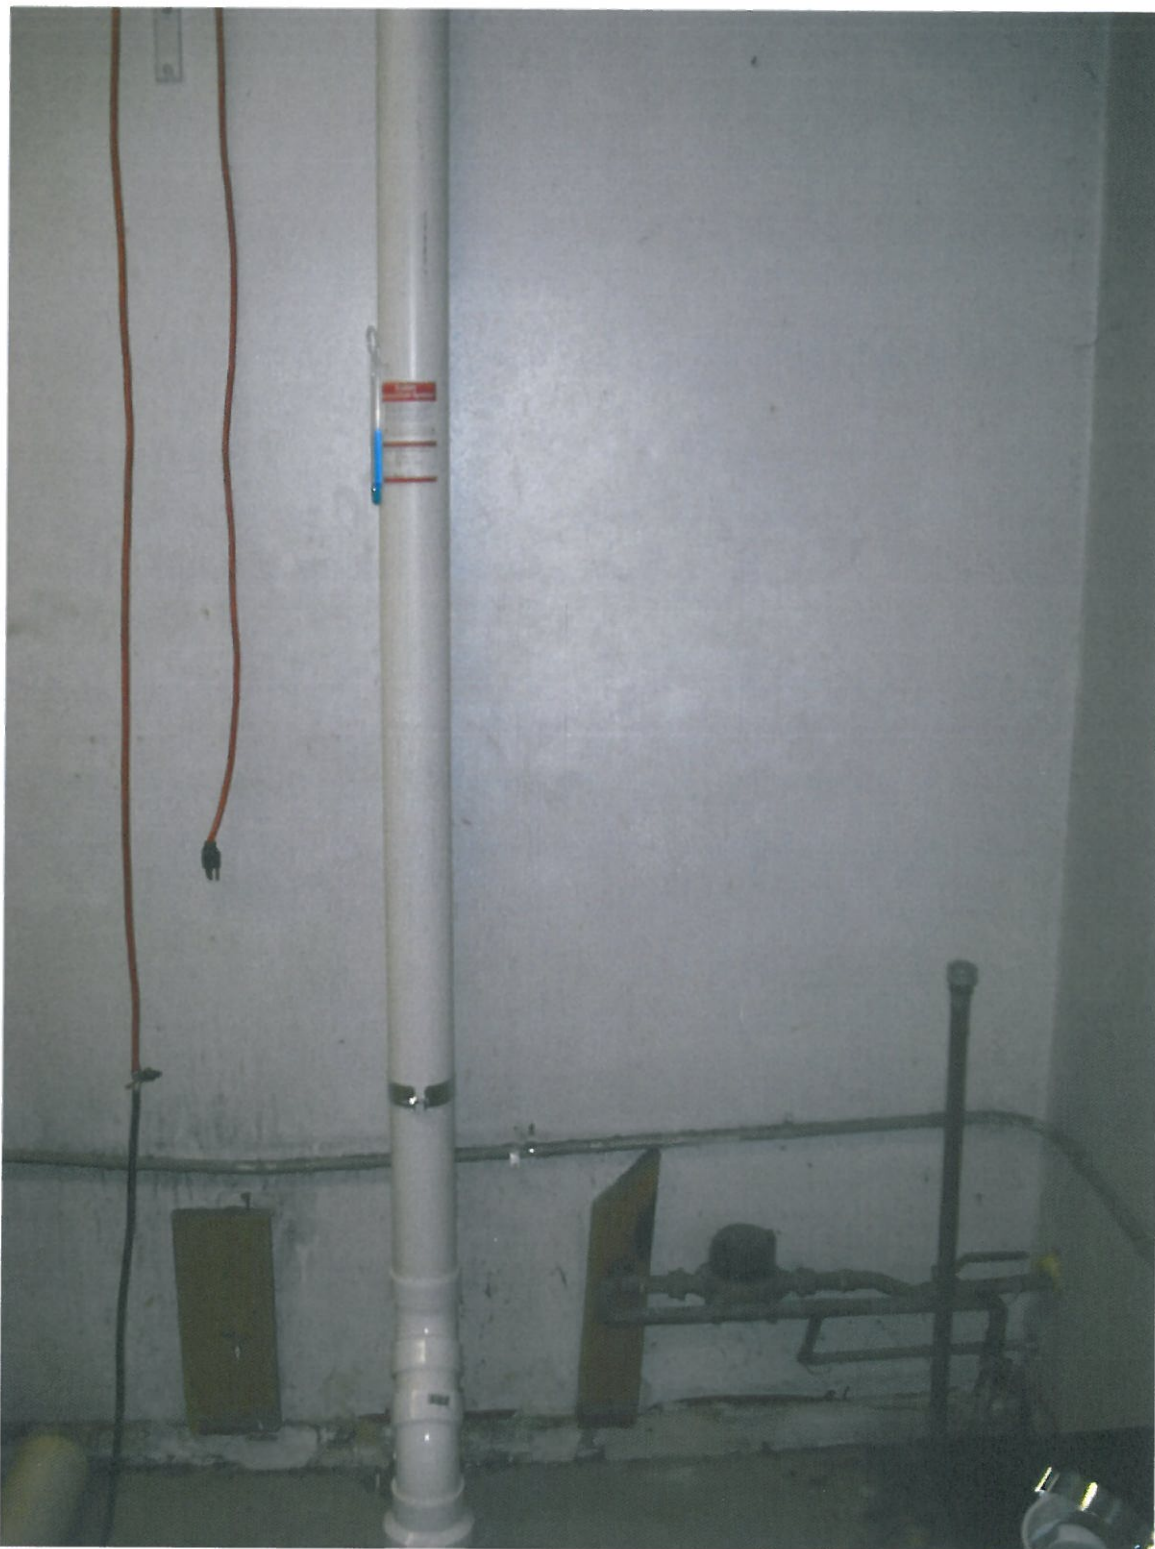
Viewing the sub-slab depressurization system installed on April 19, 2012 at the former One-Hour Martinizing property. Note blue anemometer near the top of the picture.

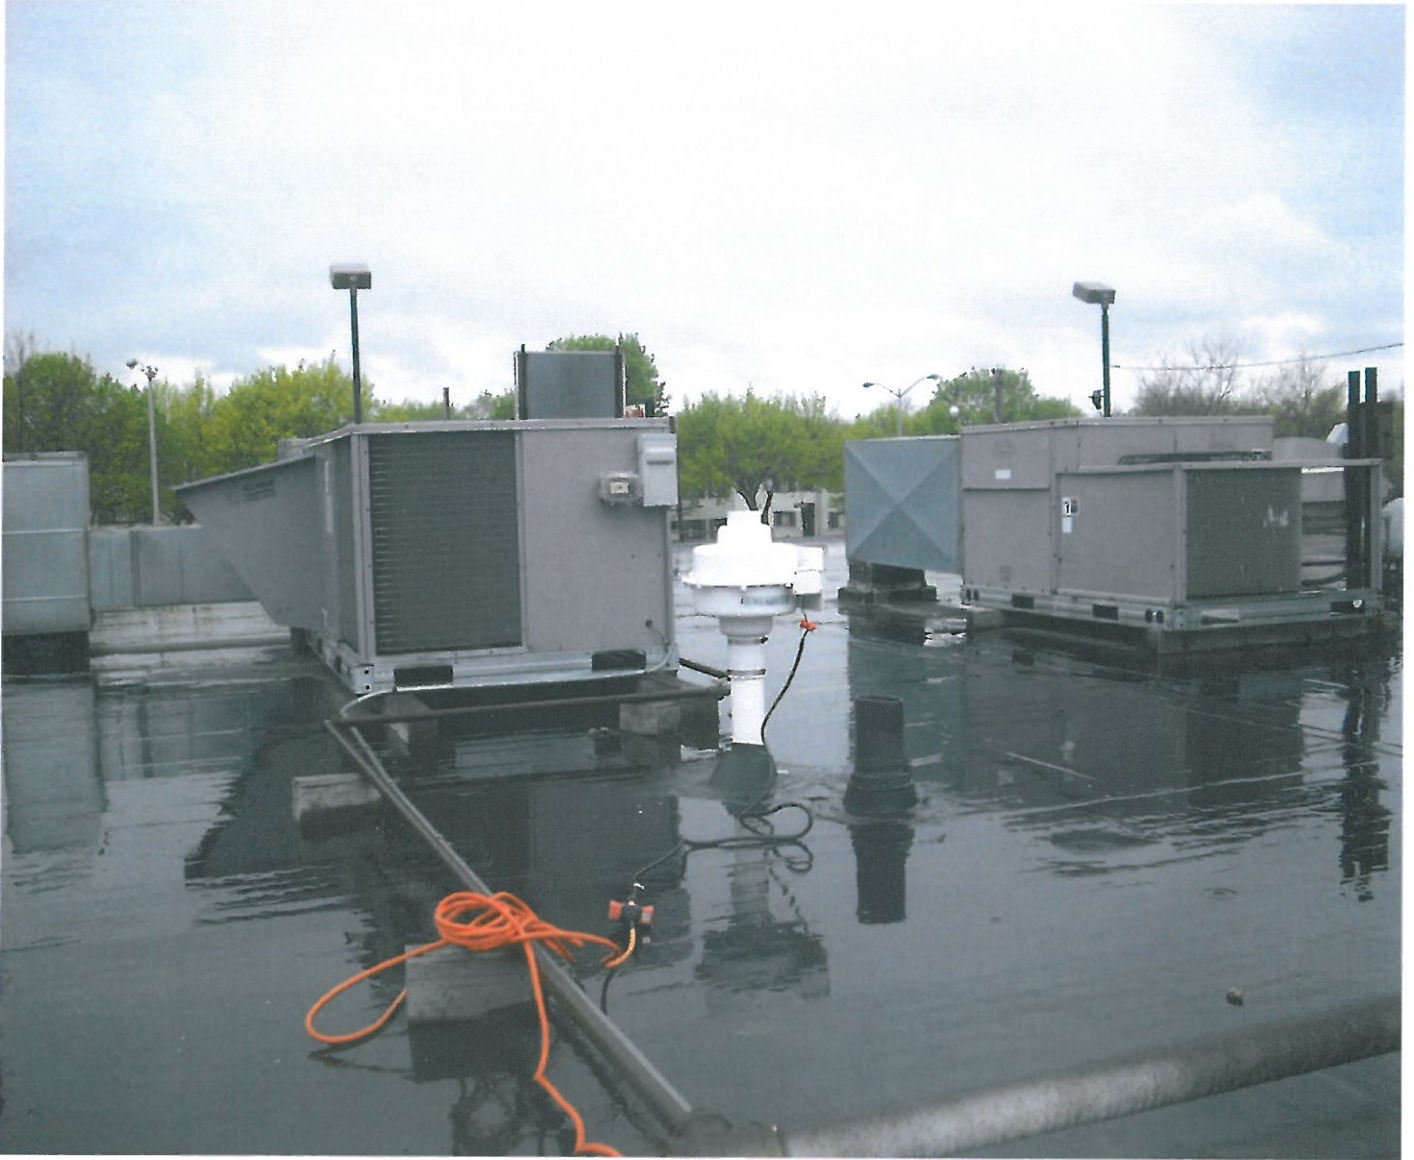
Viewing the roof penetration and fan placement at the former One-Hour Martinizing. The electrical wiring shown was temporary to test the functionality of the system. An electrician properly wired the system at a later date.

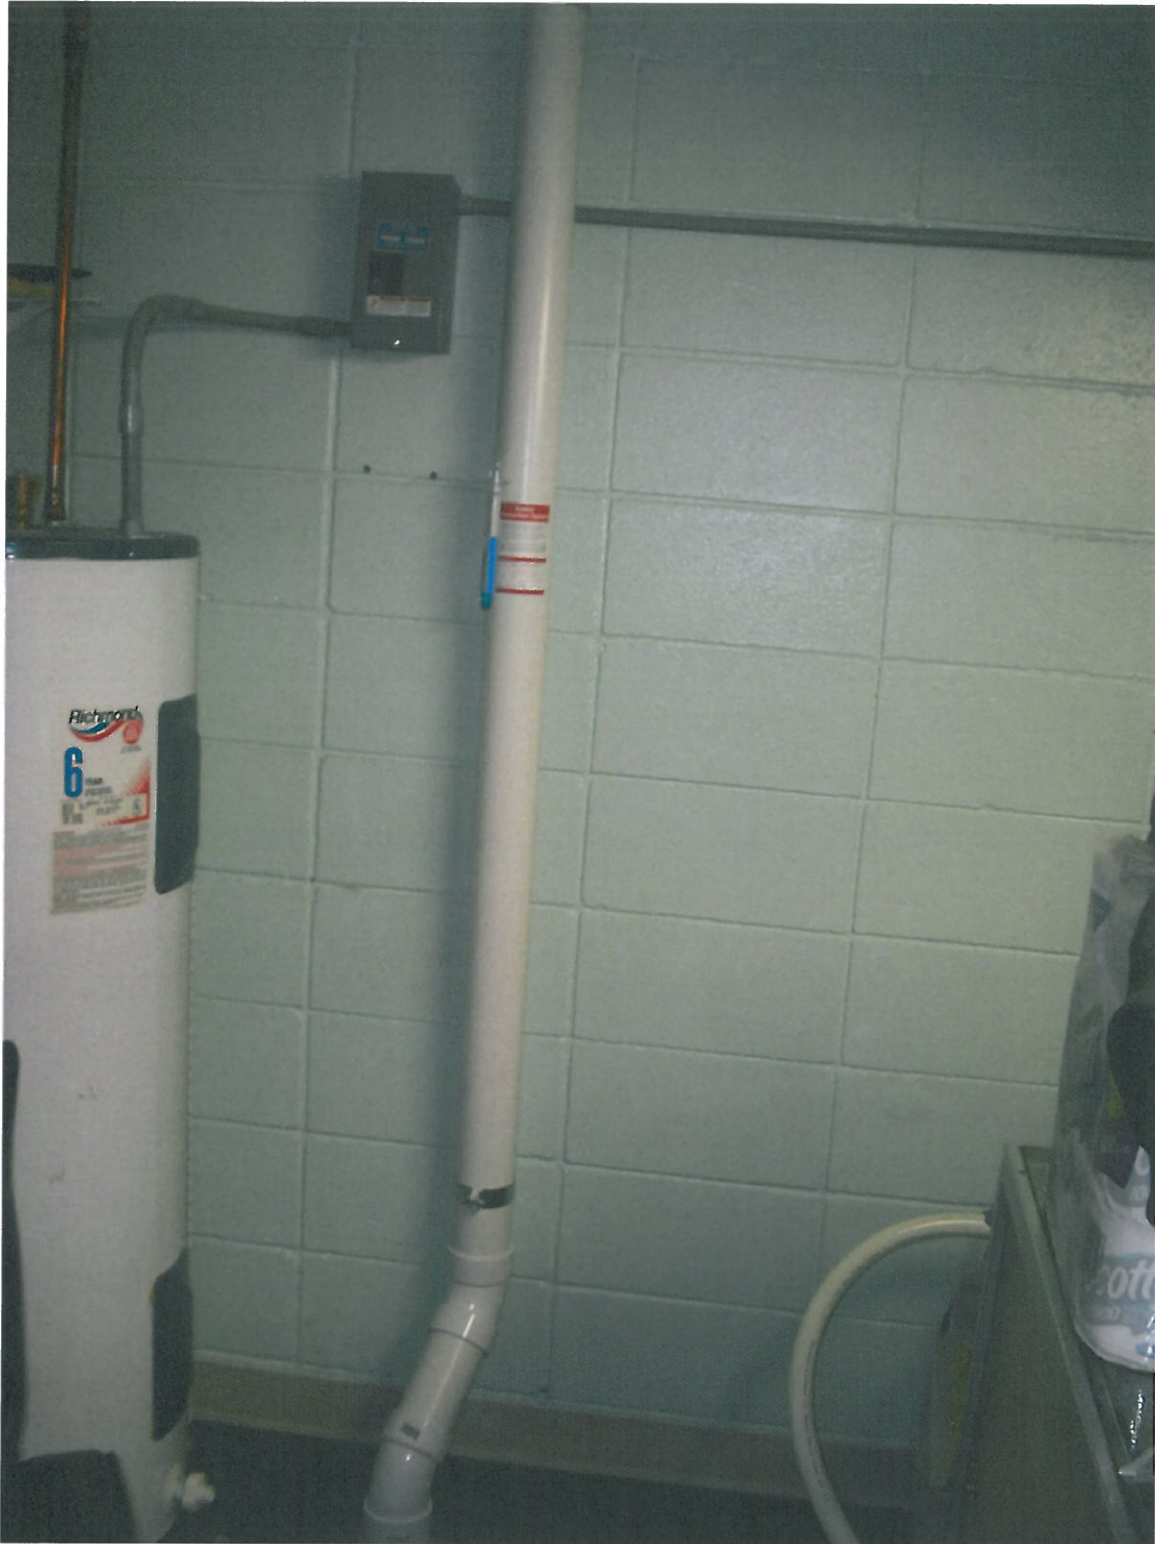
Viewing the sub-slab depressurization system installed on April 19, 2012 at the former Exotic Nails property. Note blue anemometer near the top of the picture.

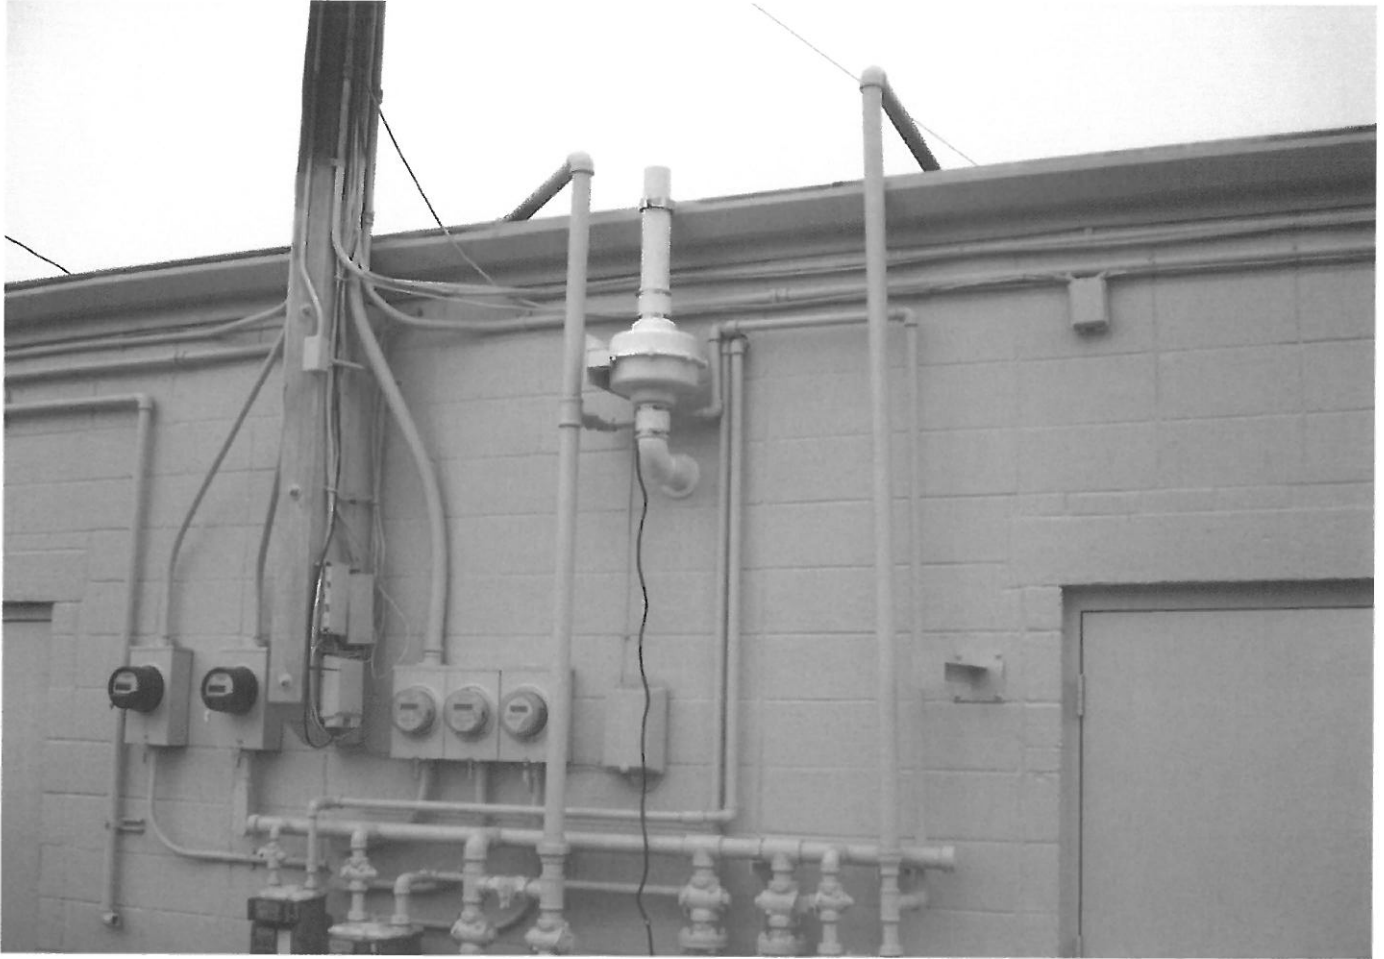
Viewing the eastern wall penetration and fan placement at the former Exotic Nails property.

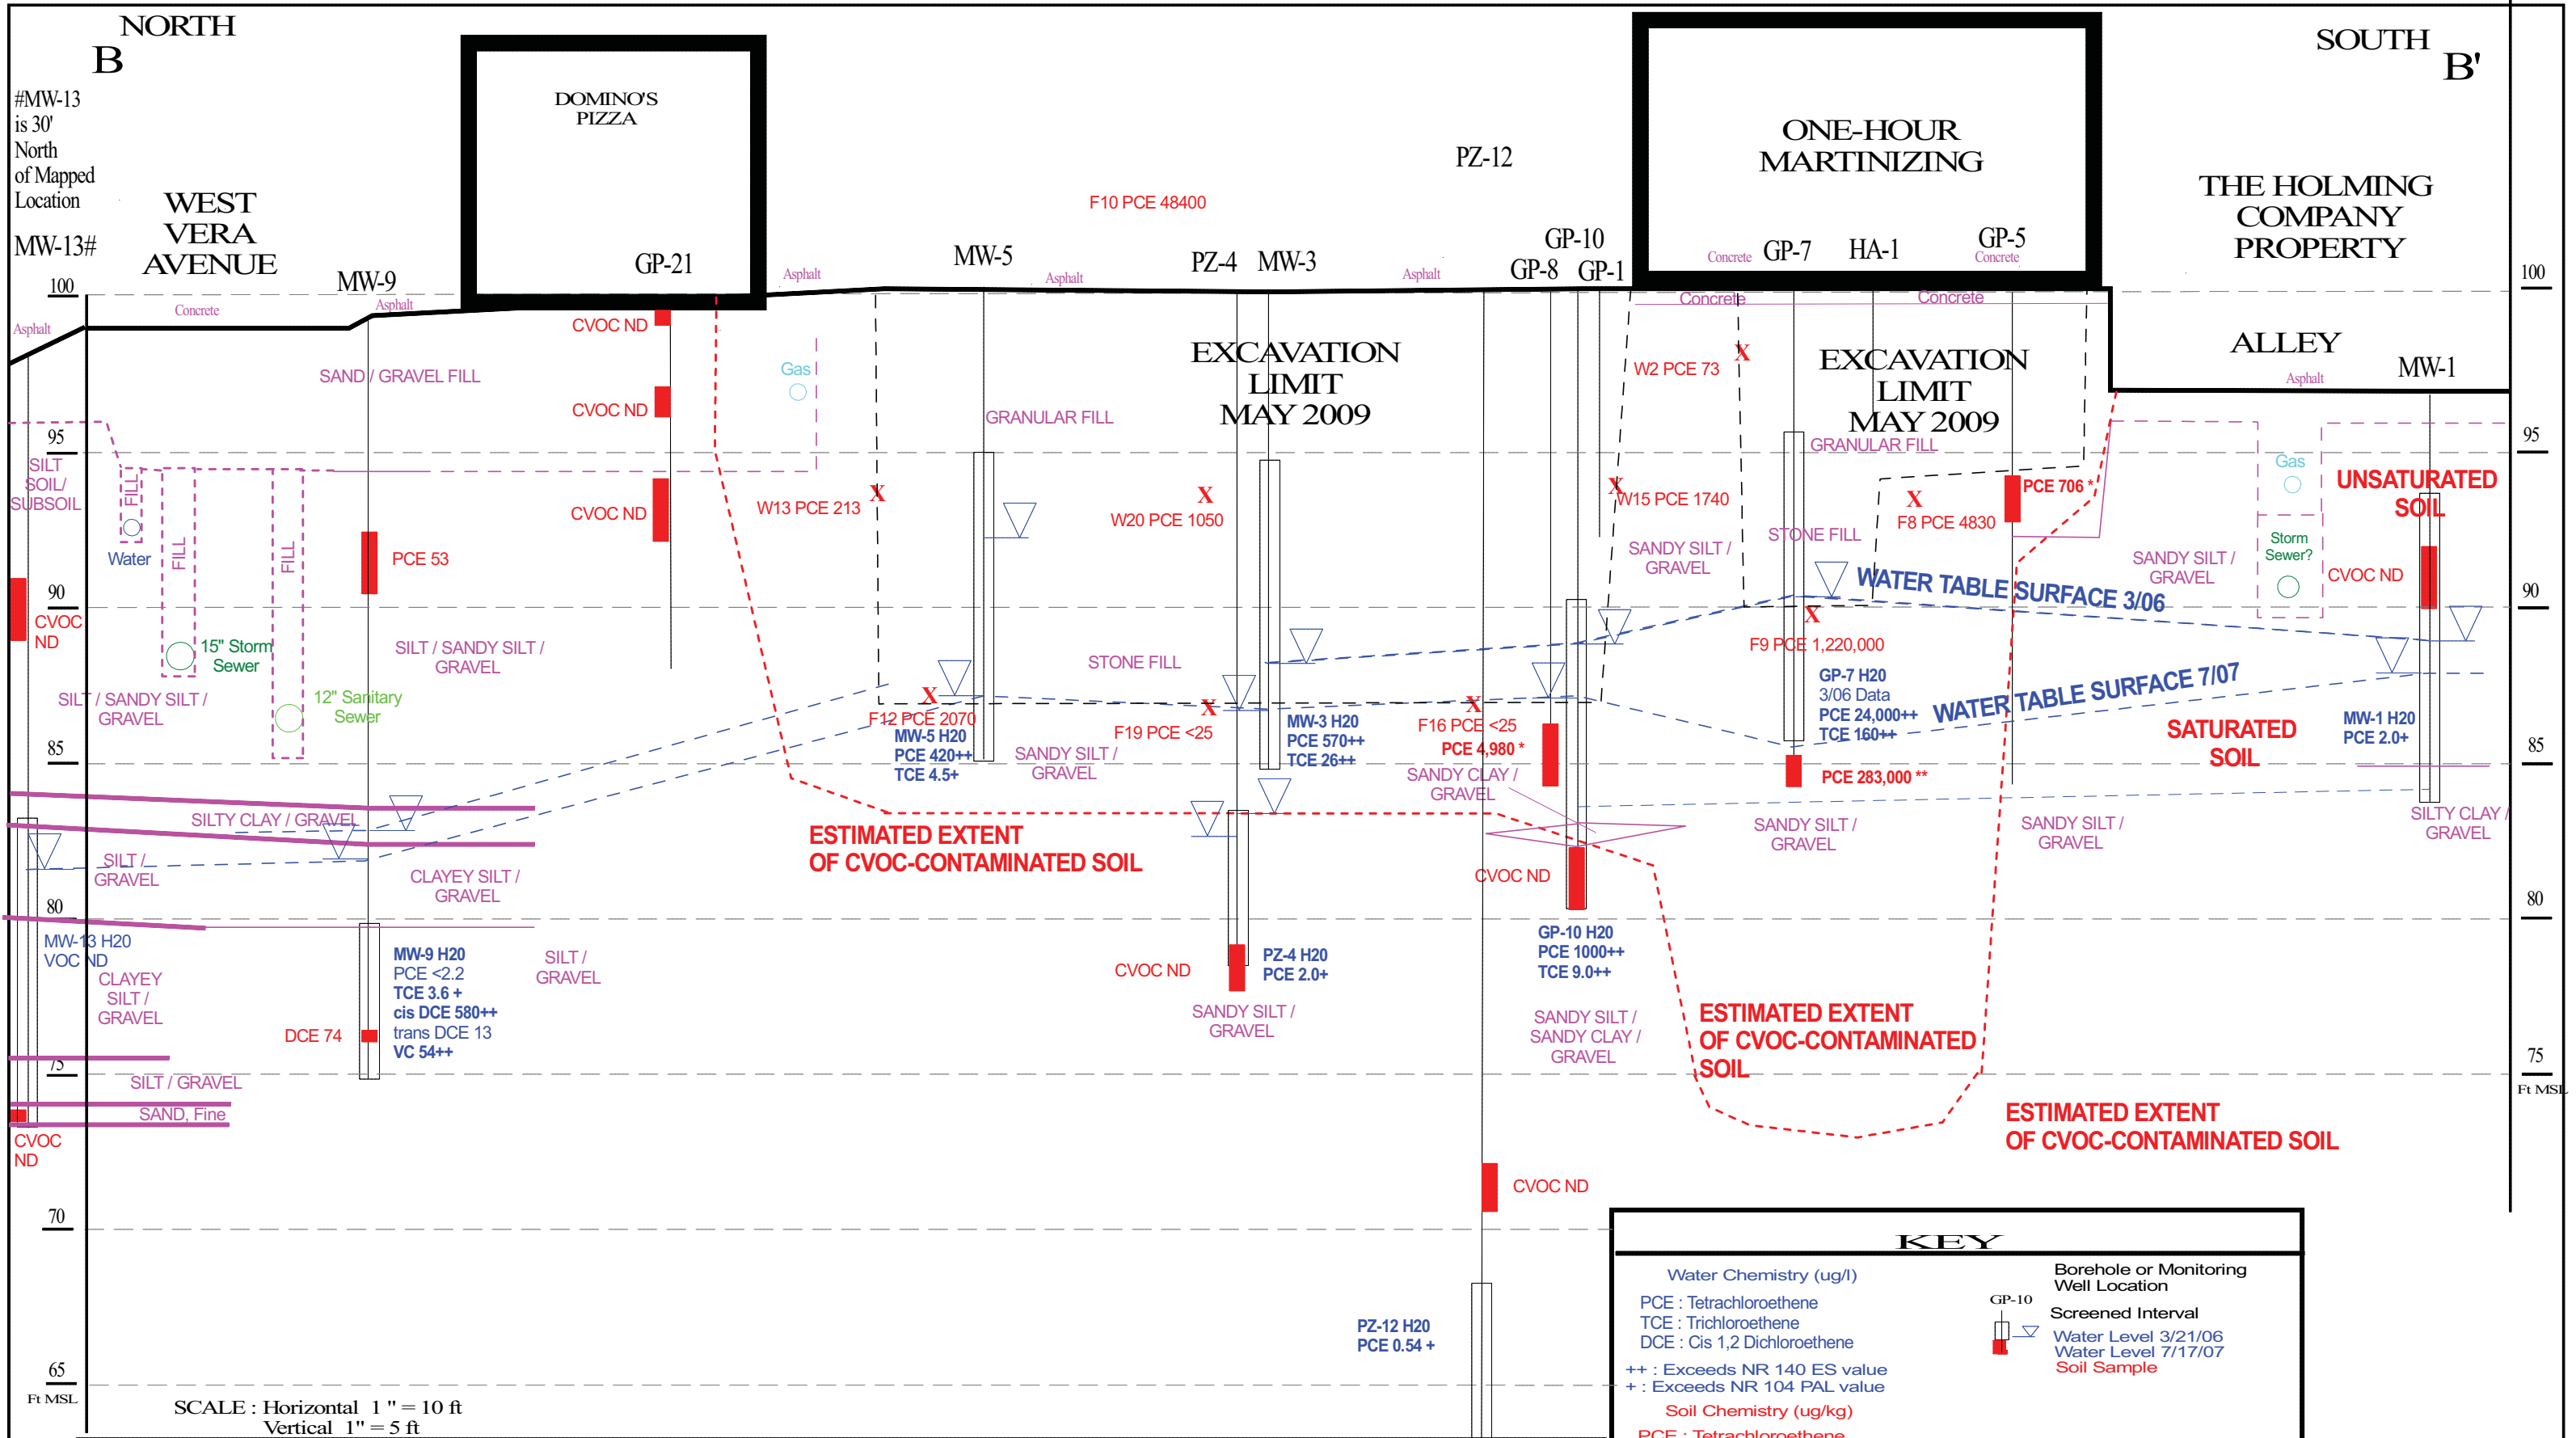
Title: **Pre-Remedial Soil Contamination**

SCALE : Horizontal 1" = 10 ft
Vertical 1" = 5 ft

Groundwater chemistry from July 2007
Only detected compounds shown
CVOC ND = No detect for Chlorinated VOC's

Borehole or Monitoring Well Location
Screened Interval
Water Level 3/21/06
Water Level 7/17/07
Soil Sample

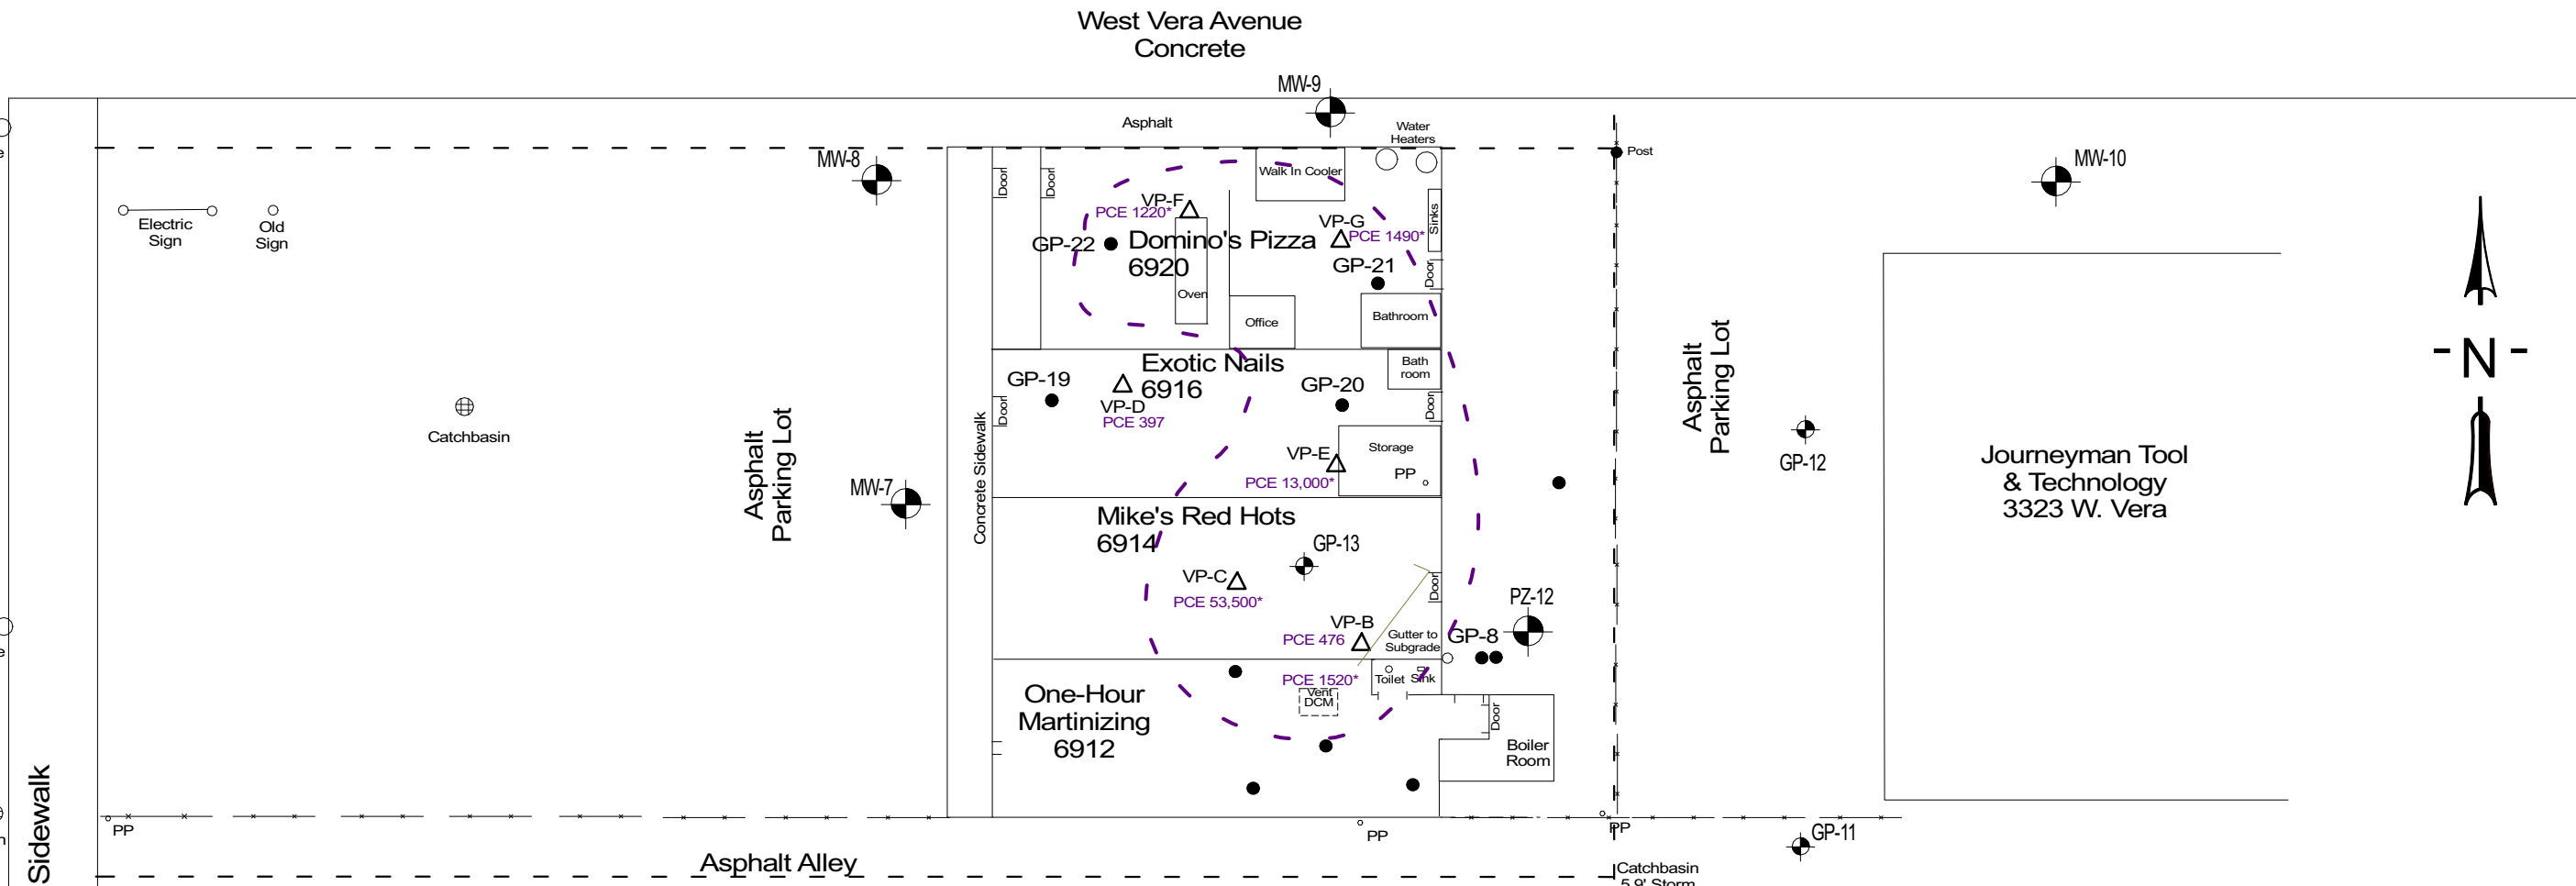
TITLE: Monitoring Wells			
SITE: Former Steve Plater Fac. 6912 N. Teutonia Ave., Milwaukee, WI		DATE: 7/7/11	
SCALE: 1"=20'	ATS PROJECT NUMBER: PLS-2004-01	DWG #... newsite.skf	
REV:	DATE:	DESCRIPTION:	APPVD.: DRAWN BY: KAE
			Figure B.3.d

—+—+—	Fence Line	●	Geoprobe Soil Boring
- - -	Approximate Property Line	⊕	Geoprobe / Small Diameter Well
		⊕	GP-3
		⊕	NR171 Monitoring Well / Piezometer
		⊕	Solid = Abandoned
			MW-1

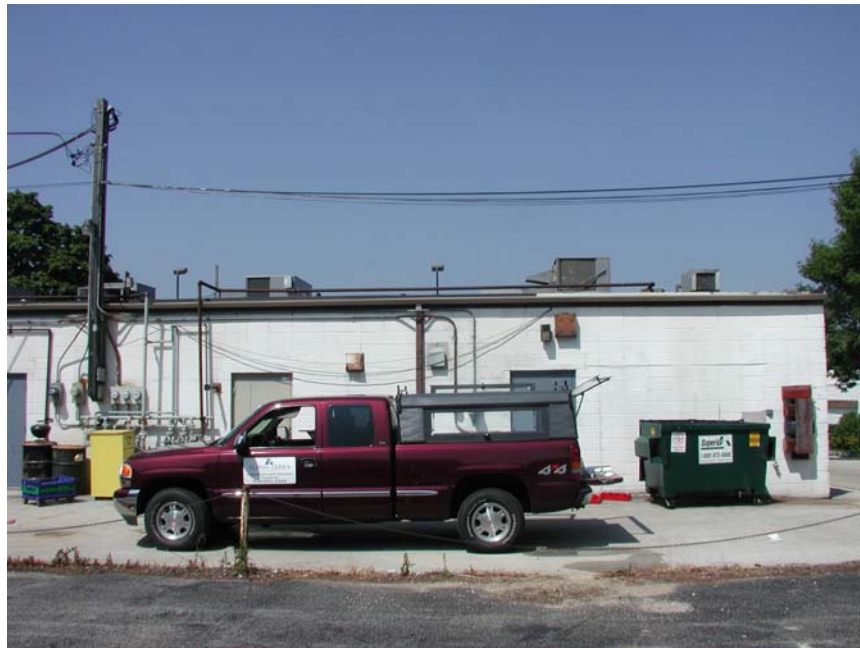
One-Hour Martinizing - N. Teutonia Ave.
North view of asphalt cap
