**RE: Technical Meeting fee  
Superior Health Linens  
5005 South Packard Avenue  
Cudahy, Wisconsin**

**FID #241780880  
BRRTS #02-41-532649**

**Subject: Remedial Approach Documentation  
Superior Health Linens  
Cudahy, Wisconsin**

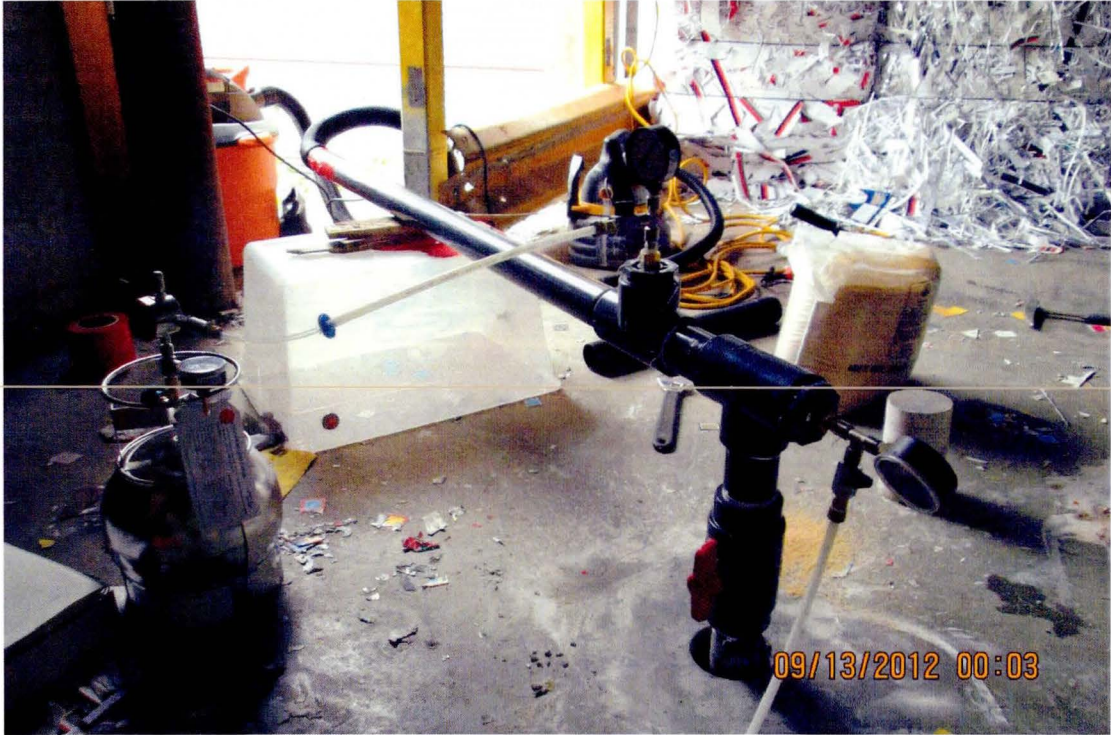
**Attachment 2**

**September High Purge Volume Testing Photographs**

- Place several inches of filter pack sand in bottom of void;
  - Place 2-inch Schedule 80 PVC suction point (open end with four ¼-inch diameter holes in side of PVC wrapped with fine gauge stainless steel wire mesh to prevent suction of filter pack sand) at the bottom of the suction point and connect rest of PVC assembly to shop vacuum (which is vented to outdoors (photos of typical setup included in **Attachment 2**);
