Reference: *Work Plan for Additional Site Investigation*
Superior Health Linens
5005 South Packard Avenue
Cudahy, Wisconsin
BRRTS #02-41-532649
FID #241780880

FIGURE 2 I
 SITE LAYOUT
 5005 SOUTH PACKARD AVENUE
 SUPERIOR HEALTH LINENS
 CUDAHY, WI

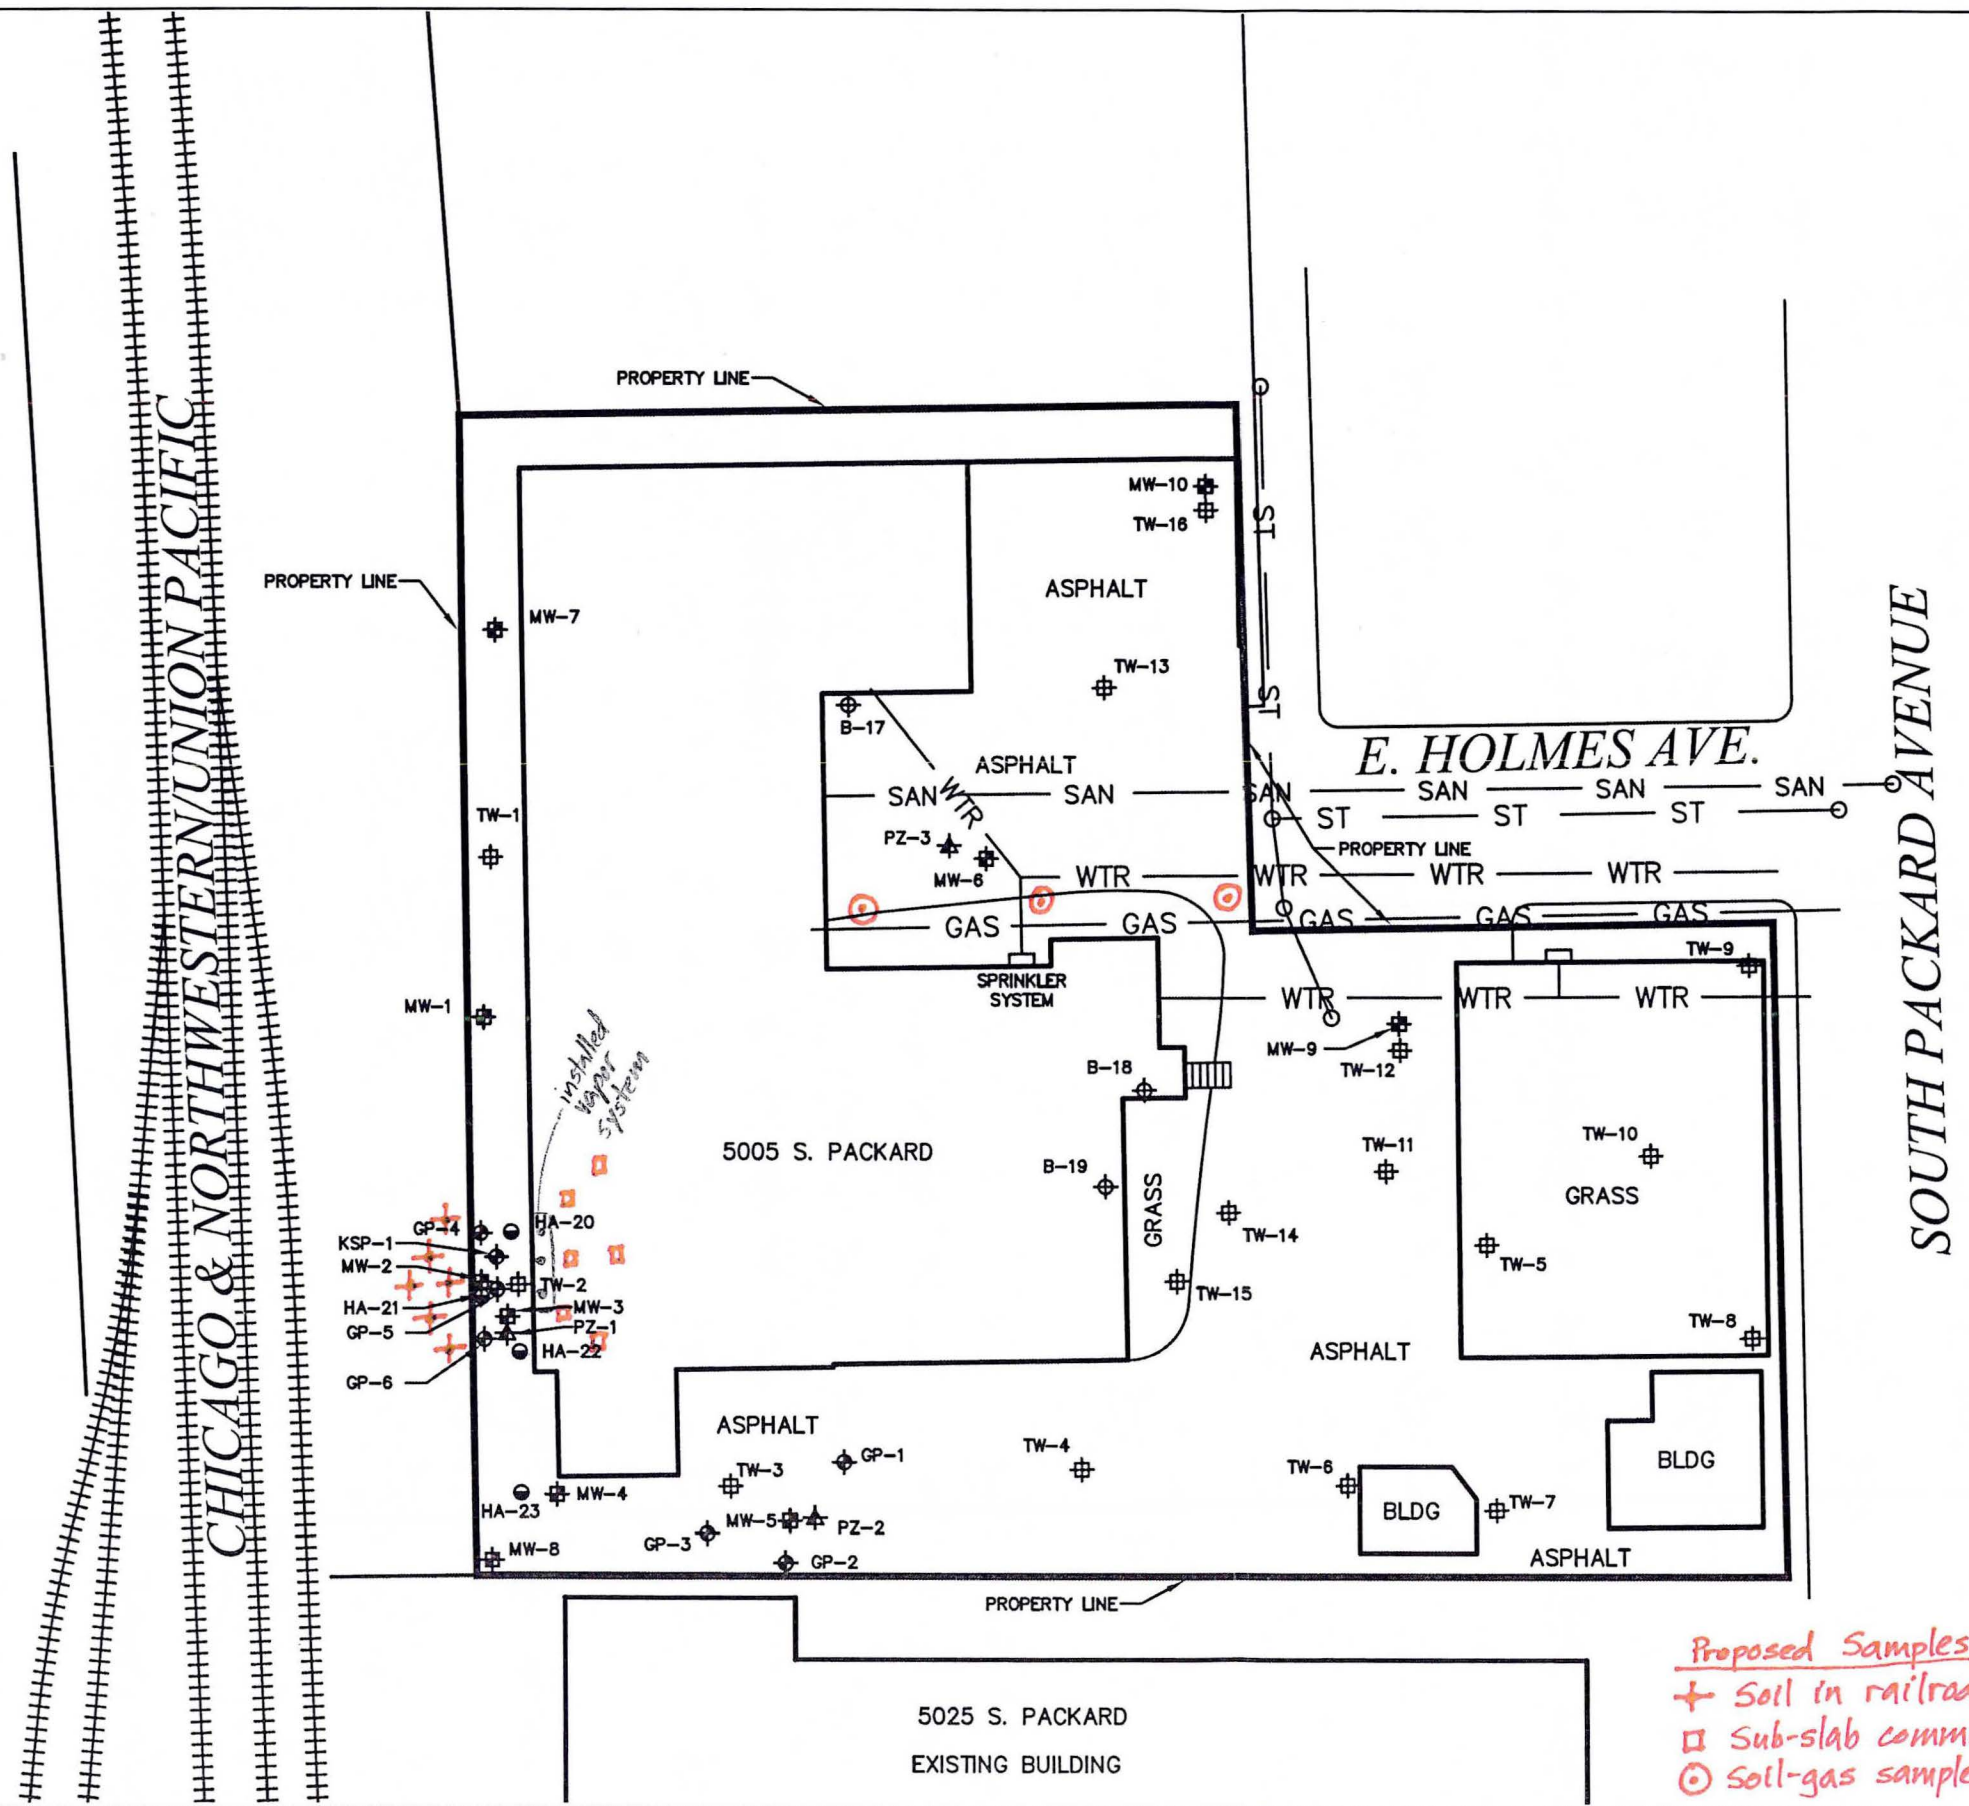
LEGEND	
	MONITORING WELL
	SOIL PROBE
	HYDRAULIC BORING/TEMP WELL BY OTHERS
	HYDRAULIC SOIL BORING BY OTHERS
	HAND AUGER BORING BY OTHERS
	PIEZOMETER
	PROPERTY BOUNDARY
	GAS — UNDERGROUND GAS LINE 1.5'-2.5' BGS
	UGS — UNDERGROUND ELECTRIC LINE 1.5-2.5' BGS
	COM — UNDERGROUND COMMUNICATIONS LINE 1.5-2.5'
	ST — UNDERGROUND STORM SEWER 4-6' BGS
	SAN — UNDERGROUND SANITARY SEWER 8-10' BGS
	WTR — UNDERGROUND WATER LINE 5.5-6.5'

Proposed Samples
 + Soil in railroad right-of-way
 □ Sub-slab communication testing
 ⊙ Soil-gas samples adjacent to utilities

The WDNR is requesting further work to address the vertical and horizontal extent of the chlorinated volatile organic compound (CVOC) contamination that has been identified on the subject site. Refer to the Site Layout figure.

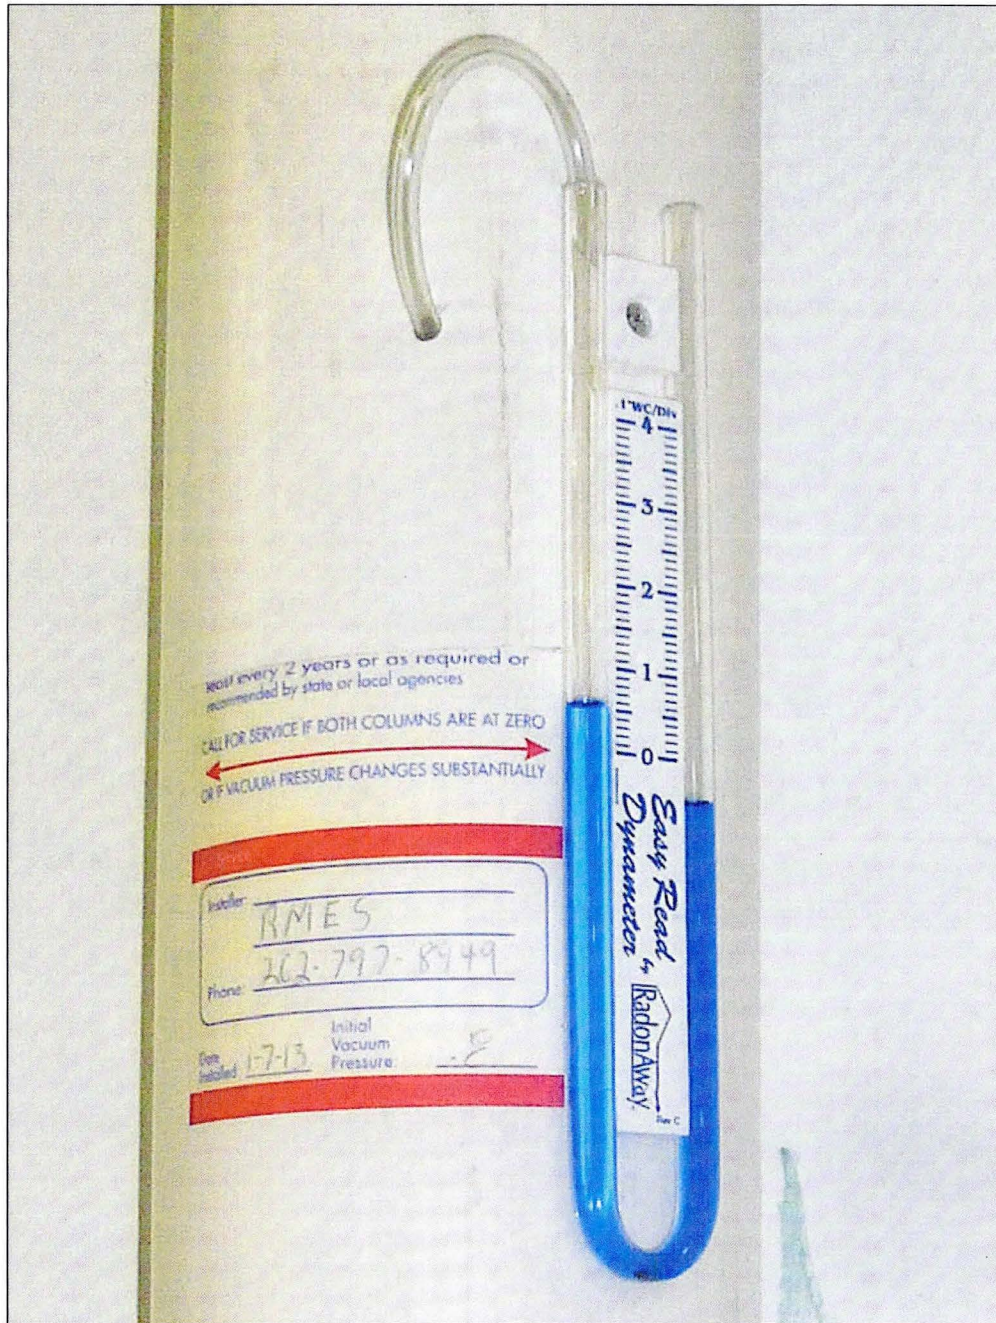
Photo 6

Manometer Installed on draw tube 3 as shown in Photo 3

System is powered by a UL listed RadonAway RP265 fan (see Specification Sheet on page 9). A 45 degree 6" PVC angle is attached to the top of the fan to point the exhaust up and away from the building (see photos 1 – 6 on pages 5 - 9). **Note – the louvers to the left of the of the vertical exhaust riser shown on photo 5, page 9 are exhaust louvers/fans.** Power to the fan is supplied by a separate 20 amp circuit that is hard-wired to a weatherproof disconnect box/switch. An Easy Read Dynameter Manometer is installed on one of the draw point risers to measure sub-slab vacuum pressure (see below). The VMS is currently at .6WC on 4" pipe, which equate to about 290cfm. The concrete floor is in good sound condition. All cracks or gaps in the concrete floor that may affect the efficiency of the system or cause back drafting were filled.

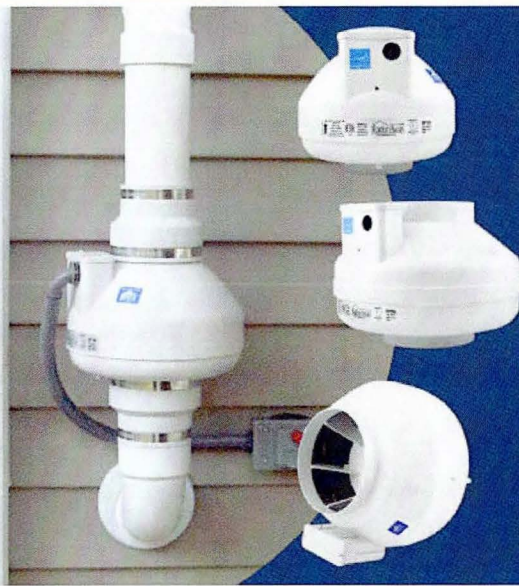
Radon Mitigation Fan

All RadonAway™ fans are specifically designed for radon mitigation. RP Series Fans provide superb performance, run ultra-quiet and are attractive. They are ideal for most sub-slab radon mitigation systems.

- Energy efficient
- Ultra-quiet operation
- Meets all electrical code requirements
- Water-hardened motorized impeller
- Seams sealed to inhibit radon leakage (RP140 & RP145 double snap sealed)
- RP140 and RP260 Energy Star® Rated
- ETL Listed - for indoor or outdoor use
- Thermally protected motor
- Rated for commercial and residential use
