**Re: Response to WDNR's Correspondence dated September 9, 2020
Superior Health Linens / BRRTS #02-41-532649
5005 S. Packard Avenue
Cudahy, WI**

ATTACHMENT A

ATTACHMENT B

Sub-Slab Depressurization System (SSDS)

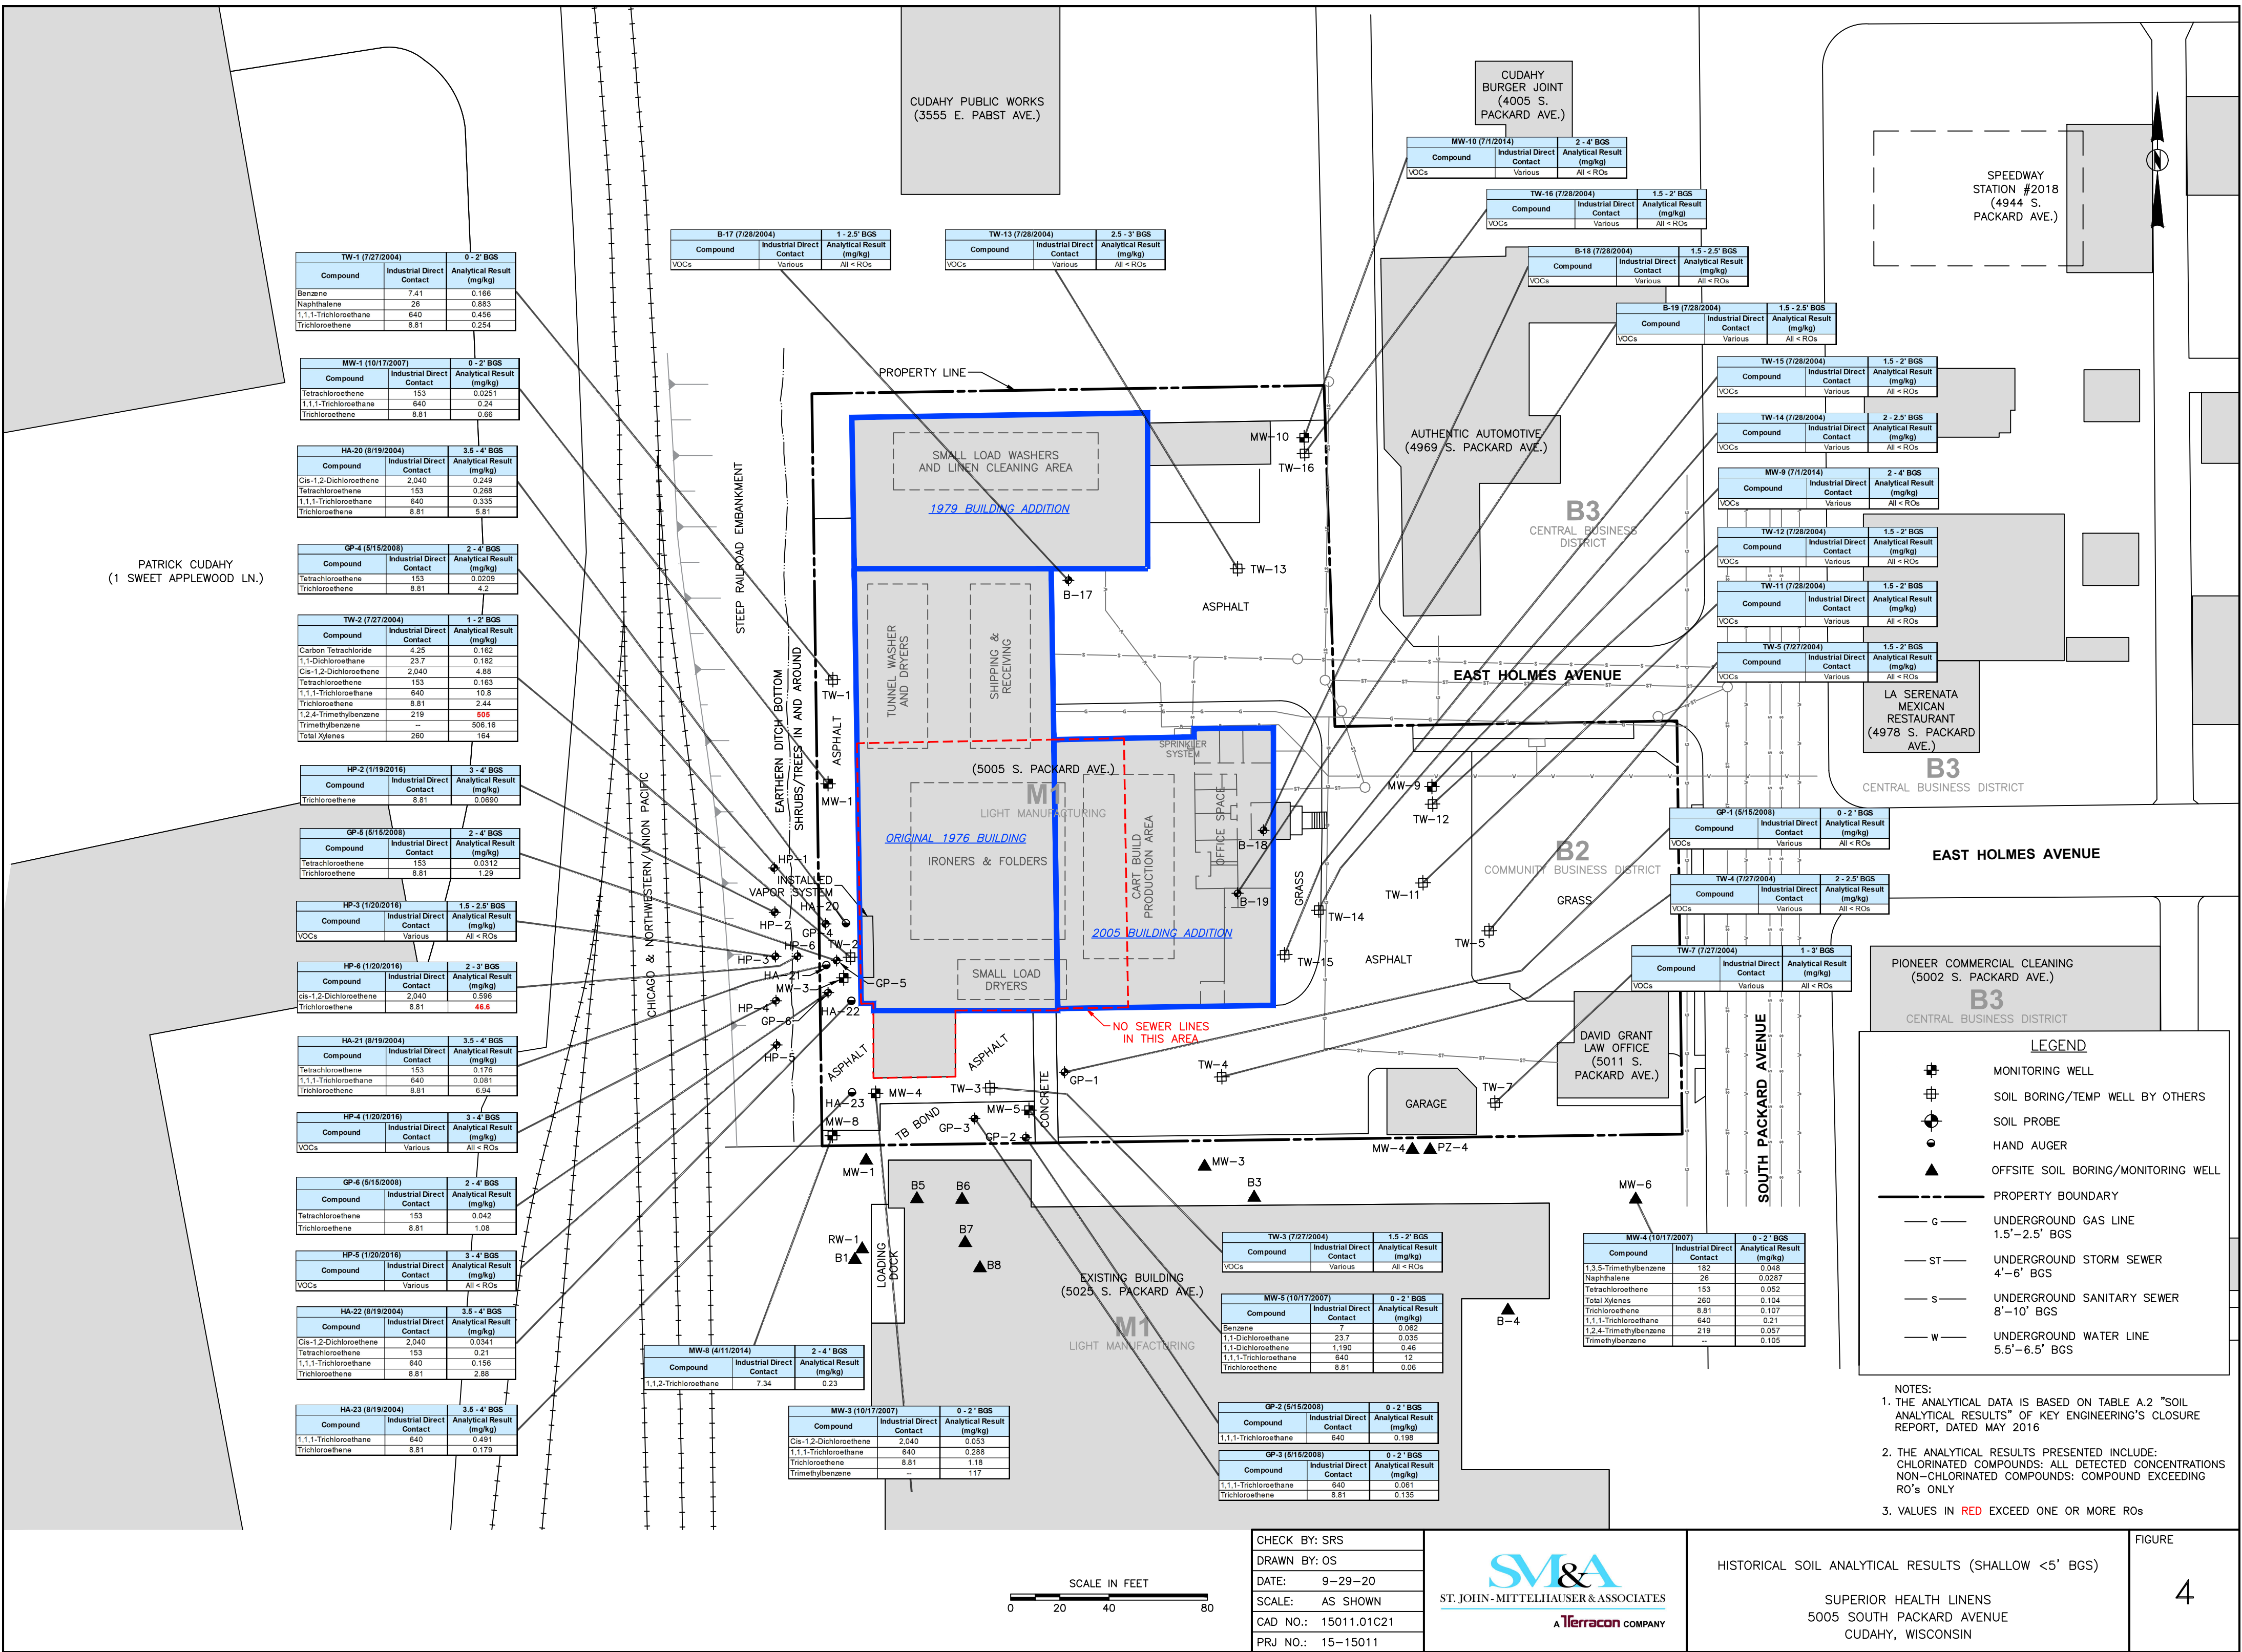
TW-1 (7/27/2004) 0 - 2' BGS

Compound	Industrial Direct Contact	Analytical Result (mg/kg)
Benzene	7.41	0.166
Naphthalene	28	0.883
1,1,1-Trichloroethane	640	0.456
Trichloroethane	8.81	0.254

This inspection found that the closest sewer line identified is associated with the tunnel washers, located approximately 140 feet north of the source area (MW-2 / MW-12). The sewer lines do not intersect the impacted soil at the southwest portion of the facility. Therefore, no further investigation of the sewer lines is warranted. The general layout of the facility, including construction dates, facility layout, and location of utilities is provided on the updated Figures 4, 20, and 23 in Attachment A to this letter.

Figure 4 has been updated to include a comparison of all samples collected within 4 feet of the surface to the Industrial Direct Contact RCLs. An updated Figure 4 is provided in Attachment A to this letter.

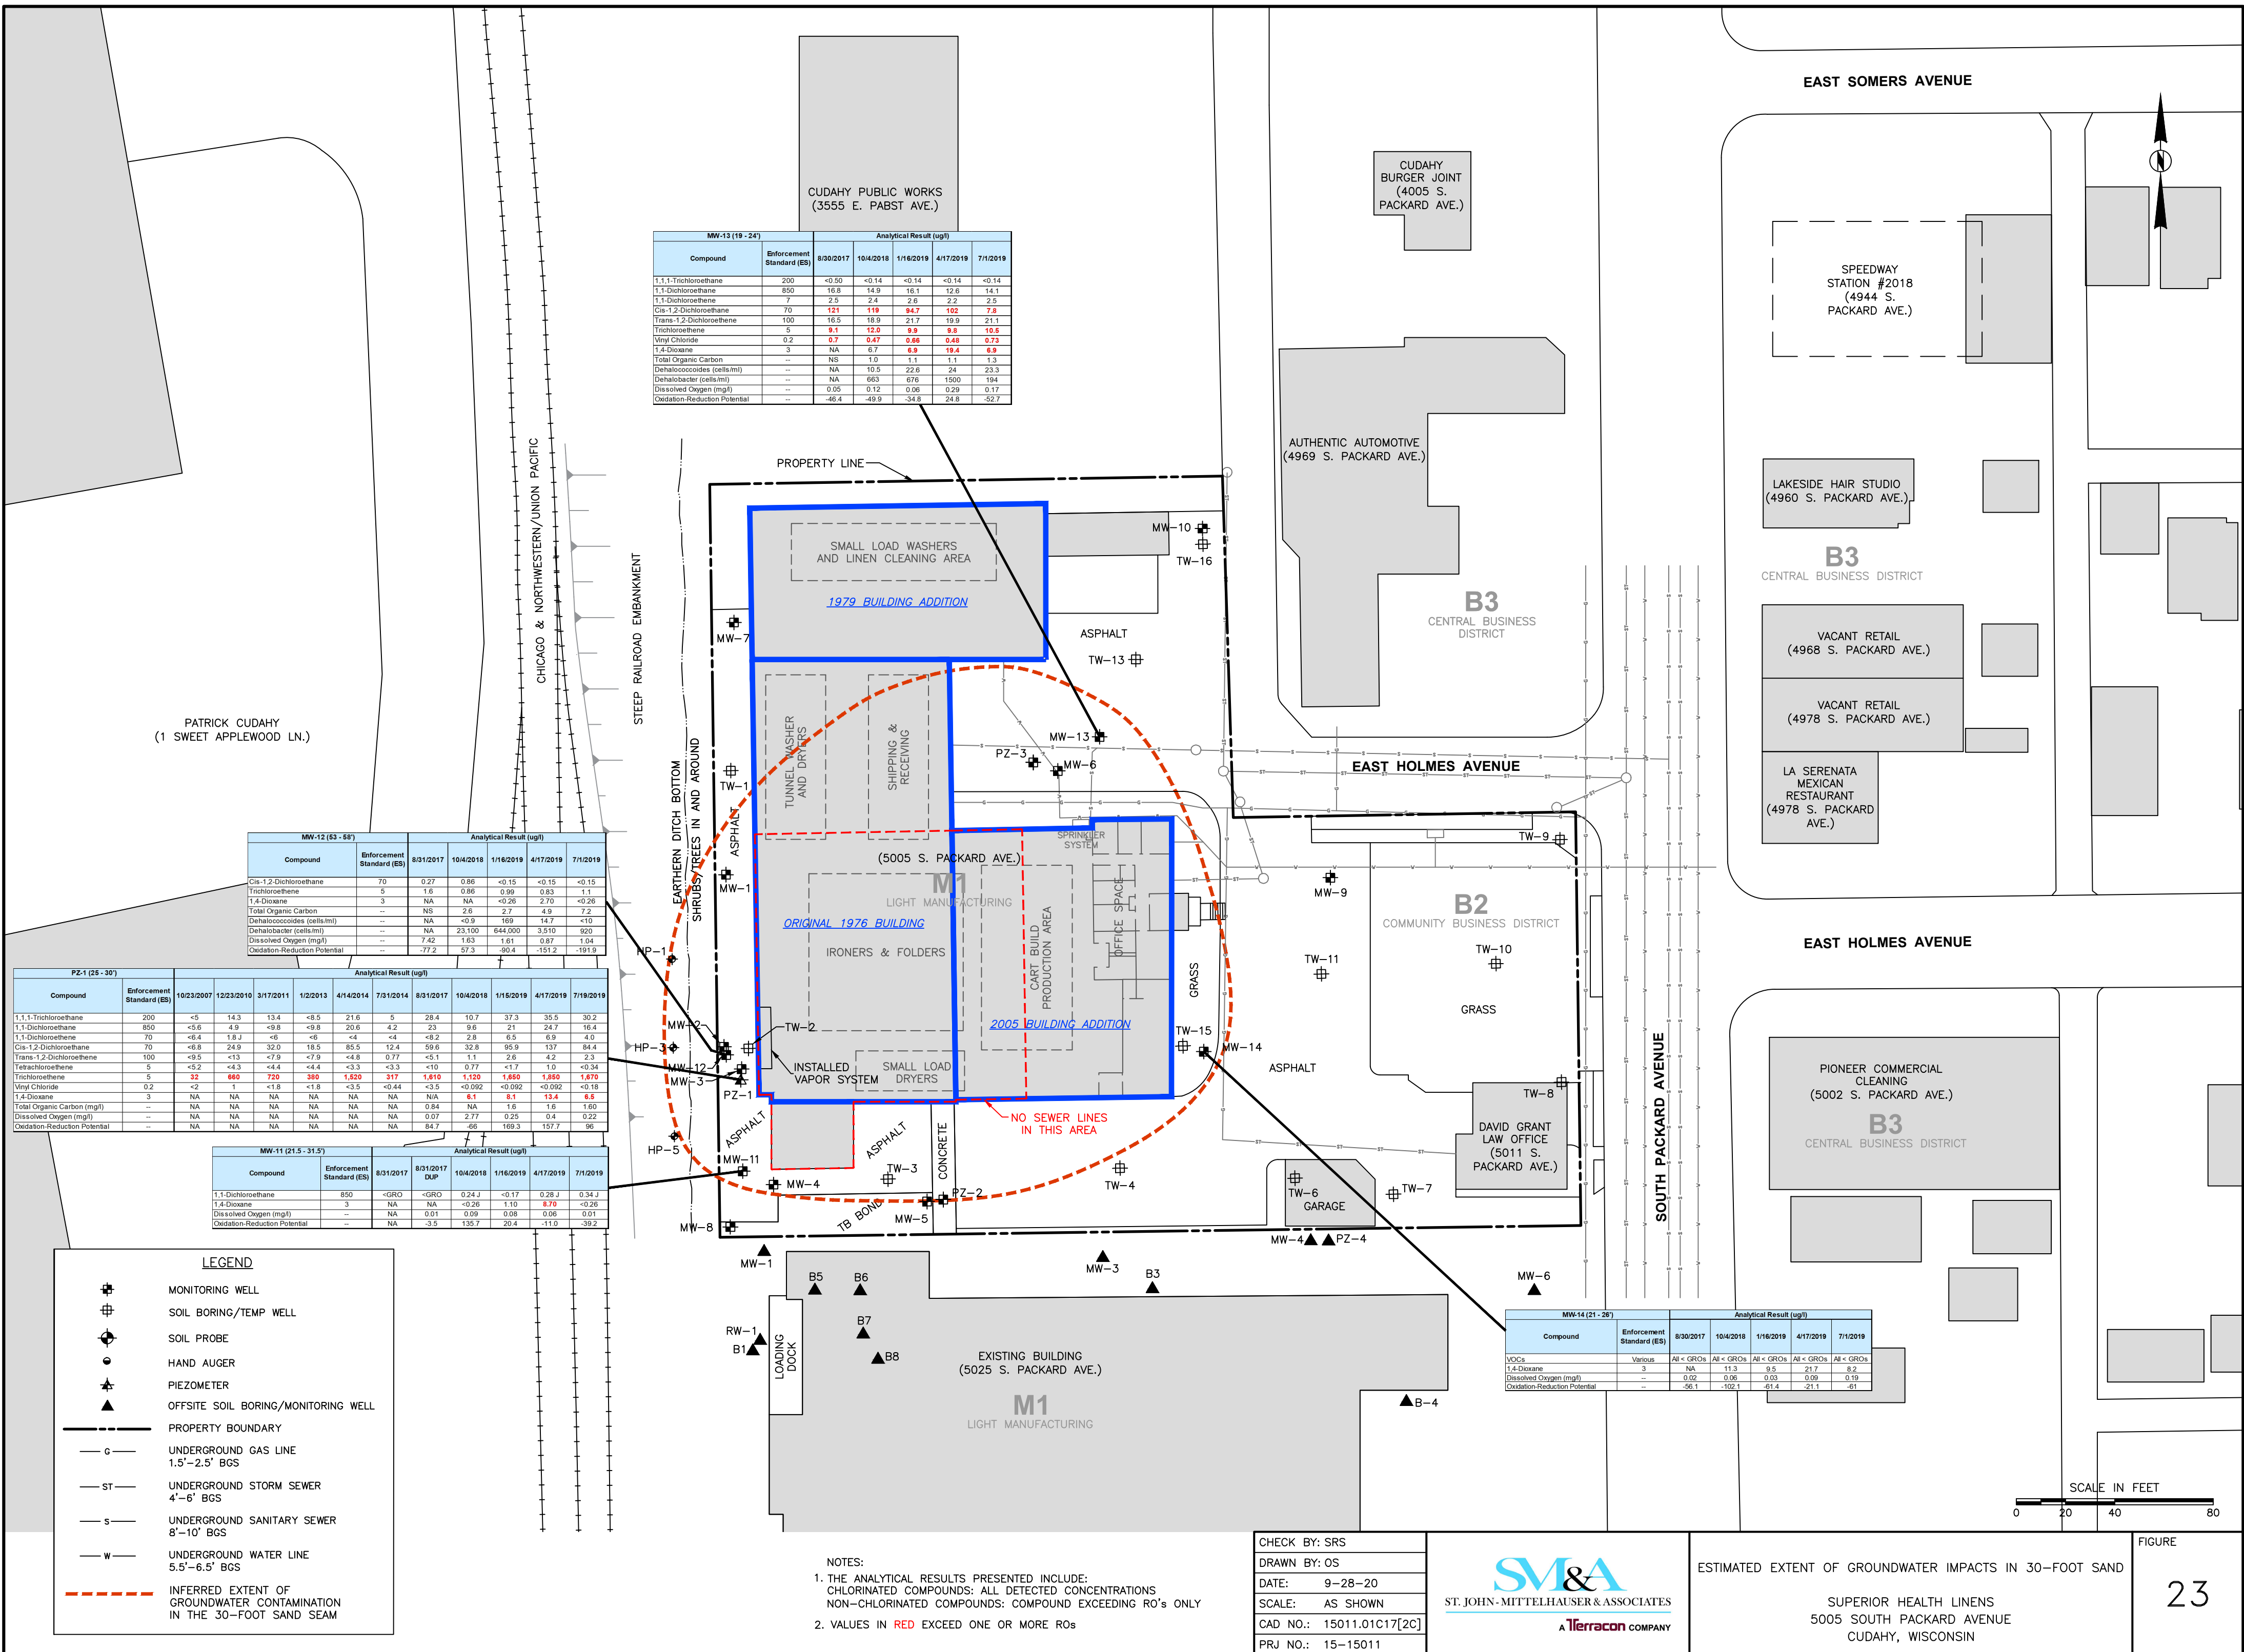
MW-13 (19 - 24)

Compound	Enforcement Standard (ES)	8/30/2017	10/4/2018	1/16/2019	4/17/2019	7/1/2019
1,1,1-Trichloroethane	200	<0.50	<0.14	<0.14	<0.14	<0.14
1,1-Dichloroethane	850	16.8	14.9	16.1	12.6	14.1
1,1-Dichloroethene	7	2.5	2.4	2.6	2.2	2.5
Cis-1,2-Dichloroethane	70	121	119	84.7	102	7.8
Trans-1,2-Dichloroethane	100	16.5	18.9	21.7	19.9	21.1
Trichloroethene	5	8.1	12.0	9.9	9.8	18.5
Vinyl Chloride	0.2	0.7	0.47	0.66	0.48	0.73
1,4-Dioxane	3	NA	6.7	6.9	19.4	6.9
Total Organic Carbon	--	NS	1.0	1.1	1.1	1.3
Dehalococoides (cells/ml)	--	NA	10.5	22.6	24	23.3
Dehalobacter (cells/ml)	--	NA	663	676	1500	194
Dissolved Oxygen (mg/l)	--	0.05	0.12	0.06	0.29	0.17
Oxidation-Reduction Potential	--	-46.4	-49.9	-34.8	24.8	-52.7

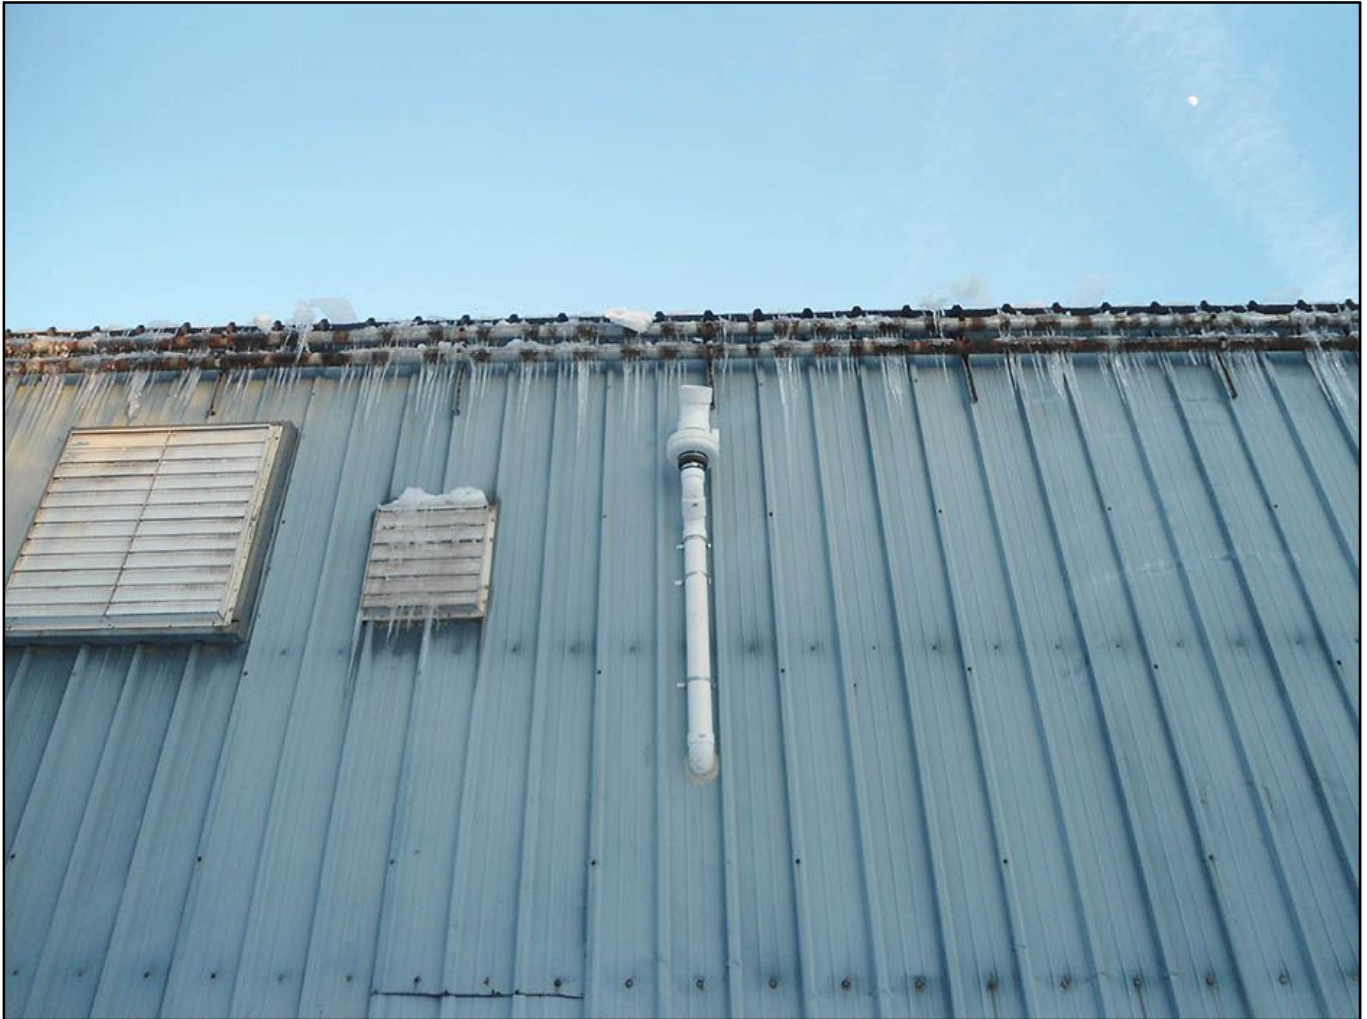
Photo 5

Note: louvers shown to the left of the vertical riser are exhaust louvers/fans

Step 5 (if required) - If the breaker is not tripped check the operation of the fan located on the exterior of the building (see photo 5 on page 9). If the fan is not operating properly check to make sure the cutoff switch on the waterproof box is in the “ON” position. If there is power to the fan then the issue is with the fan. Replace the fan with one of similar specification shown on page 12.

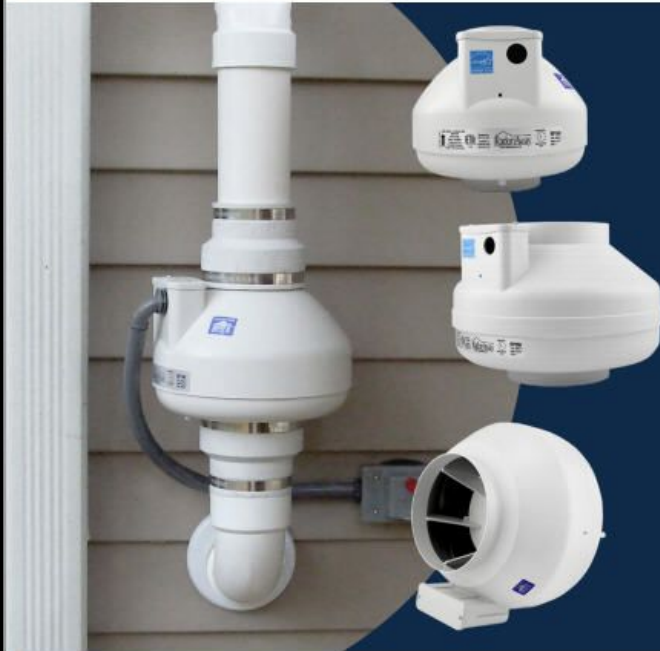
Radon Mitigation Fan

All RadonAway™ fans are specifically designed for radon mitigation. RP Series Fans provide superb performance, run ultra-quiet and are attractive. They are ideal for most sub-slab radon mitigation systems.

- Energy efficient
- Ultra-quiet operation
- Meets all electrical code requirements
- Water-hardened motorized impeller
- Seams sealed to inhibit radon leakage (RP140 & RP145 double snap sealed)
- RP140 and RP260 Energy Star® Rated
- ETL Listed - for indoor or outdoor use
- Thermally protected motor
- Rated for commercial and residential use

the vertical riser continues to a height of approximately 17'. The Vapor Mitigation System is powered by a UL listed RadonAway RP265 fan (see Specification Sheet on page 9). A 45 degree 6" PVC angle is attached to the top of the fan to point the exhaust up and away from the building (see photos 1 – 6 on pages 5 - 9). **Note – the louvers to the left of the of the vertical exhaust riser shown on photo 5, page 9 are exhaust louvers/fans.** Power to the fan is supplied by a separate 20 amp circuit that is hard-wired to a weatherproof disconnect box/switch. An Easy Read Dynameter Manometer is installed on one of the draw point risers to measure sub-slab vacuum pressure (see below). The VMS is currently at .6WC on 4" pipe, which equate to about 290cfm. The concrete floor is in good sound condition. All cracks or gaps in the concrete floor that may affect the efficiency of the system or cause back drafting were filled.
