SUBJECT: Case Closure with Continuing Obligations
Superior Linens-SW Corner Surface Spill, 5005 S. Packard Avenue, Cudahy, WI 53110
BRRTS #: 02-41-532649, FID #: 241780880

Figure 1: Extent of Soils Exceeding Applicable RCLs & Extent of Engineered Barrier

VMS Design Diagram

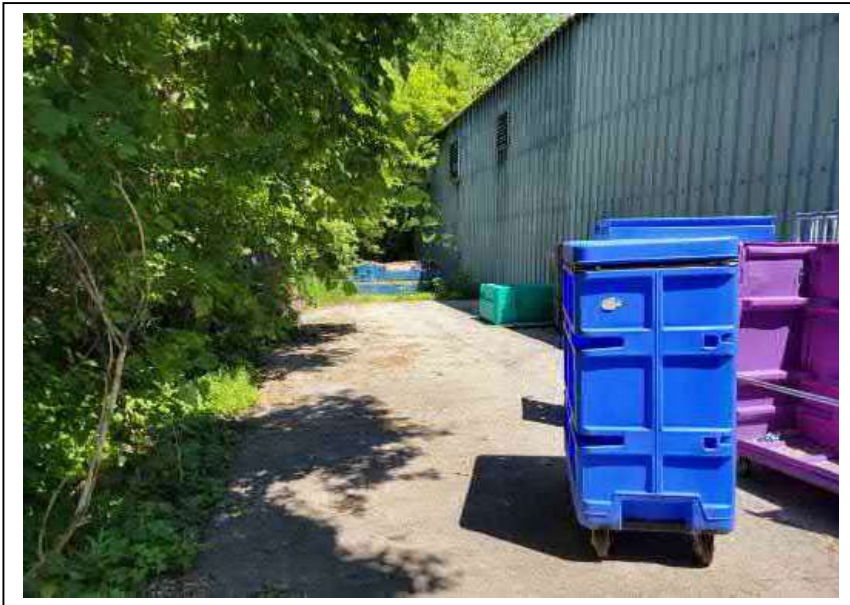
PHOTOGRAPH # 3

Description: Photo of engineered barrier along west side of building, facing north towards the former location of MW-7

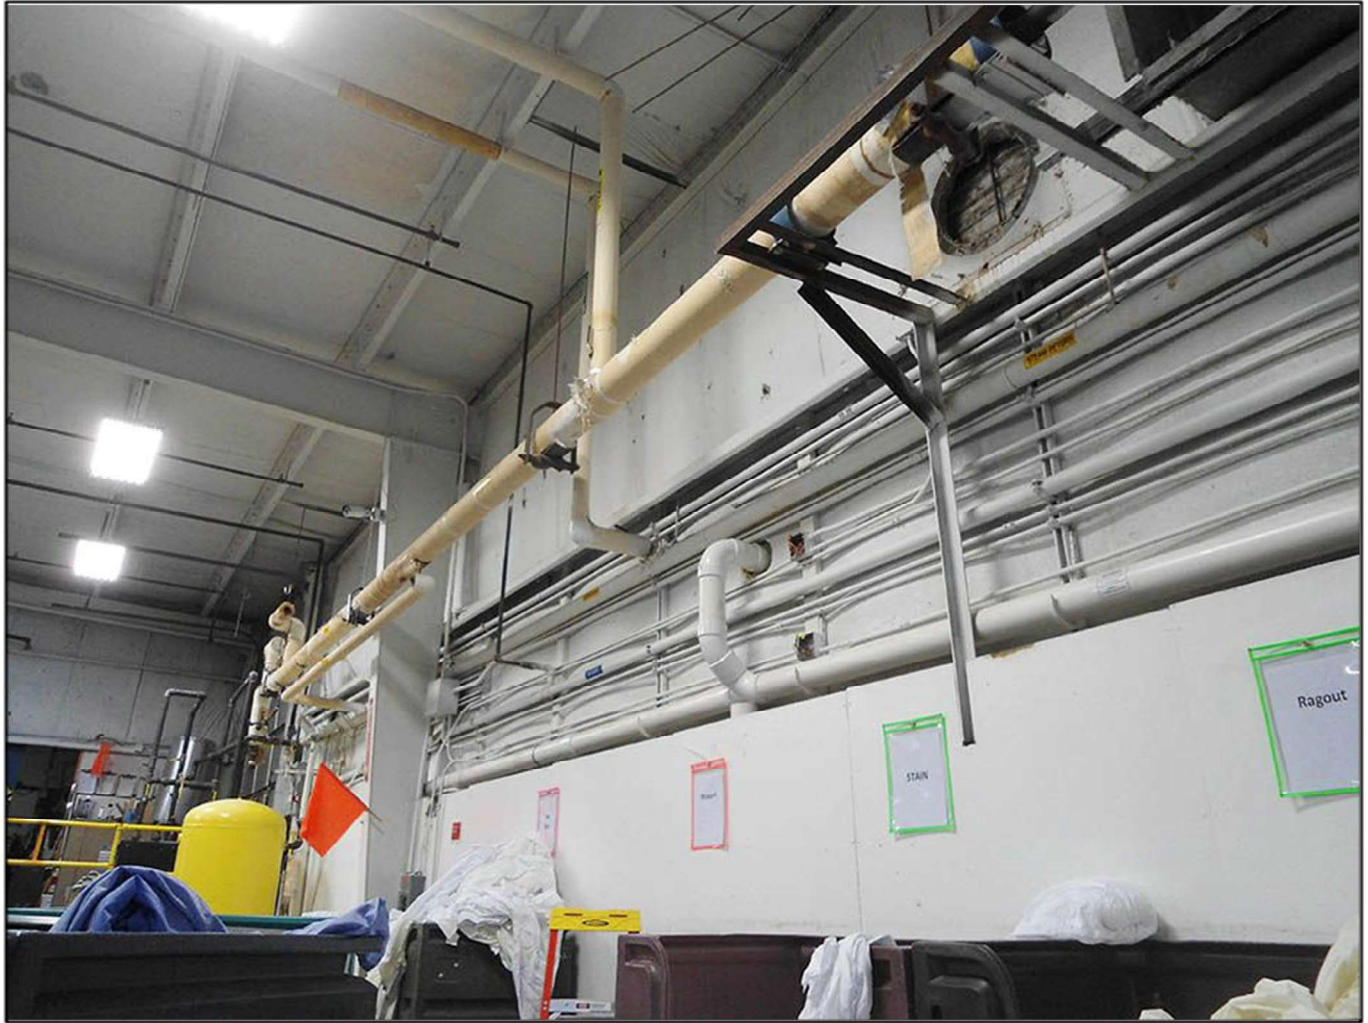
Photo 5

Note: louvers shown to the left of the vertical riser are exhaust louvers/fans

Step 5 (if required) - If the breaker is not tripped check the operation of the fan located on the exterior of the building (see photo 5 on page 9). If the fan is not operating properly check to make sure the cutoff switch on the waterproof box is in the “ON” position. If there is power to the fan then the issue is with the fan. Replace the fan with one of similar specification shown on page 12.

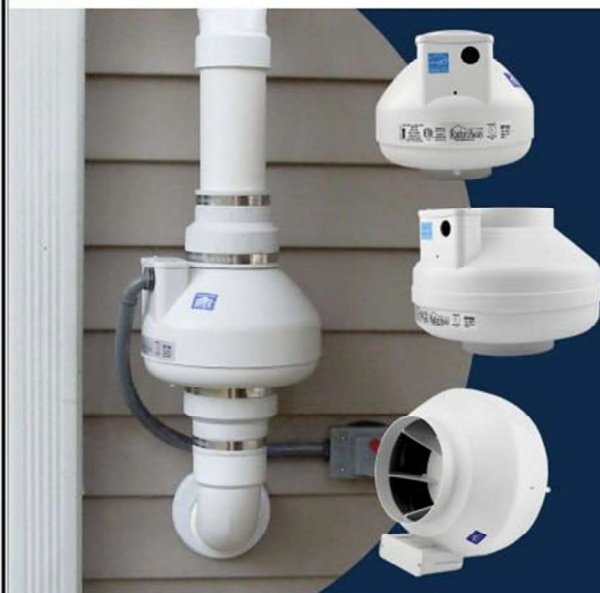
Radon Mitigation Fan

All RadonAway™ fans are specifically designed for radon mitigation. RP Series Fans provide superb performance, run ultra-quiet and are attractive. They are ideal for most sub-slab radon mitigation systems.

- Energy efficient
- Ultra-quiet operation
- Meets all electrical code requirements
- Water-hardened motorized impeller
- Seams sealed to inhibit radon leakage (RP140 & RP145 double snap sealed)
- RP140 and RP260 Energy Star® Rated
- ETL Listed - for indoor or outdoor use
- Thermally protected motor
- Rated for commercial and residential use

the vertical riser continues to a height of approximately 17'. The Vapor Mitigation System is powered by a UL listed RadonAway RP265 fan (see Specification Sheet on page 9). A 45 degree 6" PVC angle is attached to the top of the fan to point the exhaust up and away from the building (see photos 1 – 6 on pages 5 - 9). **Note – the louvers to the left of the of the vertical exhaust riser shown on photo 5, page 9 are exhaust louvers/fans.** Power to the fan is supplied by a separate 20 amp circuit that is hard-wired to a weatherproof disconnect box/switch. An Easy Read Dynameter Manometer is installed on one of the draw point risers to measure sub-slab vacuum pressure (see below). The VMS is currently at .6WC on 4" pipe, which equate to about 290cfm. The concrete floor is in good sound condition. All cracks or gaps in the concrete floor that may affect the efficiency of the system or cause back drafting were filled.

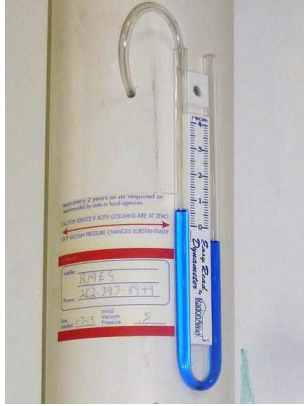
SYSTEM COMPONENT	WHAT DOES IT DO?	WHAT DO I CHECK?	WHAT SHOULD I SEE?	Date of Inspection:
NAME				WHAT TO FIX?
Manometer or Differential Pressure Gauge	Measures differential pressure between vacuum side of vent pipe and indoor space. This measurement confirms there is a vacuum being pulled by the fan.	Liquid Level on Manometer or Gauge	Liquid level in manometer should be offset (not level with each other).	A change in liquid level indicates a change in the vacuum below foundation. This could be caused by failure of fan, blockage of vent pipe, change in water level below building, or other conditions. Hire a professional to identify cause and repair if needed.

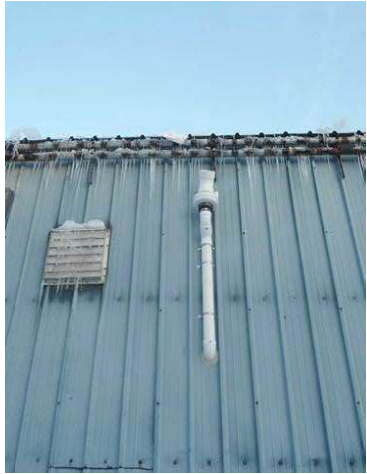
SYSTEM COMPONENT		WHAT DOES IT DO?	WHAT DO I CHECK?	WHAT SHOULD I SEE?	Date of Inspection:
NAME	WHAT TO FIX?				
Fan	<p>Fan creates a vacuum and lowers pressure below foundation.</p> <p>The fan also removes soil gases from below foundation for discharge to atmosphere.</p>	<p>Fan Operation</p> <p>Fan Location</p> <p>Motor Noise</p>	<p>Fan is on.</p> <p>Fan mounted outside & secure.</p> <p>Fan motor is quiet (loud motor may indicate problem).</p>	<p>Replace the fan immediately once the fan stops running. Fans typically run for 10-20 years, but it may be less.</p> <p>Replacement fan to have similar specifications as original with respect to flow and vacuum.</p> <p>After a fan is replaced, the system should be evaluated by a mitigation professional to verify effectiveness, which includes pressure readings.</p> <p>Original Fan Make and Model:</p>
