SUBJECT: Case Closure with Continuing Obligations
Superior Linens-SW Corner Surface Spill, 5005 S. Packard Avenue, Cudahy, WI 53110
BRRTS #: 02-41-532649, FID #: 241780880

The Wisconsin Department of Natural Resources (DNR) is pleased to inform you that the Superior Linens case identified above met the requirements of Wisconsin Administrative (Wis. Admin.) Code chs. NR 700 to 799 for case closure with continuing obligations (COs). COs are legal requirements to address potential exposure to remaining contamination. No further investigation or remediation is required at this time for the reported hazardous substance discharge and/or environmental pollution.

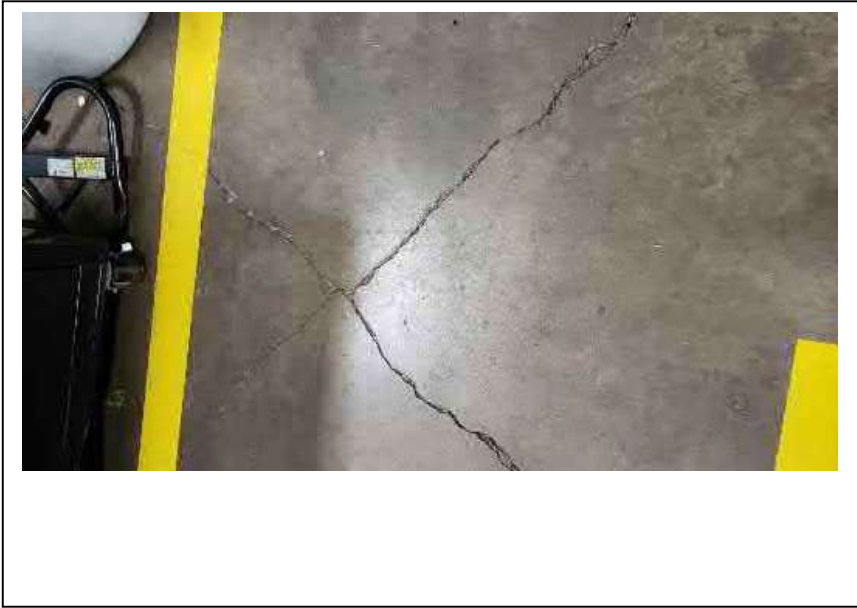
PHOTOGRAPH # 1

Description: View of the concrete floor with sealed cracks within the southwest corner of the building.

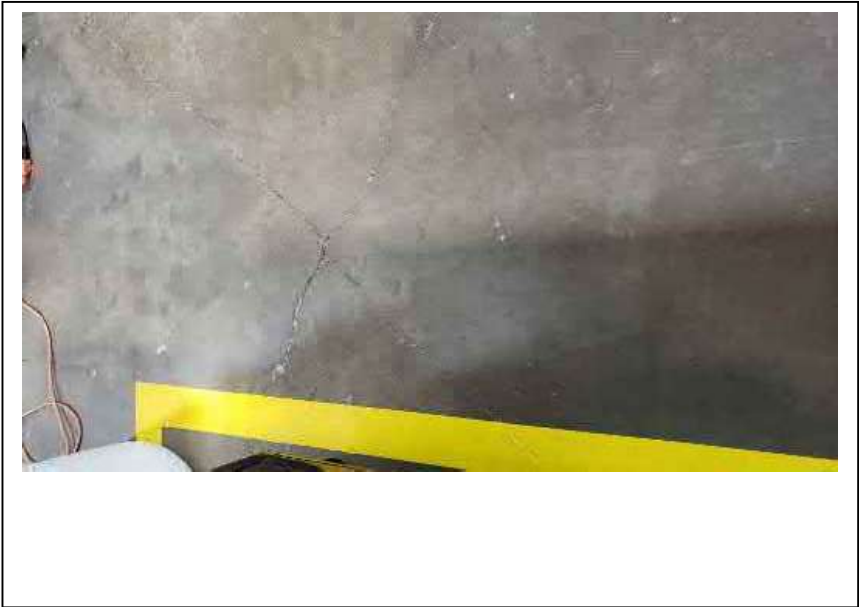
PHOTOGRAPH # 2

Description: View of the concrete floor within southwest corner of the building.

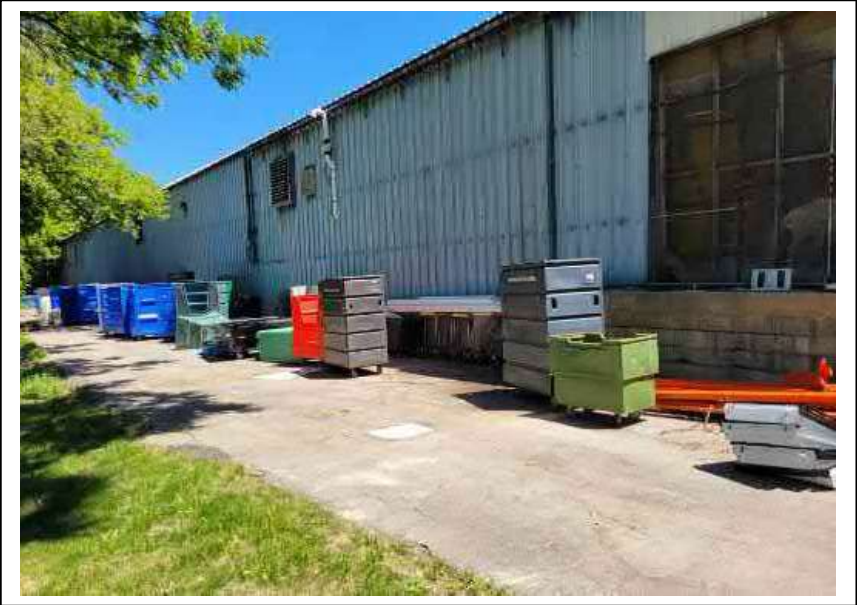
PHOTOGRAPH # 1 *Taken on: 6/27/21*
Description: View of engineered barrier along west side of building, facing northwest. Union Pacific Right-of-Way visible in the lower left (grass). White PVC vent pipe and blower associated with the Sub-Slab Depressurization System is visible in the center of the photo.

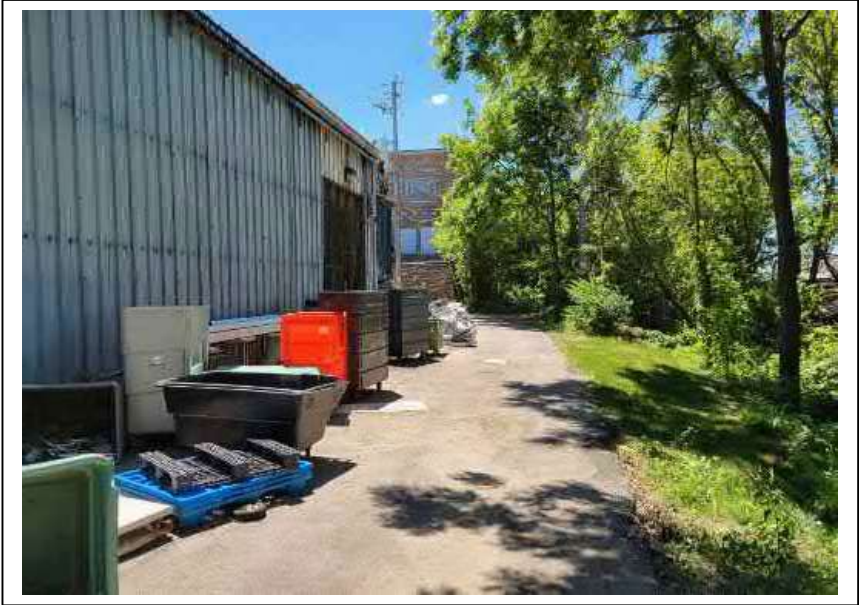
PHOTOGRAPH # 2 *Taken on: 6/27/21*
Description: View of engineered barrier along west side of building, facing south. Union Pacific Right-of-Way visible on the right side of the photograph.

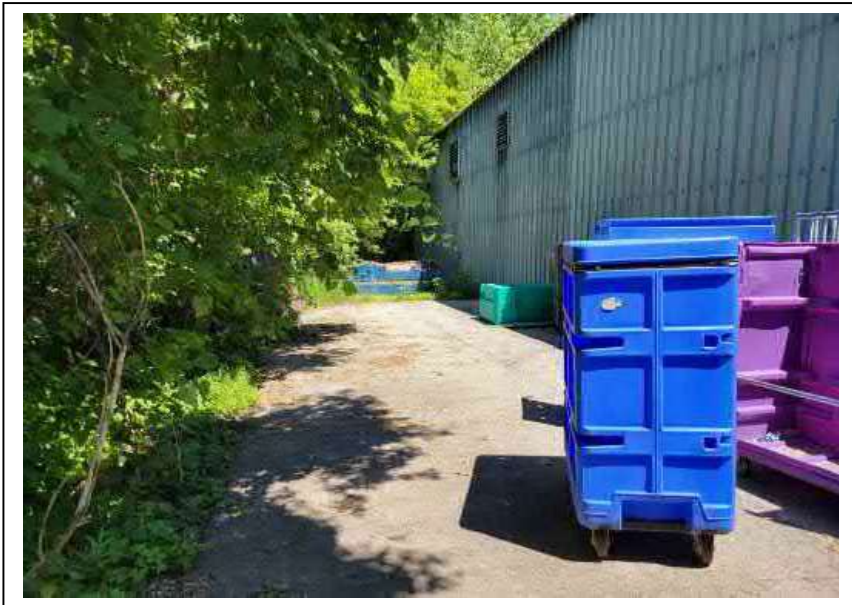
PHOTOGRAPH # 3

Description: Photo of engineered barrier along west side of building, facing north towards the former location of MW-7

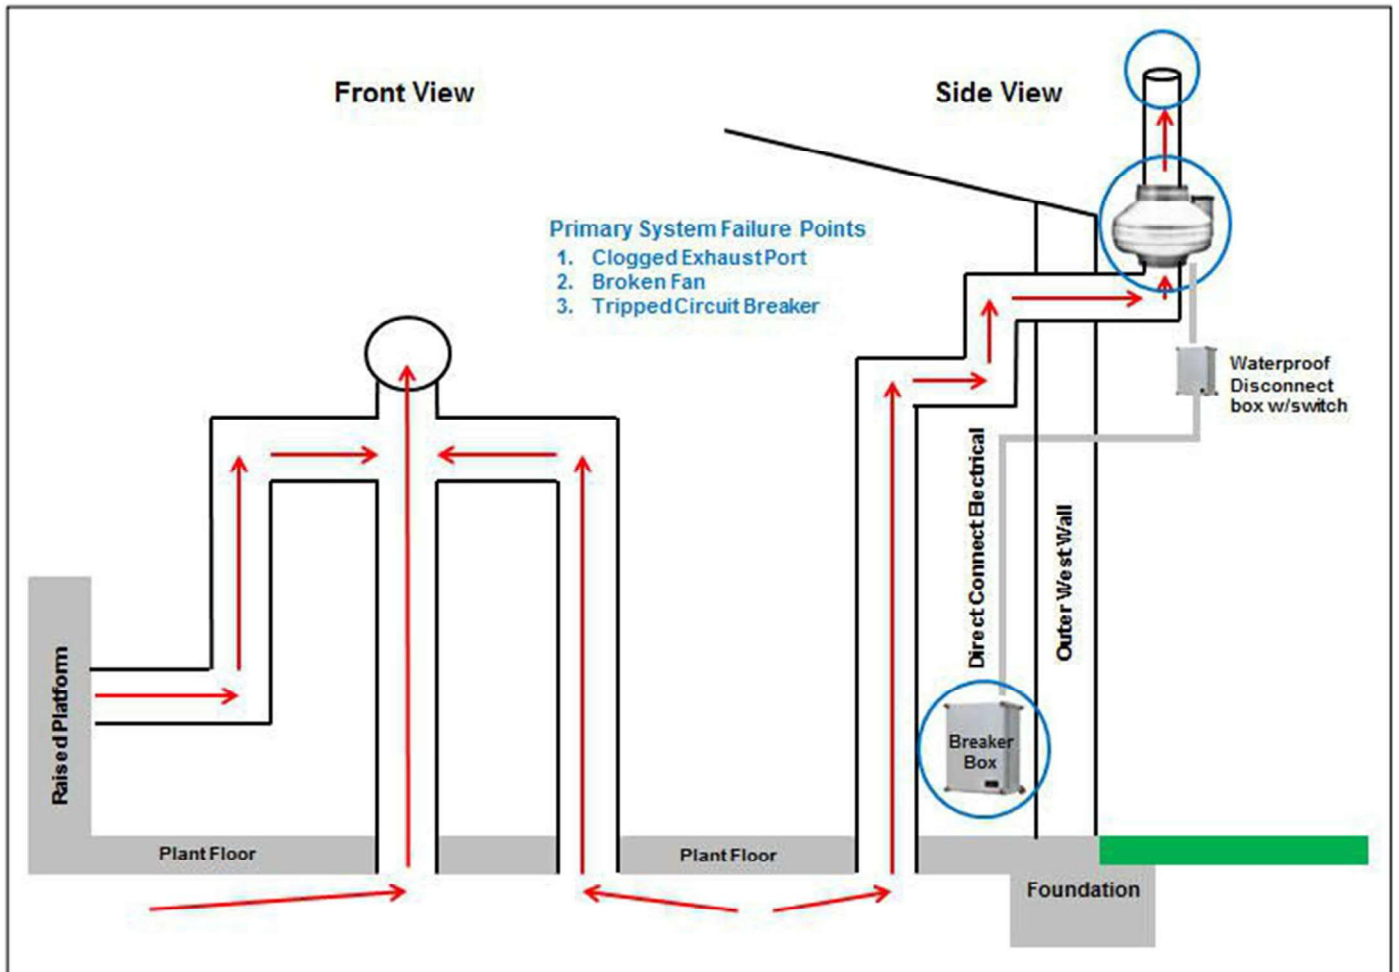
Failure/Monitoring Points

There are three primary potential areas where system failure can occur noted by the blue circles in the above VMS Design Diagram. 1) The external exhaust port could become clogged by debris; 2) The system fan could fail; 3) The circuit breaker could be tripped for some reason.

The Vapor Mitigation System is located in the southwest corner of the building (see VMS Location Diagram on page 4). Three 5" sub slab draw-points were bored through the interior cement floor of the building to expose sub-soil materials. These draw-points are placed as follows - one through the wall of the raised platform area, and two through the floor adjacent to the west factory wall, approximately 12" – 15" from the wall/foundation. The entire system is constructed of 4" Schedule 40 PVC material. The draw-points are connected by 4" risers that run vertical to a 4" manifold located on top of a ledge approximately 7' off the floor. Another vertical riser runs from a central point in the manifold up approximately 3 feet and out through the sheet metal west wall to the exterior of the building. On the exterior of the building

The Vapor Mitigation System installed at 5005 South Packard Avenue is a very simple system. The only mechanical part of the system is the fan that draws air from the sub slab entry points shown in the VMS Design Diagram (page 3), System Location Diagram (page 4) and Photos 1, 2, & 3 (pages 5 – 7). Verification of an active and working system is also very easy and straightforward. In addition to making sure the VMS is operating properly, the plant floor will also be inspected to make sure that existing cracks and any new cracks are sealed properly. Cracks in the floor could reduce the effectiveness of the VMS.

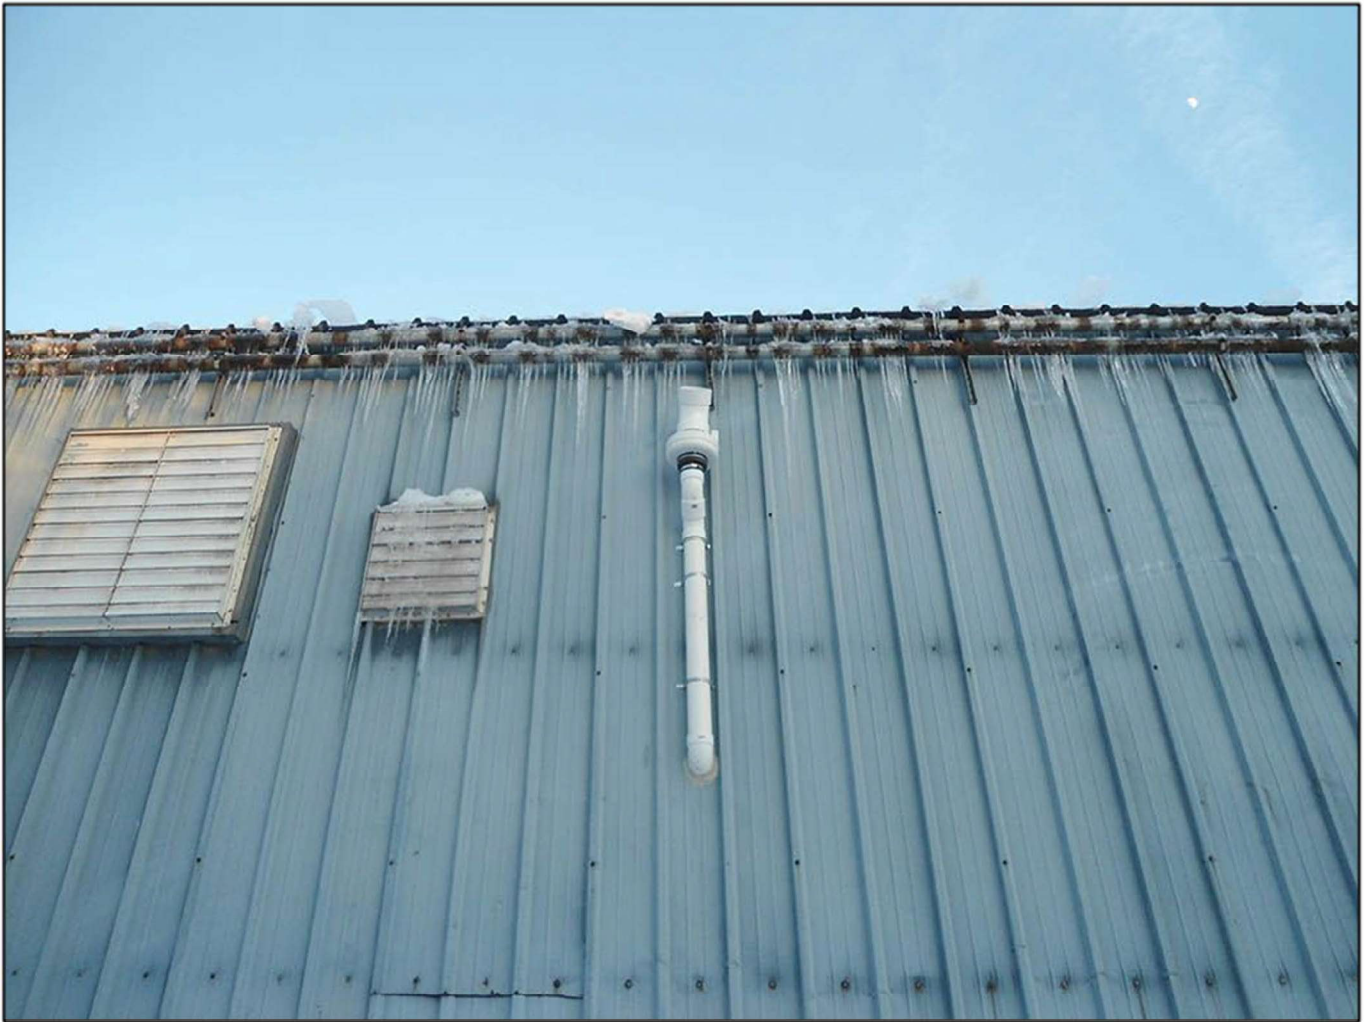
Photo 5

Note: louvers shown to the left of the vertical riser are exhaust louvers/fans

Step 5 (if required) - If the breaker is not tripped check the operation of the fan located on the exterior of the building (see photo 5 on page 9). If the fan is not operating properly check to make sure the cutoff switch on the waterproof box is in the “ON” position. If there is power to the fan then the issue is with the fan. Replace the fan with one of similar specification shown on page 12.

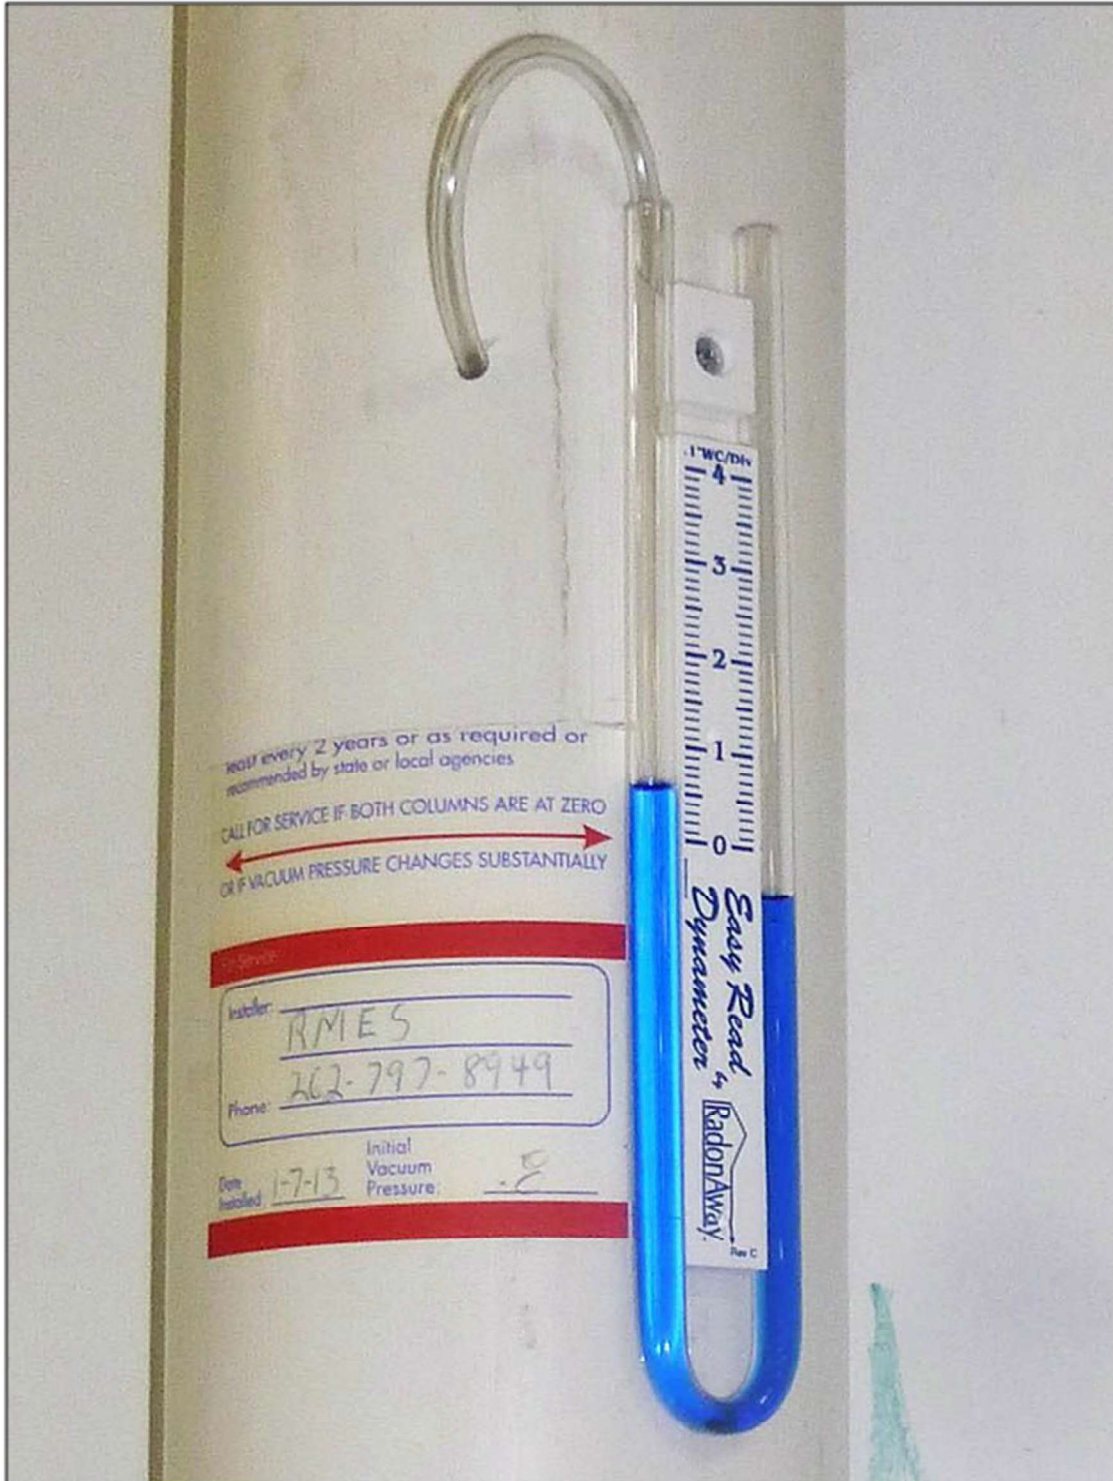
Photo 6

Manometer Installed on draw tube 3 as shown in Photo 3

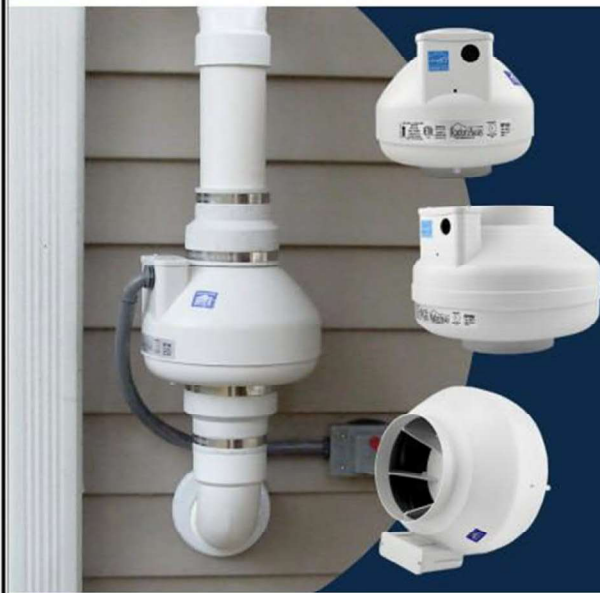
Radon Mitigation Fan

All RadonAway™ fans are specifically designed for radon mitigation. RP Series Fans provide superb performance, run ultra-quiet and are attractive. They are ideal for most sub-slab radon mitigation systems.

- Energy efficient
- Ultra-quiet operation
- Meets all electrical code requirements
- Water-hardened motorized impeller
- Seams sealed to inhibit radon leakage (RP140 & RP145 double snap sealed)
- RP140 and RP260 Energy Star® Rated
- ETL Listed - for indoor or outdoor use
- Thermally protected motor
- Rated for commercial and residential use

the vertical riser continues to a height of approximately 17'. The Vapor Mitigation System is powered by a UL listed RadonAway RP265 fan (see Specification Sheet on page 9). A 45 degree 6" PVC angle is attached to the top of the fan to point the exhaust up and away from the building (see photos 1 – 6 on pages 5 - 9). **Note – the louvers to the left of the of the vertical exhaust riser shown on photo 5, page 9 are exhaust louvers/fans.** Power to the fan is supplied by a separate 20 amp circuit that is hard-wired to a weatherproof disconnect box/switch. An Easy Read Dynameter Manometer is installed on one of the draw point risers to measure sub-slab vacuum pressure (see below). The VMS is currently at .6WC on 4" pipe, which equate to about 290cfm. The concrete floor is in good sound condition. All cracks or gaps in the concrete floor that may affect the efficiency of the system or cause back drafting were filled.

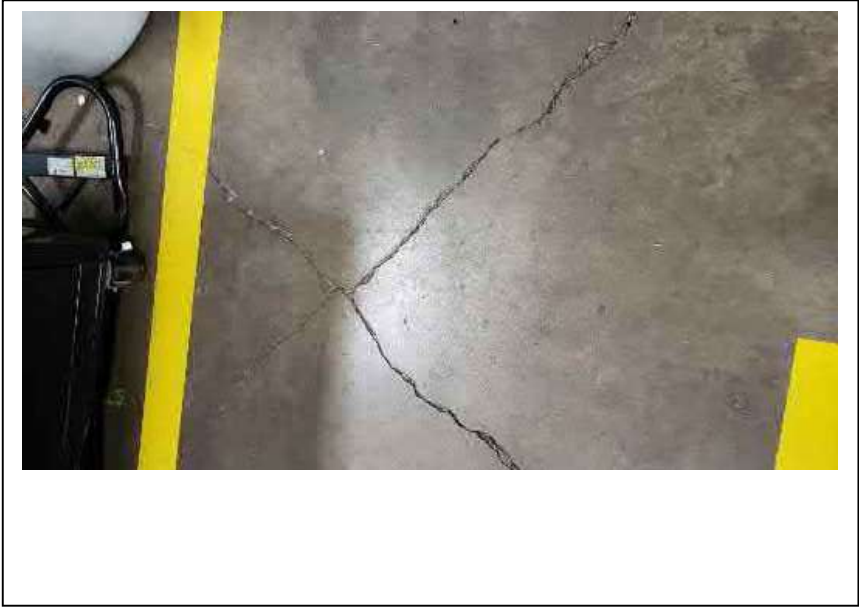
PHOTOGRAPH # 1 *Taken on: 12/27/2021*
Description: View of the concrete floor with sealed cracks within the southwest corner of the building.

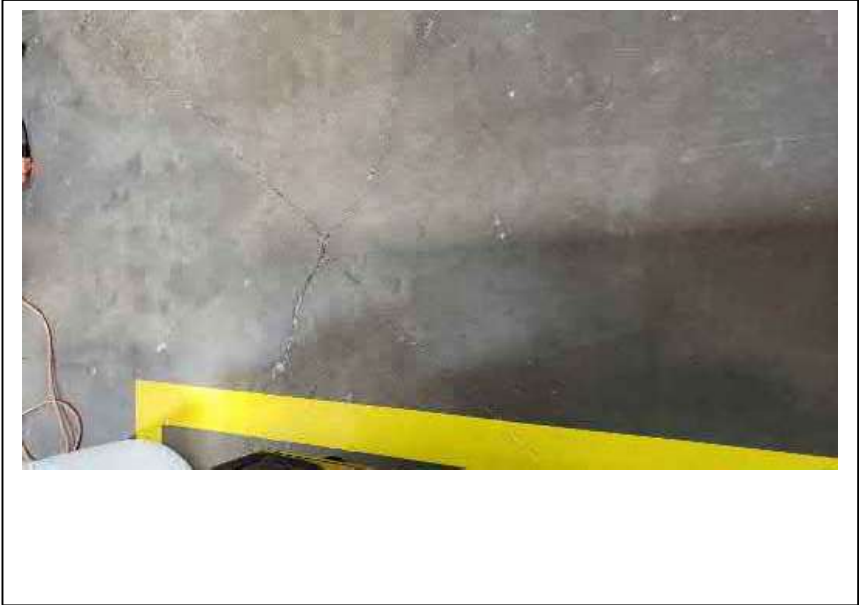
PHOTOGRAPH # 2 *Taken on: 12/27/2021*
Description: View of the concrete floor within southwest corner of the building.

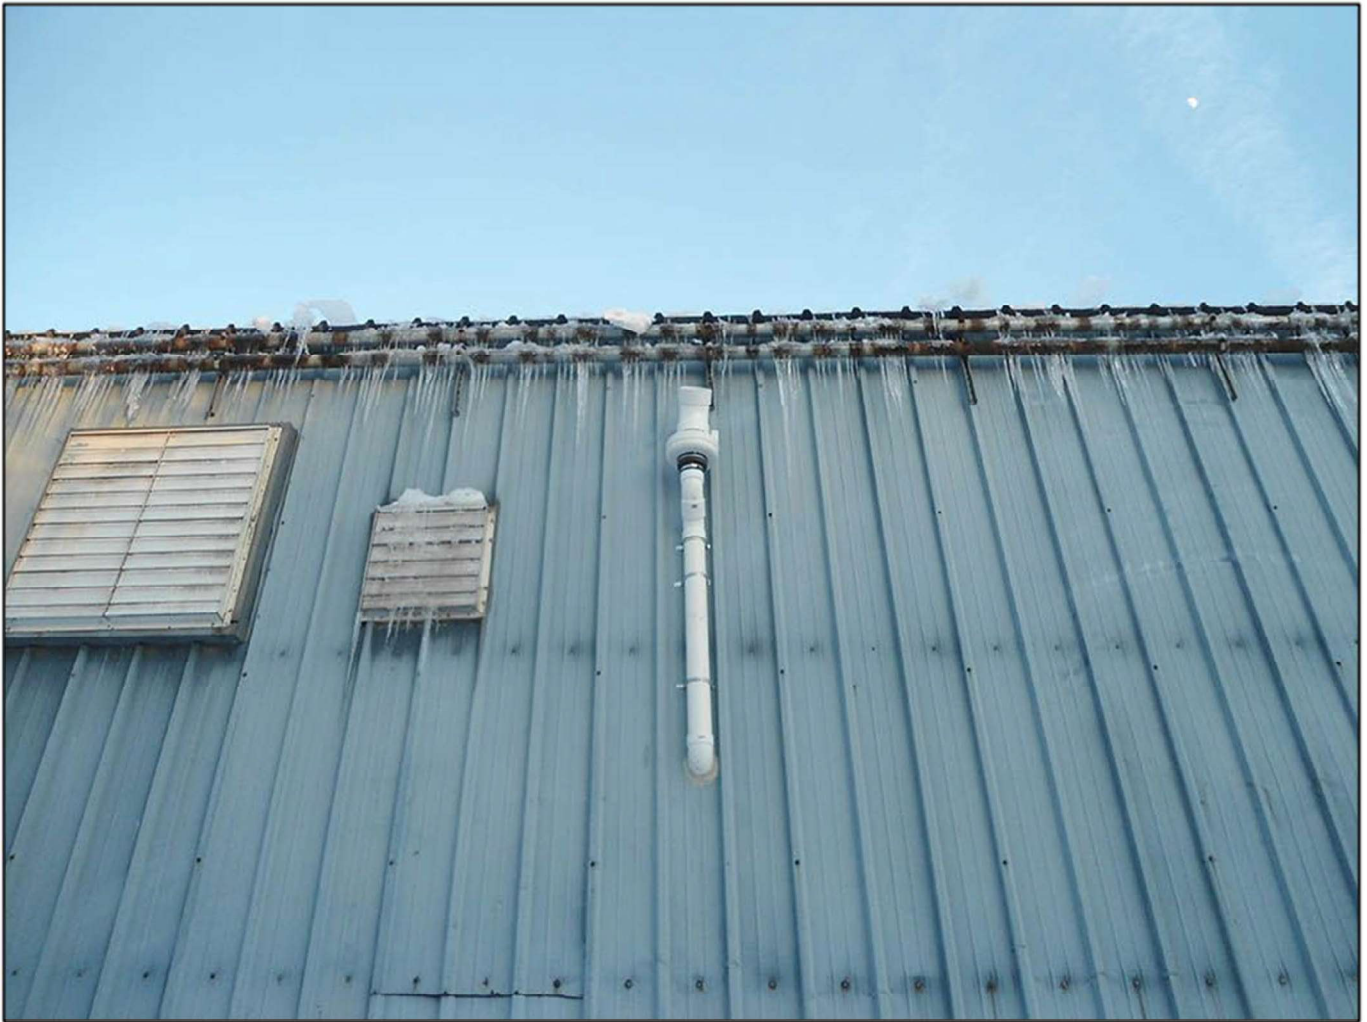
Photo 5

Note: louvers shown to the left of the vertical riser are exhaust louvers/fans

Step 5 (if required) - If the breaker is not tripped check the operation of the fan located on the exterior of the building (see photo 5 on page 9). If the fan is not operating properly check to make sure the cutoff switch on the waterproof box is in the “ON” position. If there is power to the fan then the issue is with the fan. Replace the fan with one of similar specification shown on page 12.
