Subject: Response to Beazer's March 6, 2020 Letter

Former Koppers Tar Plant and Wabash Alloys Site
9100 South 5th Avenue, Oak Creek, WI 53154
FID #: 241379050; BRRTS #: 02-41-553761
VPLE BRRTS #: 06-41-561509

City of Oak Creek Utility Corridor Lot 1
9170 South 5th Avenue, Oak Creek, WI 53154
FID #: 341074470; BRRTS #: 02-41-561425
VPLE BRRTS #: 06-41-561426

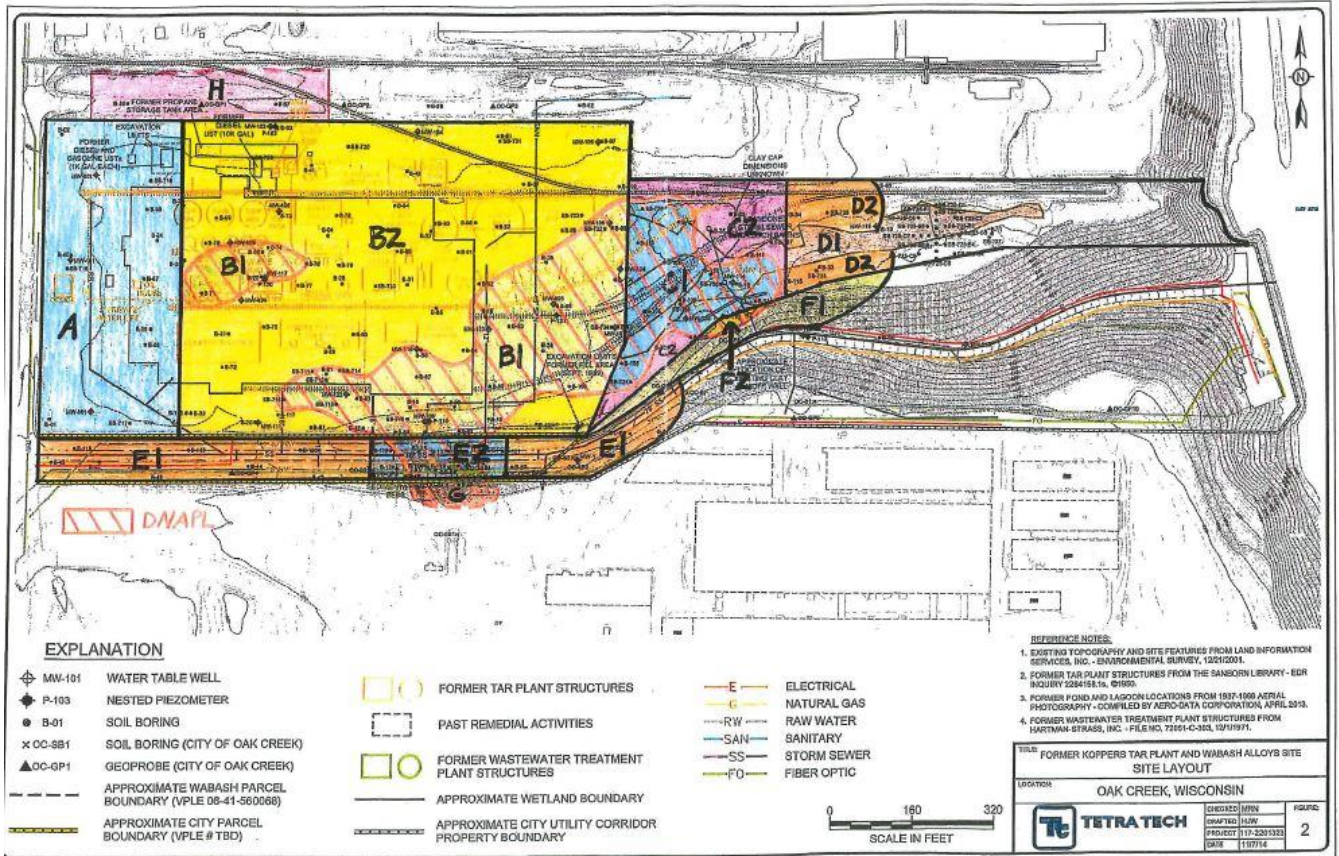
Figure 2: Former Koppers Tar Plant and Wabash Alloys Site Layout, dated 11/7/14, amended 5/14/2018

action at the following areas (Refer to Figure 2, Site Layout - Former Koppers Tar Plant and Wabash Alloys Site, Oak Creek, WI, dated November 7, 2014 and amended on May 14, 2018) to contain the DNAPL tar from reaching the utility trench and continuing to migrate off-site: B1/E2 Area and C1/F2 Area.
