RE: Supplemental Site Investigation Workplan Shorewood Commons Property 3330 University Avenue Madison, Wisconsin True North Project No.: T243003 WDNR BRRTS: 02-13-560698

- Figure 1: Identified Soil Contamination and Proposed Supplemental Sampling Locations
 - Figure 2: Vertical Distribution of PCE in Soils
 - Figure 3: Vapor Sampling Data and Proposed Indoor Air Sampling Locations
 - Figure 4: Cross-Section Showing Proposed Source Area Piezometer

Attachment A:Conceptual Site Model (including Figures and Graphs)

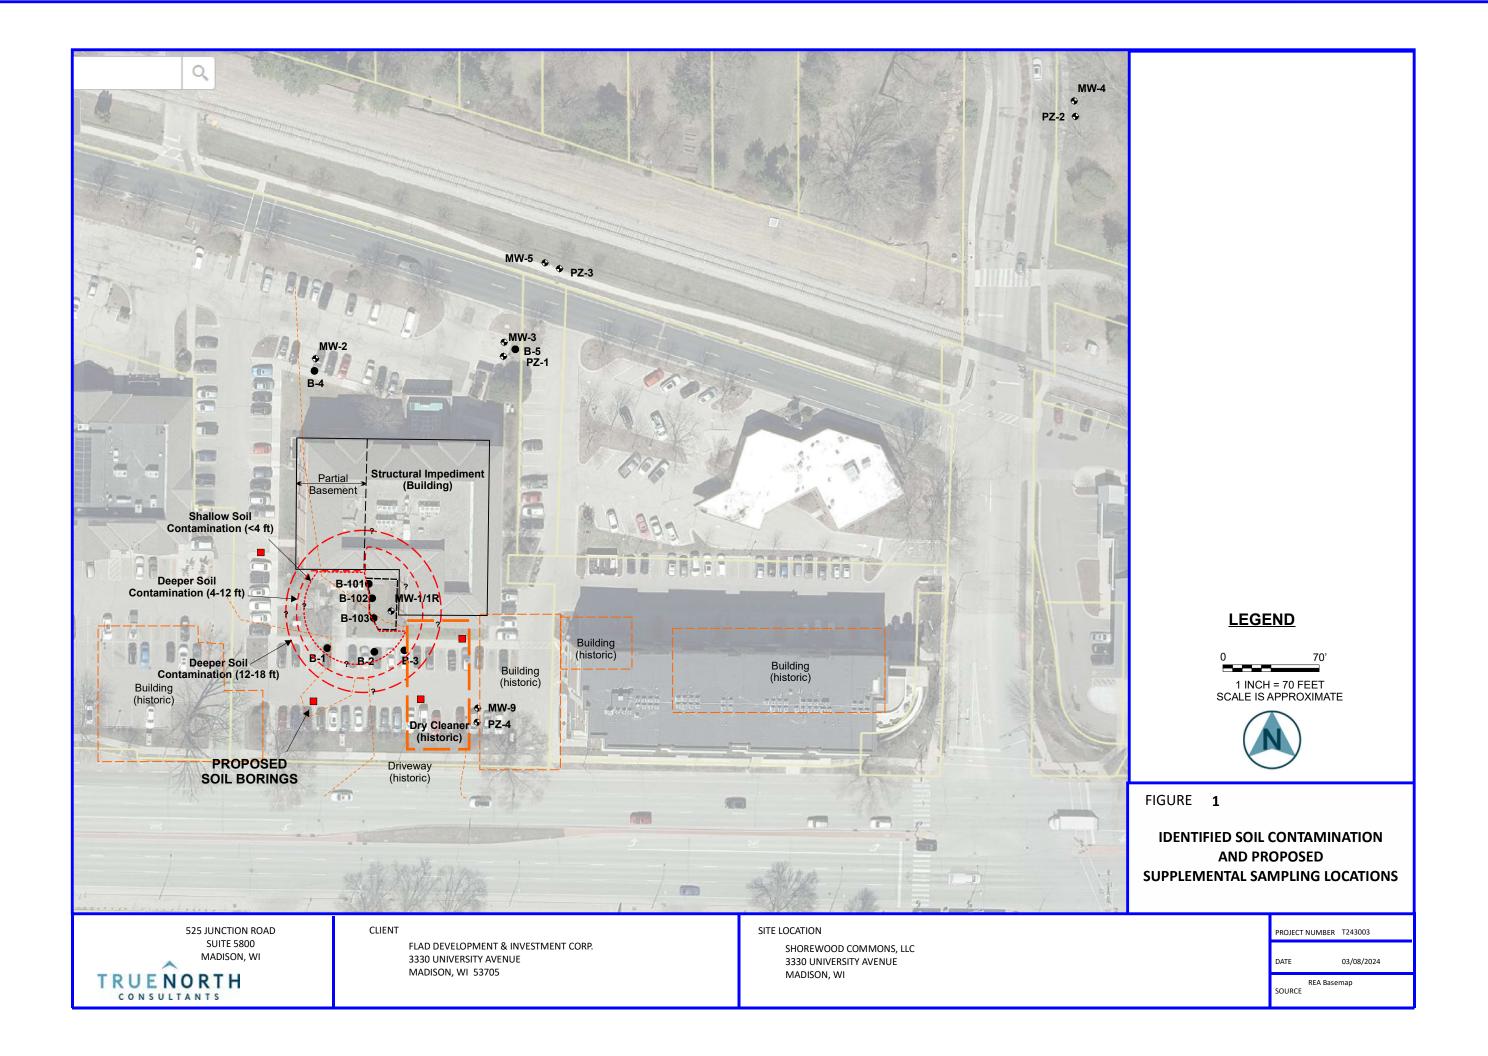
Additional soil sampling will be conducted around the source area (**Figure 1**). The objective of this sampling is to better delimit the extent of impacted soils around the former dry cleaner building. We believe this is particularly important because of the relatively large impediment (building) located in the area of the impacted soil. Four soil borings will be advanced to a depth of approximately 25 feet using direct-push technology (DPT) drilling methods. Soil samples will be collected continuously during the drilling. The soil samples will be described in the field and screened for organic vapors using a photoionization detector (PID) equipped with a 10.6 eV lamp. Laboratory analytical samples will be collected at two horizons in each boring: approximately 15 feet below ground surface (bgs), and approximately 20 feet bgs (near the water table). Analysis of the shallower soils will not be conducted since previous sampling has delimited the extent of dry-cleaning chemicals in the shallower soils. If field evidence indicates that the soil sample collected near the water table contains high levels of dry-cleaning chemicals are present. Soil samples will be analyzed for volatile organic compounds (VOCs). The proposed sampling locations/elevations are shown relative to the previously identified contamination in a cross-section on **Figure 2**.

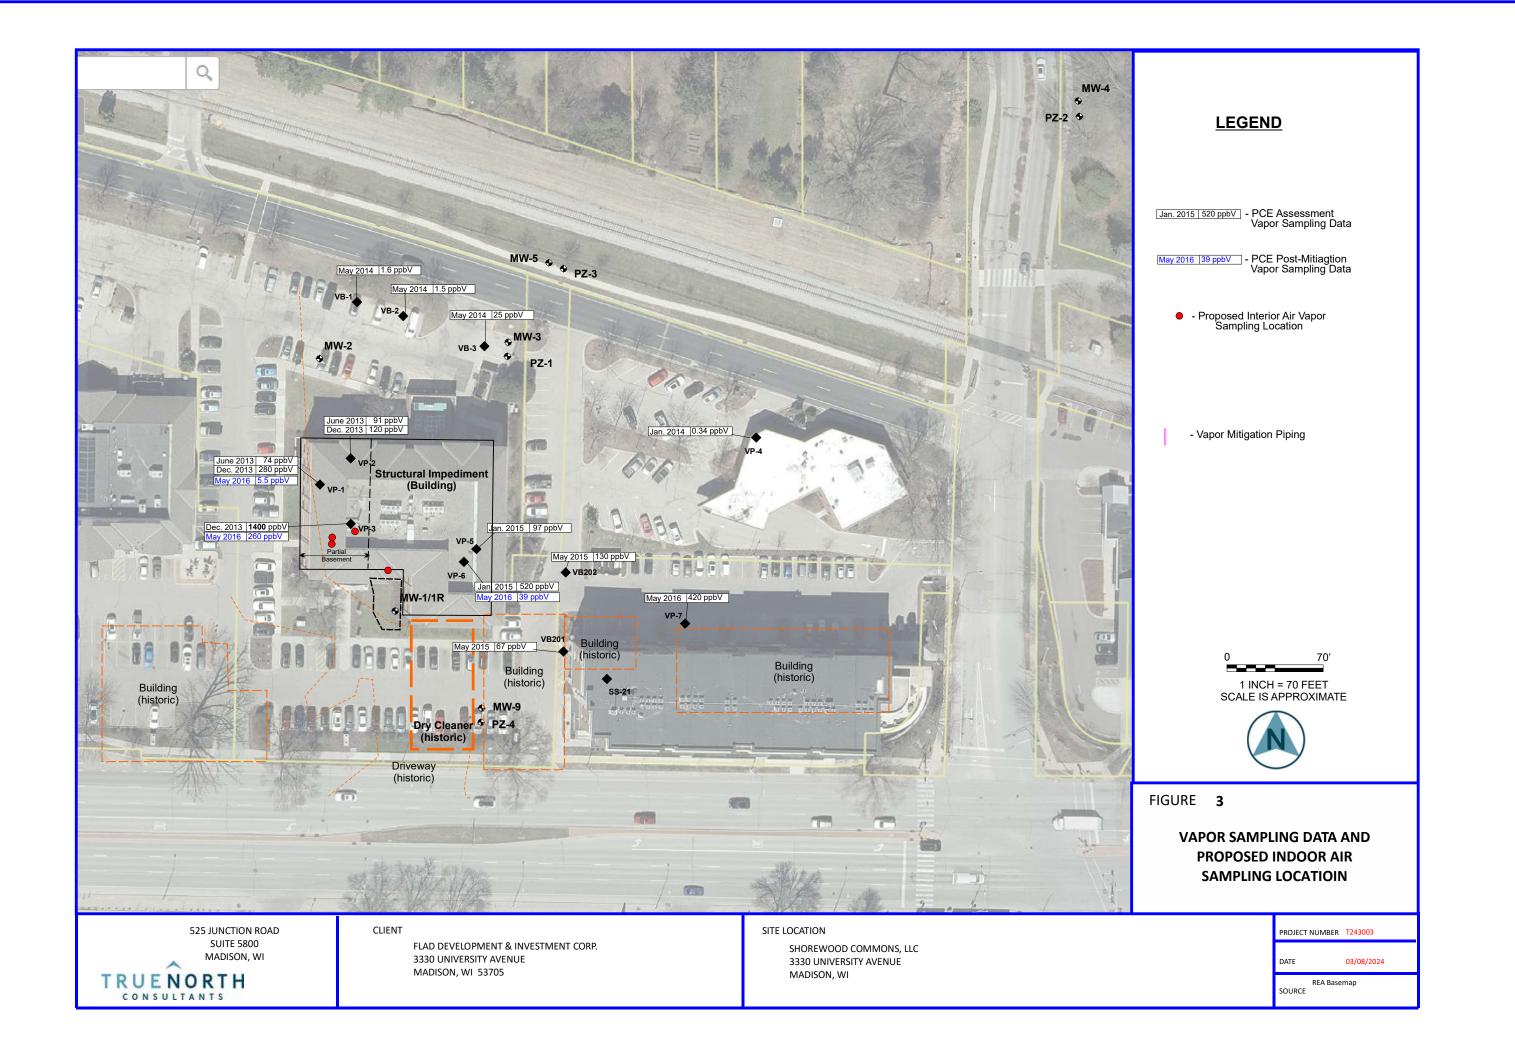
In addition to the pressure field extension testing, indoor air samples will be collected to confirm that the indoor air meets acceptable regulatory levels. Indoor air samples will be collected at locations in both the basement and the first floor. Two samples will be collected in the partial basement present under the western portion of the building. One of these samples will be collected in the east central part of the basement where elevated tetrachloroethylene (PCE) was detected at VP-3 during the previous assessment, and the second sample will be collected near the elevator pit (**Figure 3**). Two indoor air samples will also be collected on the first-floor level. One of these samples will be collected in the mechanical room which is present adjacent to the May 2017 remedial excavation. The second first floor sample will be collected near the elevators to evaluate

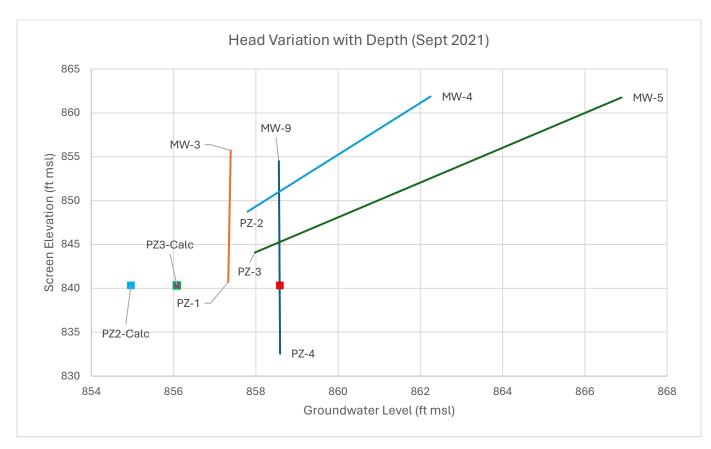
This figure illustrates the flow situation at the site. There are higher water table elevations to the north. Infiltrating water flows downward at a steep gradient in that area through the upper 15 feet of the saturated aquifer. This steep vertical gradient does not extend southwaard very far onto the subject property. On the north side of the site a slight downward gradient remains as the pressure passifies. The water pressure in the aquifer then increases (upward flow) below an elevation of 840 ft.

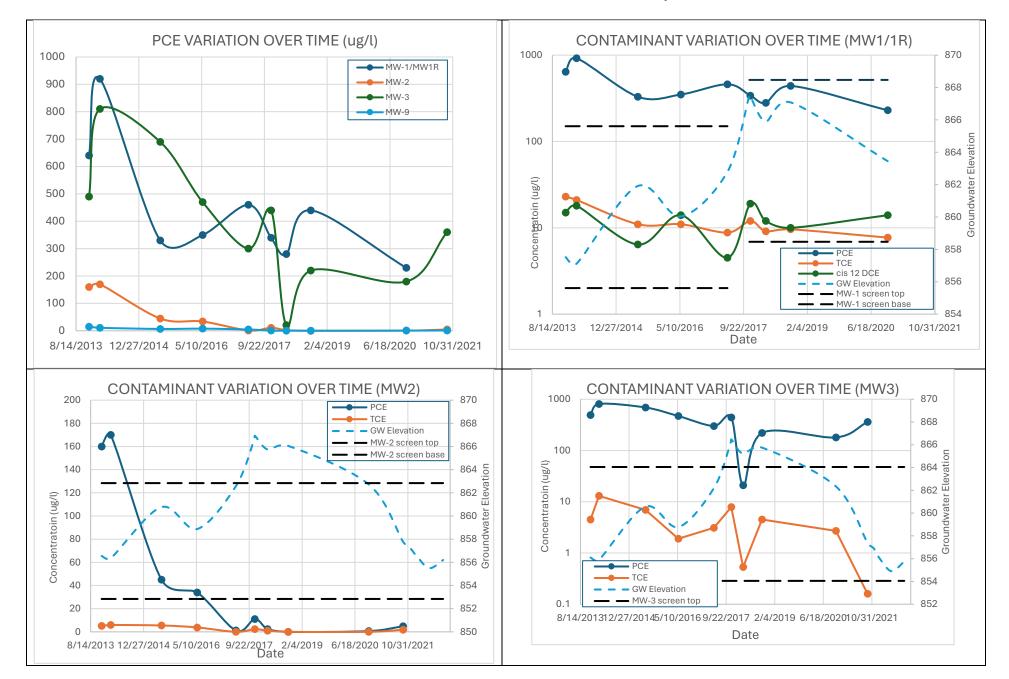
FIGURE 15 - Contaminant Concentration Trend Graphs

Groundwater analytical data indicate that the contaminant levels at the wells are stable or declining. The groundwater contaminant trends are shown graphically on **Figure 15** and details regarding individual wells are discussed below.

- Contaminant levels in the source area well (MW-1/1R) showed a small but steady decline during the monitoring. Variations in the groundwater elevation do not appear to have caused significant changes in the groundwater chemistry at MW-1/1R.

- The contaminant levels at well MW-3, located northeast of the identified soil contamination, showed a steady decline from 2013 to 2017. During this time the water level at the well rose steadily. From 2018 to 2021 the groundwater levels at the well dropped and the contaminant levels increased. The variation in the contaminant levels at MW-3 appears to be related primarily to dilution by clean infiltrate. PCE concentrations in the piezometer located adjacent to MW-3 (PZ-1) typically were higher than those in the monitoring well. However, the contaminant concentrations at PZ-1 showed a steady decline from 2017 to 2021.

- Similar to other wells at the Subject Property, the PCE levels at MW-9 showed a decline from 2013 to 2015 as the water table at the site rose. PCE concentrations rebounded slightly as the water table dropped from 2018 to 2021. At the piezometer located adjacent to this well, PZ-4, the contaminant concentrations also declined during the time-frame of the rising groundwater levels. However, the contaminant levels at the piezometer jumped dramatically when the groundwater elevation declined from 2018 to 2021. This appears to indicate that substantial contaminant mass is present below the water table in this area unlike at PZ-1 located slightly downgradient.
