Vapor Mitigation System designed and installed by A-1 Vacuum & Radon at 111 Steele St. Algoma, WI, on 6/22/17

System Description:

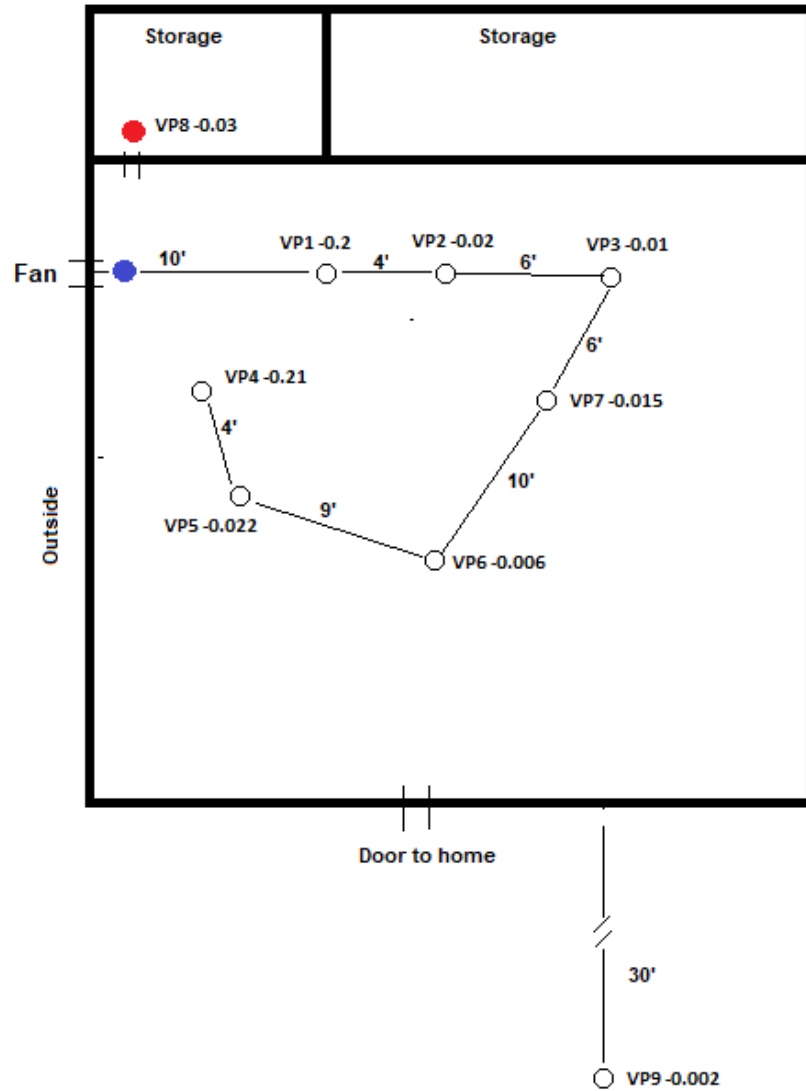
Diagram 1
Vapor Mitigation location and Vapor Pressure Readings

- Suction Point #1 ●
- Suction Point #2 ●

A fan installed in line with the exhaust piping, but outside the structure (figure 4), provides active mitigation by creating a draw on air below the foundation. Negative pressure measurements detailing the effectiveness of the system at various points throughout the sub slab are mapped in diagram 1. The mitigation fan includes a power switch secured to the outside wall of the building (figure 4). This power switch may be secured with a lock (not supplied by the mitigation installers) to prevent unwanted disabling of the fan. The fan is warrantied for 5 years from the date of installation. The manufacturer will cover the cost of the fan (less installation) should it need replacement during this time. All related manufacturer warranty filings, along with proper dated records of installation, can be completed and submitted by A-1 Vacuum & Radon.
