**Re: Remedial Action Options Report/Design Report**  
**BRRTS #: 02-41-576336 & 02-41-579429**  
**FID #: 241828620**  
**Sunrise Shopping Center**  
**2410-2424 10<sup>th</sup> Avenue & 1009 Marquette Avenue**  
**South Milwaukee, Wisconsin 53172**

**REMEDIAL ACTION OPTIONS REPORT/  
DESIGN REPORT  
SUNRISE SHOPPING CENTER  
2410-2424 10<sup>TH</sup> AVENUE & 1009 MARQUETTE AVENUE  
SOUTH MILWAUKEE, WISCONSIN 53172  
WDNR BRRTS ACTIVITY #02-41-576336 & 02-41-579429  
WDNR FID #241828620**

DAI Project Number: 6255

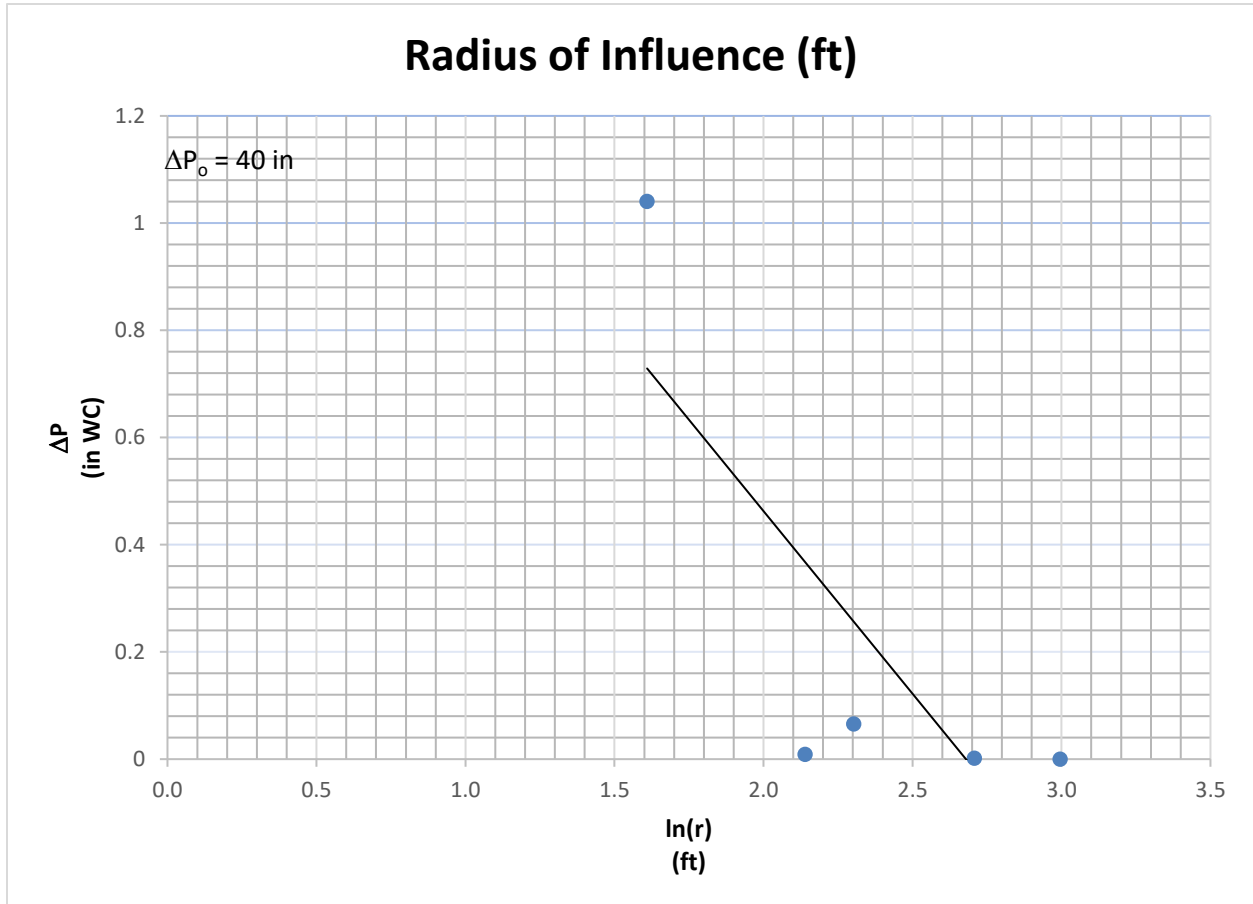
**4.3.1.2 Pilot Test Data Evaluation:** Following the suggestion of Johnson and Kemblowski’s design for in-situ soil venting systems, the subsurface gauge pressure (i.e., the vacuum measurement) is plotted against the natural log of the distance from the extraction point, as shown below.

As can be observed, the pilot scale testing results indicated that a radius of influence (defined as the distance at which a vacuum of 0.003-in water column (WC) is generated) of 14.5-ft can be achieved under a static pressure of 40-in WC at the extraction point. This radius of influence was obtained at a flowrate of 9-ft<sup>3</sup>/min. Analysis of the duct fan test run indicated a smaller radius of influence and multiple sump pits, such that a duct fan would not be cost effective. The sand underlying the concrete slab, rather than more highly permeable gravel, is the likely reason for a relatively small radius of influence.

**4.3.1.1 Pilot Test Procedures:** To estimate the site-specific design parameters needed to design a full-scale SSD system, a pilot scale test was conducted on September 23, 2016. The pilot testing consisted of extracting air from beneath the concrete building slab (depressurizing) under a series of operating conditions and then monitoring the sub-slab pressure at variable distances from the point of air extraction.

In addition to measuring the vacuum at multiple locations from the extraction point, the stratigraphy below the slab was evaluated during the pilot testing. The 4-in concrete slab is underlain by a layer of plastic sheeting, followed by approximately 1.5-ft of clayey sand (building pad sub-base). A black clay and slag (non-native fill) followed by native clay are observed below the clayey sand (as determined from September 2016 soil borings).
