SUBJECT: Case Closure with Continuing Obligations  
Krystal Kleaners 145 E. Sunset Drive, Waukesha, WI 53186  
BRRTS #: 02-68-576741, FID #: 268280430

The Wisconsin Department of Natural Resources (DNR) is pleased to inform you that the Krystal Kleaners case identified above met the requirements of Wisconsin Administrative (Wis. Admin.) Code chs. NR 700 to 799 for case closure with continuing obligations (COs). COs are legal requirements to address potential exposure to remaining contamination. No further investigation or remediation is required at this time for the reported hazardous substance discharge and/or environmental pollution.

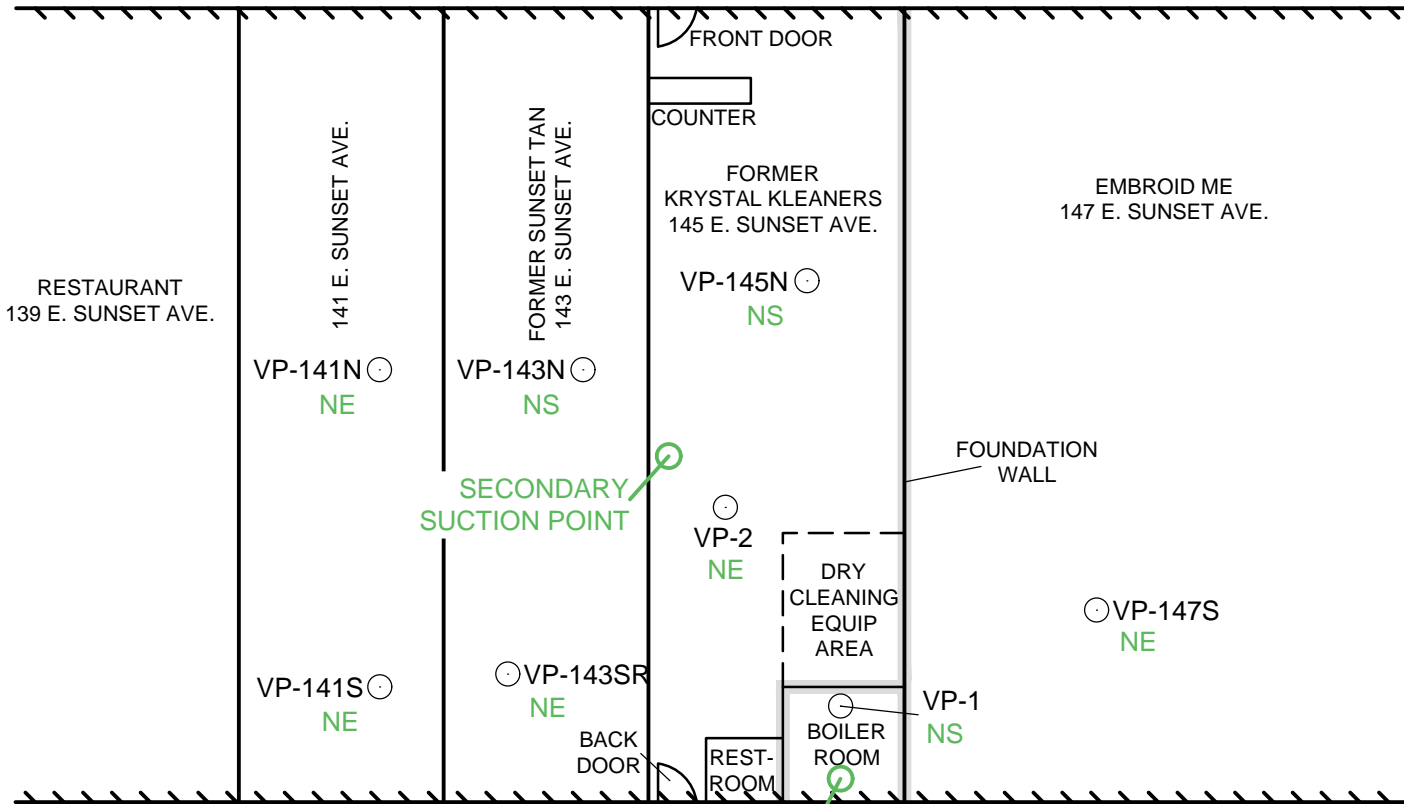
D.2.e

EDGE OF BUILDING  
 — X — FENCE  
 — C — UNDERGROUND COMMUNICATIONS/CONDUIT  
 — ELC — UNDERGROUND ELECTRIC LINE  
 — GAS — GAS LINE  
 ○ SUBSLAB VAPOR SAMPLING POINT LOCATION  
 NE - NO EXCEEDANCES OF SMALL COMMERCIAL SUB-SLAB REGIONAL SCREEING LEVEL  
 NS - NOT SAMPLED  
 NM - NOT MEASURED

MAIN SUCTION POINT

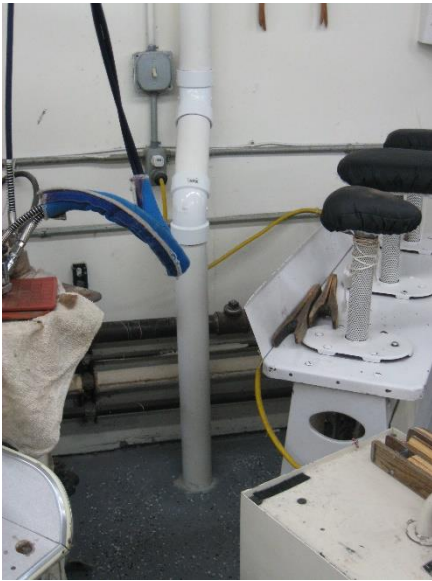
1. 3" secondary suction pipe penetration.

The SSDS consists of solvent-glued PVC pipe which penetrates the slab-on-grade in two (2) locations. The layout of the SSDS is depicted on **Figure D.2.g – Mitigation System**. A rubberized latex caulk was utilized to seal the suction pipe penetrations through the slab-on-grade. A RadonAway HS Series fan was installed on the south exterior wall of the building to provide suction to the two (2) penetrations. Photographs of the installed mitigation system may be found in **Attachment D.3**.

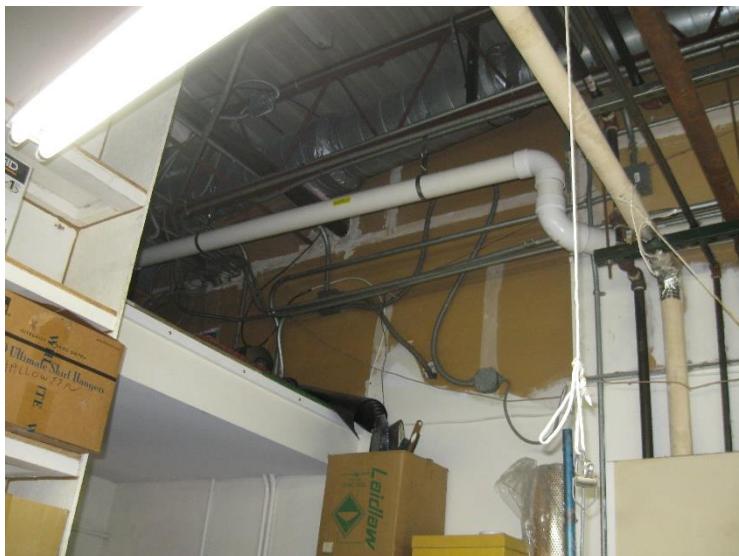
3. 3" secondary suction pipe overhead routing.

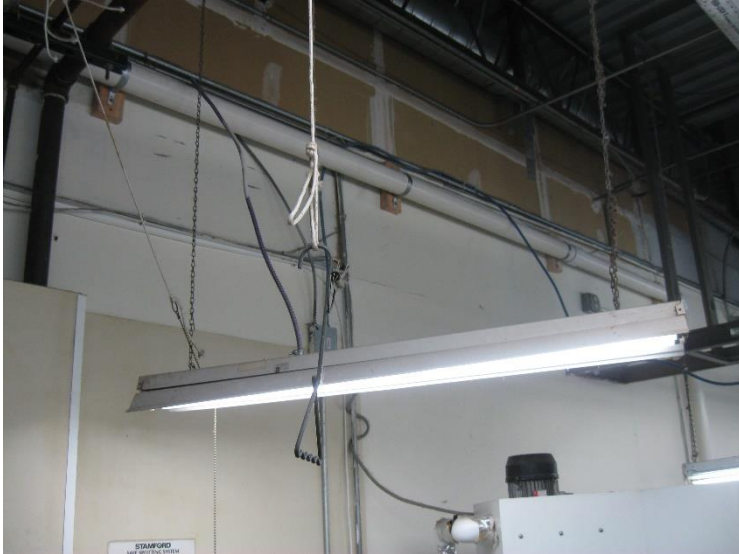
4. 3" secondary suction pipe overhead routing.

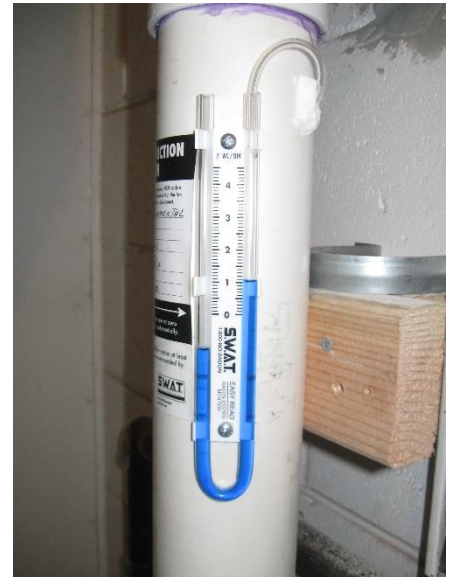
5. Manometer on 3" main suction pipe after fan install.

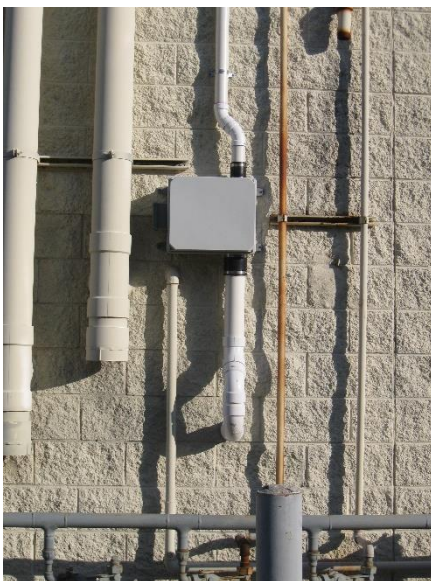
6. Exterior fan installation.

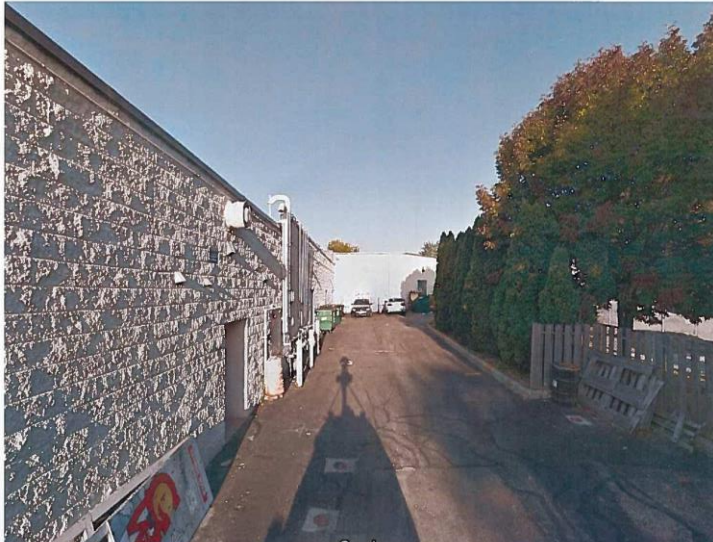
10. South side of building looking East. The back door of Krystal Kleeners (on left) and asphalt protective barrier with MW-1, PZ-1 (foreground), MW2 (right) and MW-2 (in background).

The barrier/cover consists of approximately three (3) inches of concrete inside the building (slab on grade). Outside and adjacent to the building, the cover consists of approximately 3 inches of bituminous asphalt. The barrier is expected to function adequately based on the current use of the site unless disturbed. Photographs of the Protective Barrier/Cover System may be found in **Attachment D.3**.

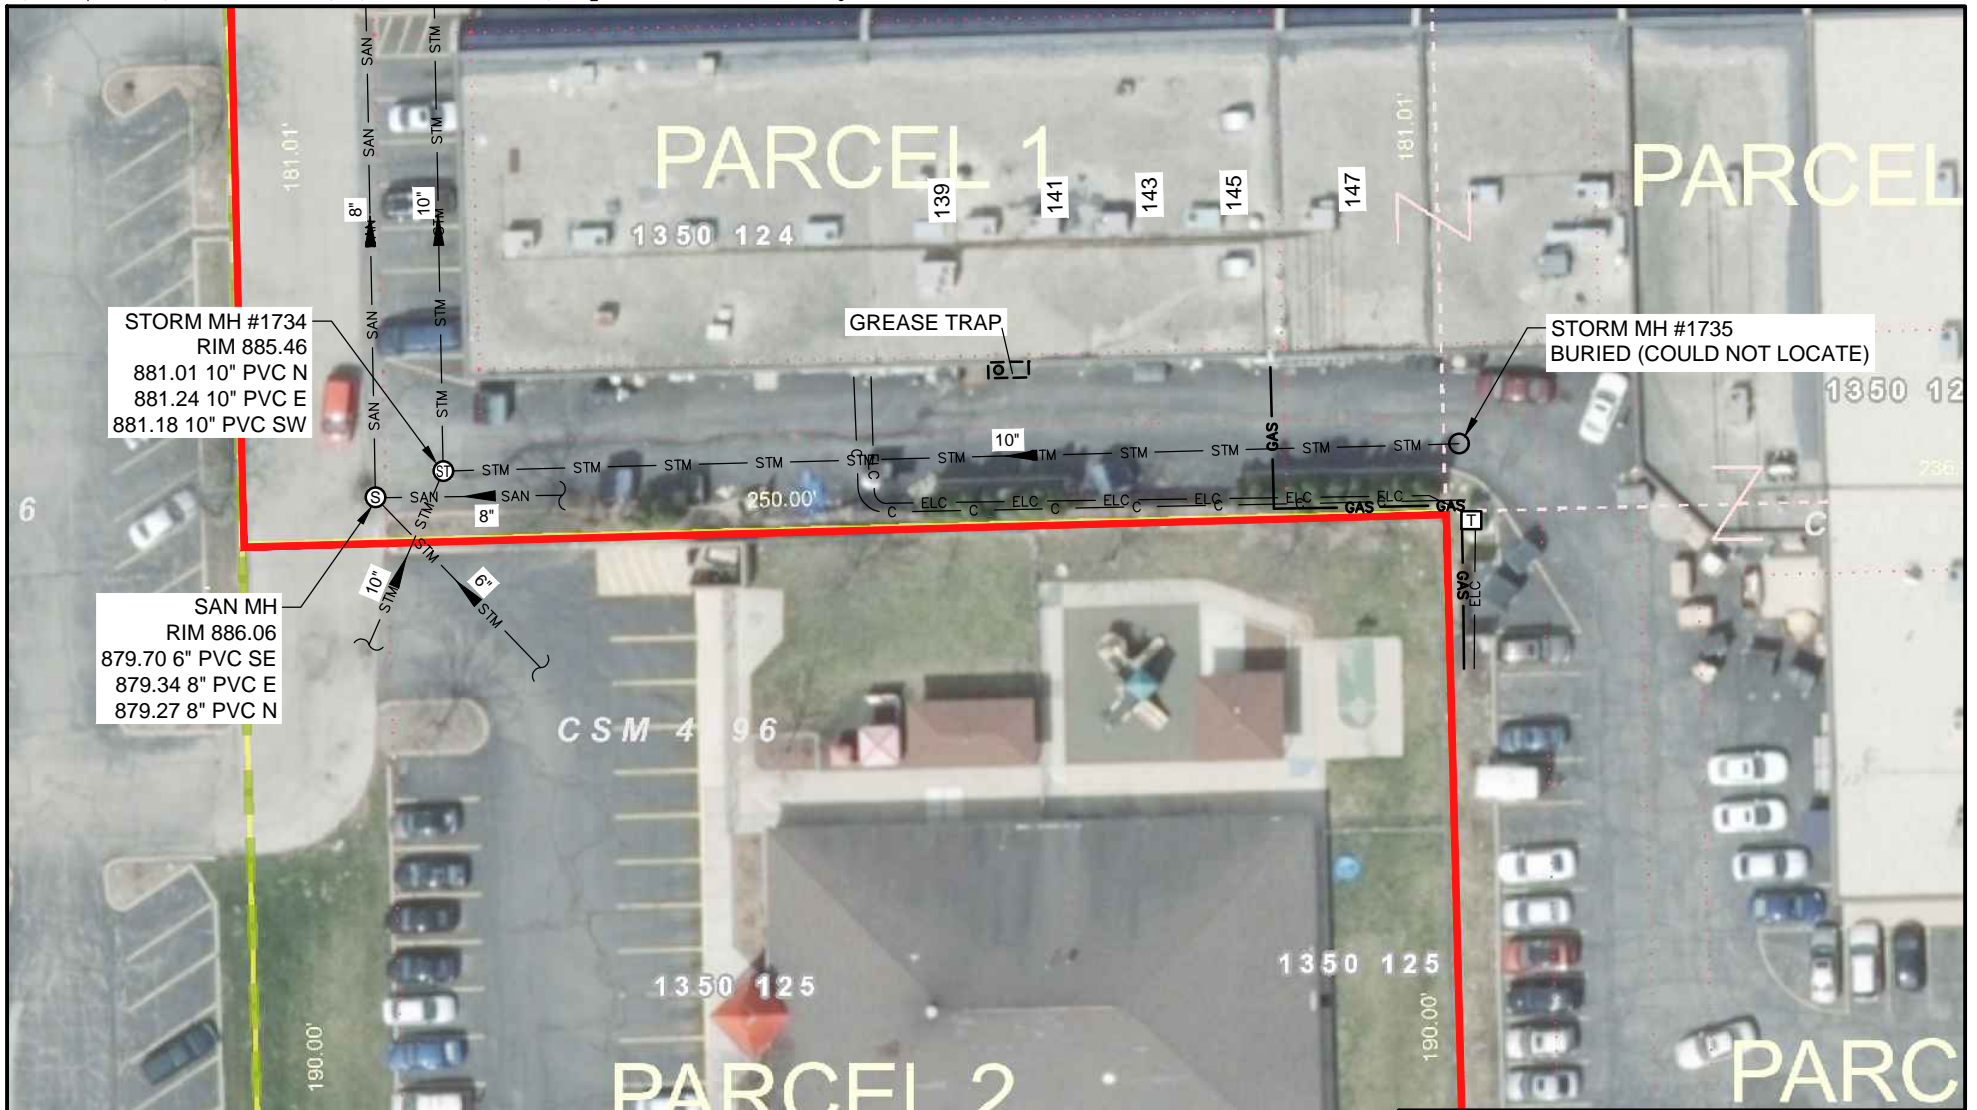
SUBJECT PROPERTY
	UNDERGROUND COMMUNICATIONS/CONDUIT
	UNDERGROUND ELECTRIC LINE
	GAS LINE
	GRAVITY SANITARY SEWER
	GRAVITY STORM SEWER
	SANITARY MANHOLE
	STORM INLET/MANHOLE
	TRANSFORMER

NOTE: ALL UNDERGROUND UTILITIES ARE SHOWN APPROXIMATE.

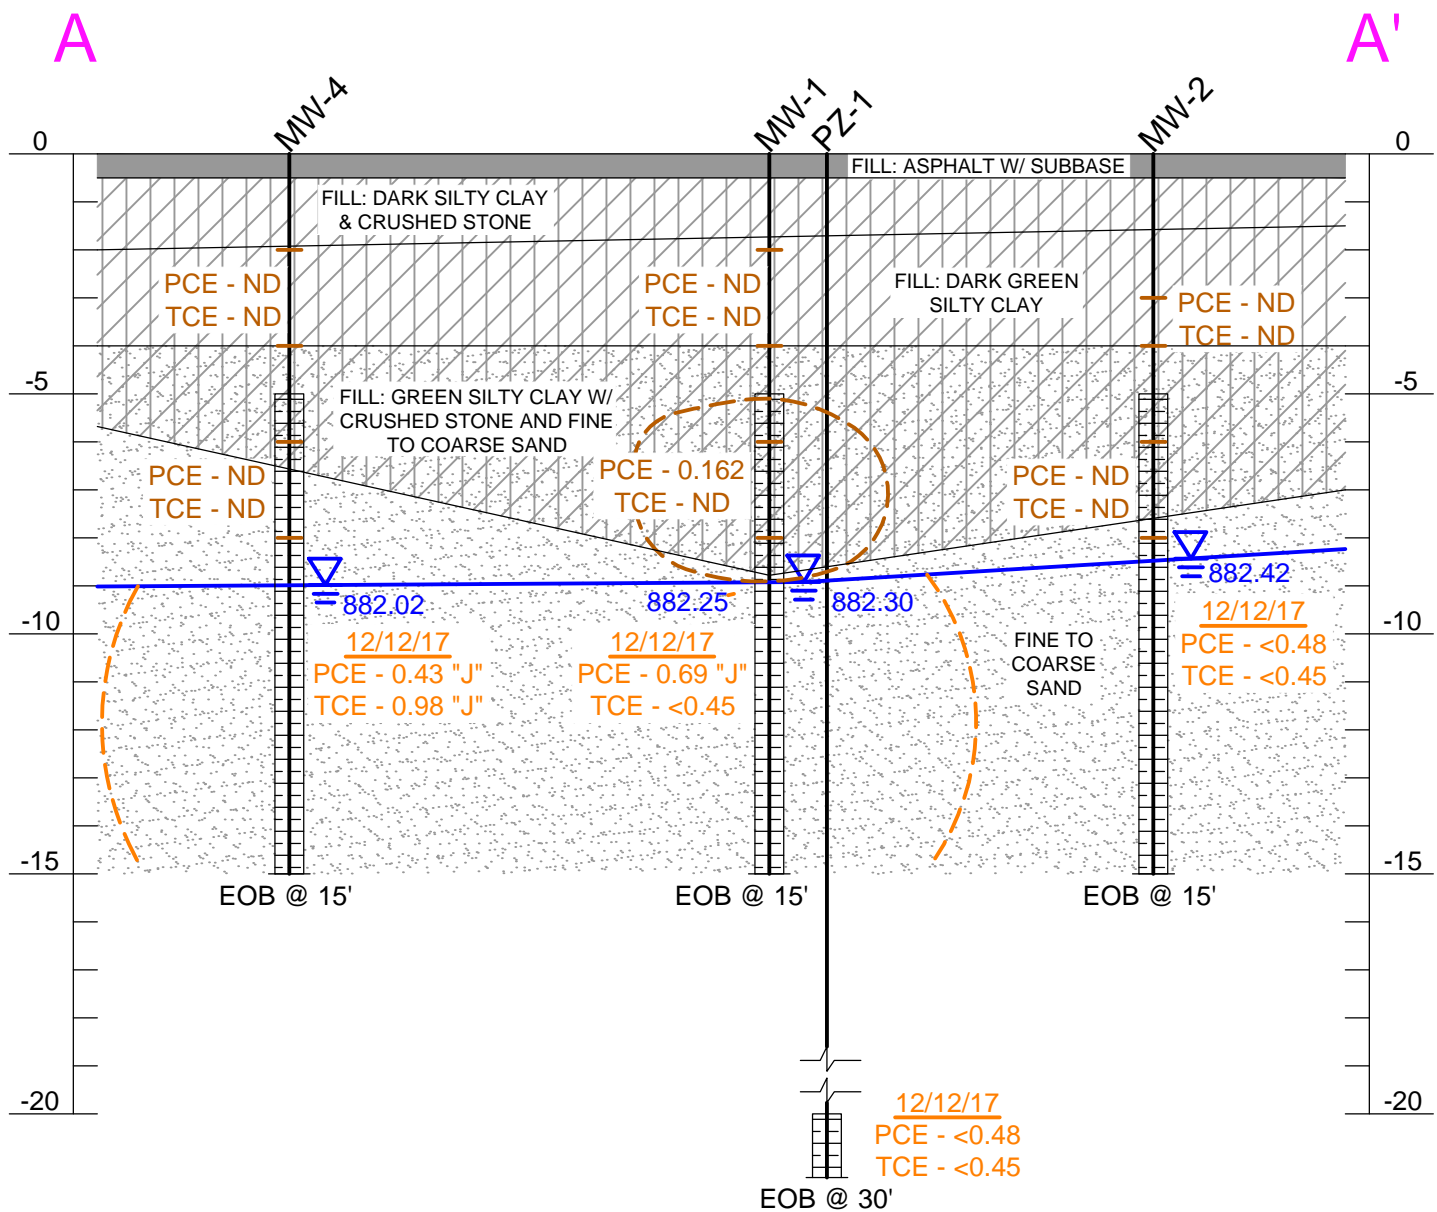
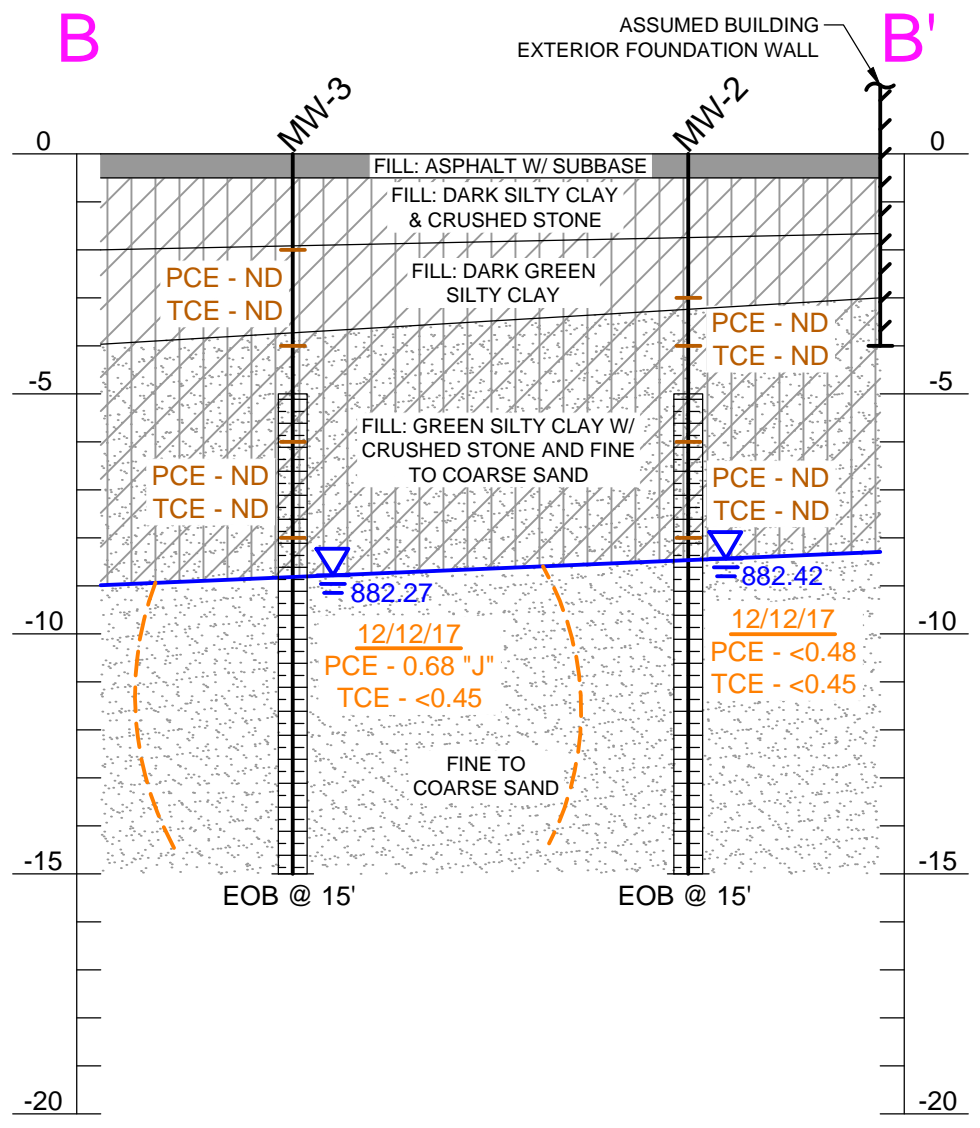
- EDGE OF BUILDING
- FENCE
- SOIL BORING LOCATION
- SHALLOW SOIL SAMPLE LOCATION AND IDENTIFIER
- SOIL BORING W/ MONITORING WELL LOCATION
- APPROXIMATE EXTENT OF SOILS EXCEEDING SOIL-TO-GROUNDWATER PATHWAY RCLs
- APPROXIMATE EXTENT OF GROUNDWATER WITH PAL EXCEEDANCES
- GROUNDWATER ELEVATION DECEMBER 2017
- MONITORING WELL SCREEN
- ASPHALT W/ SUBBASE
- FILL (SILTY CLAY)
- FILL (SANDY CLAY)
- NATIVE SAND

**SOIL RESULTS IN MILLIGRAMS PER KILOGRAM (mg/kg)**

- A. **Soil/Geology**
- i. **Describe soil type(s) and relevant physical properties, thickness of soil column across the site, vertical and lateral variations in soil types.**  
In order to define the soil profile eight (8) soil borings were advanced. In general, the soil profile consists of silty clay and stone fill beneath the asphalt paved surface from (0-8 ft bgs) with natural soils consisting of fine to coarse sand from (8-12 ft bgs).
- ii. **Describe the composition, location and lateral extent, and depth of fill or waste deposits on the site.**  
A layer of fill was observed in the soil borings from below the asphalt paved surface to approximately 8.5 ft bgs, which consists of a silty clay and stone.
