Subject: **Response to Wisconsin DNR Comments from April 23, 2021**
Greentree Cleaners
5111 Douglass Avenue, Racine, Wisconsin
Wisconsin DNR Facility Identification # 252138700
Wisconsin DNR BRRTS Activity # 02-52-579863

Greentree Station LLC retained Apex to conduct additional site investigation at the location of the former dry cleaner tenant space at 5111 Douglas Avenue, Unit D. This tenant space is located within Greentree Station LLC's Greentree Centre, a retail strip mall located at 5055 & 5111-5141 Douglas Avenue in Racine, Racine County, Wisconsin.

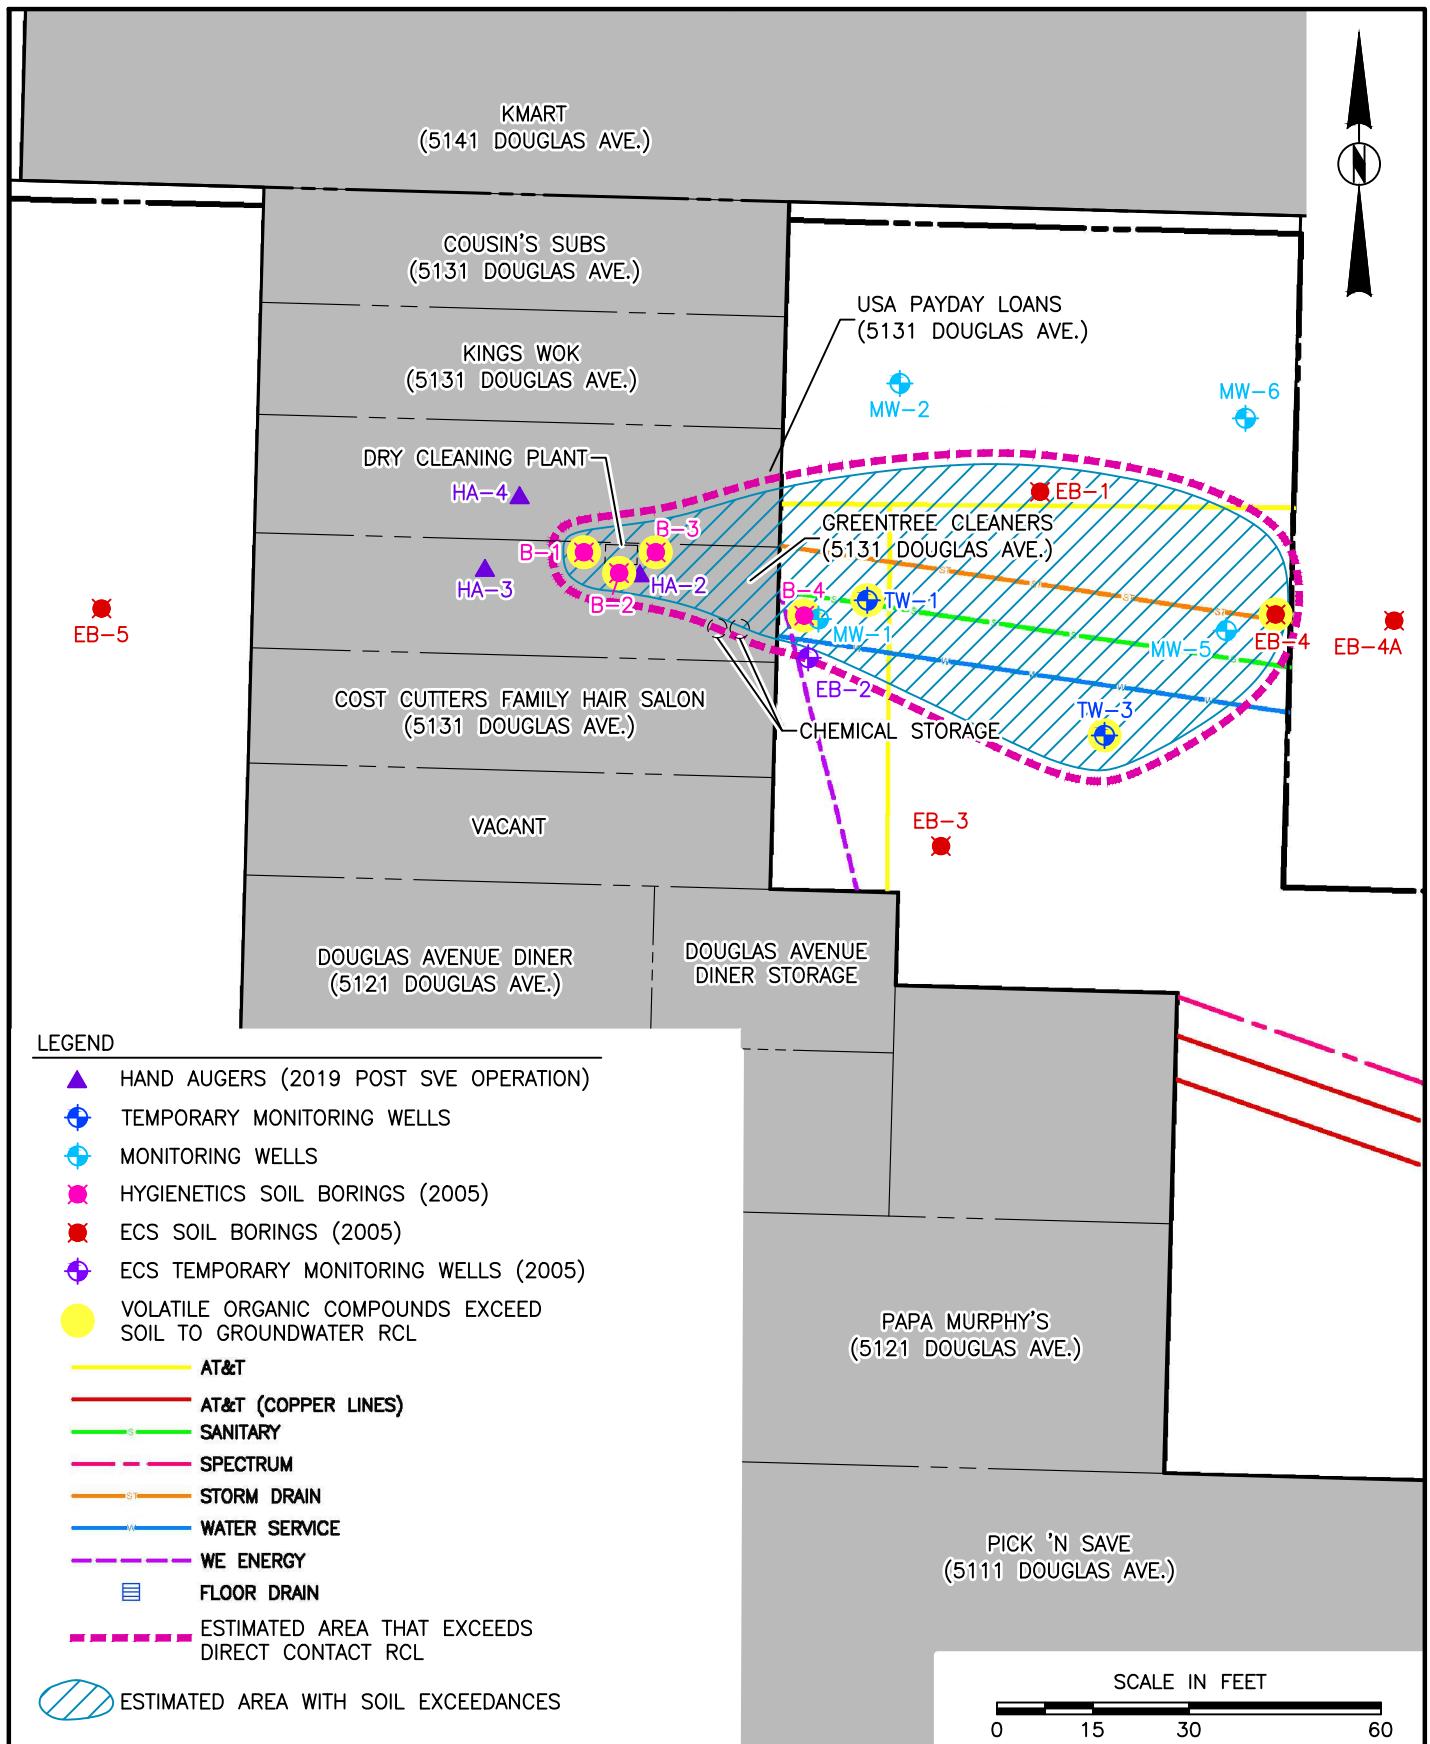
CHECK BY JA	SOIL CONTAMINATION GREENTREE CENTRE 5111 DOUGLAS AVENUE, UNIT D RACINE, WISCONSIN	APEX	FIGURE
DRAWN BY OS			B.2.a
DATE 4-28-22			
SCALE AS SHOWN			
CAD NO. PECO.2017.100e4			
PRJ NO. PECO_2017-100

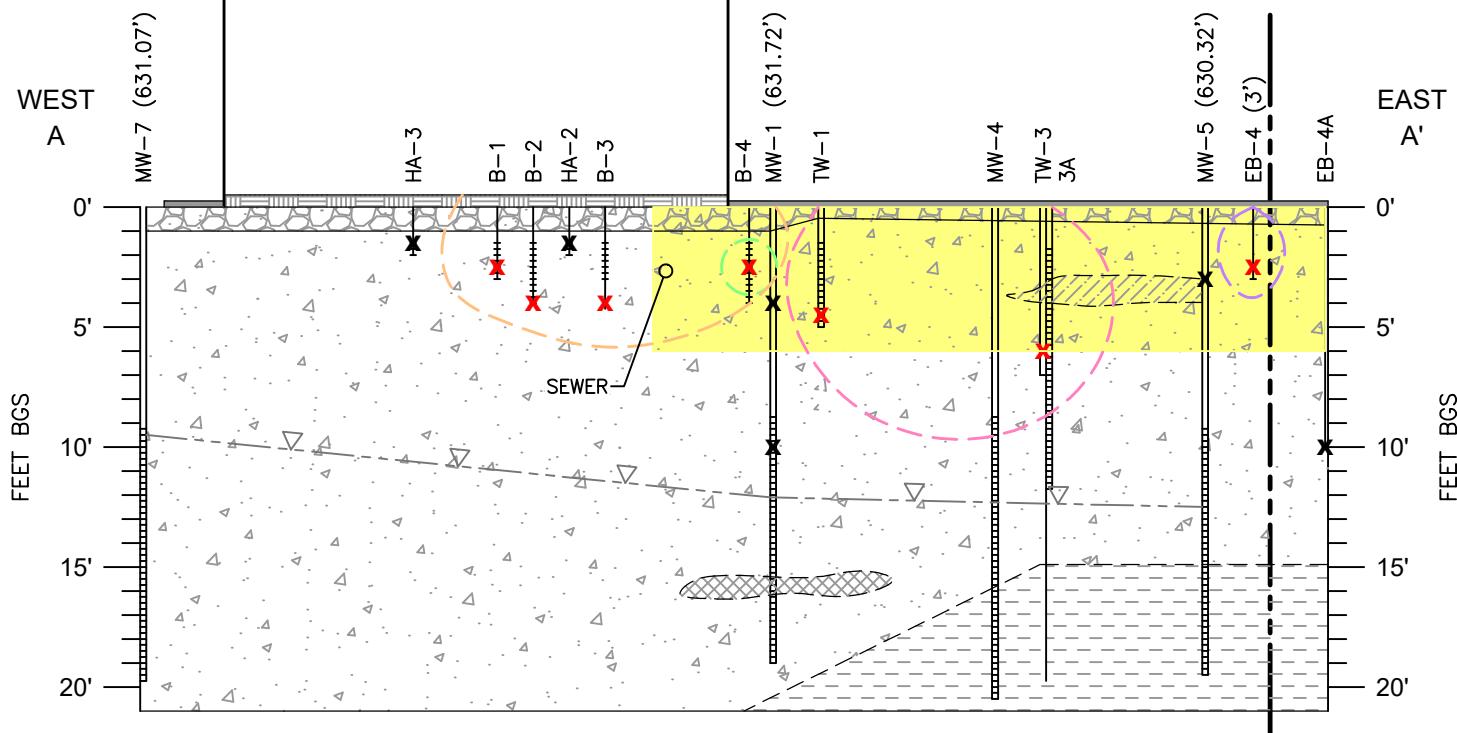
CROSS SECTION VIEW (A-A')

- ▽— GROUNDWATER ELEVATION MEASURED ON SEPTEMBER 15, 2017
- BENZENE EXCEEDANCE
- METHYLENE CLORIDE EXCEEDANCE
- NAPHTHALENE EXCEEDANCE
- TETRACHLOETHYLENE EXCEEDANCE
- AREA OF UTILITIES BETWEEN BUILDING AND PROPERTY WITH ESTIMATED DEPTHS LESS THAN 7'
- ✖ EXCEEDANCE OF SOIL TO GROUNDWATER RCL
- ✗ NO EXCEEDANCE OF SOIL TO GROUNDWATER RCL

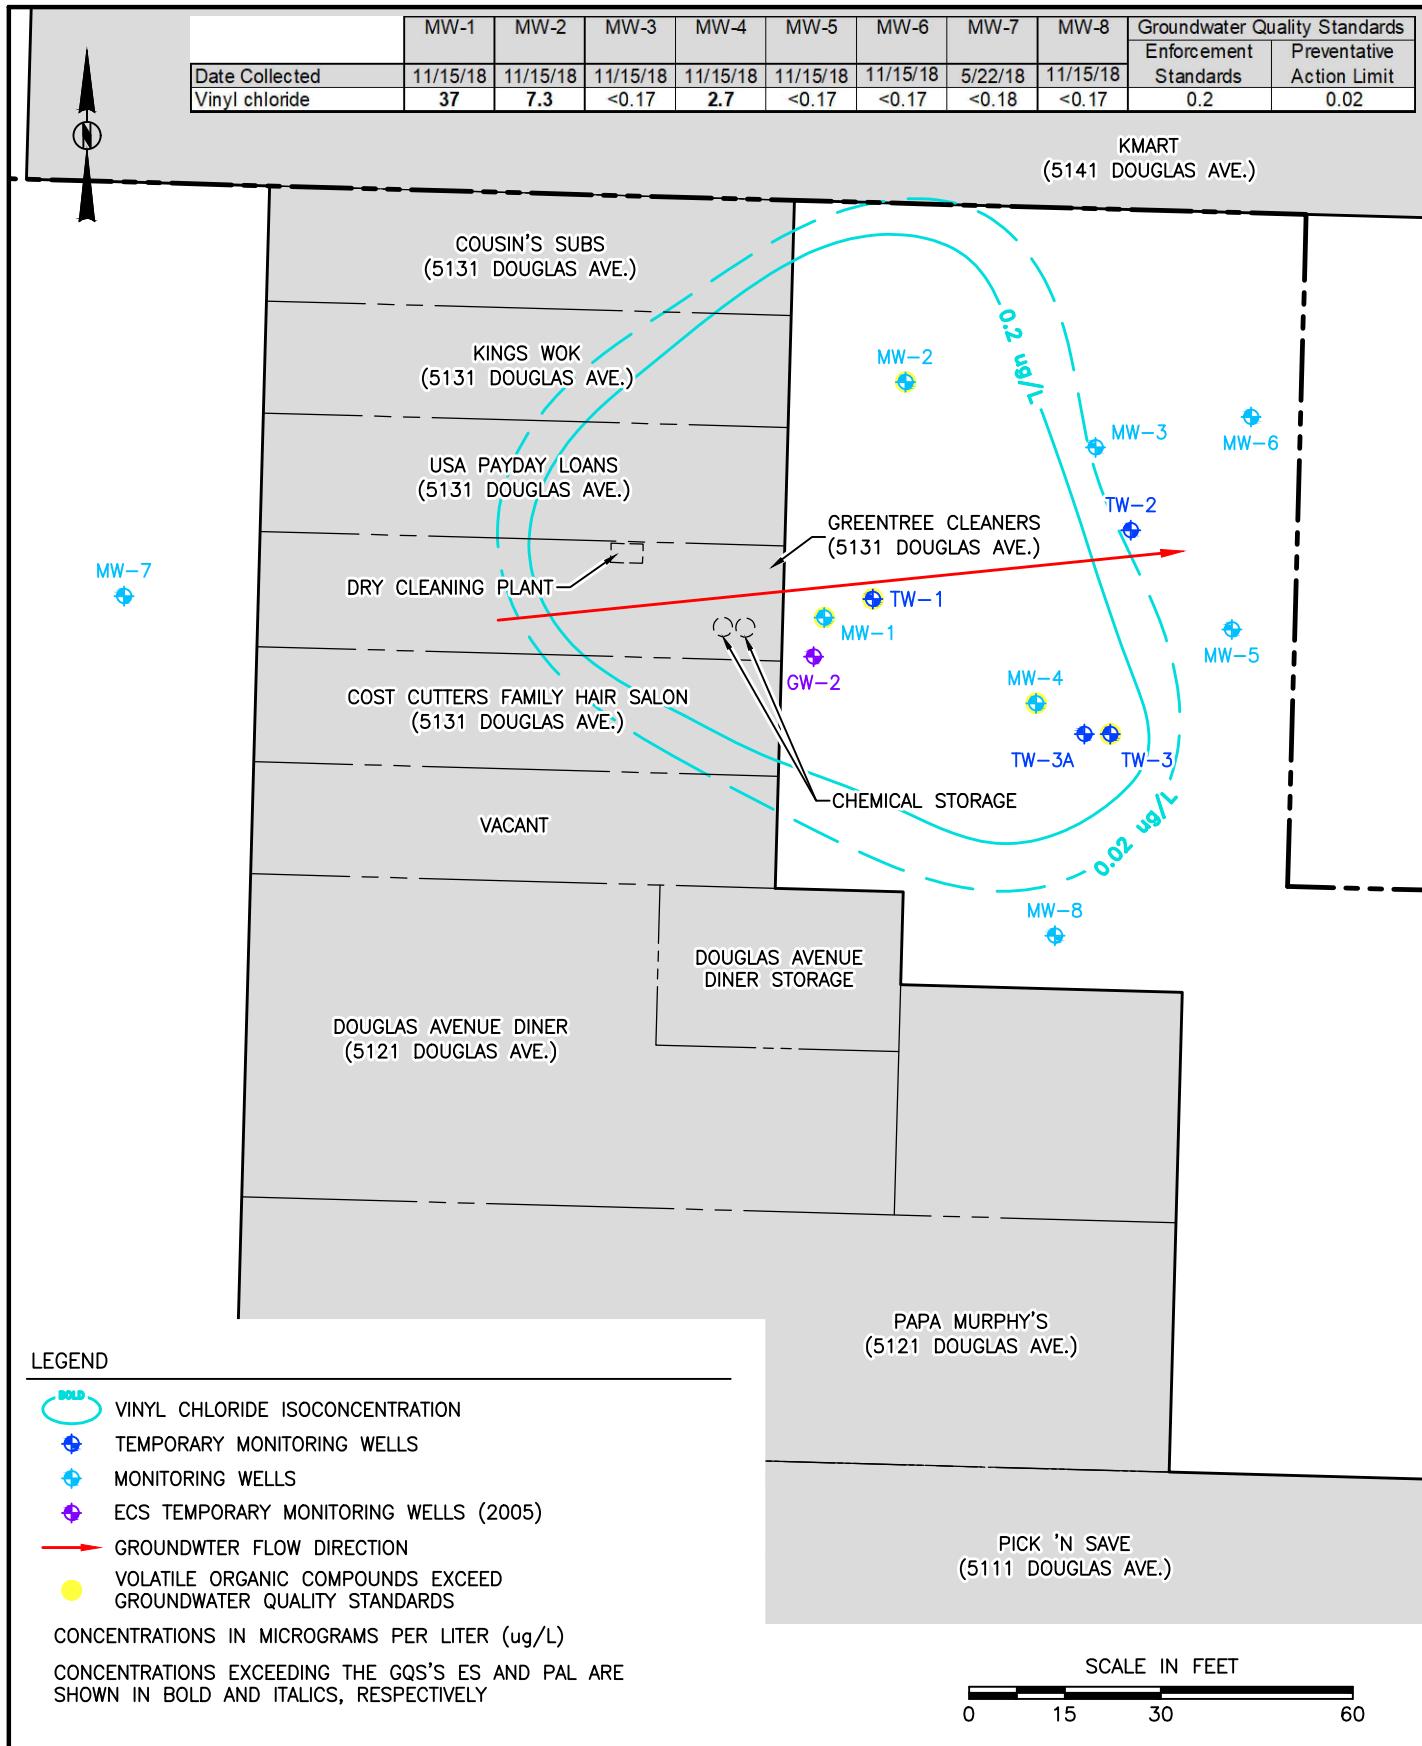
CHECK BY JA	GROUNDWATER ISOCONCENTRATION VINYL CHLORIDE GREENTREE CENTRE 5111 DOUGLAS AVENUE RACINE, WISCONSIN		FIGURE
DRAWN BY EM			B3b4
DATE 04-19-22			
SCALE AS SHOWN			
CAD NO. 2017-100.05[2]			
PRJ NO. PECO_2017-100

In conclusion, the 2018 data indicate that there is degradation of the CVOCs in the groundwater through the destruction of CE and the plume is at a minimum stable; not reaching the east or north property lines. Figure B3b4 has been modified to extend the PAL iso-concentration line to the north property line and Figures B3b1 through B3b4 have been modified to extend the ES iso-concentration to the dry cleaning machine.

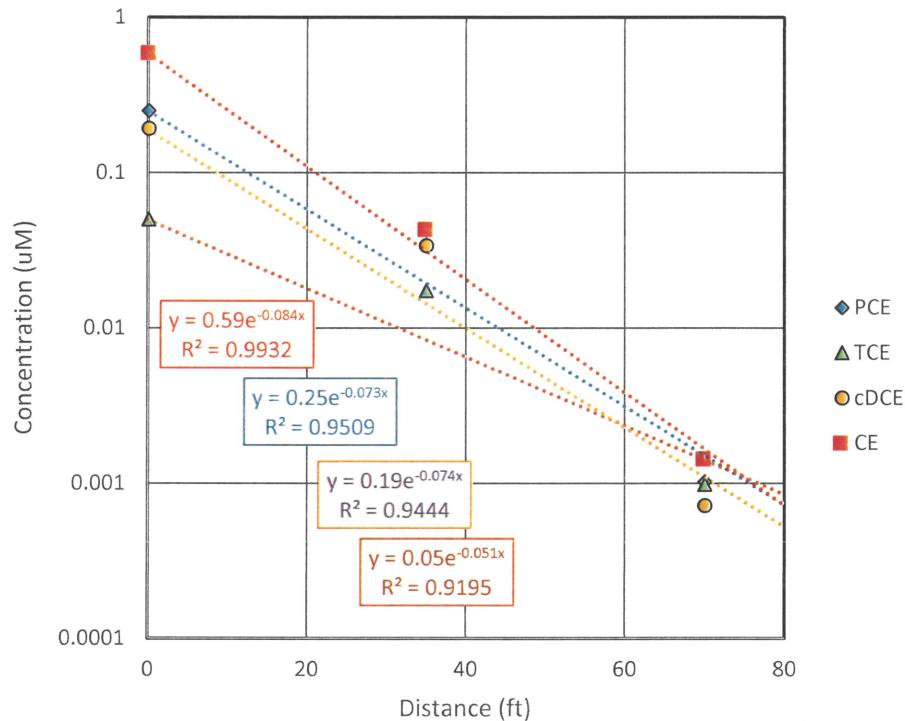
Figure 2. CVOC distance trends. Note that the y-intercept set at the observed MW-1 concentrations.

Monitoring wells MW-1, -4 and -5 approximate a groundwater flow path with travel distances of 0, 35 and 70 feet, respectively. The concentration trends along this flow path for November 2018 are shown on Figure 2. Note that all concentrations at MW-5 were below the laboratory detection limits. The data fit a linear first order rate model:

The calculated concentration decay rates for PCE, TCE, cDCE and CE are 0.073, 0.051, 0.074 and 0.084 per foot, respectively. The decay model supports the trends over time conclusion that the plume is stable and CVOCs are degrading with distance from MW-1 to nondetectable levels by the property line.

The comment regarding MW-2 is assumed to apply to the CE Enforcement Standard since no other CVOCs have been reported at MW-2. The degradation rate per foot for CE from Figure 2 is approximately a factor of ten for every 30 feet of travel while CE is still being produced from the degradation of precursor CVOCs along the flow path between MW-1 and MW-5. Without the addition of CE from precursor degradation (as no precursor CVOCs were observed at MW-2), the rate of CE loss would be higher. Assuming that there is significant transverse migration of CE from the source area to MW-2 through a higher permeability seam, the 30 feet to the north property line would result in more than a 10-fold reduction in CE concentrations since there are no precursor compound to produce more CE. Conservatively assuming a 10-fold decrease would bring the concentration of CE to ~0.7 µg/L. Given the decreasing CE trend at MW-2 and the underestimation of degradation rate considering no CE production from degradation of precursor CVOCs, it appears unlikely that the 0.2 µg/L Enforcement Standard would reach the north property line. Placing the PAL line at the north property boundary is adequately conservative.
