GILES ENGINEERING OSSOCIATES, INC.

Subject: Request for Technical Assistance Meeting

Pershing Plaza Shopping Center

7536 Pershing Boulevard Kenosha, Wisconsin

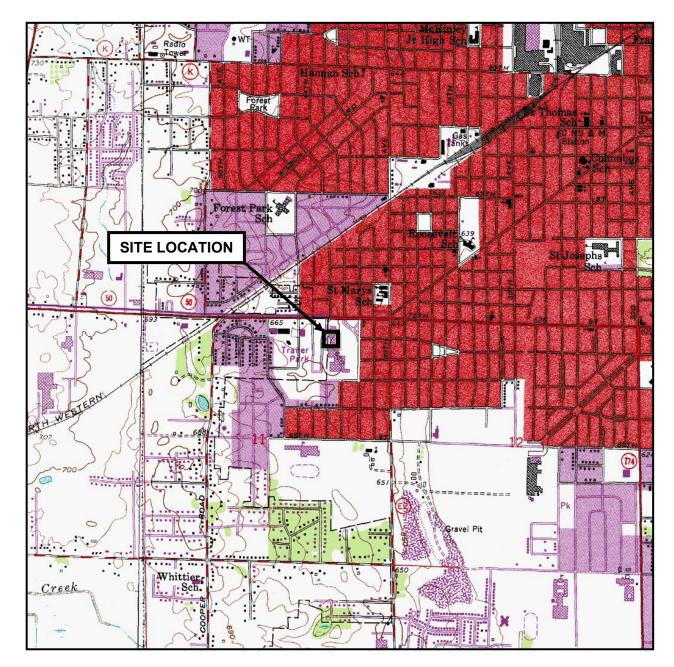
FIGURE 1

Source: USGS *Kenosha, Wisconsin* 7.5-Minute Series (topographic) Quadrangle Map (1958, revised 1971)

Scale: 1:24,000 Contour Interval: 10 Feet

SITE LOCATION MAP
