Case Closure

Site Information								
BRRTS No.	VPLE No.							
02-13-583171								
Parcel ID No.								
154/0610-032-4510-1								
FID No.	WTM Coordinates							
	X Y	202727						
BRRTS Activity (Site) Name	576796 WTM Coordinates Represent:	282637						
	·							
Best Way Cleaners Site Address		cel Center State ZIP Code						
	City							
5914 State Highway 51	McFarland	WI 53558						
Acres Ready For Use	1							
	1							
Responsible Party (RP) Name

Best Way Cleaners

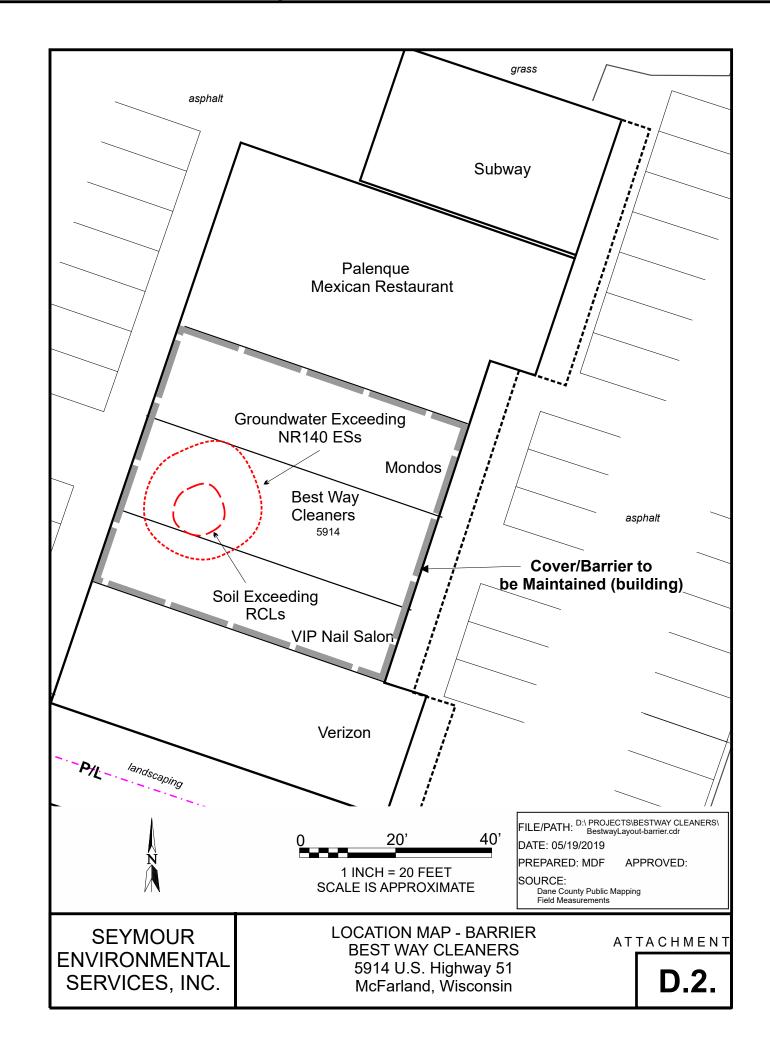
VIEW LOOKING WEST SOUTHWEST

Barrier to be Maintained (Building)

The building floor slab over the contaminated soil serve as a barrier to act as a partial infiltration barrier to minimize future soil-to-groundwater contamination migration that would violate the groundwater standards in ch. NR 140, Wisconsin Administrative Code. Based on the current use of the property for commercial activities the barrier should function as intended unless disturbed.

The barriers overlying the contaminated soil and groundwater as depicted in Attachment D.2. will be inspected once a year, normally in the spring after all snow and ice is gone, for deterioration, cracks and other potential problems that can cause additional infiltration into or exposure to underlying soils. The inspections will be performed by the property owner or their designated representative. The inspections will be performed to evaluate damage due to settling, exposure to the weather, wear from traffic, increasing age and other factors. Any area where soils have become or are likely to become exposed and/or where infiltration from the surface will not be effectively minimized will be documented.

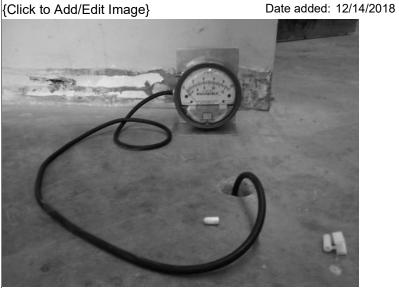
Title: Vapor Probe showing induced vacuum (0.2 inch water)

This document is a Maintenance Plan for an active vapor mitigation system installed at the site to protect against inhalation exposure at the above-referenced property in accordance with the requirements of s. NR 724.13(2), Wisconsin Administrative Code. Elevated levels of chlorinated volatile organic compounds were identified in vapors beneath the building floor slab at the location of a former dry cleaning extractor machine. The contaminant levels noted in the sub-slab vapors exceeded the acceptable screening levels for small commercial building. The maintenance activities relate a sub-slab depressurization system installed in the location of the former dry cleaning equipment.
