SUBJECT: Case Closure with Continuing Obligations
Best Way Cleaners, 5914 Highway 51, McFarland, WI 53558
BRRTS #: 02-13-583171

FIGURE D.2(2)
 LOCATION MAP (VAPOR MITIGATION SYSTEM MAINTENANCE PLAN)
 FORMER BEST WAY CLEANERS
 5914 HIGHWAY 51
 McFARLAND, WISCONSIN

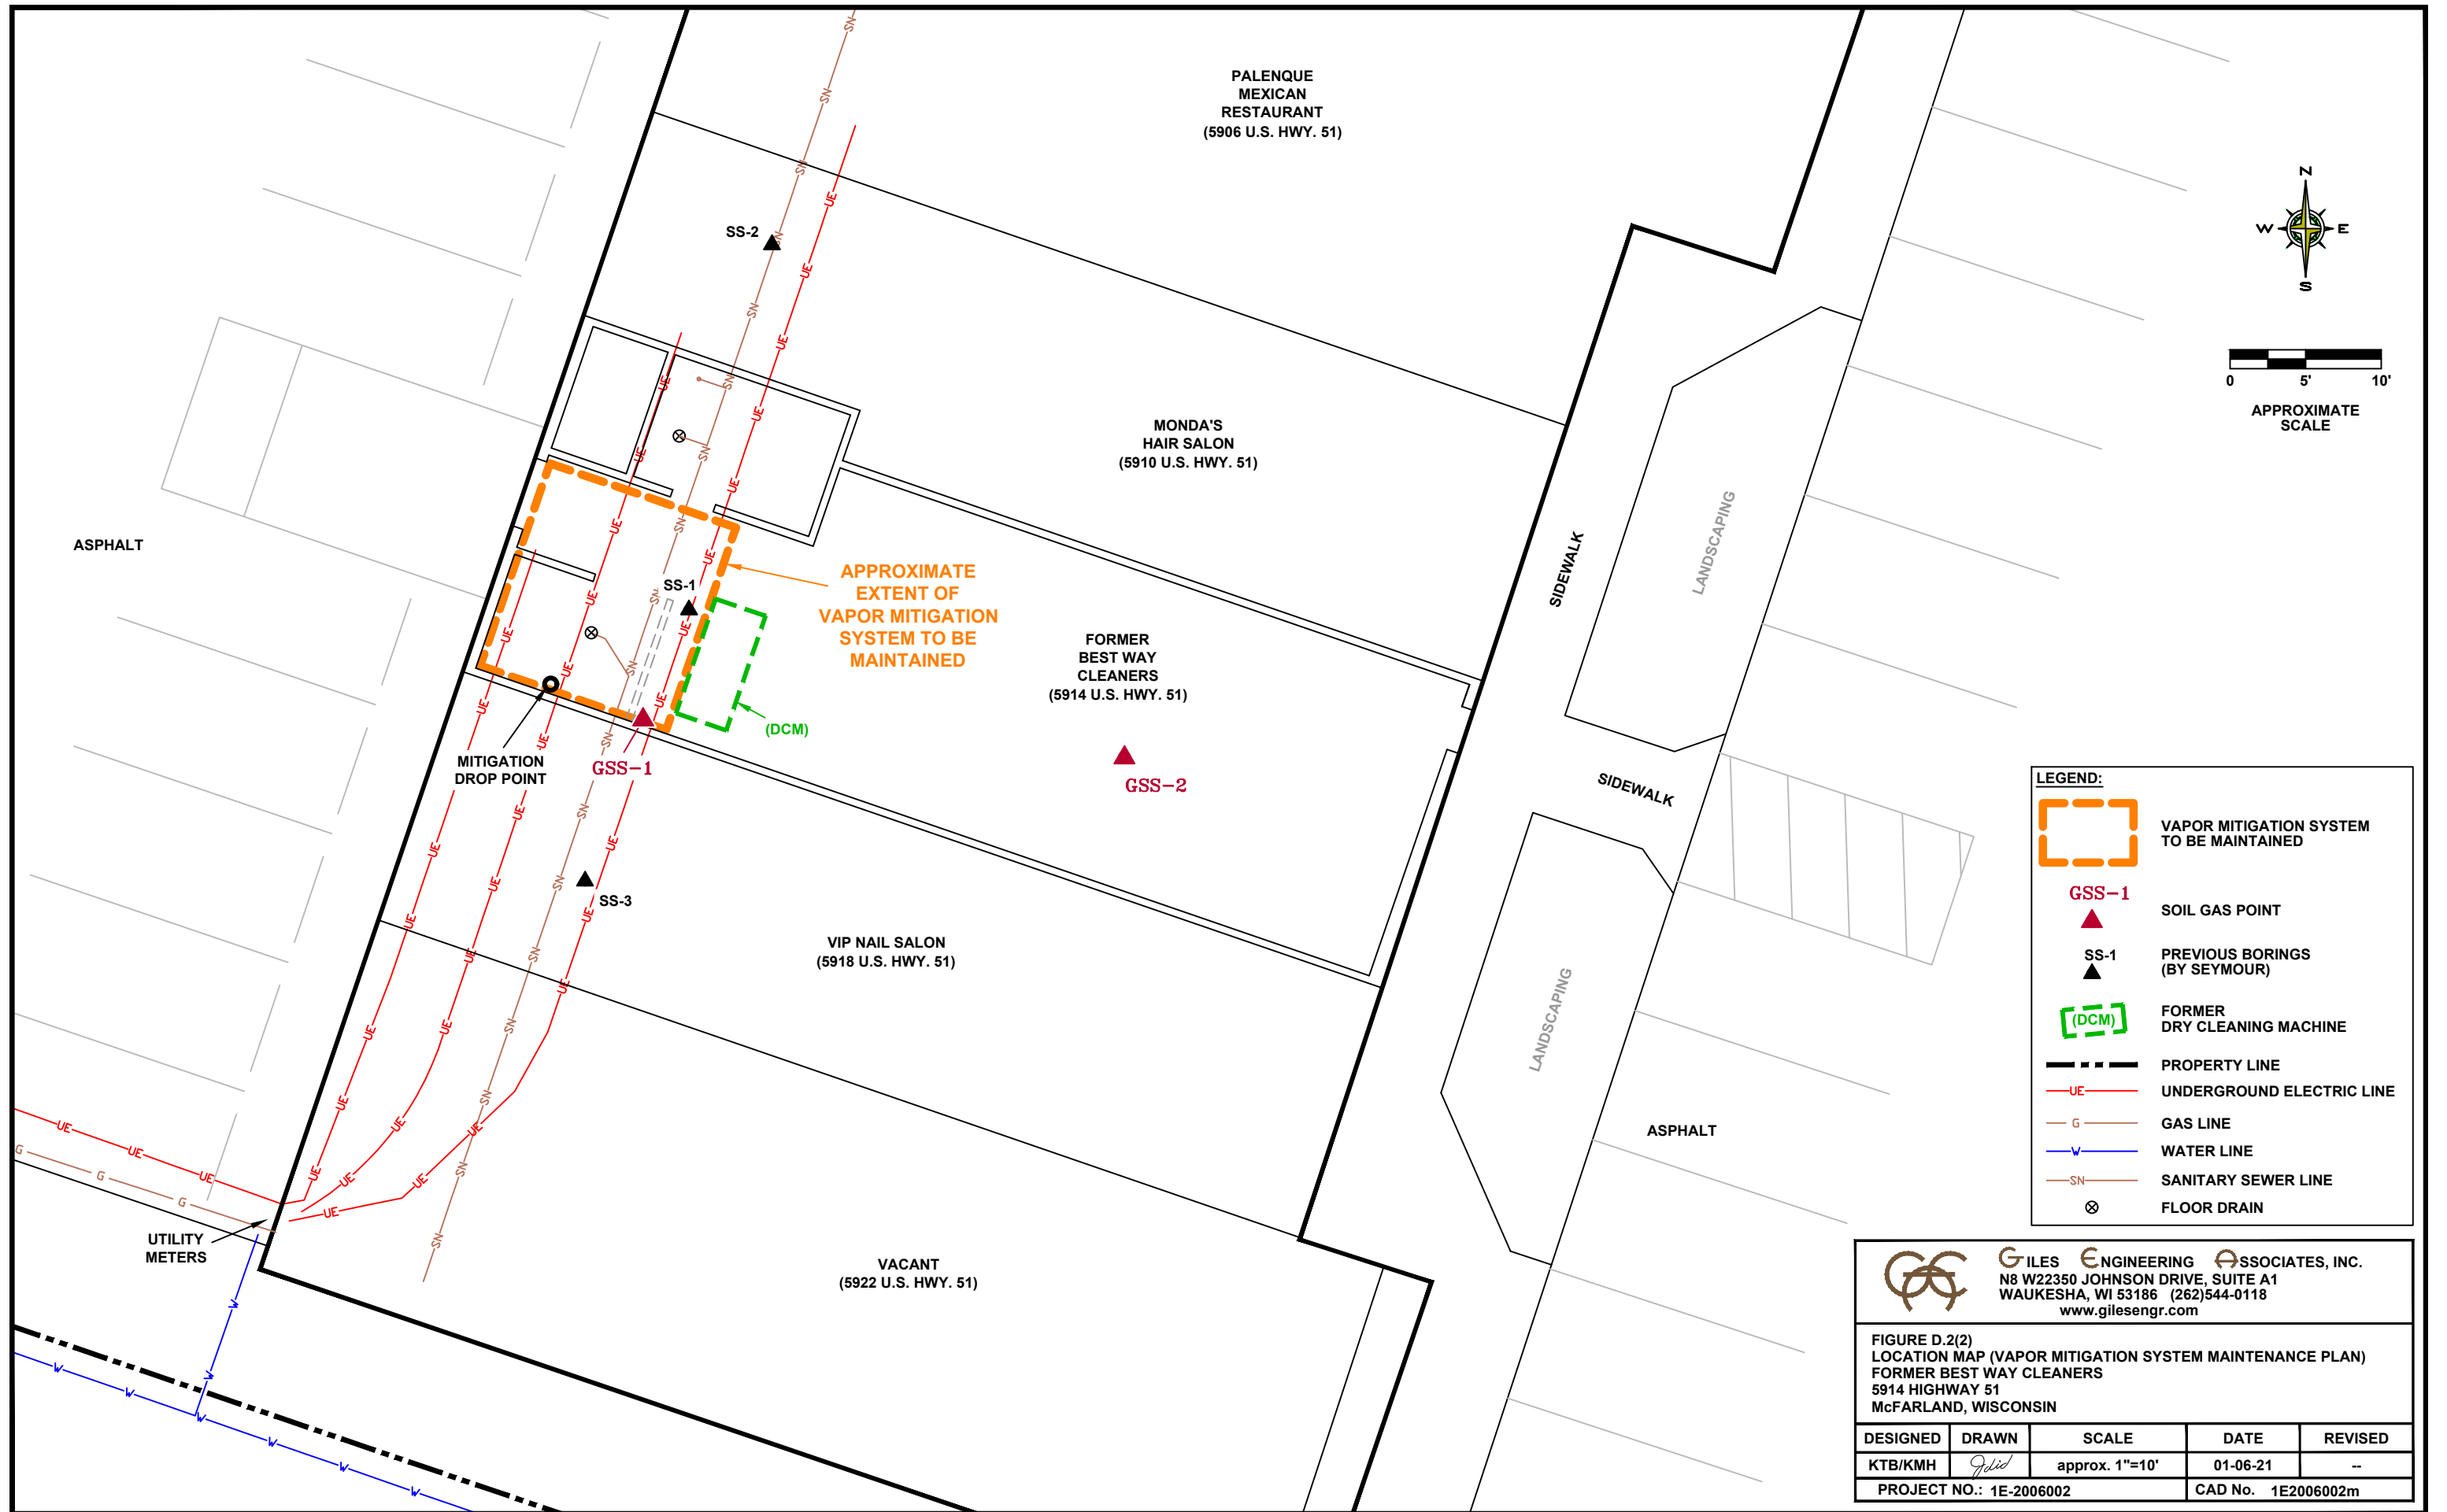
The sub-slab depressurization system consists of a roof-mounted ventilation blower, a drop point within the source unit (former Best Way Cleaners), and connective piping. The drop point is located near the source of the impacted soil gas, the former DCM. The point penetrates the building's approximately 6-inch thick floor slab and terminates within the underlying base course material. The blower creates a negative pressure beneath the floor slab to reduce the potential for sub-slab vapors to infiltrate the building. Vapors extracted by the system are vented to the atmosphere through stacks located on the roof of the existing building.

Vapor is mitigated with a sub-slab depressurization system installed in the west end of the former Best Way Cleaners tenant space; the system uses a blower to move collected vapors through connective piping to a roof-mounted vent pipe. The property owner must maintain, operate, and inspect the vapor mitigation system, installed in December 2018, in accordance with the enclosed maintenance plan, dated December 2020. System components must be repaired or replaced immediately upon discovery of a malfunction. The property owner must document inspections on the VMS inspection log (Form 4400-321). See the Other Closure Requirements section of this letter for more details.

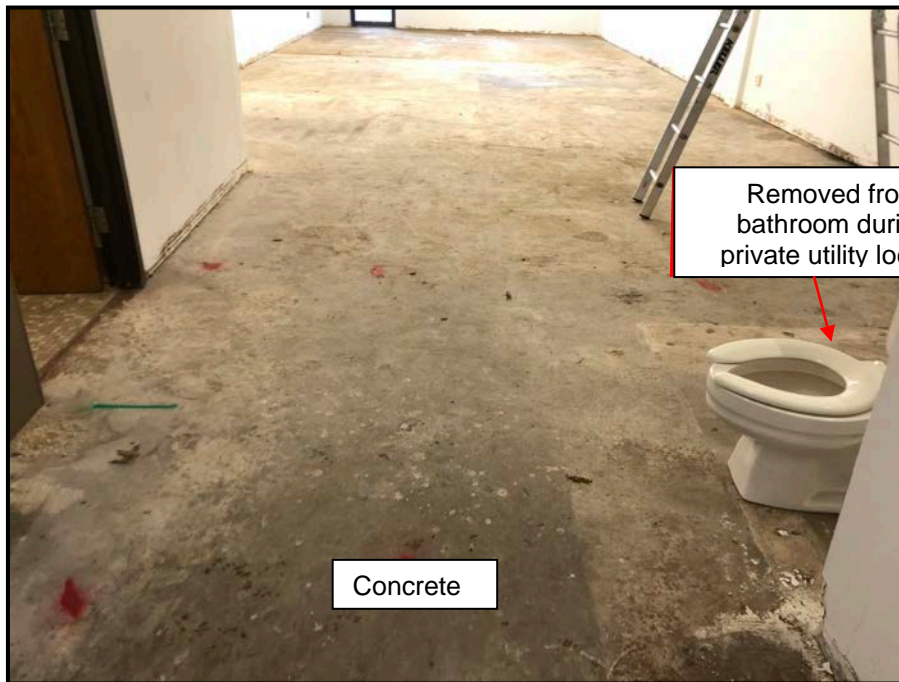
View of the interior of source unit and typical concrete floor to be maintained, facing east.

The contamination is limited to the vicinity of the former DCM that had been located within the Best Way Cleaners lease space. Therefore, the cap consists of the concrete floor slab of the existing shopping center building that overlies the contaminated soil. The floor slab over the area of residual VOC contamination is approximately 6-inch thick and will act as a cap to protect against direct contact with the contaminated soil, and act as an infiltration barrier. Based on the current commercial use of the property, the cap should function as intended unless disturbed.

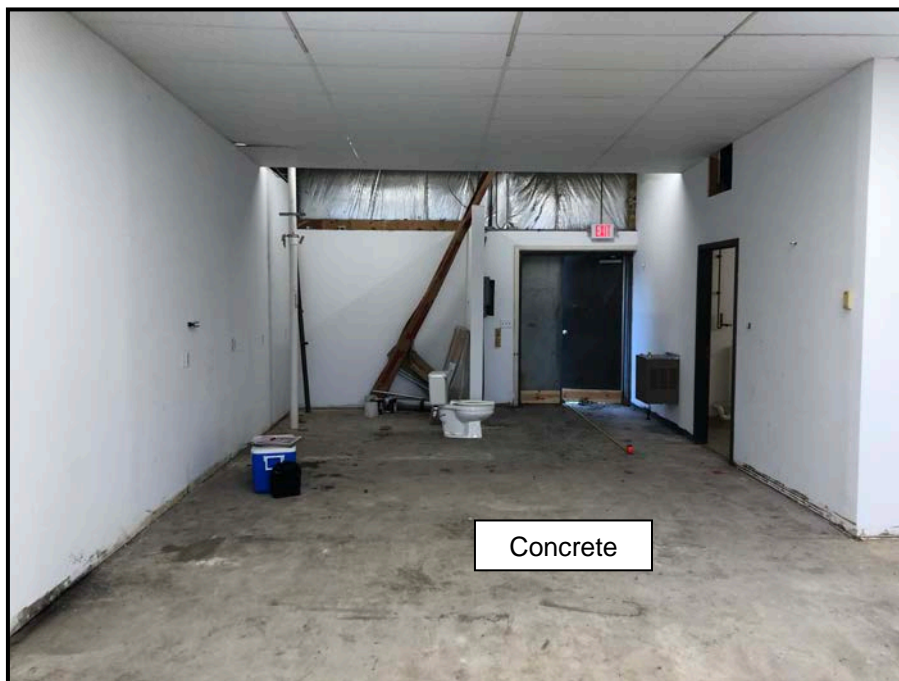
View of the interior of source unit and typical concrete floor to be maintained, facing west.

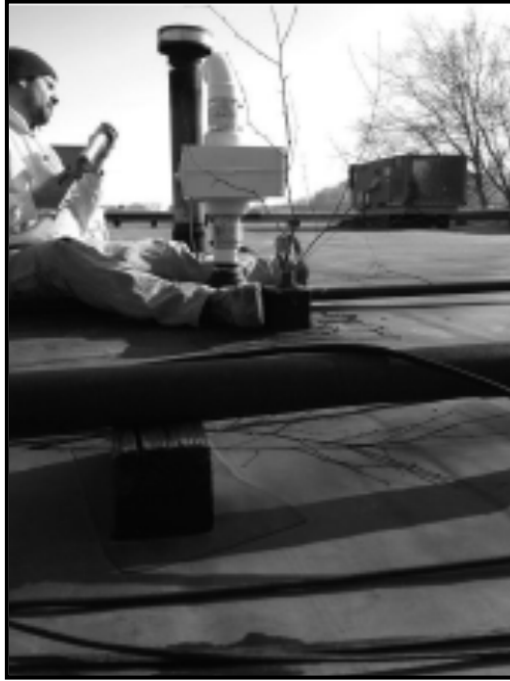
View of the roof-mounted ventilation blower.

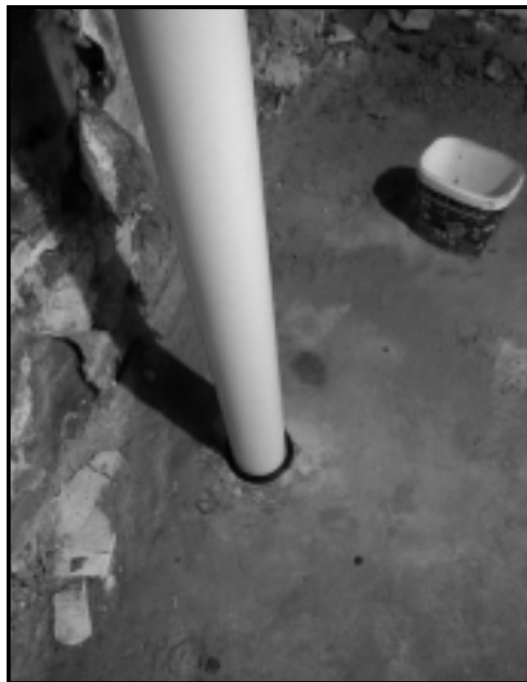
View of the mitigation system piping penetrating the concrete floor slab.

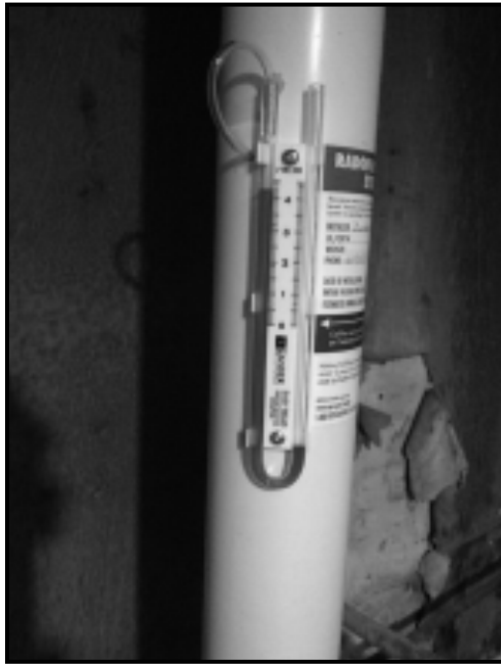
View of the manometer reading 4 inches of water.

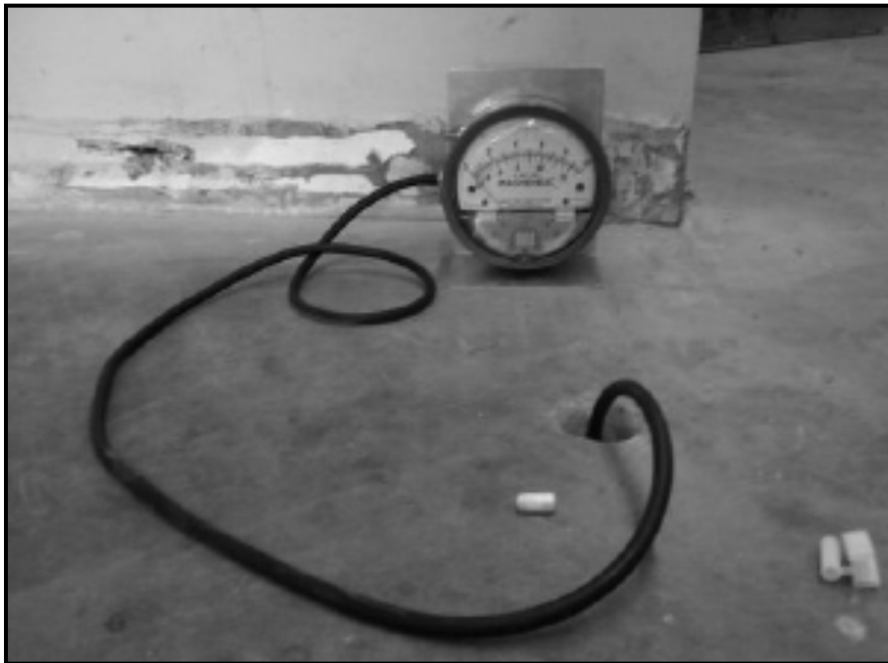
View of a manometer reading at SS-1 showing negative pressure of 0.2 inches of water.

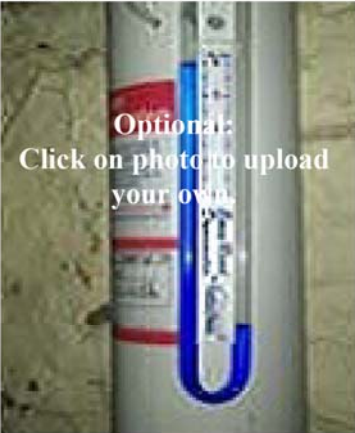
SYSTEM COMPONENT		DATE:		
NAME	WHAT DOES IT DO?	WHAT DO I CHECK?	WHAT SHOULD I SEE?	WHAT TO FIX?
Manometer or Differential Pressure Gauge	Measures differential pressure between vacuum side of vent pipe and indoor space. This measurement confirms there is a vacuum being pulled by the fan.	Liquid Level on Manometer or Gauge	Liquid level in manometer should be offset (not level with each other).	A change in liquid level indicates a change in the vacuum below foundation. This could be caused by failure of fan, blockage of vent pipe, change in water level below building, or other conditions. Hire a professional to identify cause and repair if needed.
PHOTO

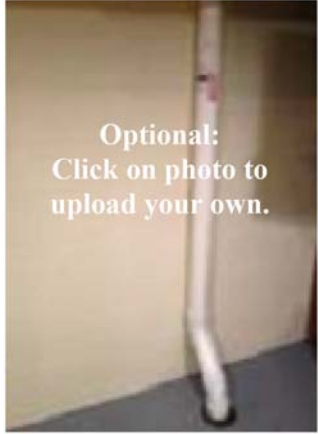
SYSTEM COMPONENT		WHAT DO I CHECK?	WHAT SHOULD I SEE?	DATE:
NAME	WHAT DOES IT DO?			WHAT TO FIX?
Suction Drop Point w/ Vent Pipe		Suction Point Seal Vent Pipe Condition	Seal is air tight around pipe penetration. Vent pipe is connected to fan, has not cracked.	Suction point seal or vent pipe may need to be sealed or replaced if cracks or leaks appear. If any piping or sealing of the system is altered or replaced, the system should be evaluated by a mitigation professional to verify effectiveness, which includes pressure readings.
PHOTO

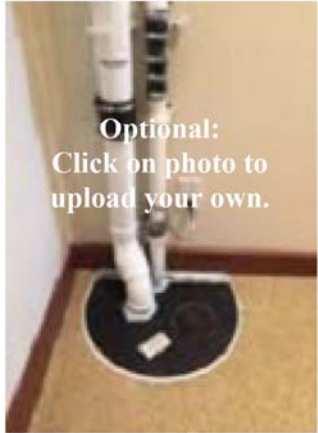
<p>Optional: Click on photo to upload your own.</p>		NOTES: (Identify specific building and location description:) <input type="checkbox"/> Not Applicable		
Sealed Sump w/Vent Pipe		Suction Point Seal Vent Pipe Seal Condition	Seal is airtight to floor. Vent pipe is connected to the sump cover and is not cracked.	Sump cover or vent pipe may need to be sealed or replaced if cracks or leaks appear. If any piping or sealing of the system is altered or replaced, the system should be evaluated by a plumber or a mitigation professional to verify effectiveness, which includes pressure readings.

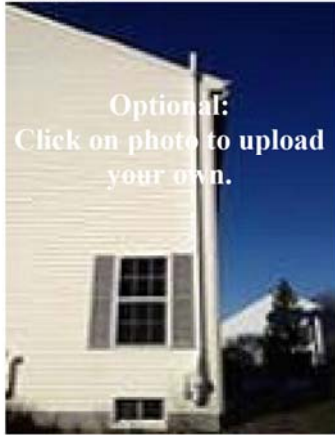
SYSTEM COMPONENT	WHAT DOES IT DO?	WHAT DO I CHECK?	WHAT SHOULD I SEE?	DATE:
NAME				WHAT TO FIX?
Outdoor Vent Pipe	Pipe transports the soil gas from beneath the foundation for discharge to the atmosphere.	Vent Pipe Condition Vent Pipe Location	Vent pipe remains connected to fan. End of pipe free from obstructions. The exhaust is more than 15 feet from windows or air intakes.	Vent pipe may require replacement, or cleaning to remove ice or debris. If any piping or sealing of the system is altered or replaced, the system should be evaluated by a mitigation professional to verify effectiveness, which includes pressure readings.

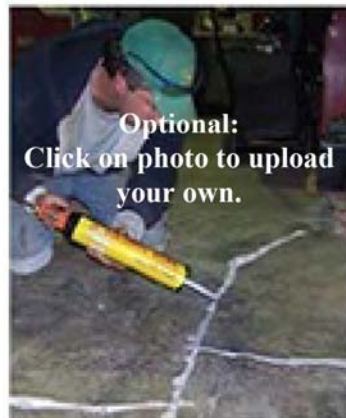
Foundation Floor	Foundation is a barrier that minimizes soil gas entry into building, and helps fan to work efficiently.	Foundation Condition Foundation Footprint	No penetrating cracks or holes in foundation. Check if there have been alterations or additions to building or footprint.	Seal cracks or other penetrations as you would to prevent water from entering. If building floor plan has changed, notify DNR and contact a mitigation professional to evaluate if modifications to the vapor mitigation system are necessary.
-------------------------	---	--	--	---

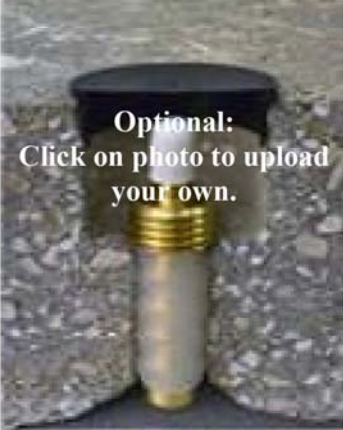
SYSTEM COMPONENT				DATE:
NAME	WHAT DOES IT DO?	WHAT DO I CHECK?	WHAT SHOULD I SEE?	WHAT TO FIX?
Sub Slab Vapor Port	This is a sample port to measure vacuum or take sample of soil gas if needed. It needs to remain sealed when not in use to prevent soil gas entry into the home.	Port Seal/Cap	If able to measure the vacuum with a micromanometer, the pressure differential should be at least 0.004 inches of H ₂ O or at least one Pascal.	Repair or replace the seal and cover as needed.
		Port Condition	Port is sealed and capped when not in use.	Permanently seal hole if sample port is ever removed.
PHOTO			<p>NOTES: (If taken, record the pressure differential reading. Identify specific building and location description:)</p> <p><input type="checkbox"/> Not Applicable</p>
