**From:** Richard Mazurkiewicz <RMAZURKIEWICZ@ramboll.com>  
**Sent:** Friday, April 15, 2022 2:15 PM  
**To:** Rice, Caroline M - DNR  
**Cc:** mommamitchell@charter.net; Jeanne Tarvin  
**Subject:** Email Work Plan - 1305 North Johns Street - BRRTS NO. 02-25-587099  
**Attachments:** F1- NAPA Inside Borings.pdf

Ramboll US Consulting, Inc. (Ramboll) submits this additional site investigation work plan for proposed investigation activities at the Trace-Mitchell Real Estate, LLC property located at 1305 North Johns Street, Dodgeville, Iowa County, Wisconsin (the "site").

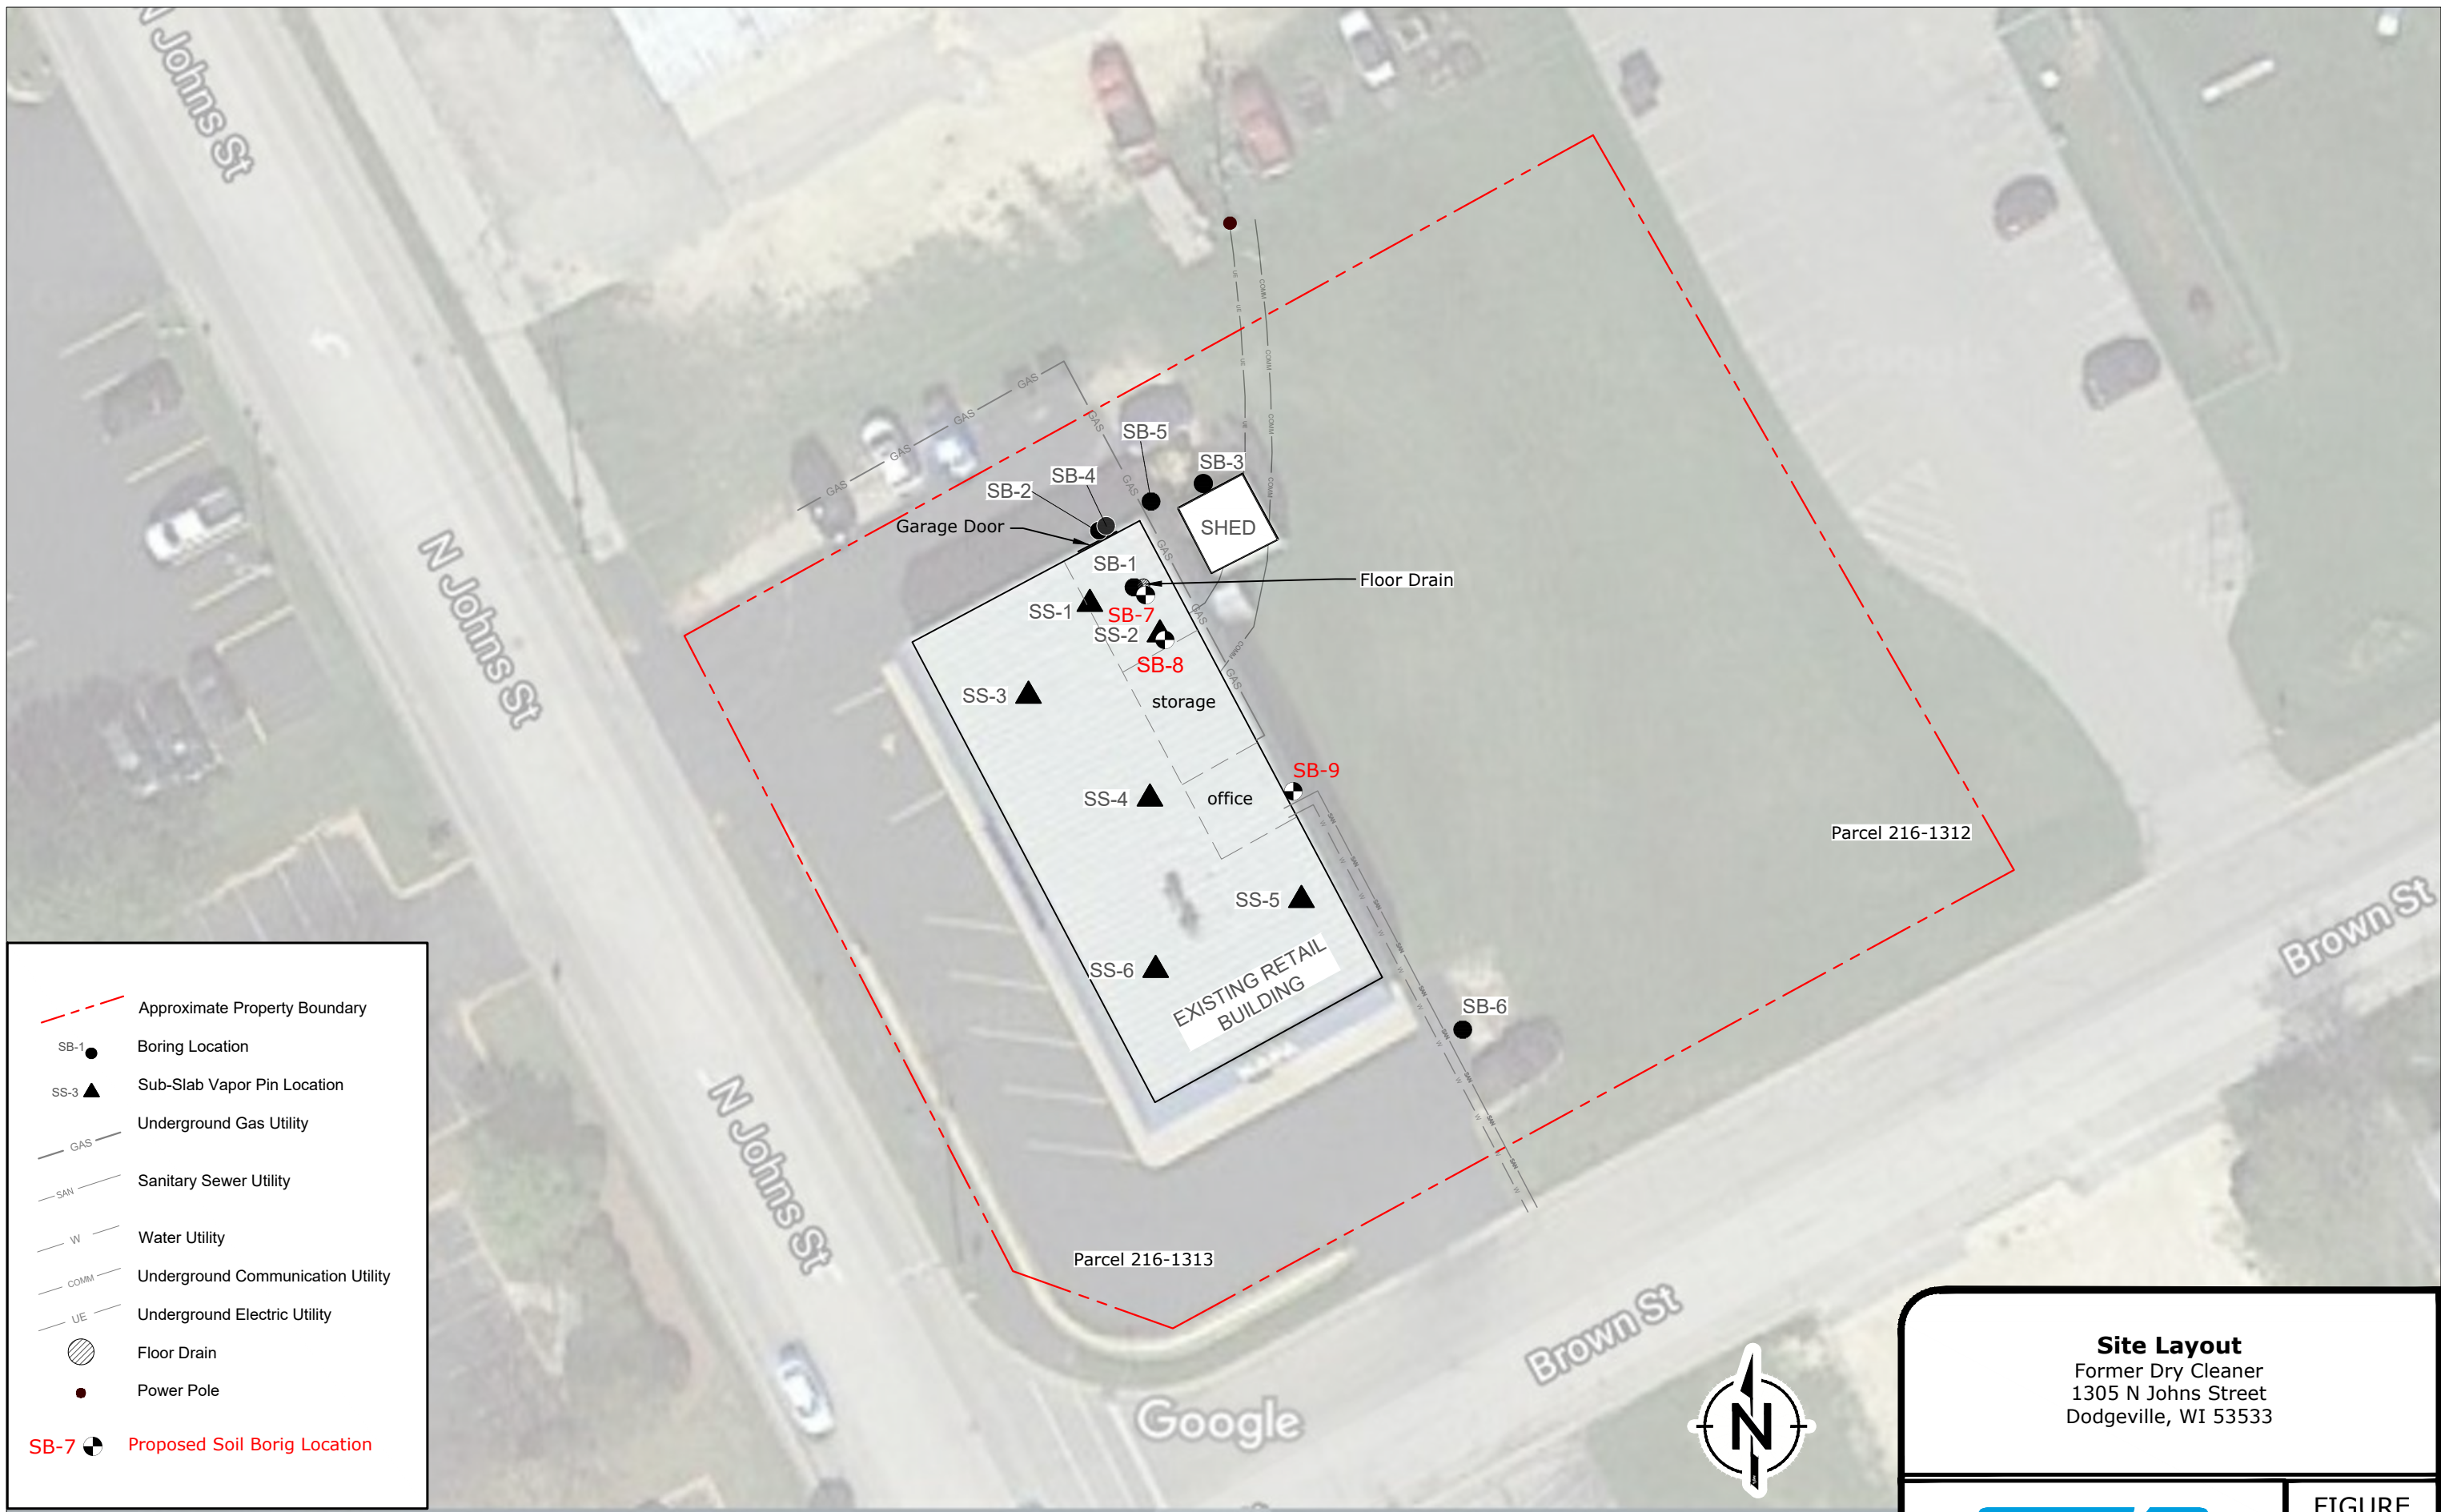
<b>Site Layout</b> Former Dry Cleaner 1305 N Johns Street Dodgeville, WI 53533	
	<b>FIGURE 1</b>
DRAFTED BY: rpm	DATE: 04/08/2022

Approximate Property Boundary
SB-1 ●	Boring Location
SS-3 ▲	Sub-Slab Vapor Pin Location
	Underground Gas Utility
	Sanitary Sewer Utility
	Water Utility
	Underground Communication Utility
	Underground Electric Utility
	Floor Drain
●	Power Pole
SB-7 ●	Proposed Soil Borig Location

Please find the following work plan for the subject site. Refer to the attached **Figure 1** for the proposed sampling locations presented herein.

Ramboll proposes to advance three soil borings (SB-7, SB-8, and SB-9) to 20 feet bgs, or to bedrock (whichever is encountered first). The locations of the proposed soil borings are depicted in **Figure 1**. Before mobilization for drilling activities, Diggers Hotline will be contacted to mark out public utility locations on the site. Ramboll will also contract with a private utility locator to clear any on-site
