**Stantec Consulting Services Inc.**  
12080 Corporate Parkway, Suite 200  
Mequon WI 53092-2661

December 2, 2022  
File: 193707141

**Reference: Response to Request for Additional Information #2; Materials Management Plan and Ch. NR 718 Exemption Request for C. Reiss Coal Dock Property, Superior, Wisconsin, BRRTS Case No. 02-16-589248**

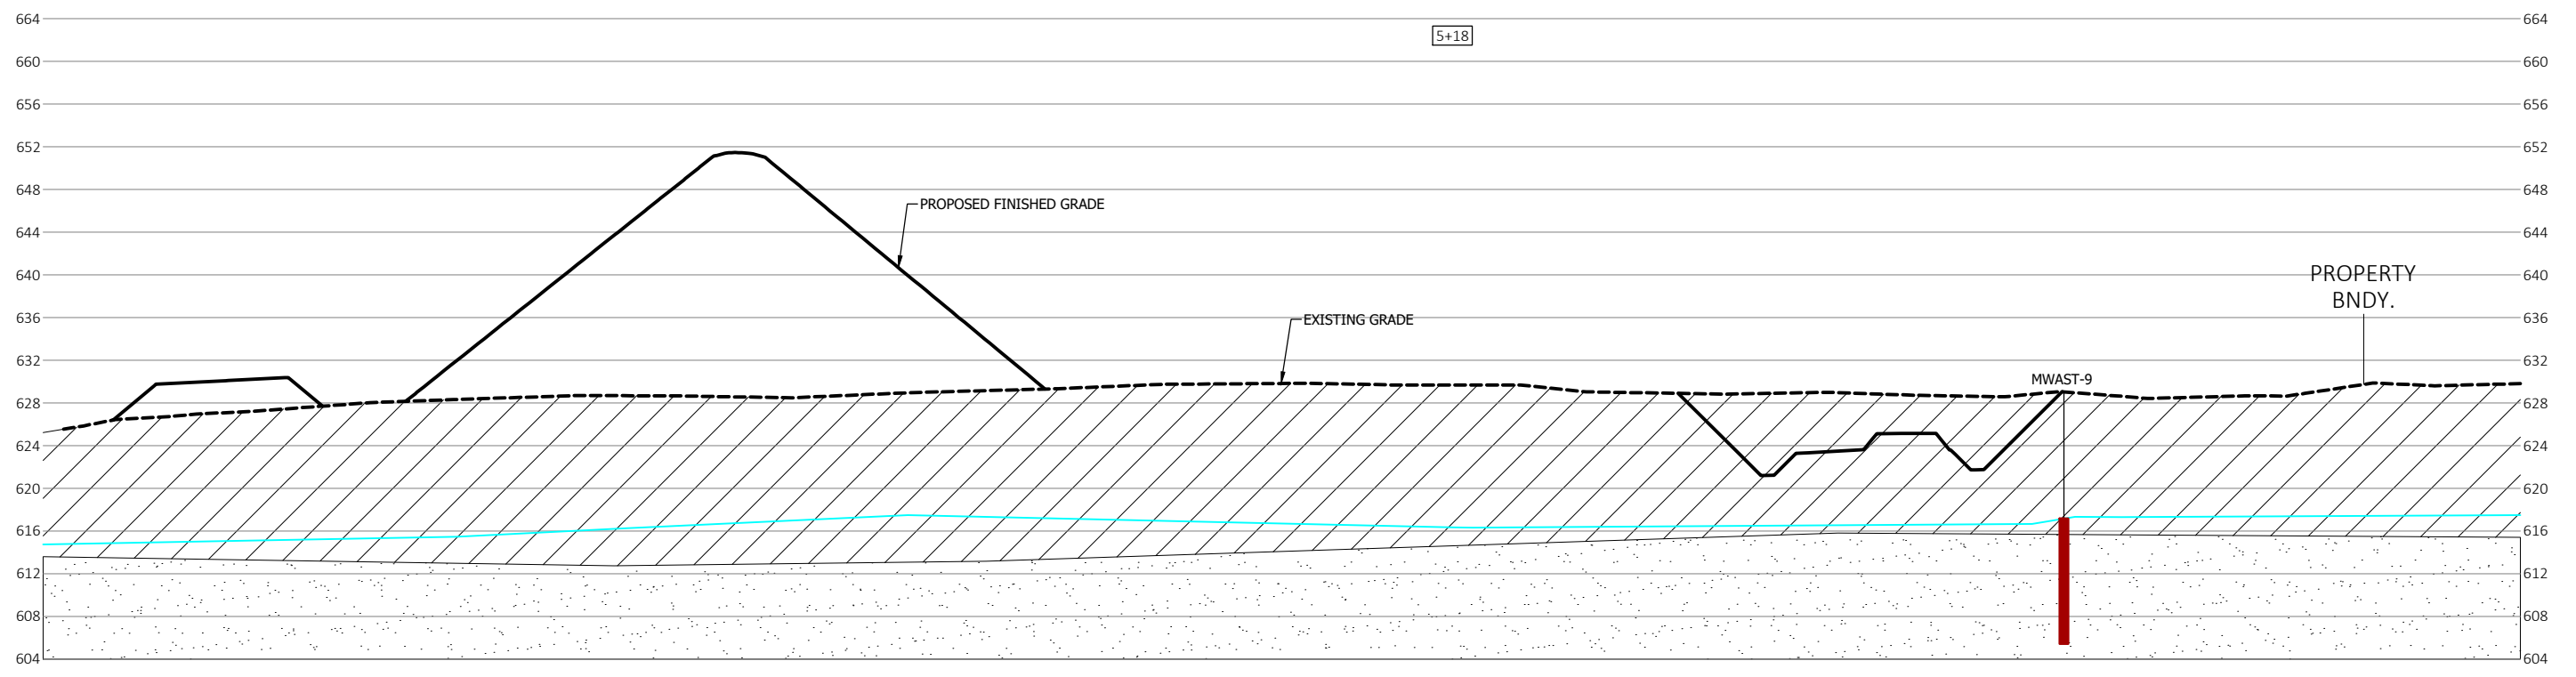
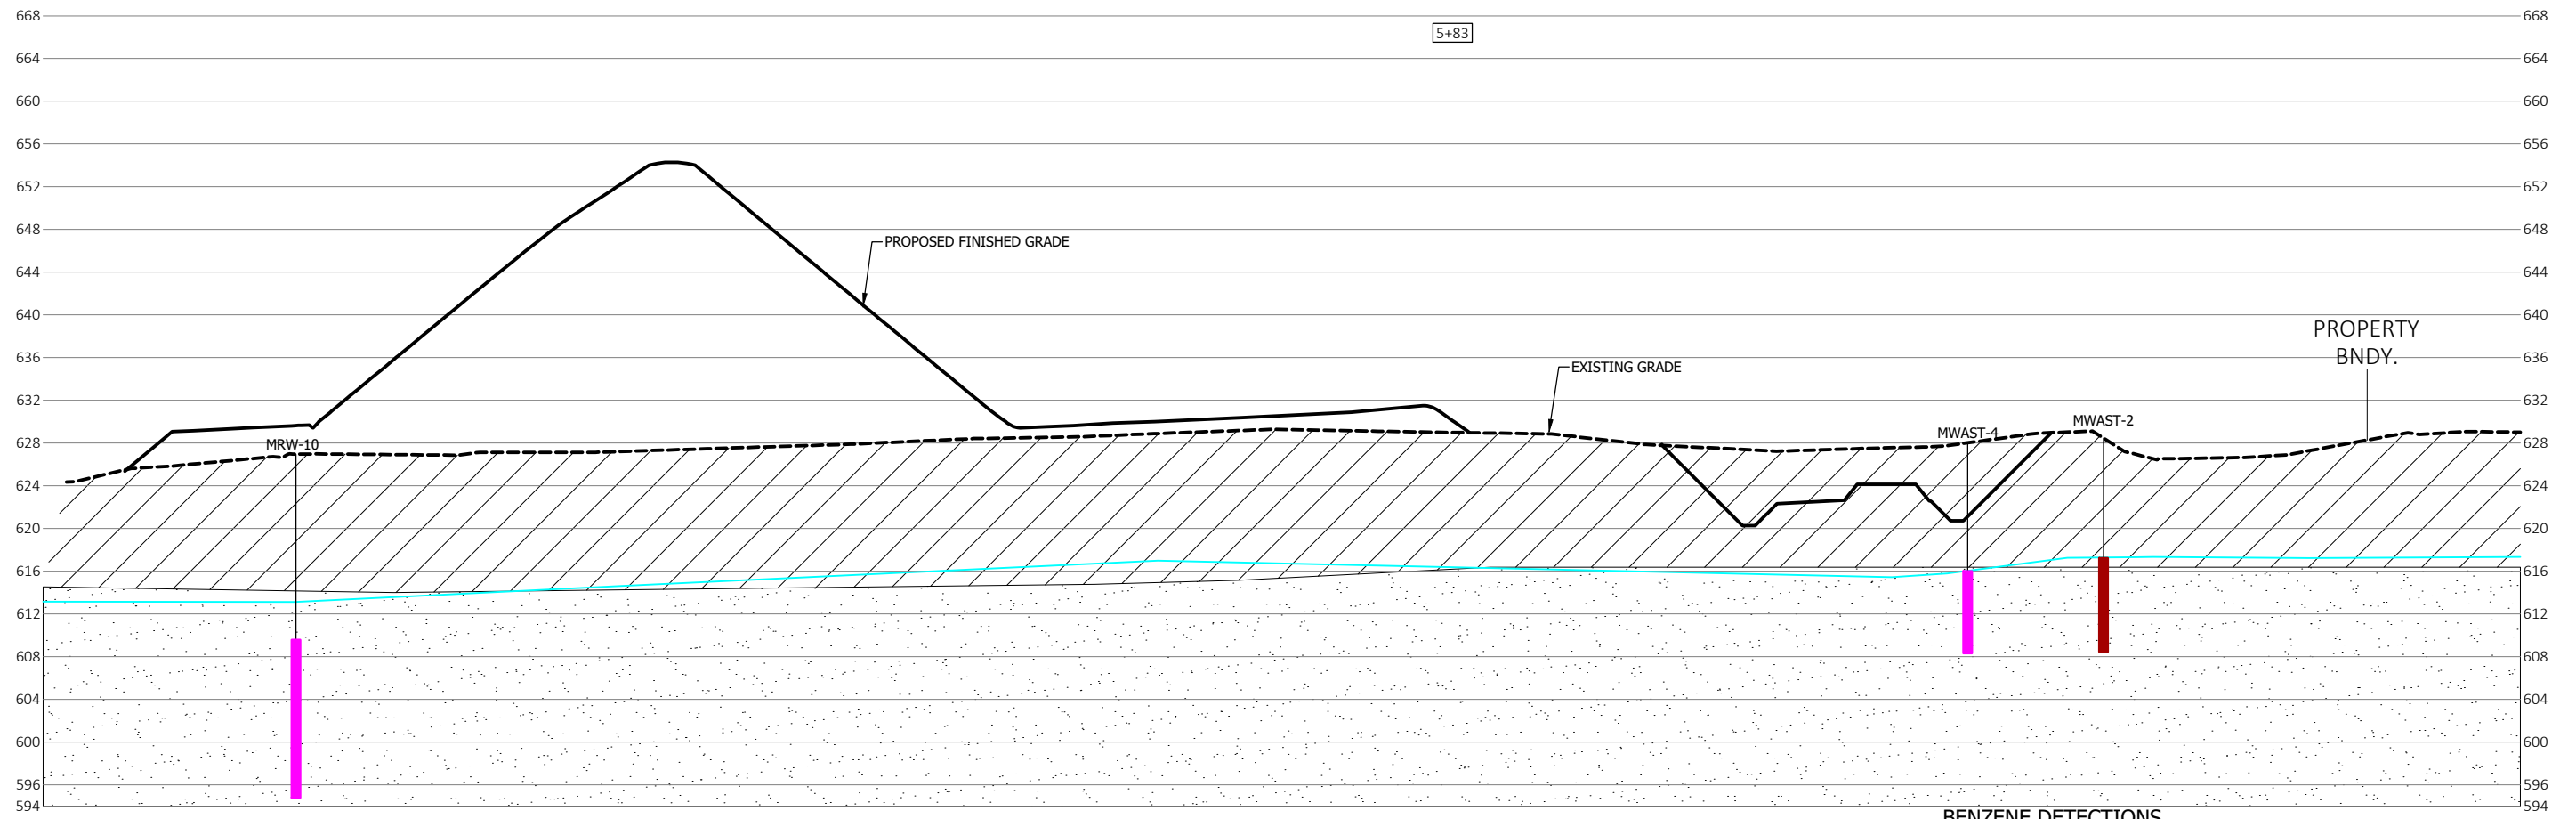
SHEET NUMBER  
**FIG. 8C**

— APPROXIMATE GROUNDWATER TABLE

CLAY

SAND/SILTY SAND

**BENZENE DETECTIONS**

**Contaminated Groundwater/LNAPL.** As previously discussed in Response #20 of the Stantec (2022b) *Response to Request for Additional Information*, the maximum depth of cut is above the groundwater table across the majority of the Property. The exceptions to this are in areas of deepest excavation on the Property corresponding to the proposed stormwater pond and portions of the railroad cut east of the stormwater pond. No LNAPL or contaminated groundwater is anticipated to be encountered as part of proposed Property excavations, including in the areas where the groundwater table will be intercepted (Station 9+78 through Station 19+50 on **Figures 7 and 8**). As later mentioned in Response #3, **Figures 7 and 8** have been updated to include groundwater quality information on the east-adjointing (upgradient) property, and include relevant laser induced fluorescence (LIF) data in areas near proposed excavations on the Property as part of construction. This information provides evidence that the LNAPL plumes present along the east-adjointing property (north of the “finger plume”) are limited in nature and are not anticipated to impact proposed Property excavations (refer to cross sections represented by Stations 9+78, 11+75, 13+73, and 21+20 on **Figure 8**).

**Clay unit.** The cross sections provided on **Figure 8** have been updated to illustrate the approximate depth/thickness of the clay unit present across the Property and depth of the underlying sand/silty sand based on available lithologic information collected by Stantec and others (AET, Antea Group

[Antea] to date. As illustrated on **Figure 8**, the maximum depth of cut is above the clay/sand interface for the majority of proposed Property redevelopment. The only areas where the proposed excavations will breach the clay unit and extend approximately 1 to 1.5 feet into the underlying sand/silty sand are at Stations 11+75 and 15+10. This area is far north of the LNAPL finger plume, and west of the smaller LNAPL plumes on the east-adjointing Property which (as discussed above) are limited in nature and not anticipated to impact proposed property excavations. Therefore, no mobilization of LNAPL or contaminated groundwater is anticipated as part of proposed Property excavations.

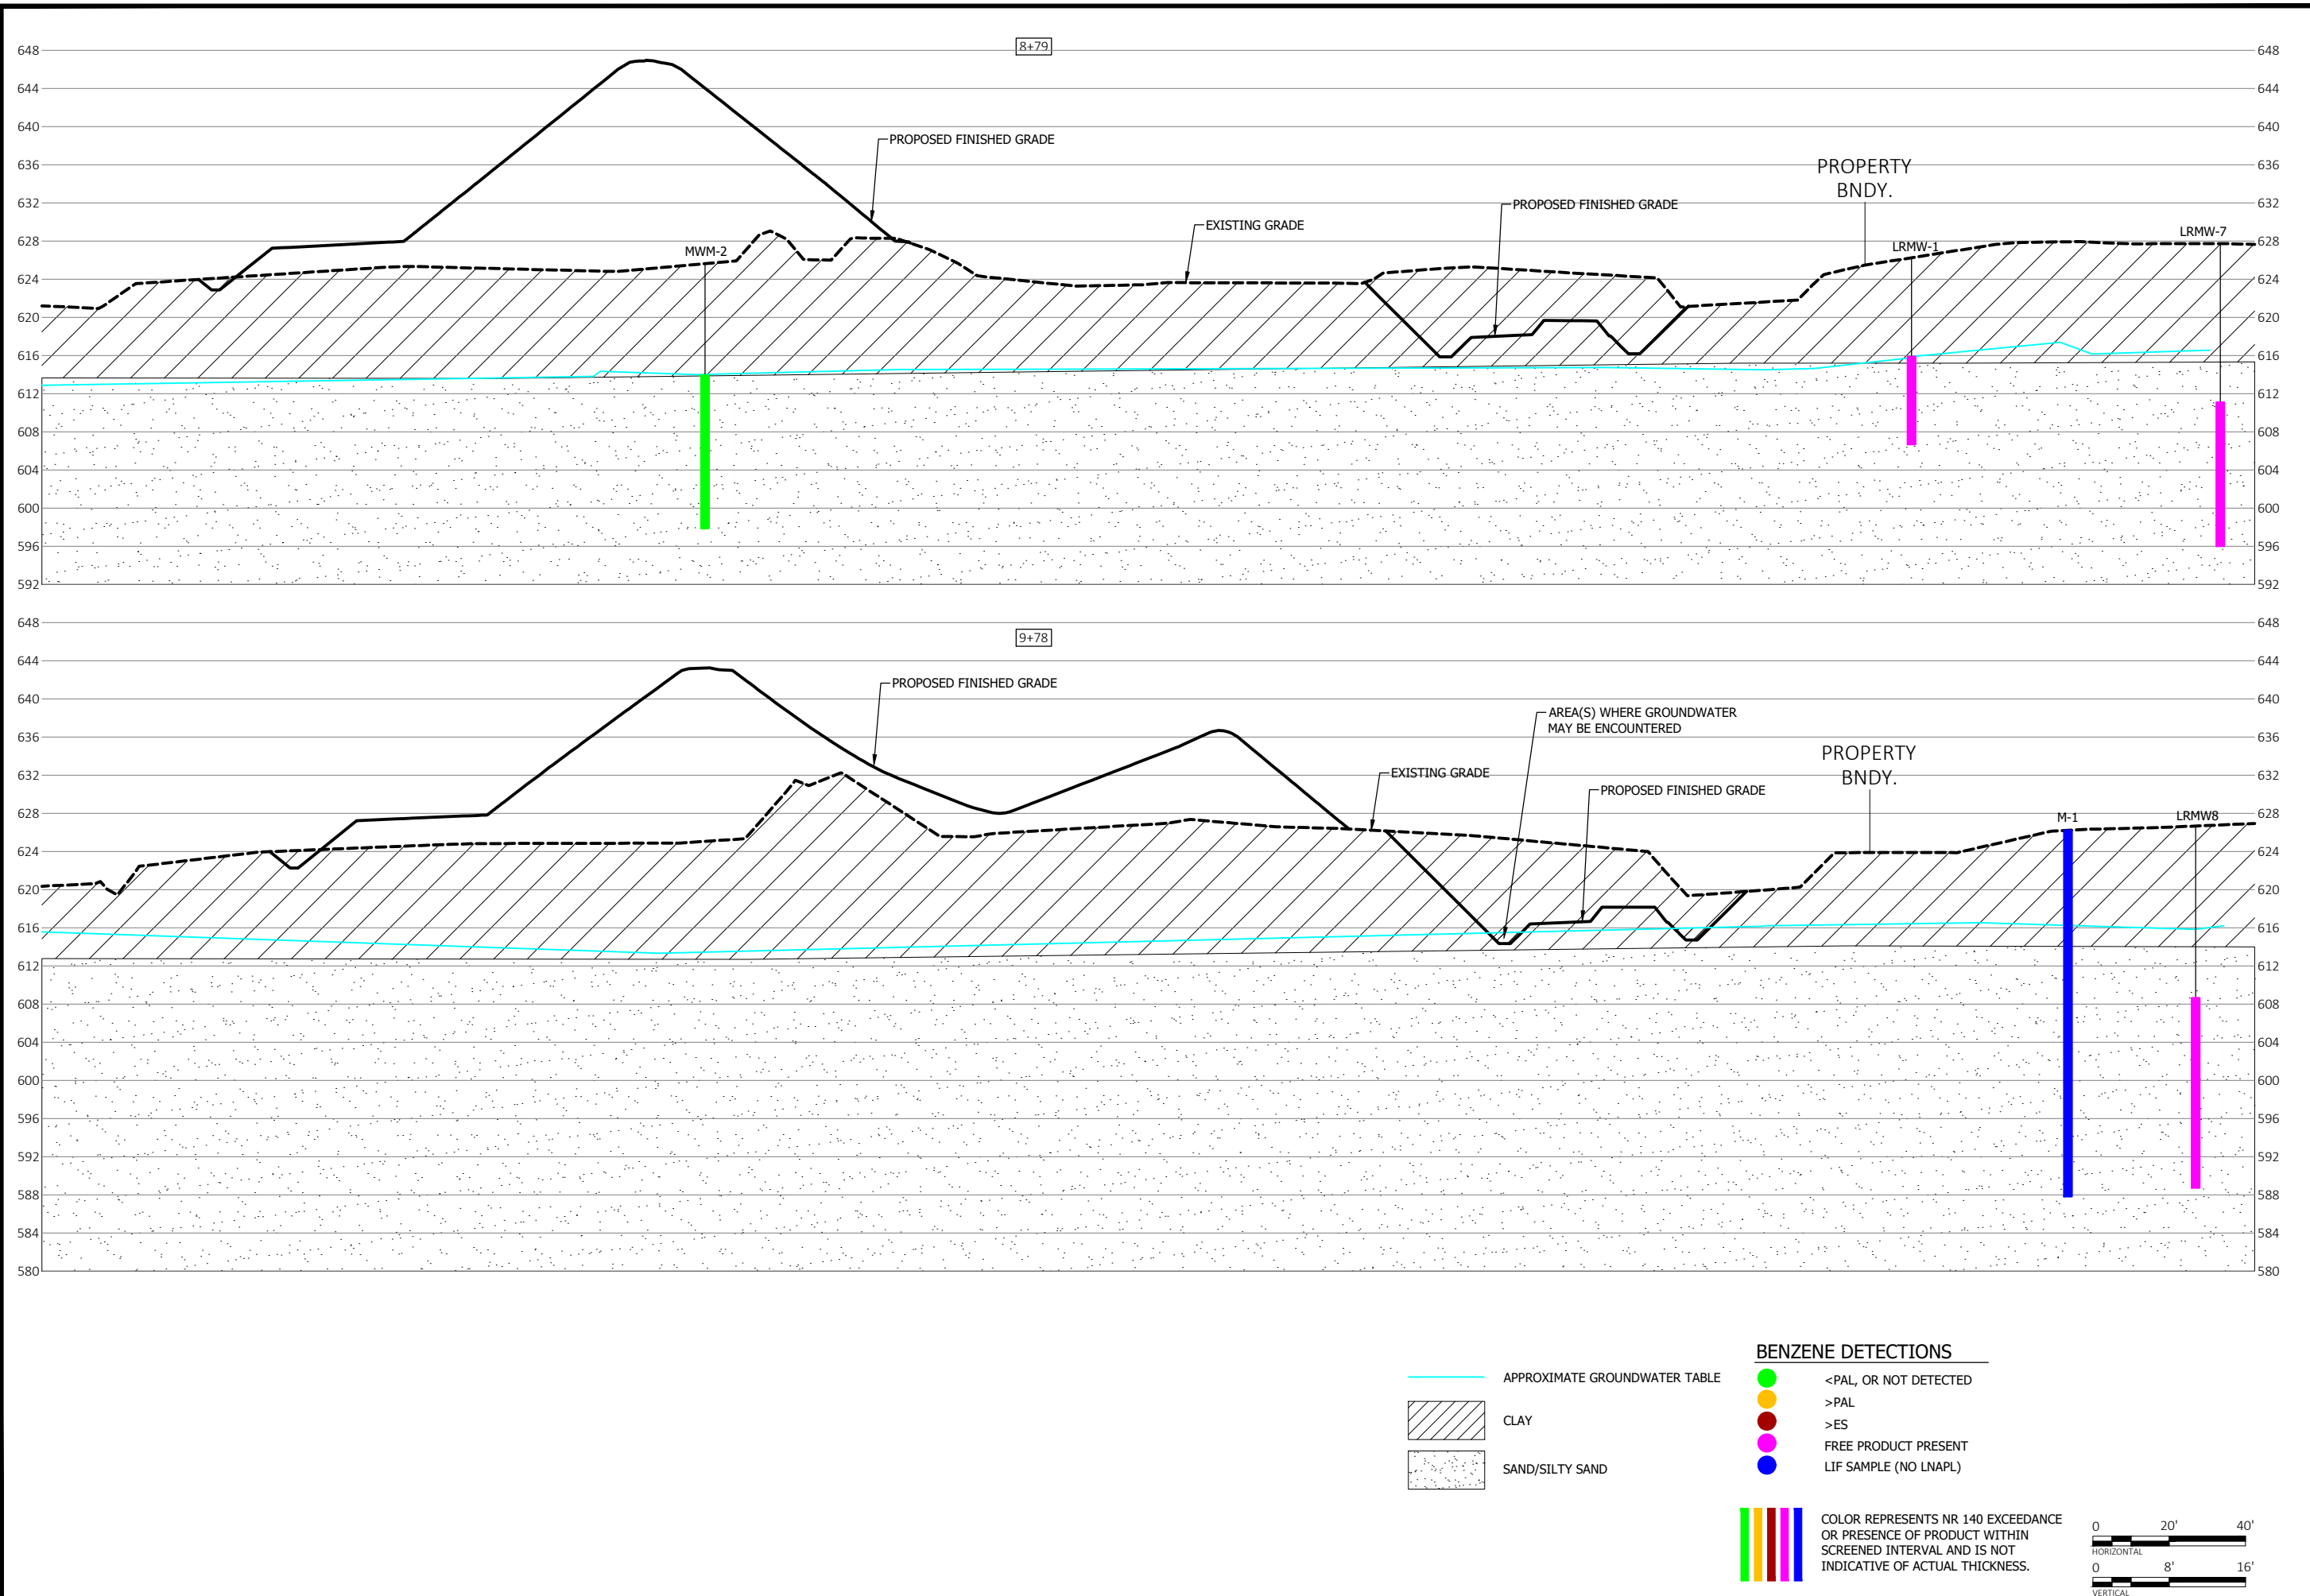
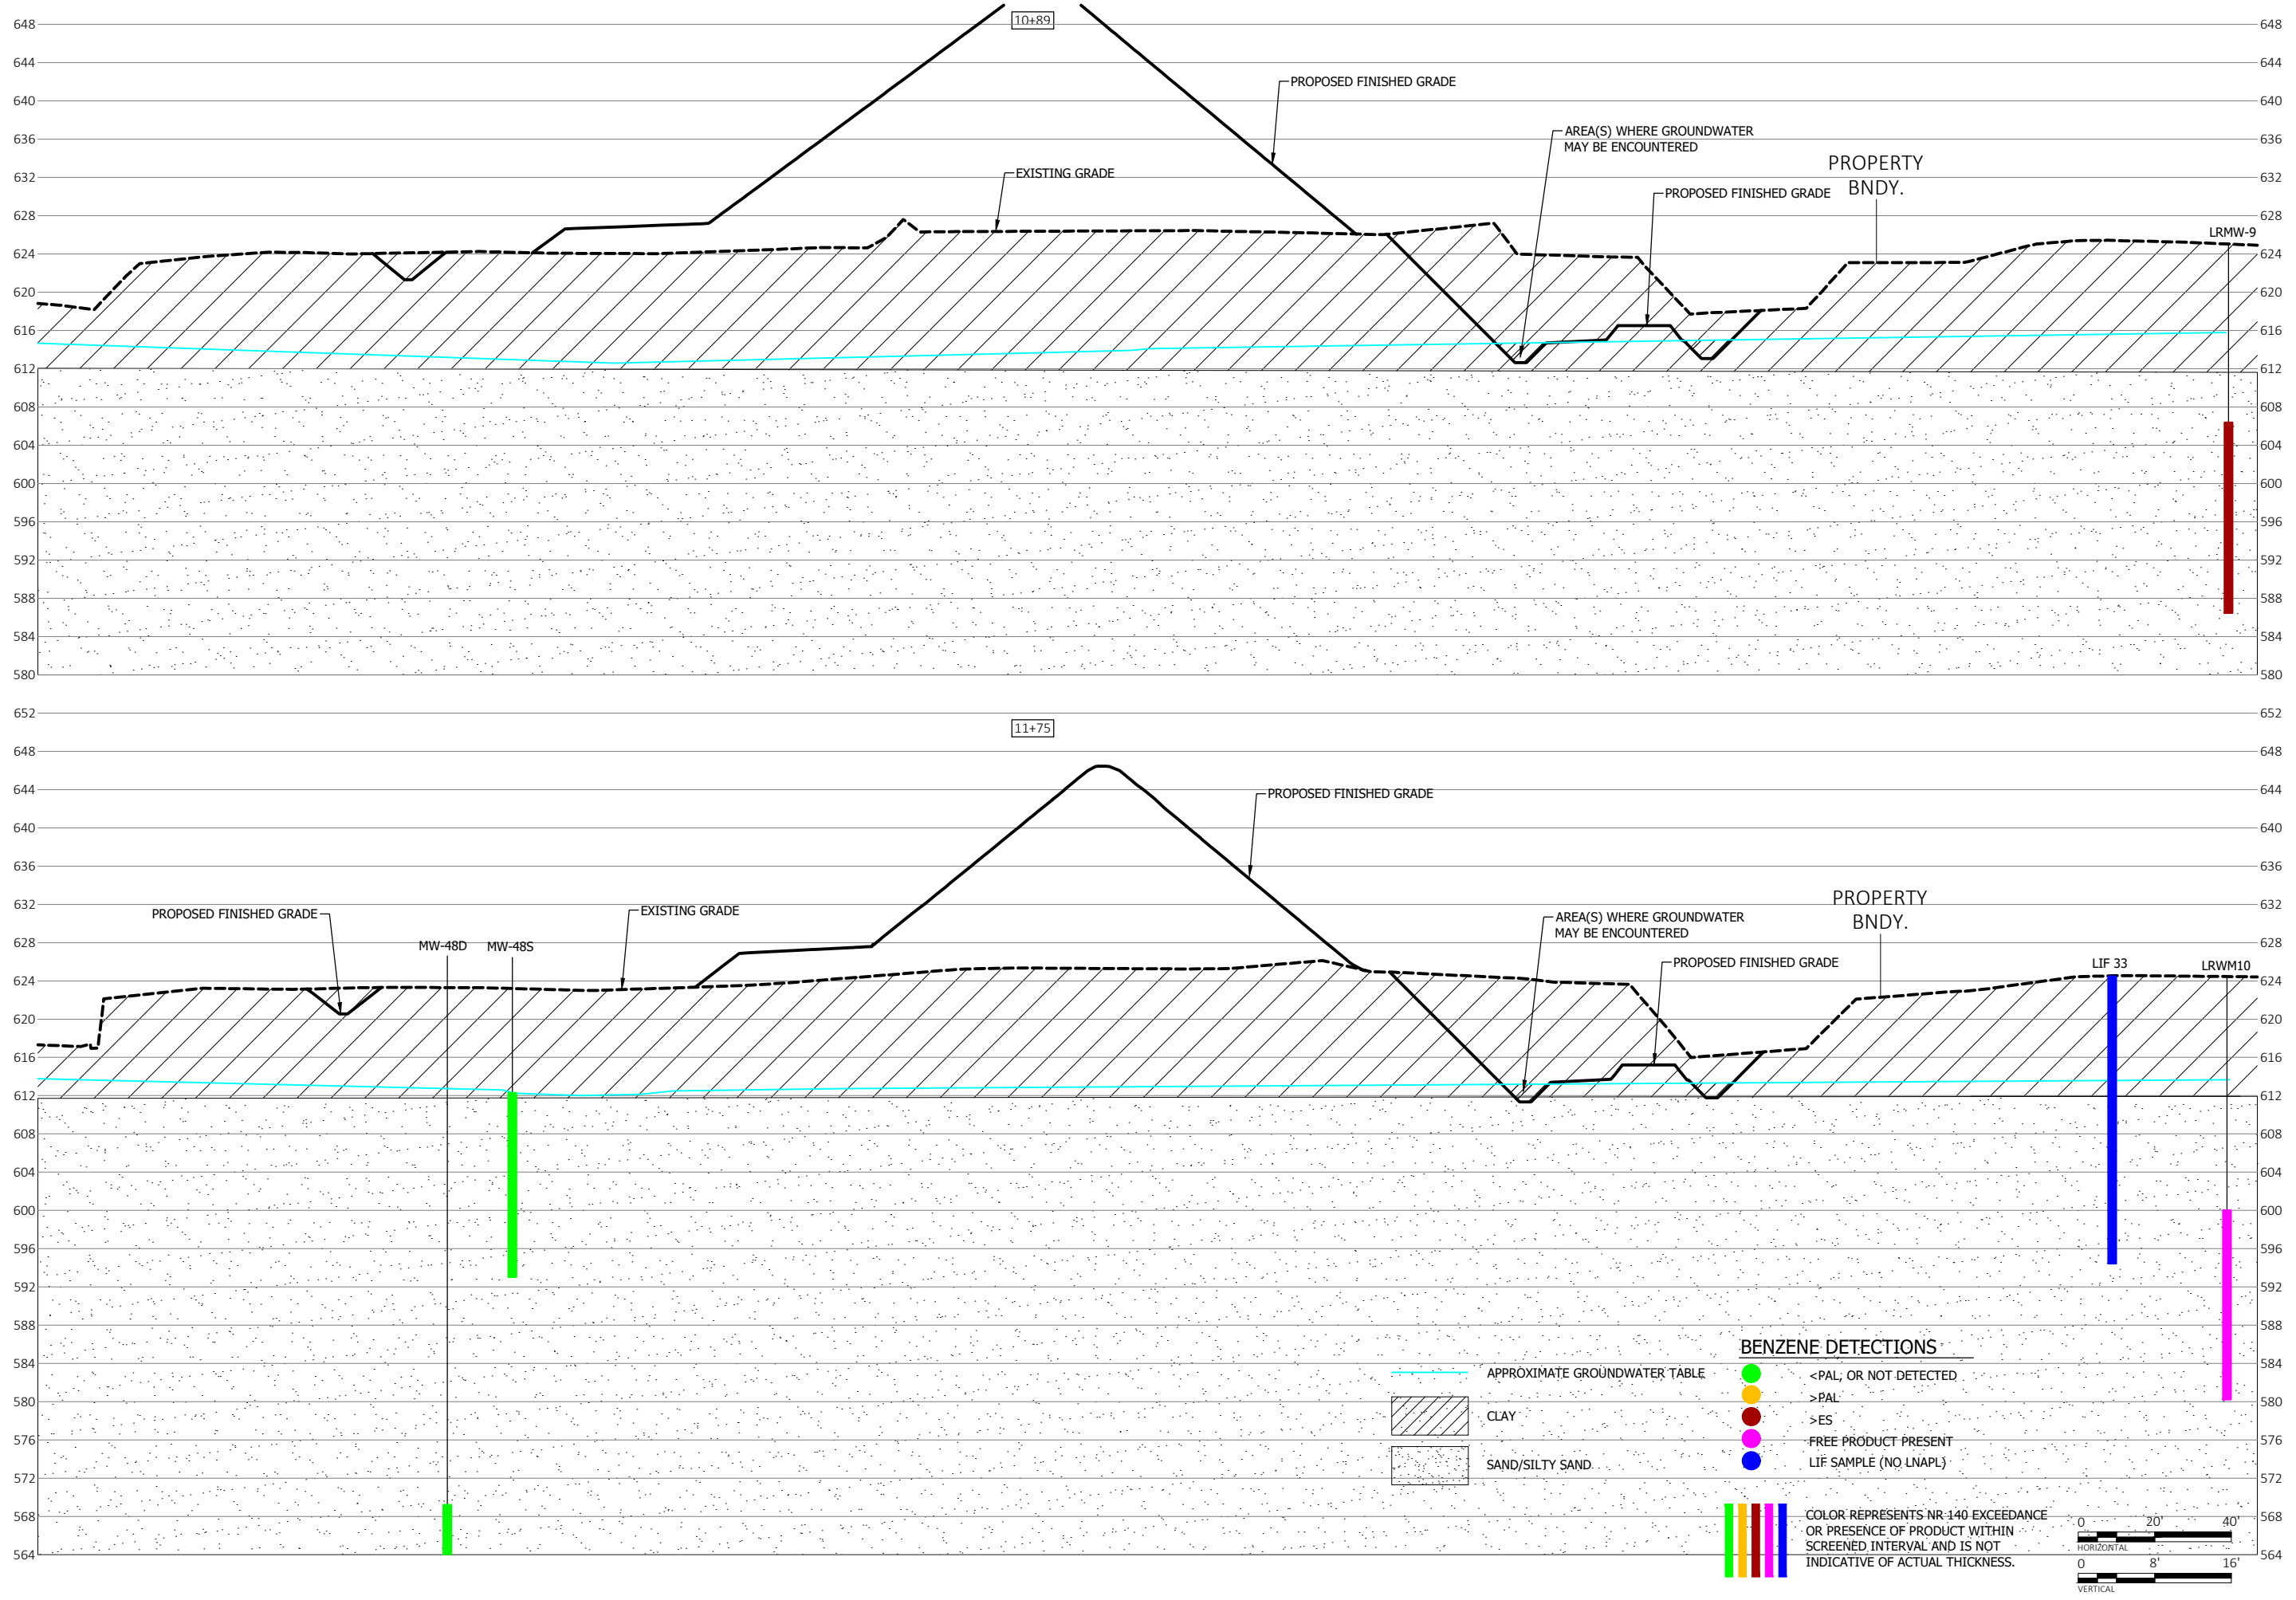
SHEET NUMBER  
**FIG. 8F**

**BENZENE DETECTIONS**

- <PAL, OR NOT DETECTED
- >PAL
- >ES
- FREE PRODUCT PRESENT
- LIF SAMPLE (NO LNAPL)

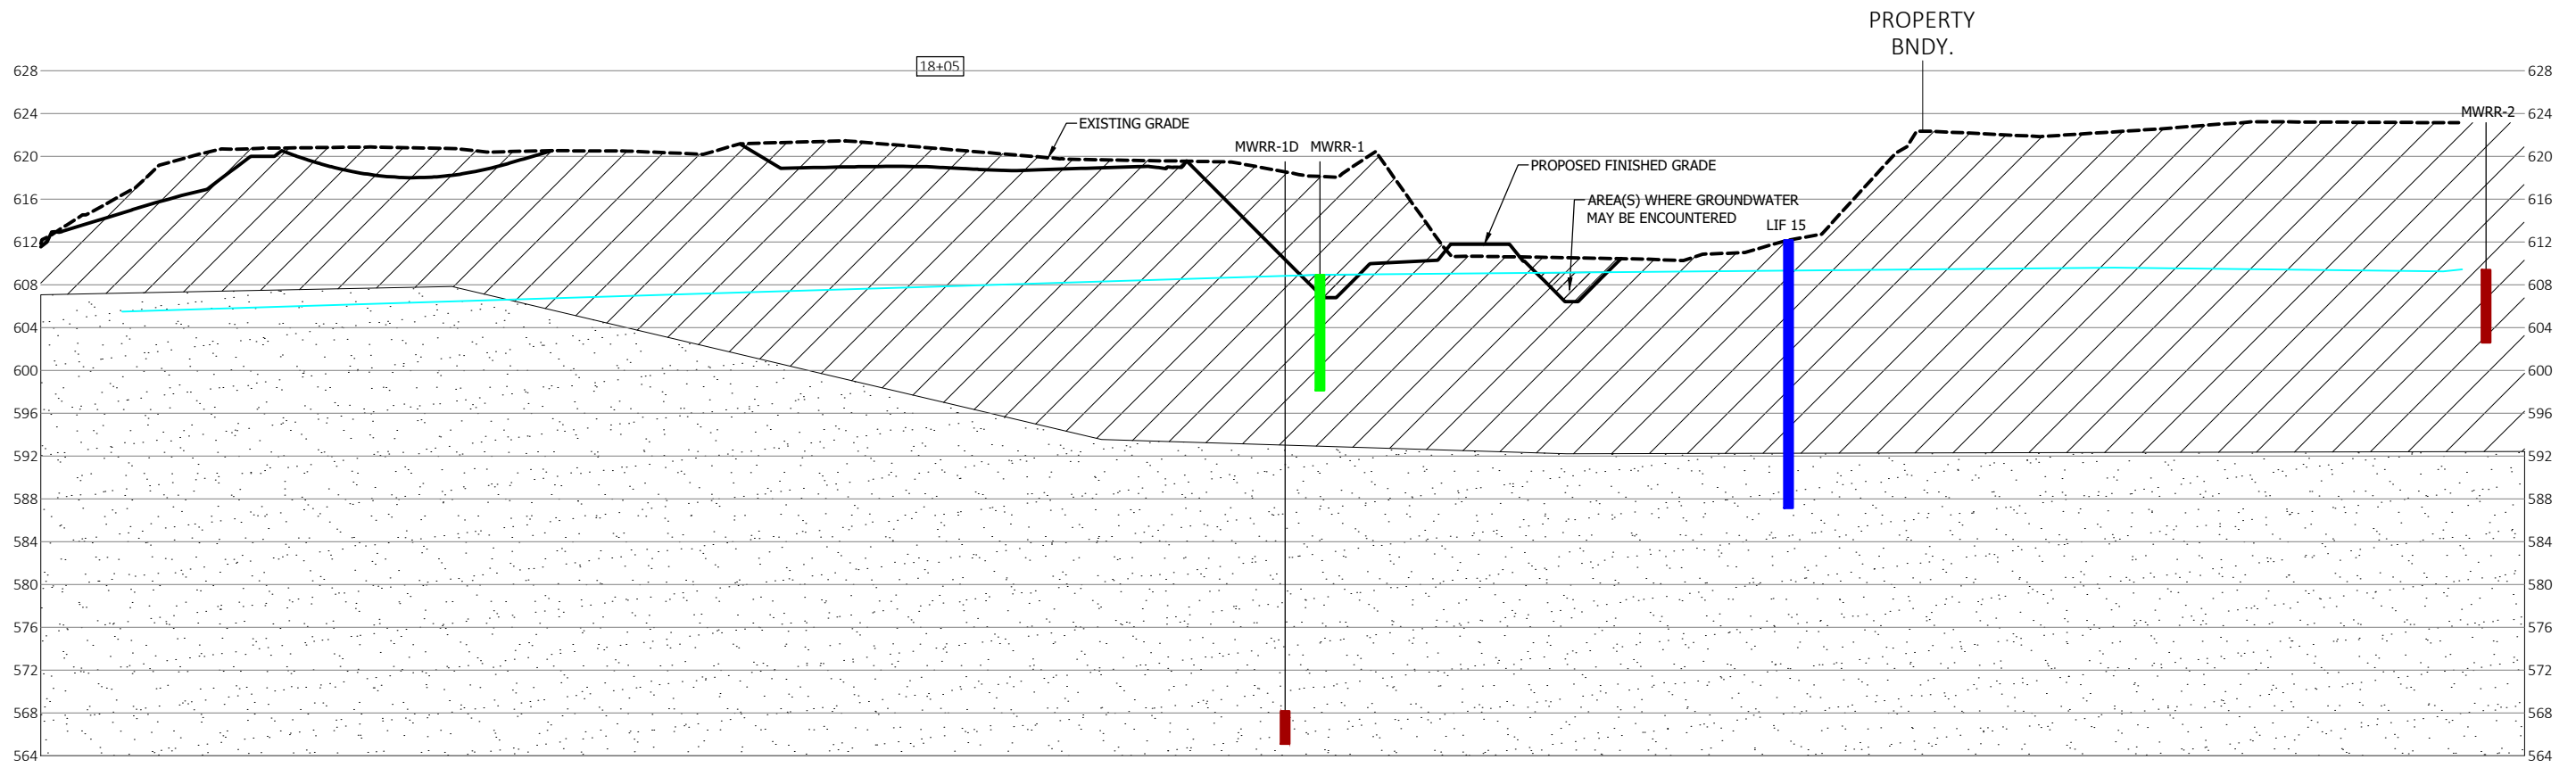
SHEET NUMBER  
**FIG. 8J**

- BENZENE DETECTIONS**
- <PAL, OR NOT DETECTED
  - >PAL
  - >ES
  - FREE PRODUCT PRESENT
  - LIF SAMPLE (NO LNAPL)

COLOR REPRESENTS NR 140 EXCEEDANCE OR PRESENCE OF PRODUCT WITHIN SCREENED INTERVAL AND IS NOT INDICATIVE OF ACTUAL THICKNESS.

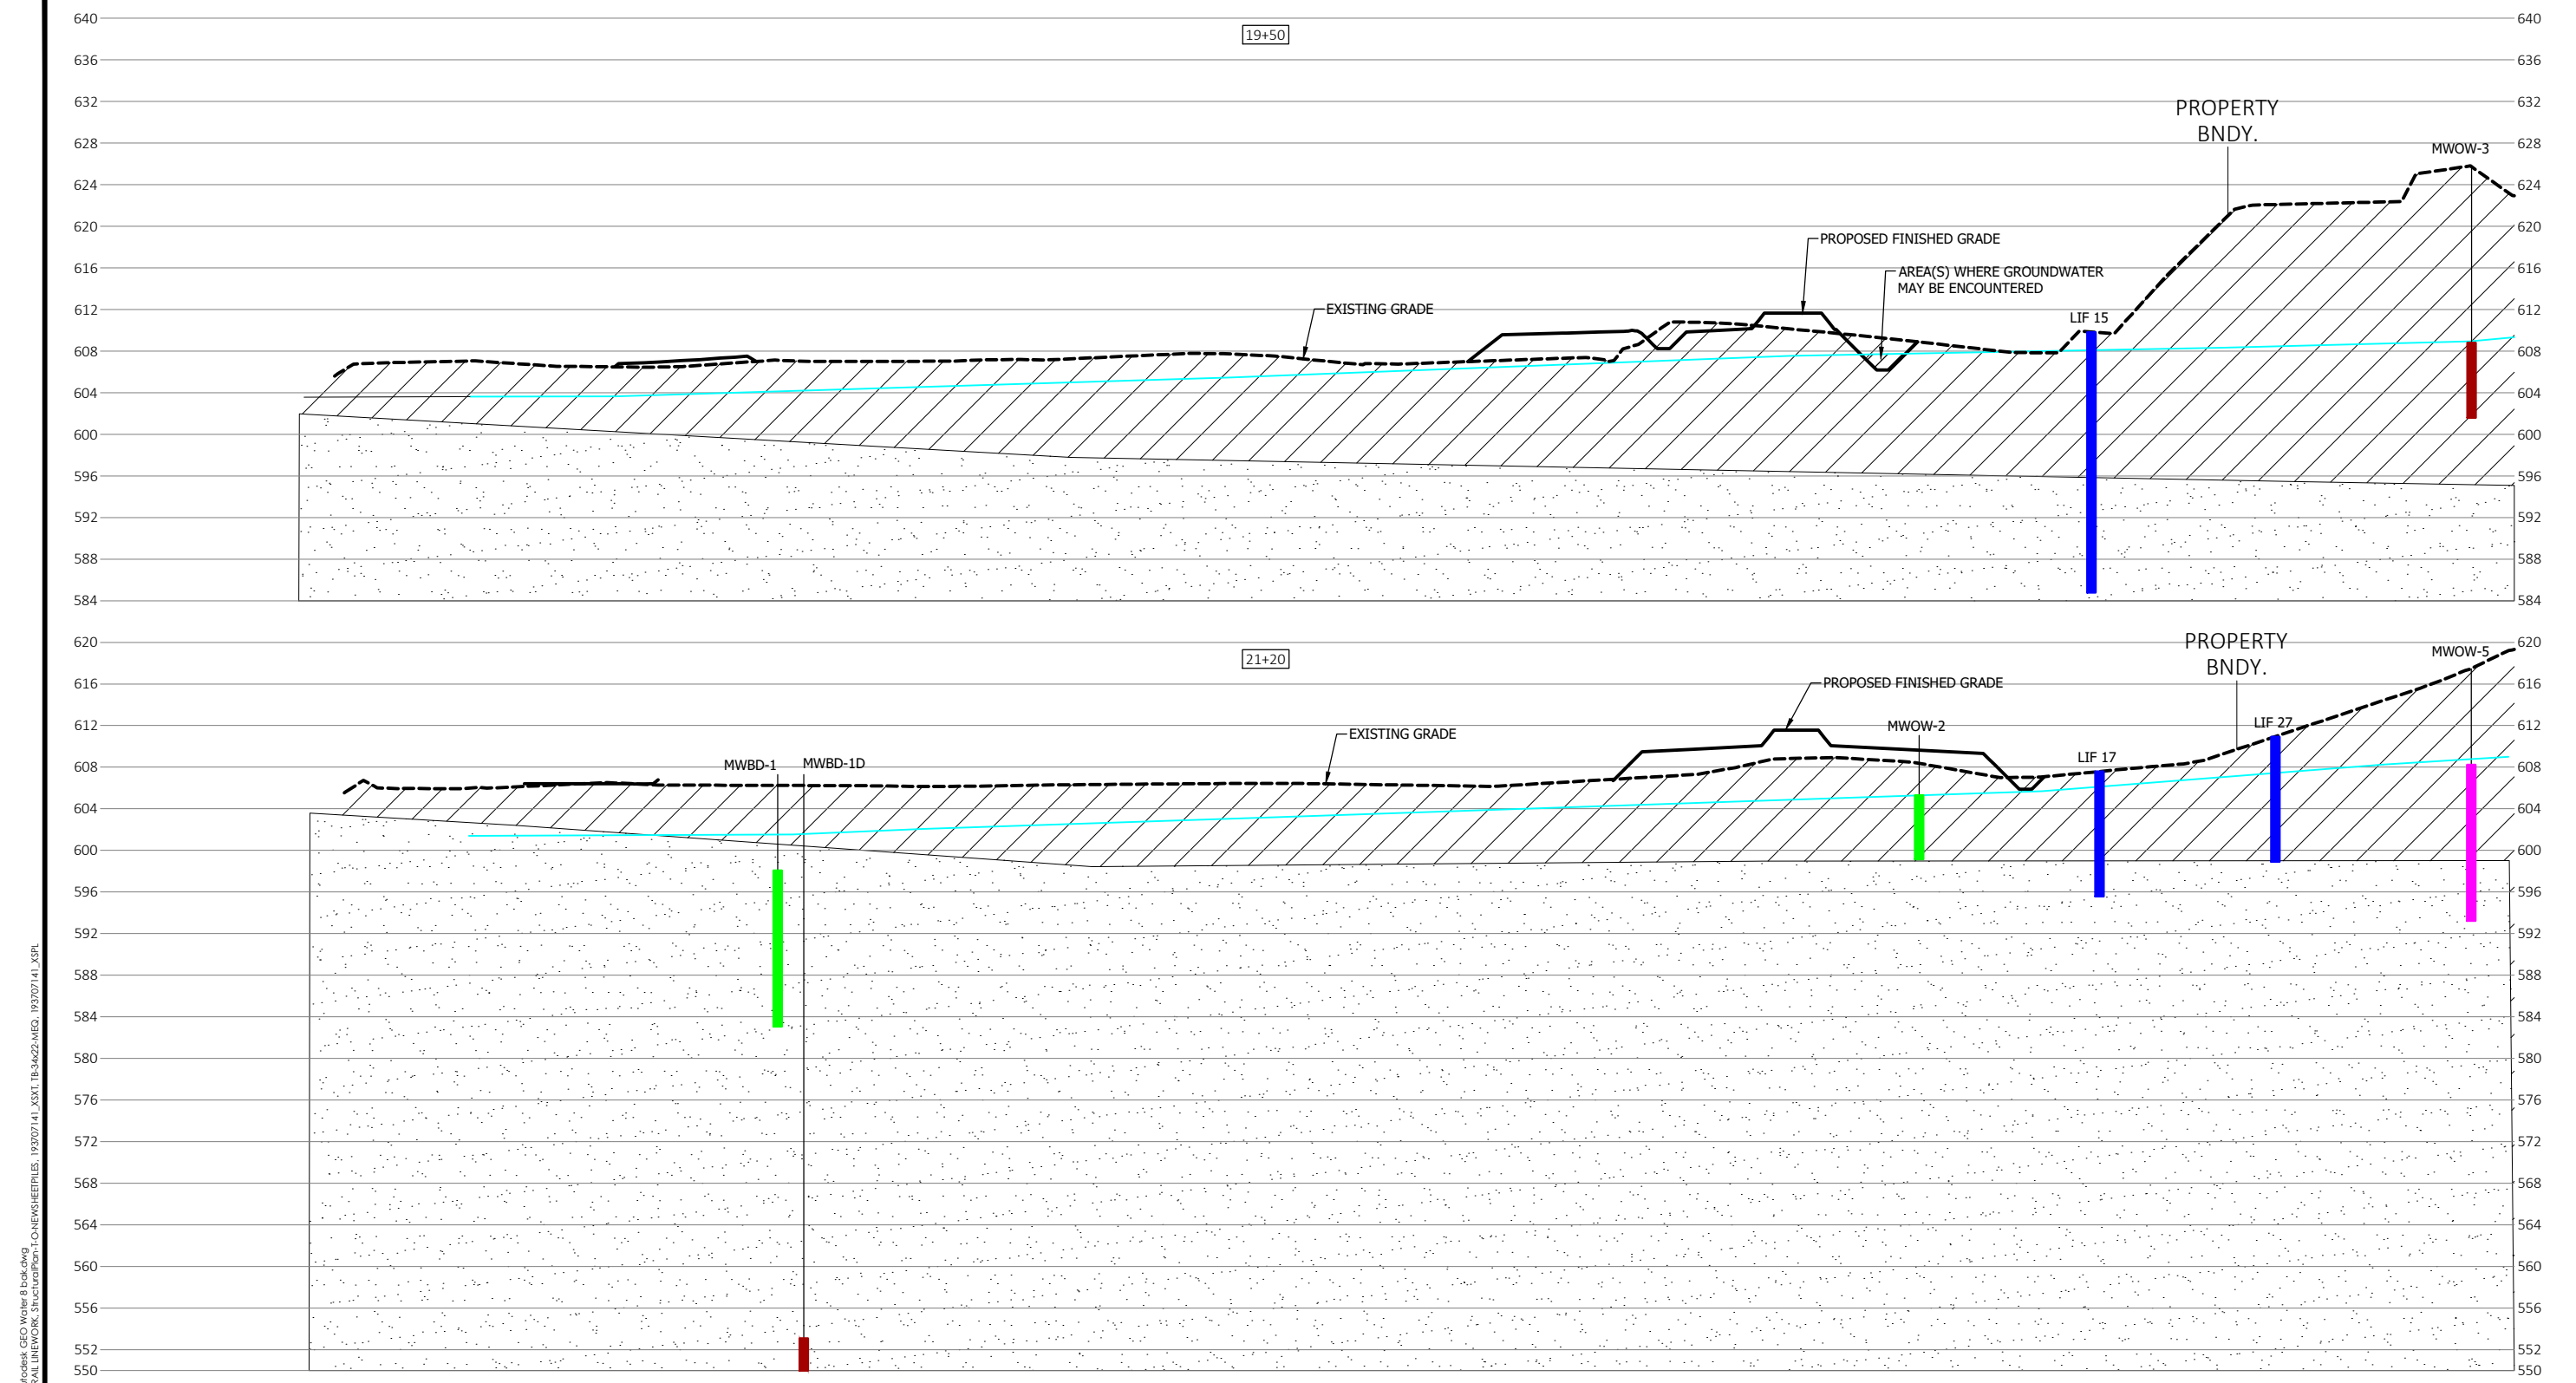
SHEET NUMBER  
**FIG. 8K**

APPROXIMATE GROUNDWATER TABLE  
 CLAY  
 SAND/SILTY SAND

**BENZENE DETECTIONS**  
 ● <PAL, OR NOT DETECTED  
 ● >PAL  
 ● >ES  
 ● FREE PRODUCT PRESENT  
 ● LIF SAMPLE (NO LNAPL)

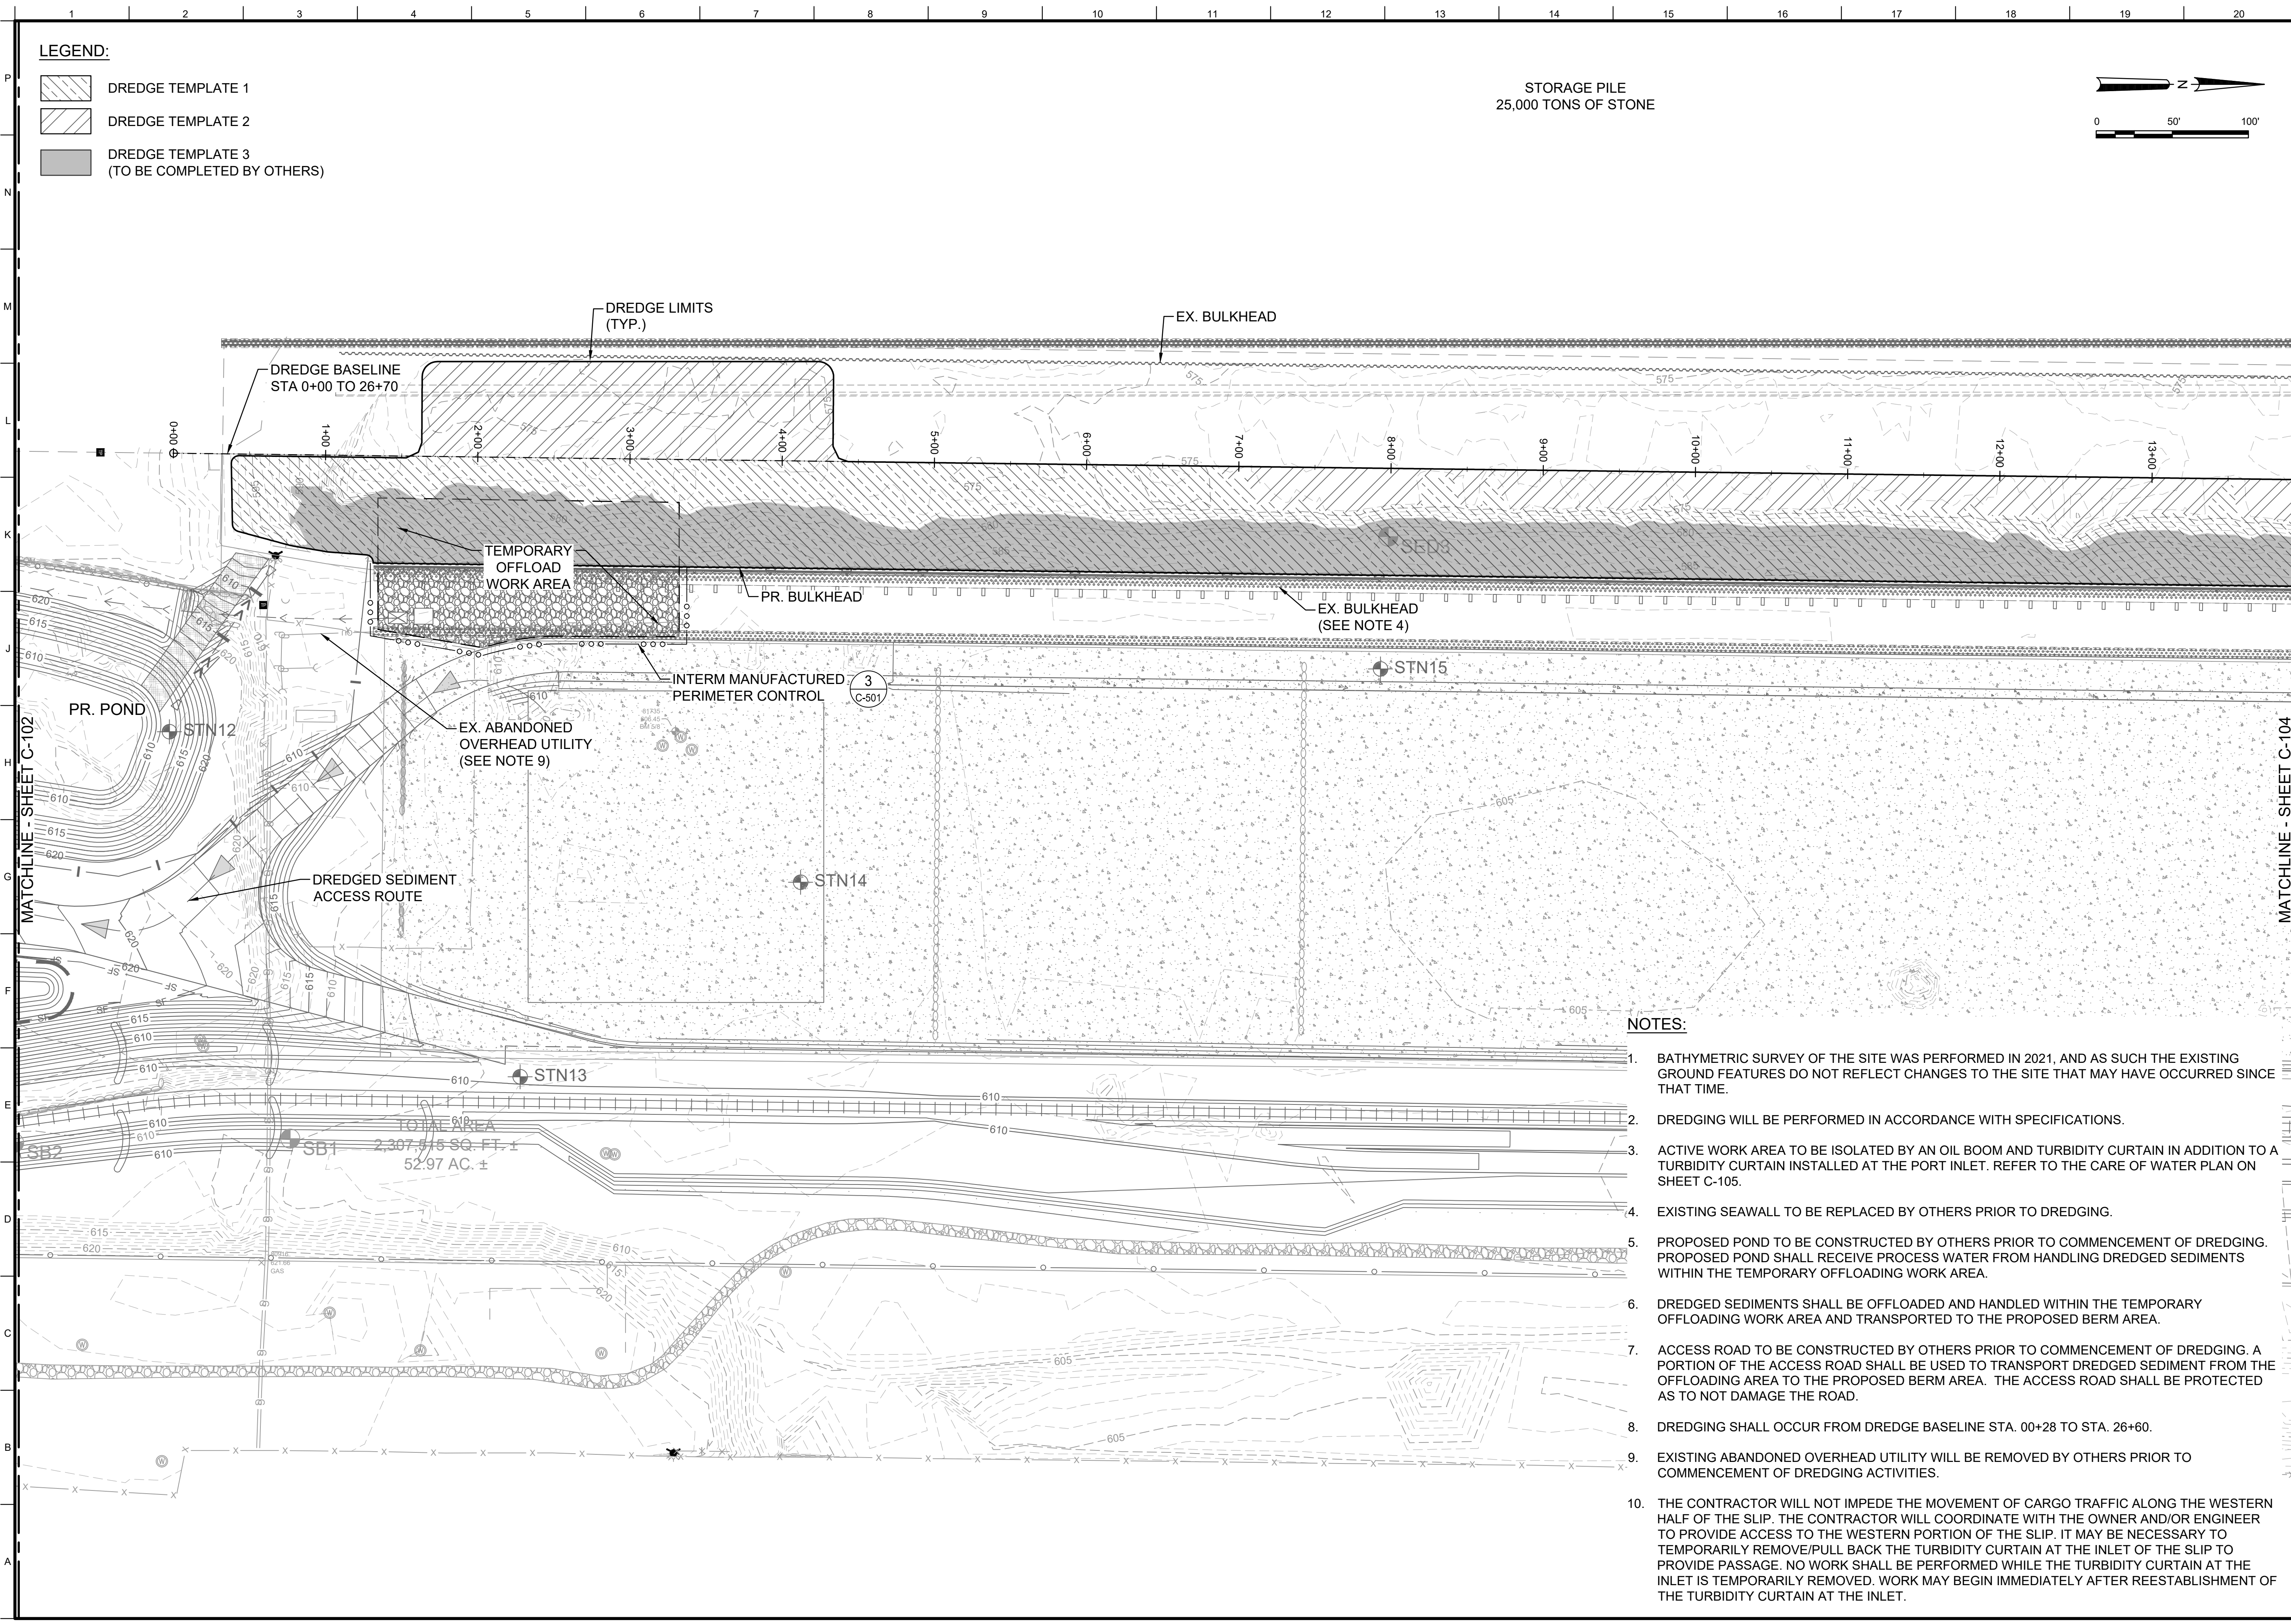
SHEET ID  
**C-103**

DREDGING PLAN

- NOTES:**
- BATHYMETRIC SURVEY OF THE SITE WAS PERFORMED IN 2021, AND AS SUCH THE EXISTING GROUND FEATURES DO NOT REFLECT CHANGES TO THE SITE THAT MAY HAVE OCCURRED SINCE THAT TIME.

- DREDGING WILL BE PERFORMED IN ACCORDANCE WITH SPECIFICATIONS.
  - ACTIVE WORK AREA TO BE ISOLATED BY AN OIL BOOM AND TURBIDITY CURTAIN IN ADDITION TO A TURBIDITY CURTAIN INSTALLED AT THE PORT INLET. REFER TO THE CARE OF WATER PLAN ON SHEET C-105.

- EXISTING SEAWALL TO BE REPLACED BY OTHERS PRIOR TO DREDGING.
  - PROPOSED POND TO BE CONSTRUCTED BY OTHERS PRIOR TO COMMENCEMENT OF DREDGING. PROPOSED POND SHALL RECEIVE PROCESS WATER FROM HANDLING DREDGED SEDIMENTS WITHIN THE TEMPORARY OFFLOADING WORK AREA.

- DREDGED SEDIMENTS SHALL BE OFFLOADED AND HANDLED WITHIN THE TEMPORARY OFFLOADING WORK AREA AND TRANSPORTED TO THE PROPOSED BERM AREA.
  - ACCESS ROAD TO BE CONSTRUCTED BY OTHERS PRIOR TO COMMENCEMENT OF DREDGING. A PORTION OF THE ACCESS ROAD SHALL BE USED TO TRANSPORT DREDGED SEDIMENT FROM THE OFFLOADING AREA TO THE PROPOSED BERM AREA. THE ACCESS ROAD SHALL BE PROTECTED AS TO NOT DAMAGE THE ROAD.
