**Stantec Consulting Services Inc.**  
12080 Corporate Parkway, Suite 200  
Mequon WI 53092-2661

December 2, 2022  
File: 193707141

**Reference: Response to Request for Additional Information #2; Materials Management Plan and Ch. NR 718 Exemption Request for C. Reiss Coal Dock Property, Superior, Wisconsin, BRRTS Case No. 02-16-589248**

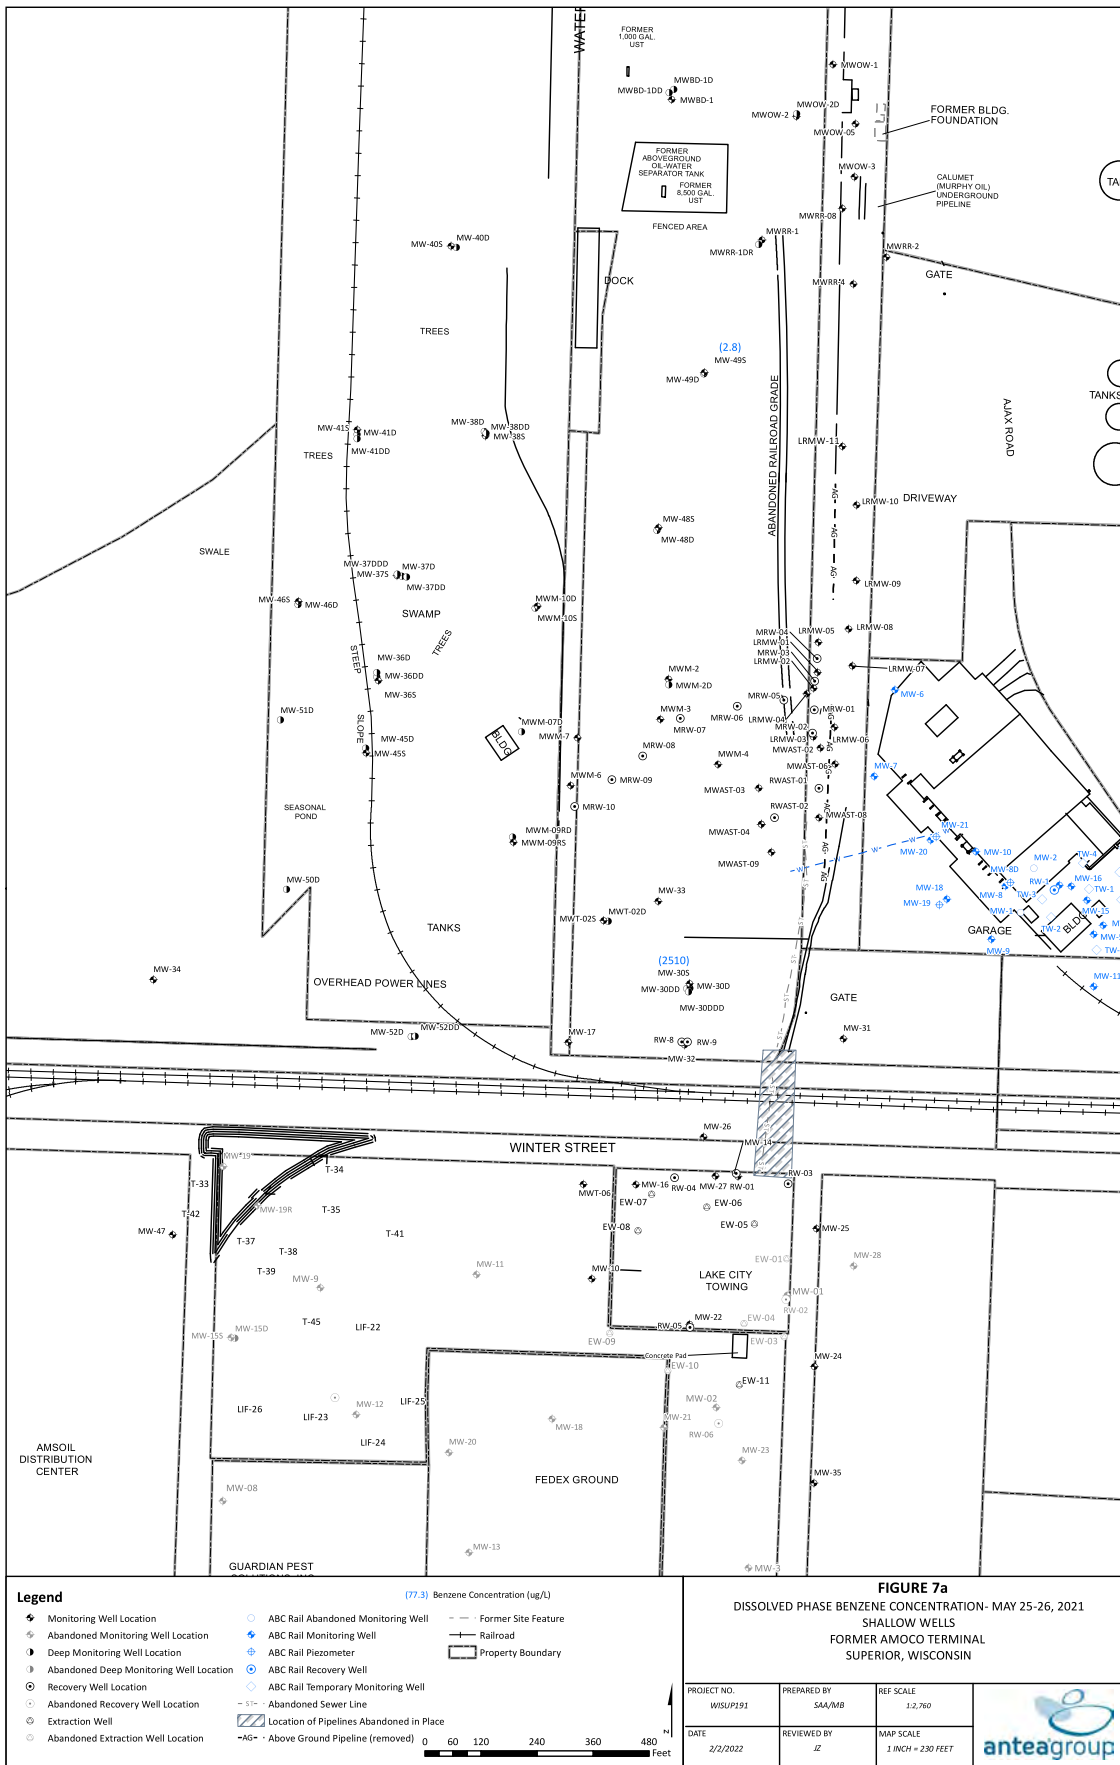
# Attachment B - Extents of Groundwater Contamination and LNAPL (Antea, 2022)

Antea, 2022. 2021 Progress Report, January - December 2021, Former Amoco Terminal, 2904 Winter Street, Superior, Wisconsin, February 8, 2022.

Attachment B: Extents of Groundwater Contamination and LNAPL (Antea, 2022)

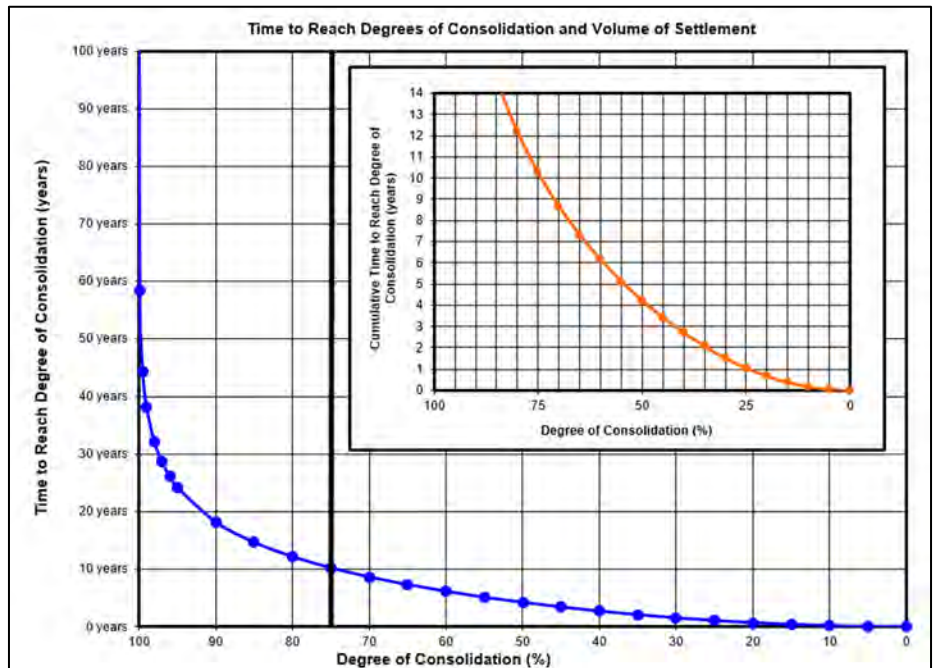
From a time-rate of settlement perspective, assuming that a liquid limit of about 70% equates to a coefficient of consolidation value of about 0.001 square centimeters per second, we estimate that it will take about 10 years to achieve 75% of the total consolidation value (or about 14 inches).

**Settlement.** Using the above assumptions, values of settlement are estimated to be between 12 to 18 inches under the tallest portion of the pile and tapering to nearly zero at the edges. It is anticipated that almost all this settlement will happen in the fill and upper clay layers. Better estimates would be achieved by performing one-dimensional consolidation tests at various depths through the existing soil.

**Geotechnical Evaluation Summary.** Settlement of the soils beneath the greatest height of the proposed disposal berm is not expected to exceed 18 inches over approximately 10 years. This is based on the following:

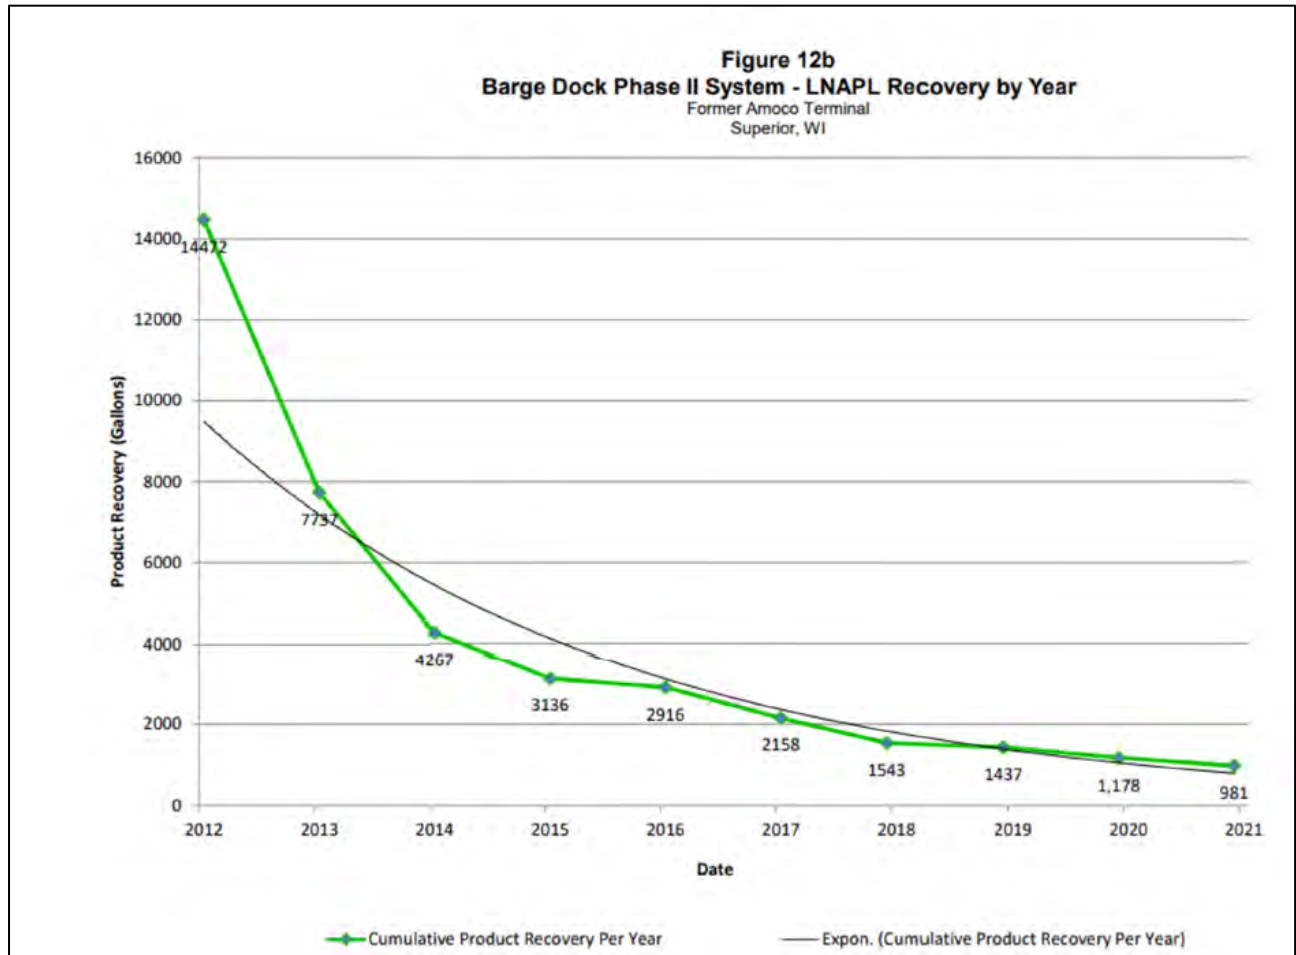
**LNAPL Recovery Efforts.** Reports of LNAPL recovery indicate that the Phase II recovery system is approaching asymptotic recovery and is no longer effective (Antea Group, 2022, Figure below). This condition is indicative of low LNAPL saturations in the subsurface are low and further reduced risk of significant migration.
