Re: Technical Memorandum – Southwest Parking Lot Remedial Action Options / Interim Remedial Action Plan
Former Navistar/RMG Foundry - 1401 Perkins Avenue, Waukesha, WI
BRRTS # 02-68-098404

SOUTHWEST PARKING LOT/STORM SEWER MEMORANDUM

RMG WAUKESHA FOUNDRY
1401 PERKINS AVE, WAUKESHA, WI

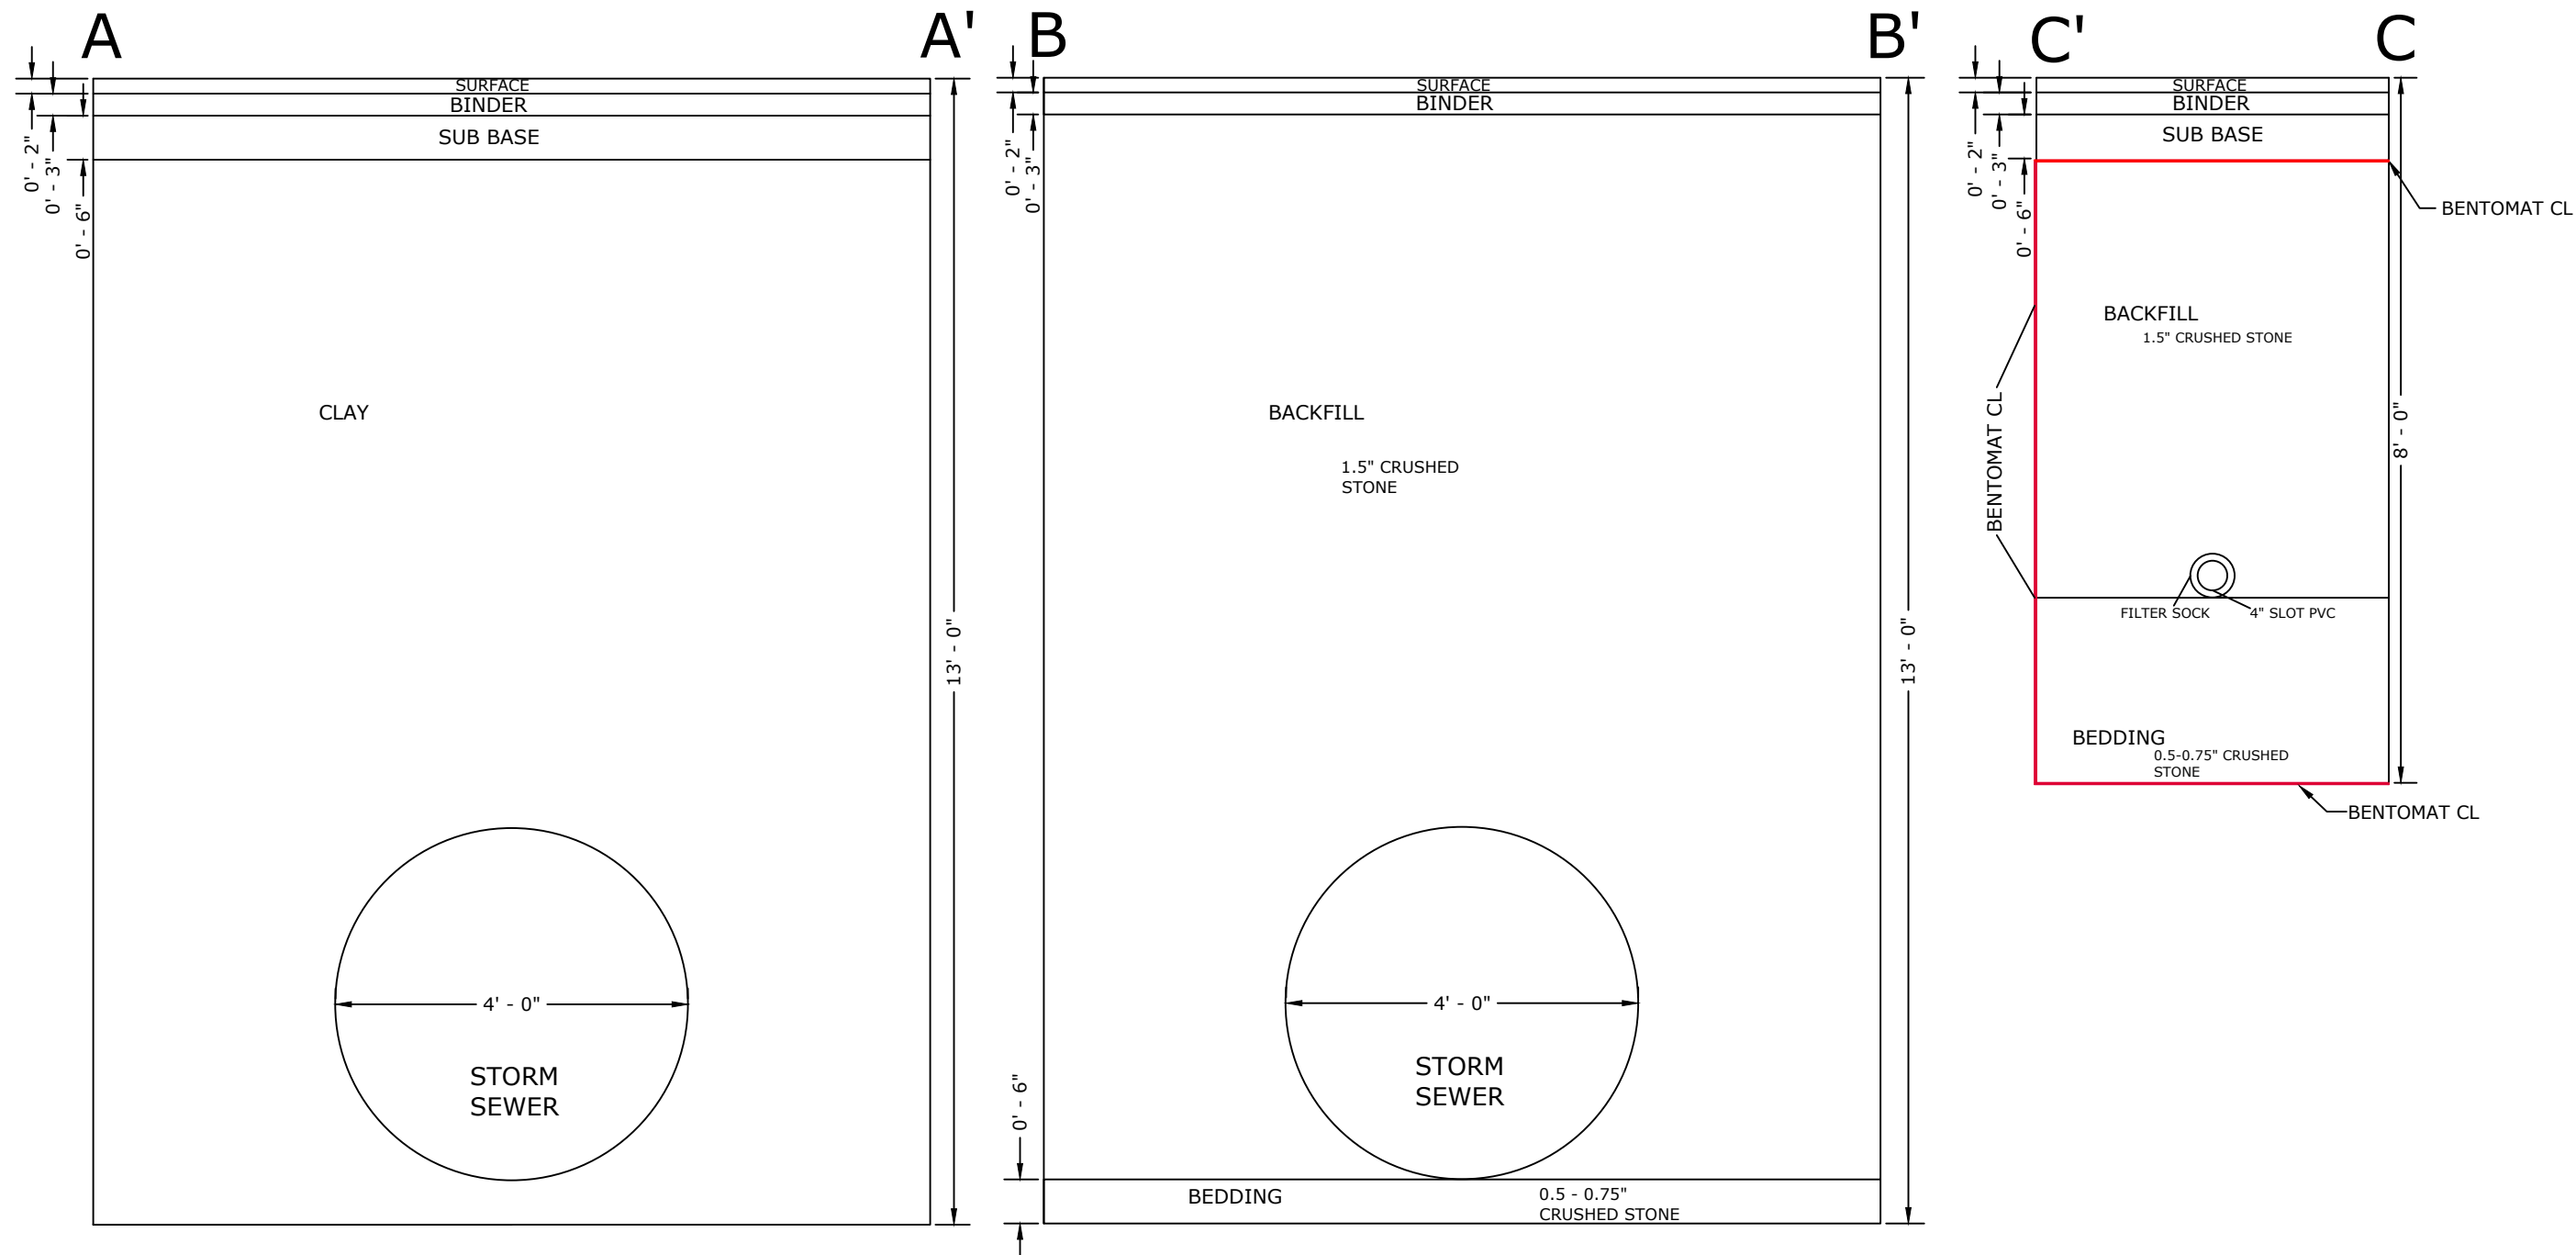
- 1. PLANT-SUPPLIED ELECTRIC FEED FOR EXHAUST MOTOR
- 2. WESTERN VERTICAL HEADER WILL BE SIMILAR BUT WITH WIND-DRIVEN PINWHEEL VENT
- 3. CONCRETE FOOTER FOR VENT, 3' DIAMETER SET FROM 0.5-4' BELOW GRADE
- 4. FOUR 4' CONCRETE-FILLED STEEL BOLLARDS (PAINTED SAFETY YELLOW) SET AT 4' OFFSETS FROM HEADER

To address the potential soil vapor migration from the lower concentration residually impacted soils to be left in place, a vapor interceptor trench will be constructed. This approximately 300-foot (the east-west distance of the soils with TCE concentration that may be above the non-industrial direct contact standard) approximately 3-feet wide trench will be dug to a depth of up to 8-feet running approximately east-west along the northern sidewalk, as shown on Figure 1. These soils comprising an additional approximately 750 tons will also be removed for proper landfill disposal. The top, bottom, and southern face of the trench will be lined with Bentomat CL, a reinforced geosynthetic clay liner (specifications provided in Attachment 1). The trench will be backfilled with a uniform graded stone to create a more porous active vapor vent. A four-inch diameter slotted horizontal pipe will be located within the backfill with two terminating vertical headers placed in protective locations that will receive prevailing winds. This eastern terminating vertical header at a height of 15 to 20 feet will utilize a radon-type electric motor with manometer to provide a continuous negative pressure (i.e., vacuum) within the horizontal trench pipe. The western terminating vertical header will be topped with a roof-type “pinwheel” vent to provide backup passive venting in the event of power outage or motor maintenance event. The stone will be topped with the geosynthetic clay liner as noted to prevent short circuiting with ambient air and topped with gravel sub base prior to asphalt surface. Bollards will be placed to protect the turbine vents from vehicle damage.
