Clark Lake, Door County Wisconsin Bulrush Mapping and Density January 2007

Date of Survey: September 2006

Site Evaluators: Justin Barrick – Water Resources Student – UWSP
Darrin Hoverson – Water Resources Graduate Student – UWSP
Ronald Crunkilton – Professor of Water Resources – UWSP

Authors: Justin Barrick and Ronald Crunkilton

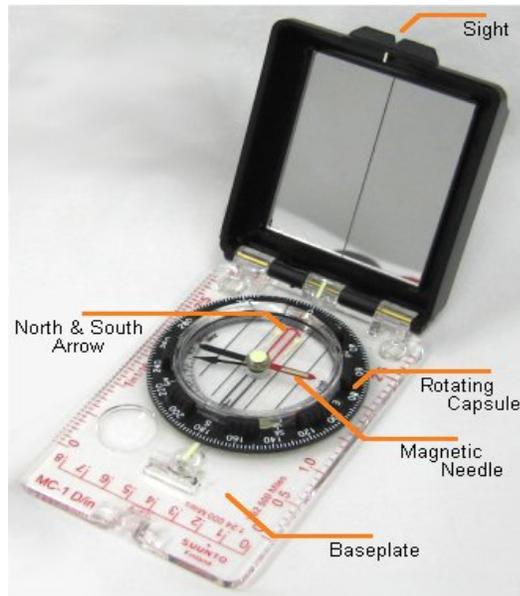
Figure 1. Suunto MC-1D Compass used in field study.

An important note is that a 4 degree west declination setting was used in this study (2006). Each year the declination changes and it should be looked up (Table 1) at the following web address and changed accordingly in future years: (www.ngdc.noaa.gov/seg/geomag/jsp/struts/calcDeclination).

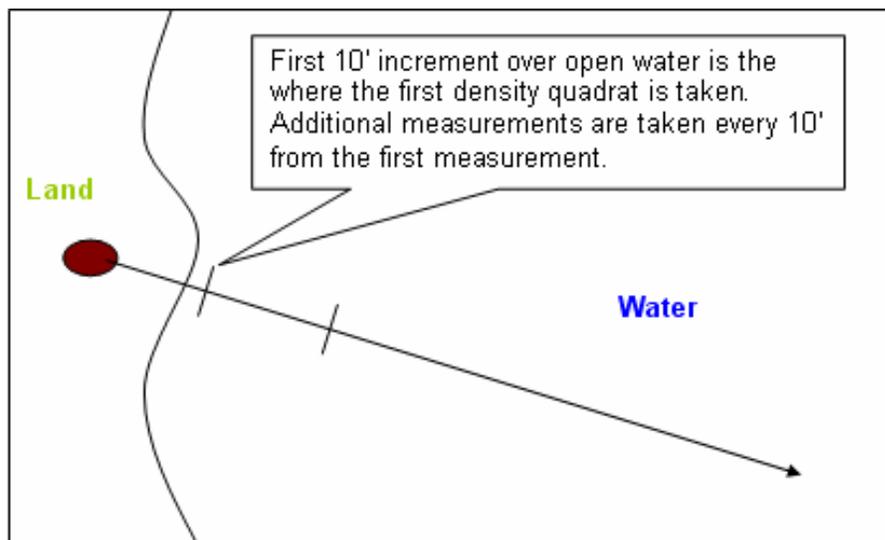
Figure 2. Schematic of density transects.

Density counts were taken within a quadrat at 10 foot increments along each transect. A 9 square foot (3' x 3') quadrat made of 1" PVC pipe was used to establish a consistent area to enumerate the emergent bulrush stems along transects. Density counts began with the 10 foot increment nearest to shore

(Figure 2). The shoreward side of the quadrat was flush with every 10 foot measurement; the quadrat itself was centered on the tape measure, lying directly over the top forming two halves of the quadrat (Figure 3). Only emergent bulrush stems with the base of the stem directly below and within the quadrat were enumerated. For each 10 foot increment the total number of stems was recorded in the appropriate transect and distance cell on the data sheet (Appendix A).

Quadrat is centered with shoreward edge on the 10' increment from starting point/benchmark

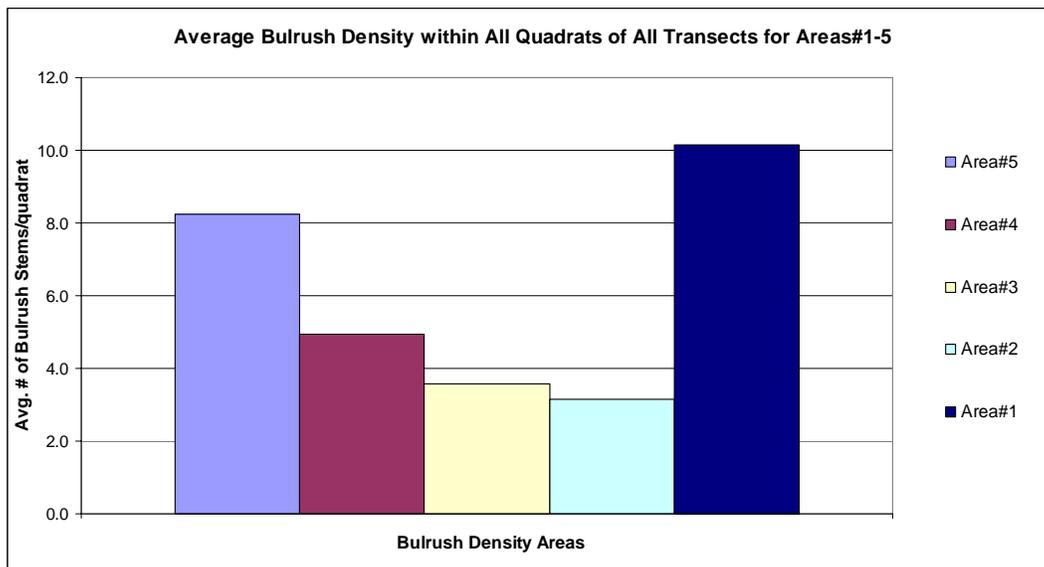
Figure 4. Average bulrush density within all quadrats of all transects for Areas#1-5.

Bulrush densities ranged from an average of 3.1 to 10.2 emergent stems per quadrat for combined transects 1-3 at each site (Figure 4). The bulrush density for each transect within each area is found in Figure 5.

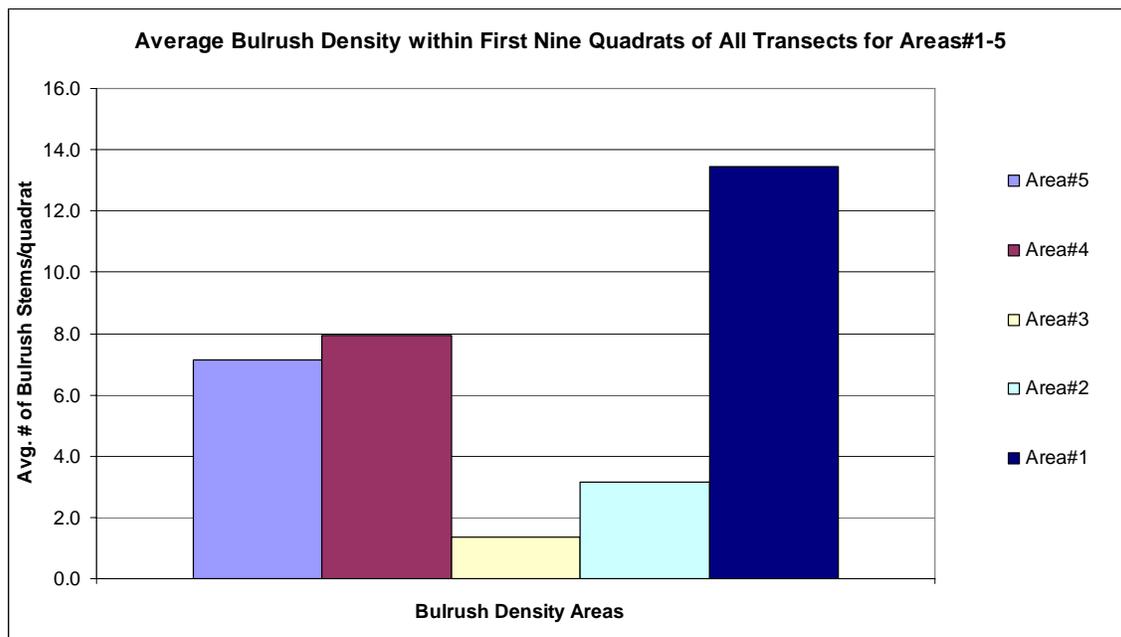
Figure 6. Average bulrush density within first nine quadrats of all transects for Areas#1-5.

Some transects only contained 9 quadrats with useful data; therefore, a more standardized comparison using only the first 9 quadrats within each transect was used at each location. Bulrush densities ranged from an average of 1.4 to 13.4 emergent stems per quadrat for combined transects 1-3 (Figure 6). Additionally, the bulrush density for each individual transect within each area is found in Figure 7.

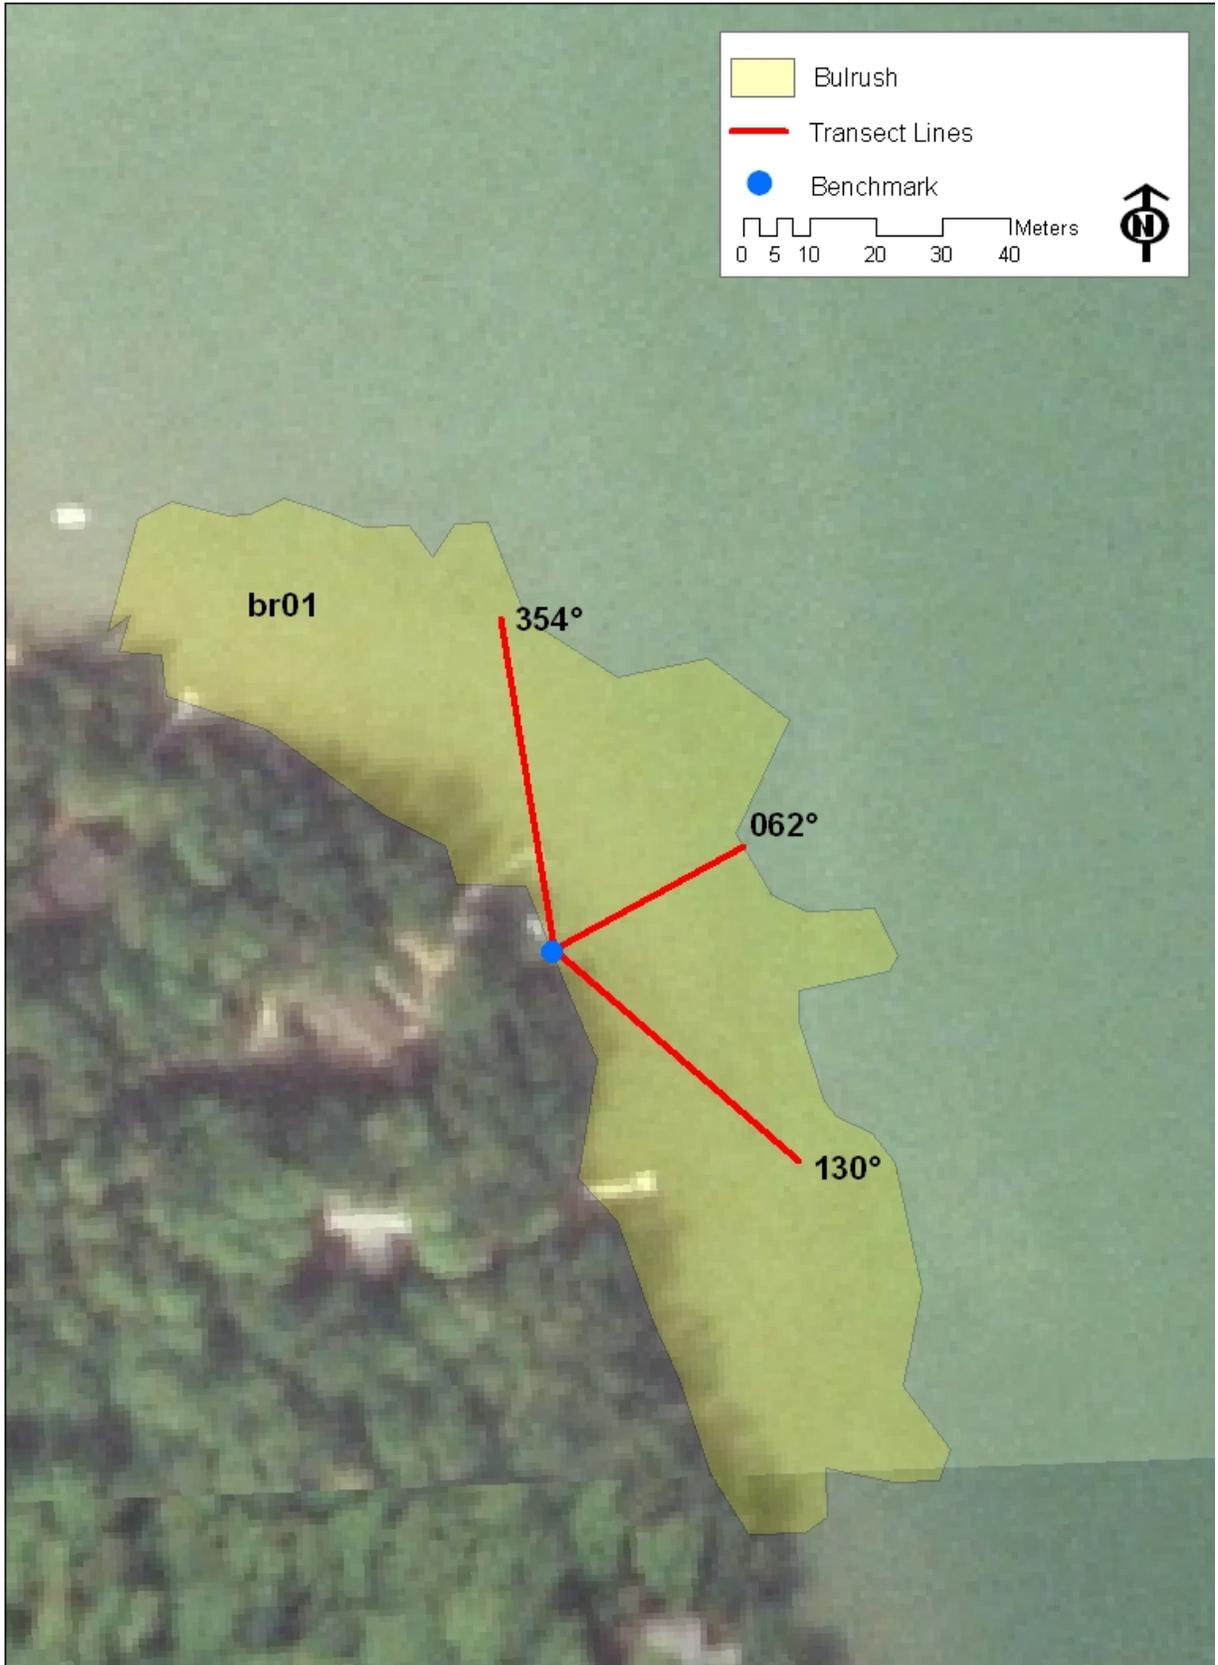
Figure 8. Aerial photo highlighting bulrush Area#1.

The raw data for each of bulrush density Areas 1-5 are located in Tables 2-6, respectively. Additionally, the data is summarized in Appendix A. Aerial photos highlighting the bearings and lengths of transects for Areas 1-5 are found in Figures 8, 9, 11, 13 and 15 respectively.

The benchmark/starting point of each transect is a white cedar tree (found below) which is approximately 20 feet south of a waterfront deck and 5 feet from the water. Area#1 lies within bulrush bed “br01”—See Figure 8.

--Within bulrush bed “br01”—See Figure 8.

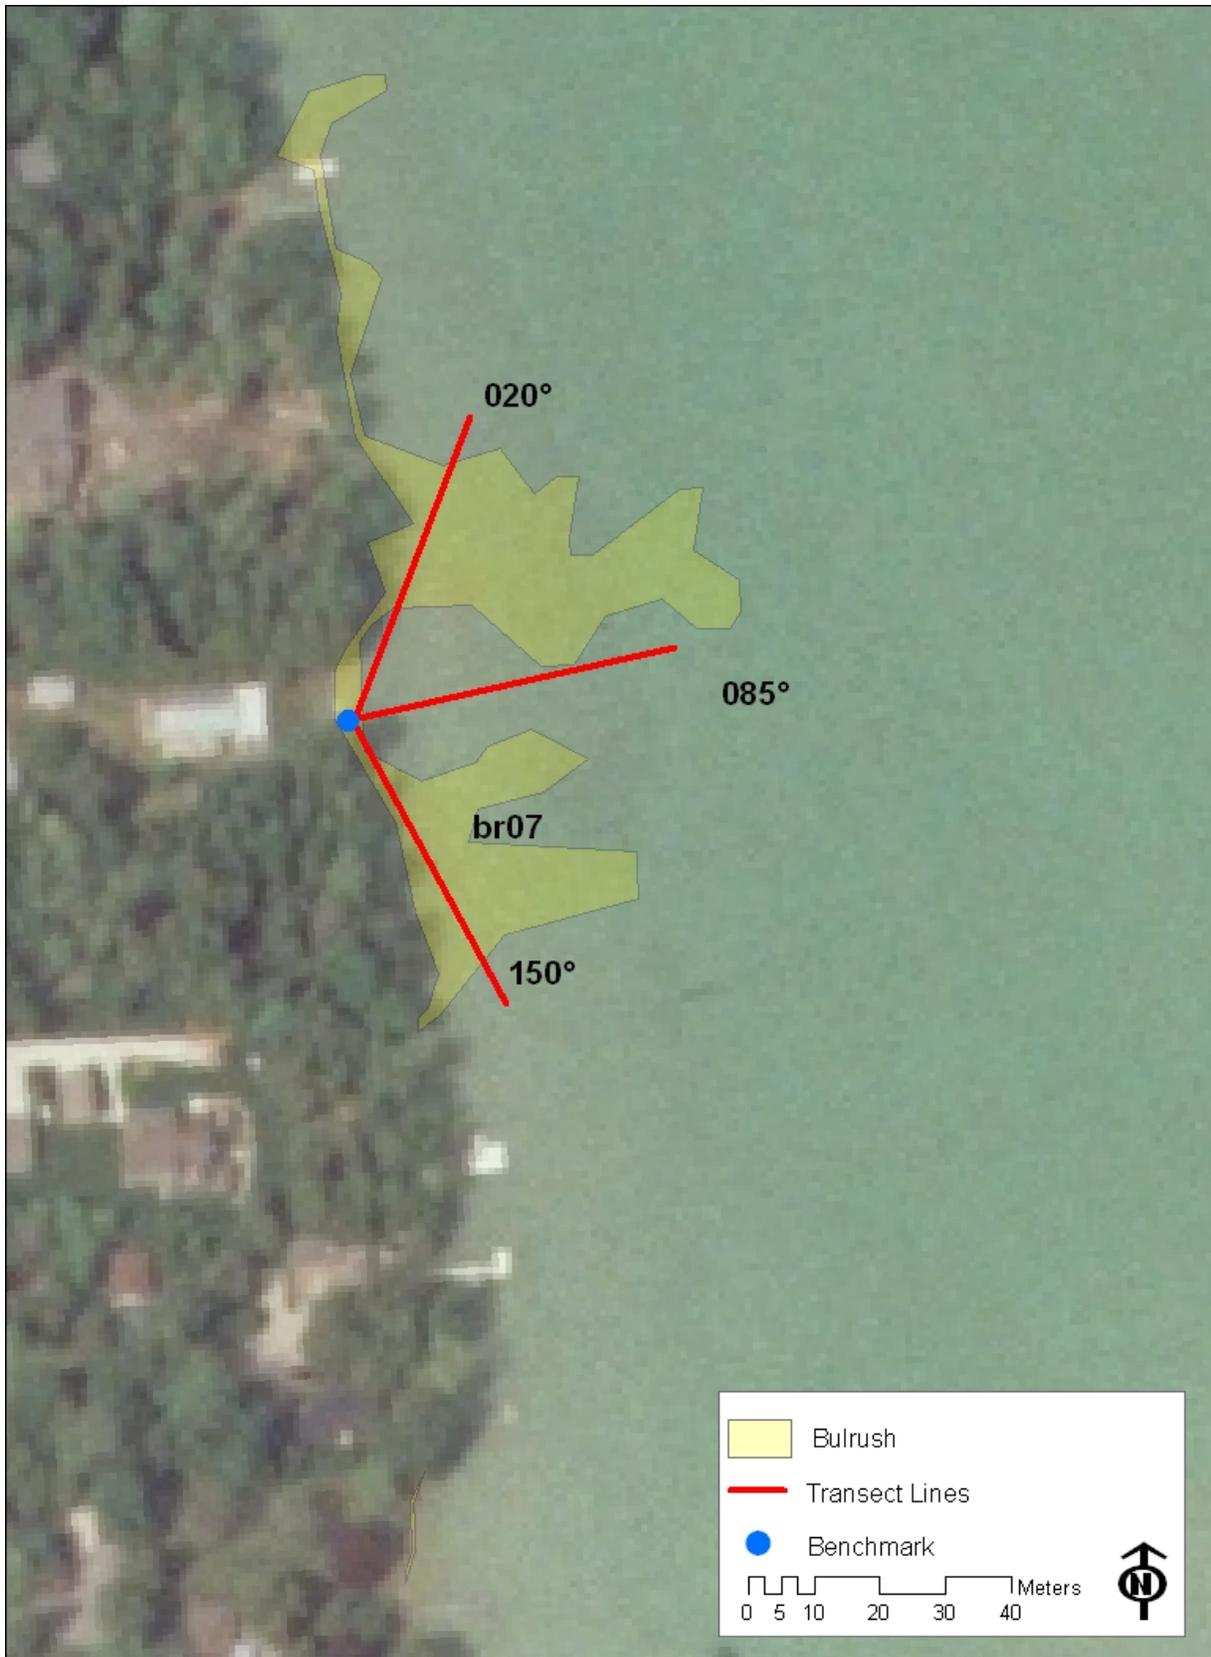
Figure 9. Aerial photo highlighting bulrush Area#2.

The benchmark is a medium sized white cedar tree as indicated below found along the southern portion of the east shore just south of a red house's waterfront. Area#2 lies within bulrush bed "br07"—See Figure 9.

--Within bulrush bed "br07"—See Figure 9.

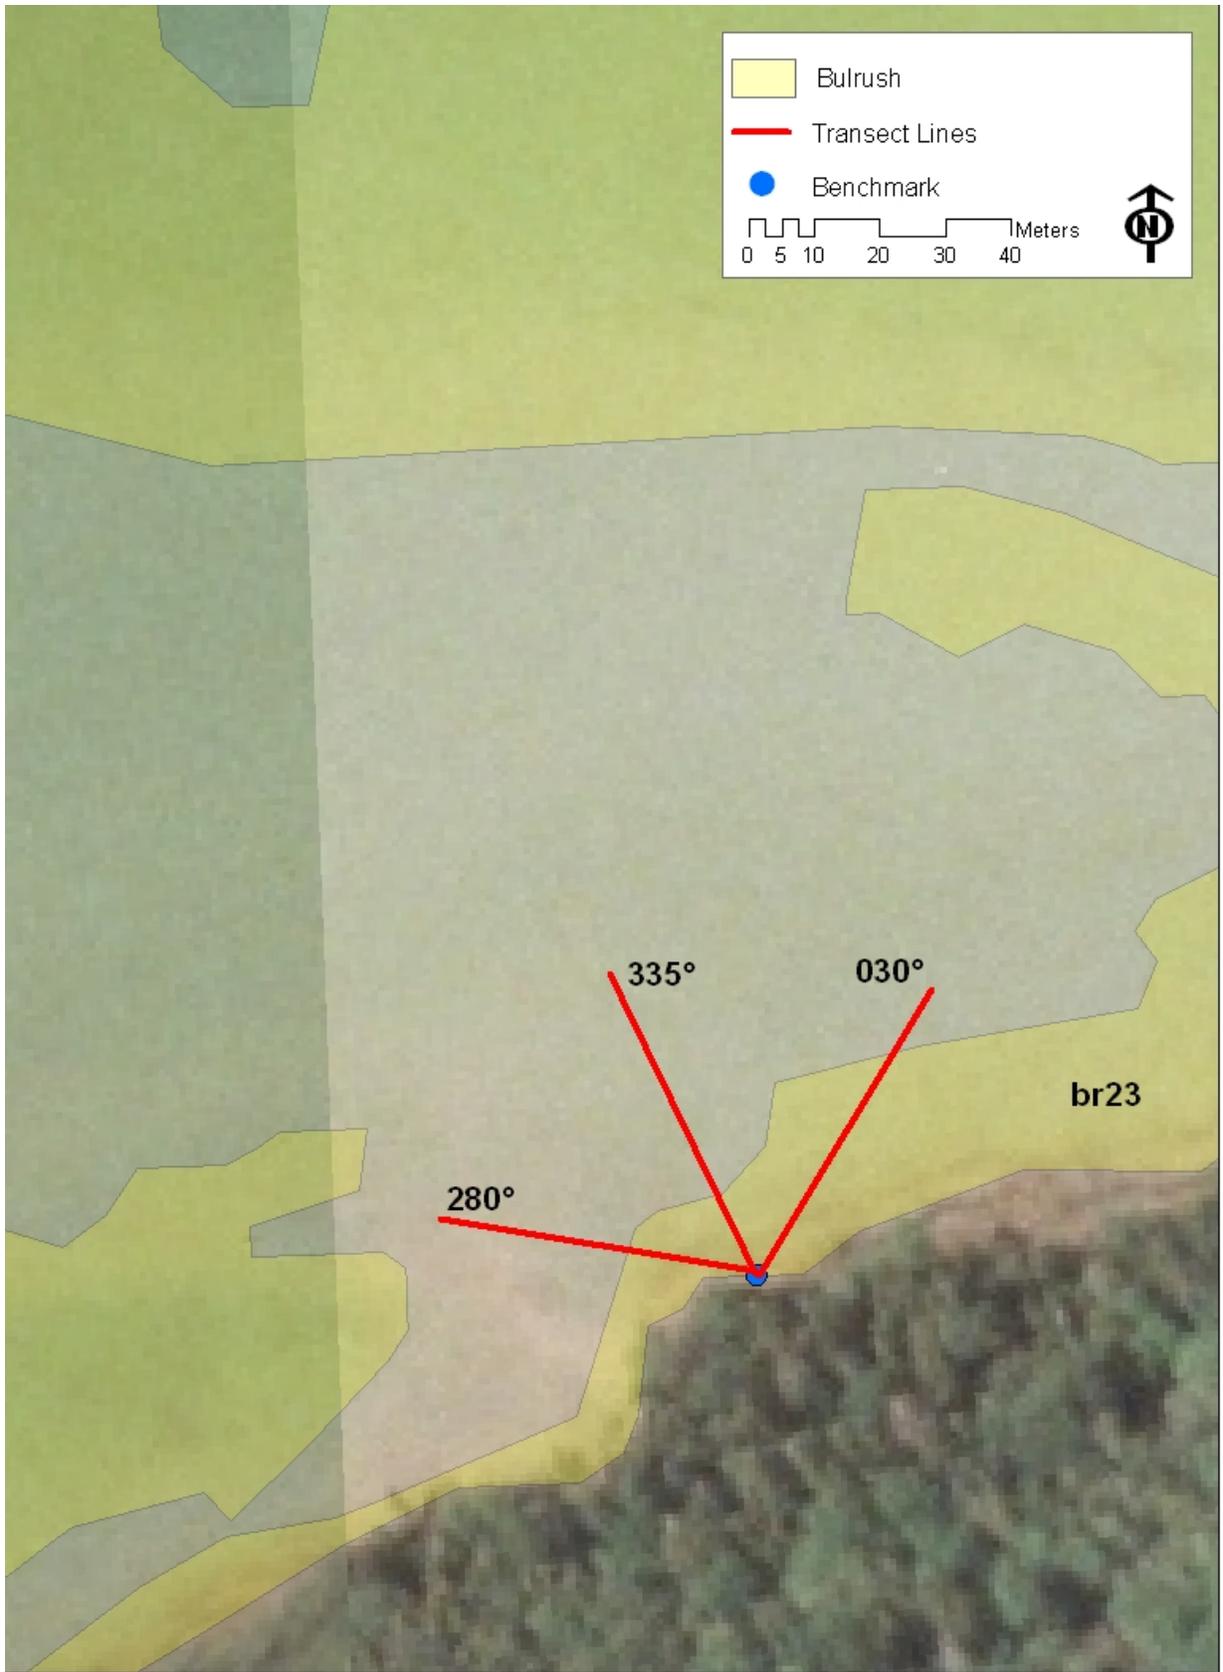
Figure 11. Aerial photo highlighting bulrush Area#3.

The benchmark is a large to medium sized white cedar tree on the southeast shore of the lake (Figure 10), just east of the Whitefish Dunes State Park access to the lake. Area#3 lies within bulrush bed “br23”—See Figure 11.

-- Within bulrush bed “br23”—See Figure 11.

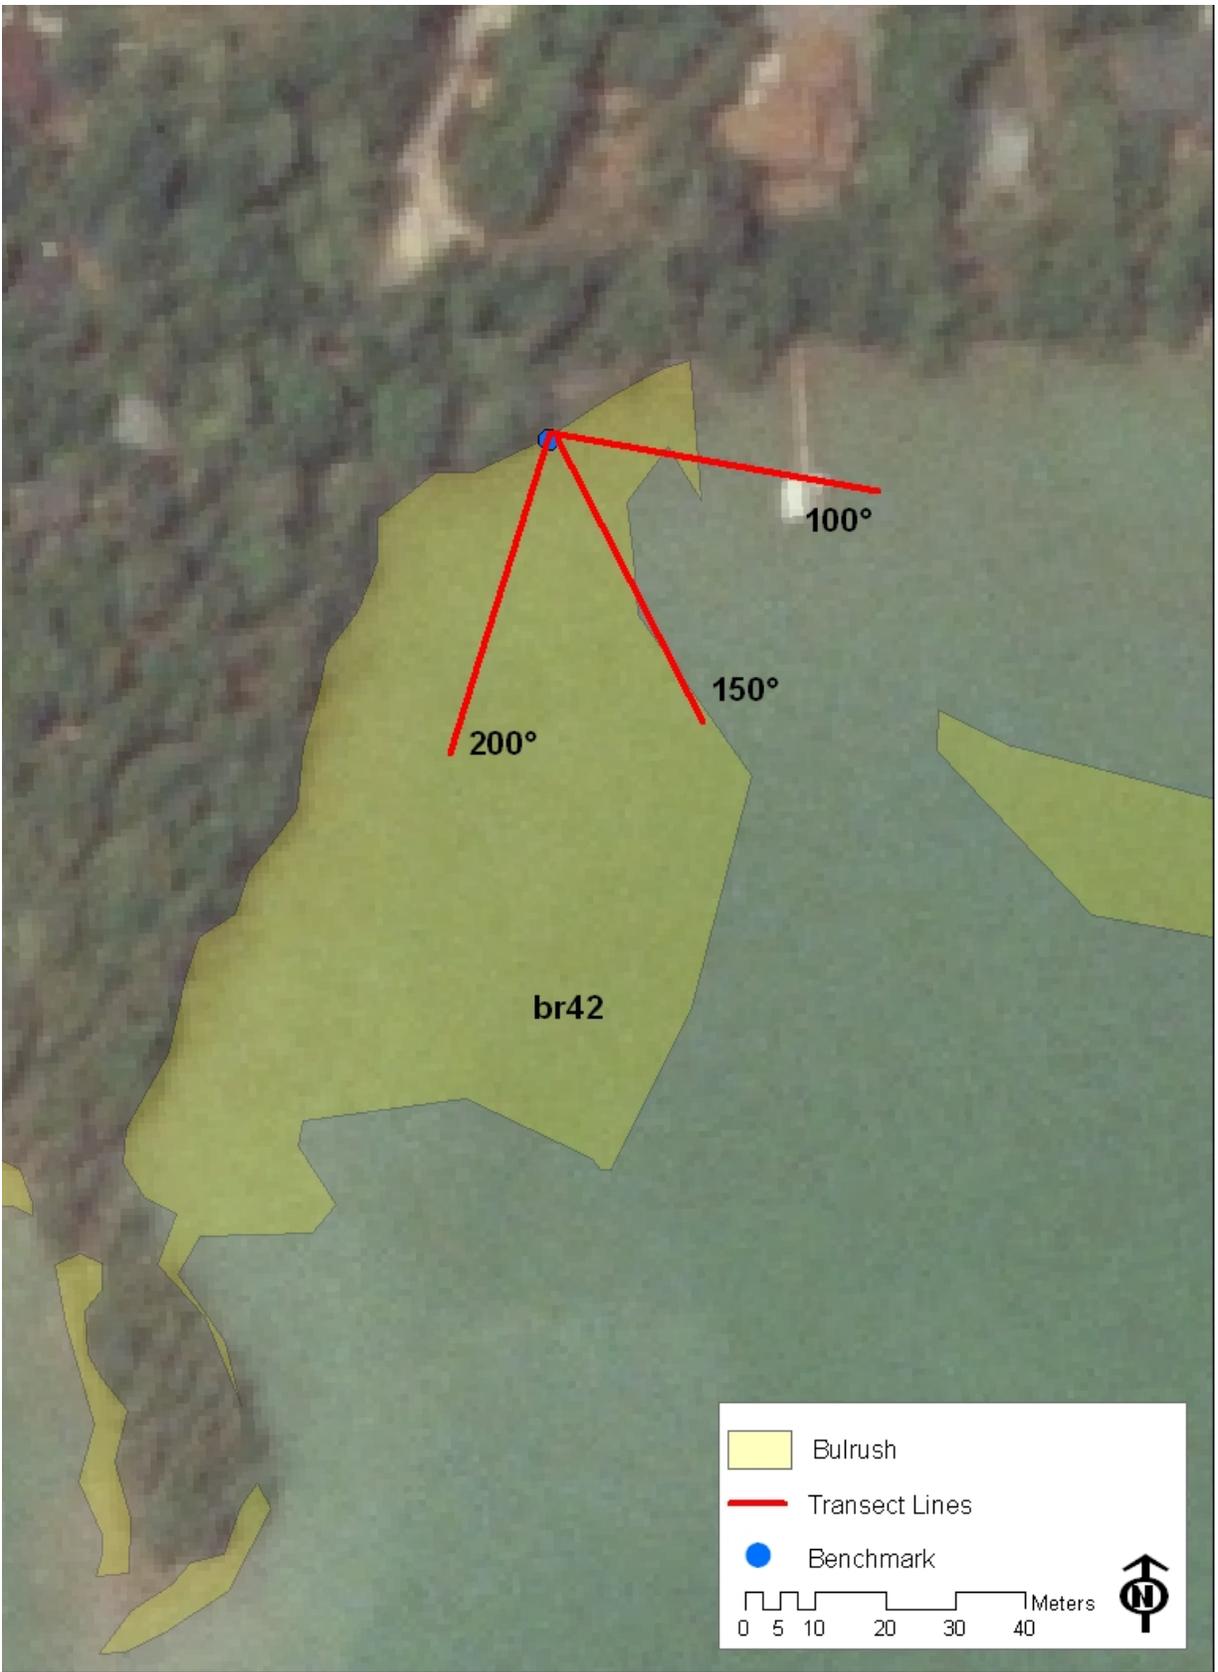
Figure 13. Aerial photo highlighting bulrush Area#4.

The benchmark is an aspen tree overhanging the water with an attached duck house (Figure 12), just west of Tom Cassidy’s house located on the northeast shore of the lake at 5522 Clark Lake Dr Sturgeon Bay, WI 54235. Area#4 lies within bulrush bed “br42”—See Figure 13.

--Within bulrush bed "br42"—See Figure 13.

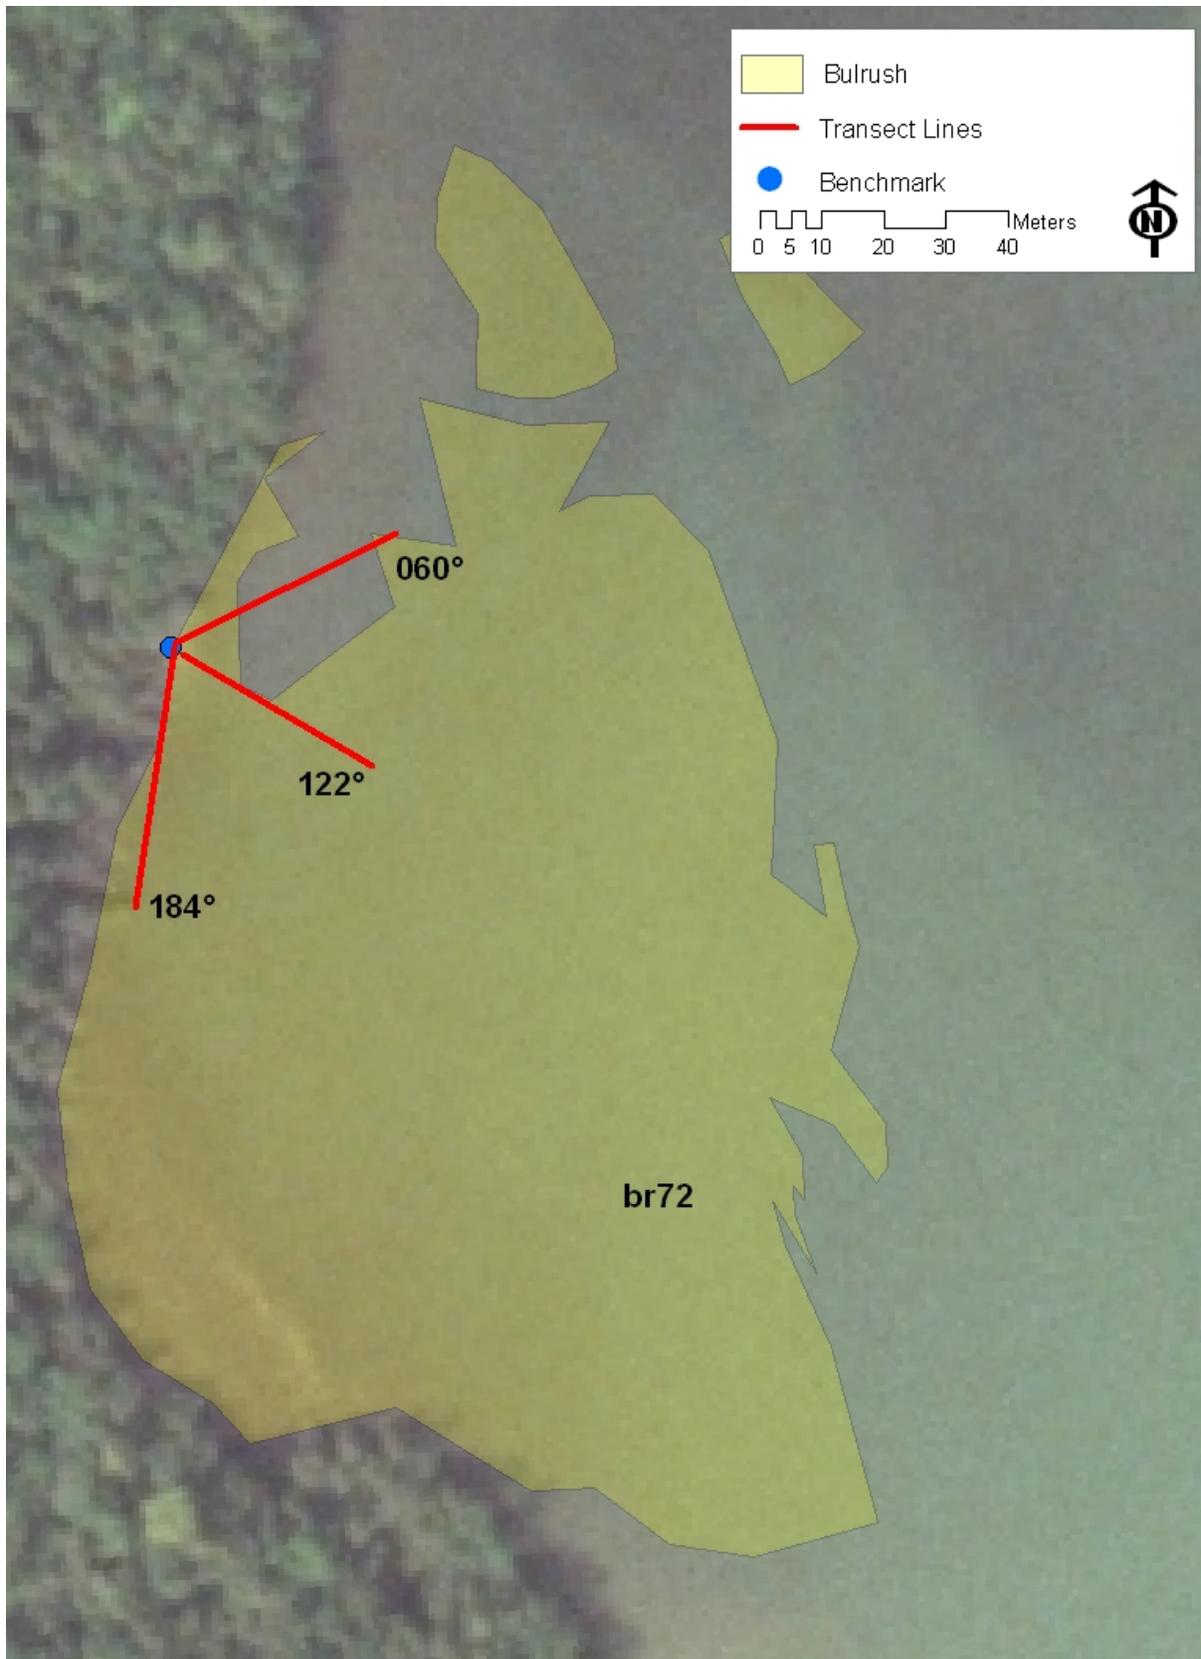
Figure 15. Aerial photo highlighting bulrush Area #5.

The benchmark is a metal pole (Figure 14) under the northeast corner of Ridges Sanctuary lookout platform (southern of the two present in 2006) on the northwest lake shore. Area#5 lies within bulrush bed “br72”—See Figure 15.

--Within bulrush bed “br72”—See Figure 15.

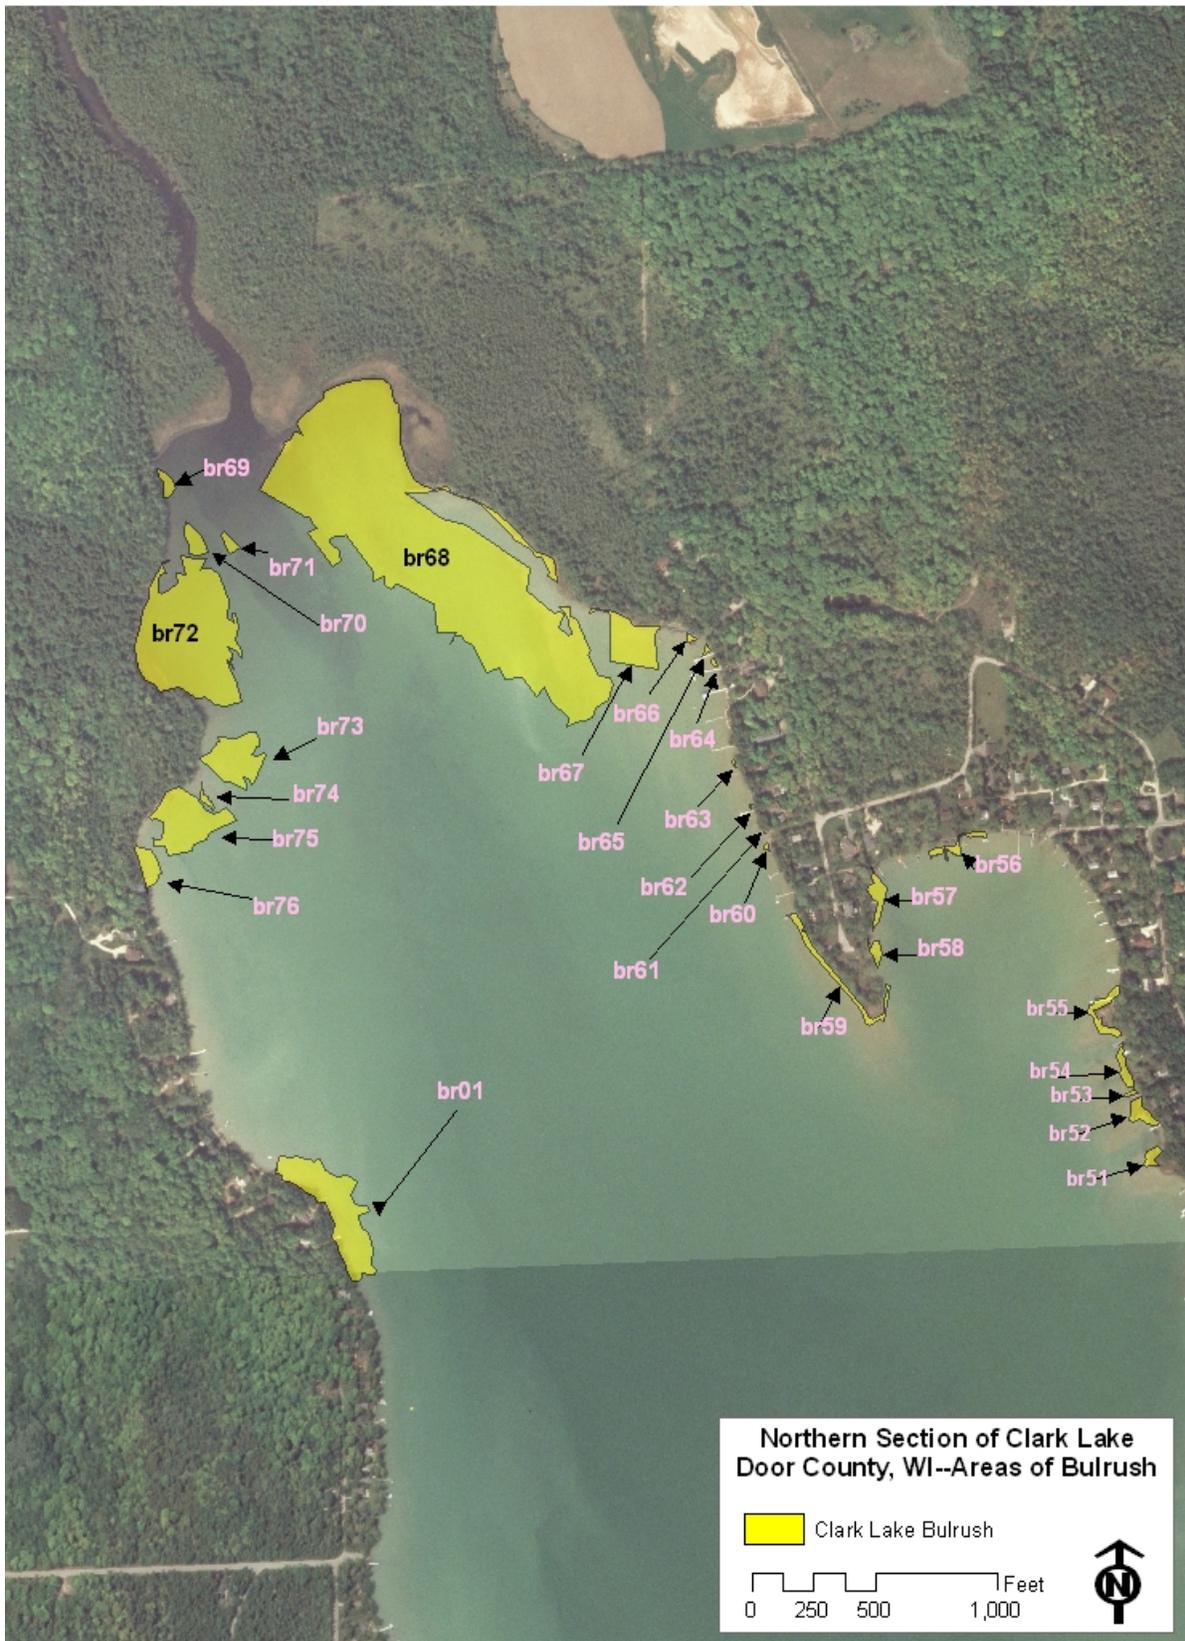
Figure 16. Aerial photo--northern area of Clark Lake's bulrush beds (br51 – br01).

Mapping of the bulrush revealed 76 separate beds of bulrush located within Clark Lake covering approximately 10.5% of the lake. All of the beds are represented in one of three sections of Clark Lake (See Figures 16-18). Detailed descriptions of each bed are found in Appendix B. Additionally, individual areas for each bulrush bed are given in Appendix C.

* See Figures Figure 16, Figure 17, Figure 18 for the location of beds on Clark Lake.
