Quantitative Instream Low Flow Characteristics Among Habitat Types in the Pewaukee Lake Tributaries: 2012 and 2015 Table A.3

NATURAL AND STRUCTURAL MEASURES **FOR SHORELINE STABILIZATION** APPENDIX B

STREAM CROSSING DESCRIPTION, LOCATION, CONDITION, FISH PASSAGE, AND NAVIGATION RATING ASSESSMENT IN THE PEWAUKEE LAKE TRIBUTARIES: 2012 AND 2015

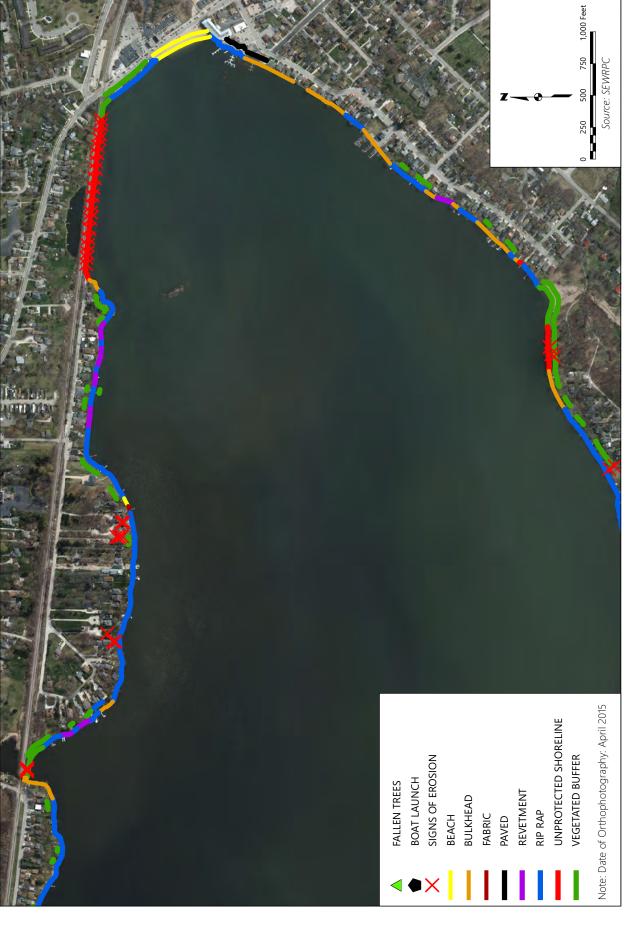
Map C.1

Map 2.22 - Inset 1 (Eastern Pewaukee Lake Shoreline Conditions: 2015)

1,000 Feet 750 Source: SEWRPC 200 0 250 Note: Date of Orthophotography: April 2015 UNPROTECTED SHORELINE VEGETATED BUFFER SIGNS OF EROSION **BOAT LAUNCH** FALLEN TREES REVETMENT BULKHEAD RIP RAP BEACH FABRIC PAVED

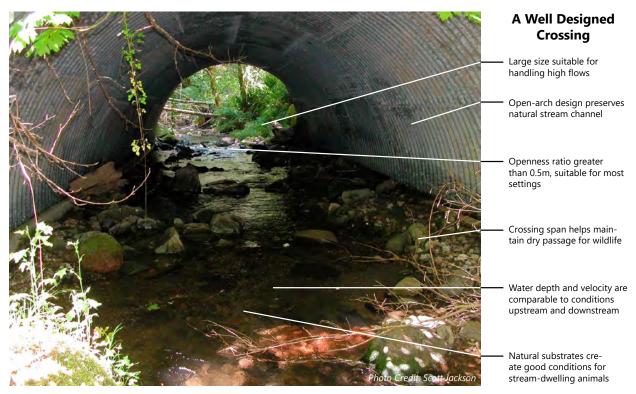
Figure E.3 **Key Features that Promote Fish and Wildlife Passage**

Provide Adequate Resting Areas

- Align the culvert with the existing stream alignment (e.g., 90 degree bends at the inlet or outlet should be avoided, even though this will increase culvert length, see Minnesota DNR guidelines).¹⁰
- The low flow culvert should be centered on the thalweg of the channel to ensure adequate depths inside the culvert.
- Provide grade control where there is potential for head-cuts that could degrade the channel.
- It may be necessary to install riprap protection on the outside bank below the outlet to reduce bank erosion during high flow events.
