Urban Nonpoint Source Construction

Final Report

Urban Nonpoint Source & Storm Water Construction & Targeted Runoff Management Small-scale Urban TMDL Grant Program

Project & Location											1000年高品品	
Governmental Unit Na	ame			1	Grant Numb	er						
Garners Creek Stori	m Water Utility				USC-LF03	-449	01-15	5				
Project Name												
2015 Stream Bank I	Erosion Control I	Projects										
County			Water	shed Name			12-0	igit HUC				
Outagamie			Plum	& Kankapo	t Creeks		040	3020402	05			
Project Contact Name			Phone	Number			E-m	ail Addres	ss			
Joe Stephenson			500 =	(920) 78	8-7740		step	hensonj(@combi	nedlocks	s.org	
For a project with	multiple site locati	ions, an	aerial p	ohoto map is	attached wi	th eac	h site	location l	abeled.			
Site Location - 1	是 5000000000000000000000000000000000000	NEW Y	Add	litional sites	may be ad	ded t	o the	project	by clicki	na the T	+ Loc] button.	
Site Name				itional oftoo	Nearest Re				ay onom			
431 Hidden Ridges	Way			0.	Garners C	reek						
Quarter/Quarter	Quarter	Sect	ion	Township	Range	E/	w	Lat	itude		Longitude	
SW	SW	2	7	21	18	E		44.25832		1	-88.3195

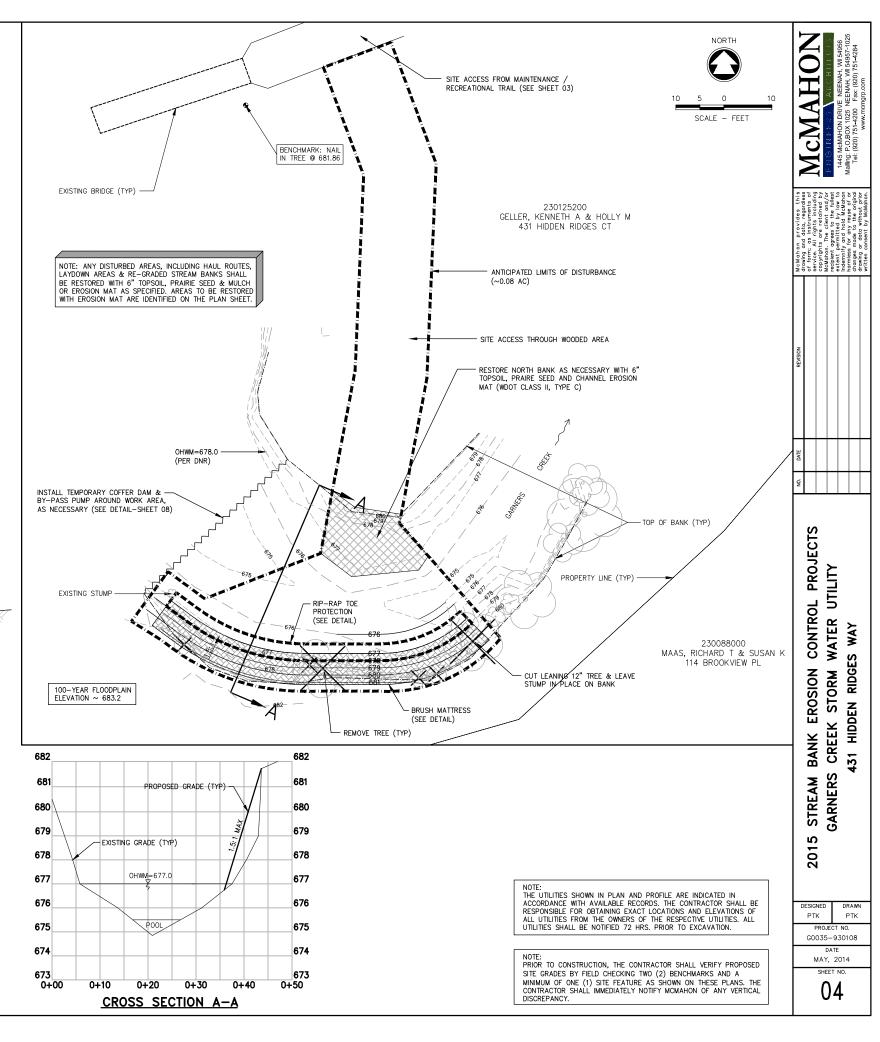
BRUSH MATTRESS DETAIL

STREAMBANK SHALL BE ROUGH GRADED & TRENCH EXCAVATED PRIOR TO PLACING BRUSH MATTRESS & RIP-RAP

- BRUSH CUTTINGS SHALL BE 1/2" TO 1" IN DIAMETER AND RECENTLY HARVESTED. CUTTINGS SHALL CONTAIN MINIMUM 50% WILLOW, DOGWOOD OR OTHER APPROVED ADVENTITIOUSLY ROOTABLE STOCK WITH UP TO 50% DEAD MATERIAL ALLOWED. RECENTLY HARVESTED BUCKTHORN MAY BE

- USED IN PLACE OF DEAD MATERIAL IF DESIRED.
 WEDGE STAKES SHALL BE DRIVEN INTO STREAMBANK PRIOR TO PLACING THE BRUSH CUTTINGS & SHALL EXTEND 8"-10" MIN.

- BRUSH CUTTINGS SHALL BE PLACED AGAINST THE FACE OF THE STREAMBANK WITH THE BASAL (CUT) ENDS PLACES IN THE TRENCH & THE GROWING TIPS EXTENDING SLIGHTLY PAST THE TOP OF BANK. THE BRUSH CUTTINGS BRANCHES SHOULD BE RETAINED & SHOULD OVERLAP IN A SLIGHT CRISSCROSS PATTERN. BRUSH CUTTINGS SHALL BE PLACED AS TIGHTLY AS POSSIBLE TO EACH OTHER TO A MINIMUM THICKNESS OF 4".

WASH LOOSE SOIL INTO THE MATTRESS BETWEEN AND AROUND THE BRUSH CUTTINGS SO THAT THE BOTTOM HALF OF THE CUTTINGS ARE
 COVERED WITH 3"-4" LAYER OF SOIL.
- BACKFILL TRENCH WITH GEOTEXTILE FABRIC AND RIP-RAP AS SPECIFIED.

- E. ONCE WORK AREA IS ISOLATED FROM STREAM FLOWS, CONTRACTOR MAY DRIVE LOW WEIGHT BEARING EQUIPMENT ON THE STREAM BED TO PERFORM THE WORK IN CONFORMANCE WITH APPLICABLE PERMITS. EQUIPMENT MUST HAVE NO LEAKS AND SHALL UTILIZE BIODEGRADABLE NON-PETROLEUM BASED FLUIDS SUCH AS VEGETABLE OIL IF WORKING BELOW THE OHWM. REMOVE IDENTIFIED TREES AND BEGIN PROPOSED GRADING OF STREAMBANKS AS DEPICTED ON CONSTRUCTION PLANS. MINIMIZE THE AMOUNT OF SOIL EXPOSED AT ANY ONE TIME. INSTALL BRUSH MATTRESS WITH RIP-RAP TOE PROTECTION PER THE CONSTRUCTION PLANS & DETAILS.
