March 8, 2006

RE: Way Dam Hydroelectric Project, FERC No. 1759-036
Article 418-Low Dissolved Oxygen Mitigation- 2005 Progress Report

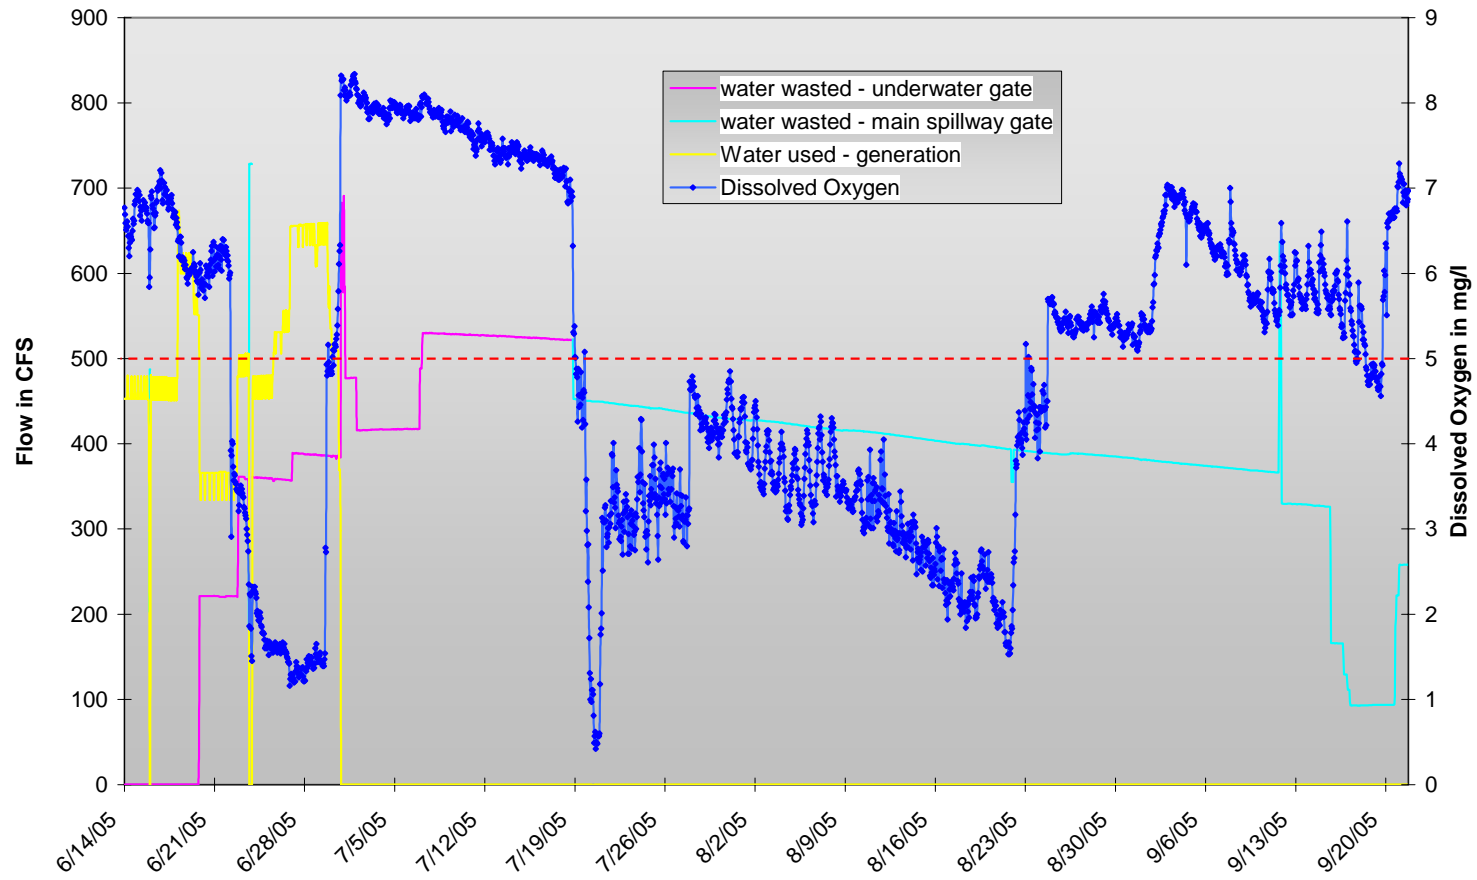
Figure 1 DO continuous monitoring vs. water use, June-September, 2005

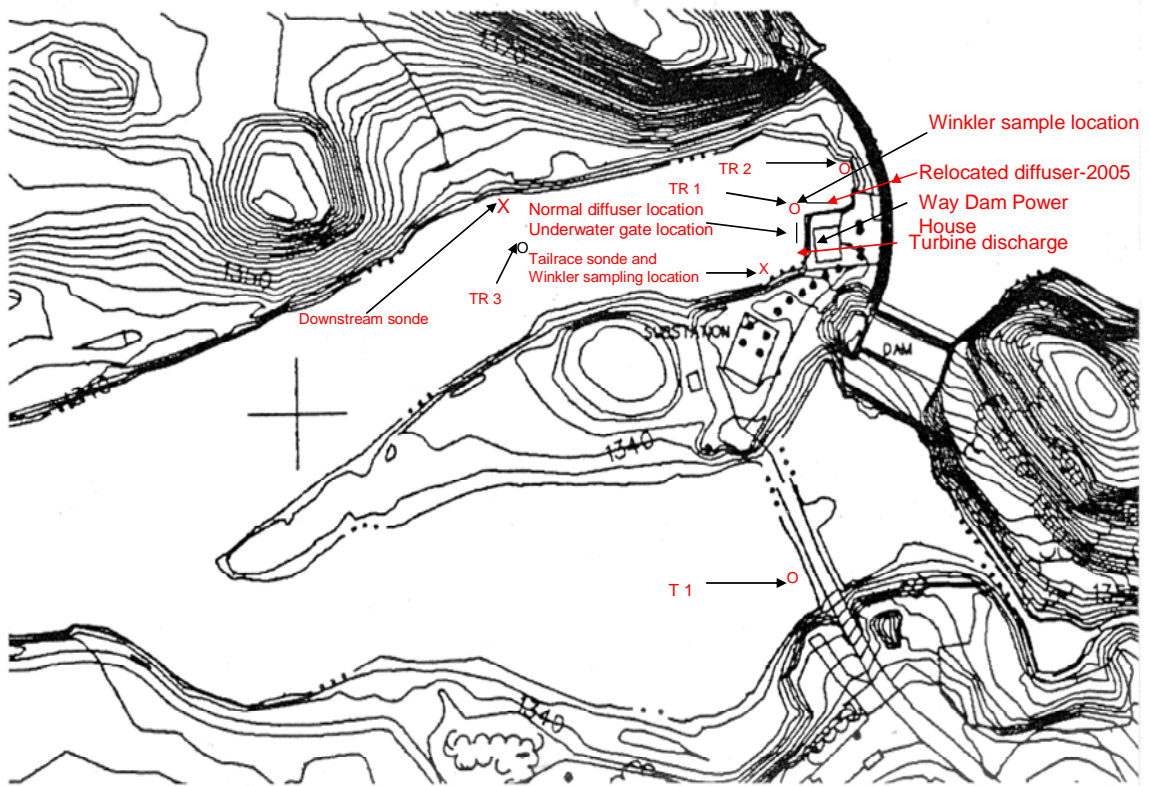
Figure 1 Location of vertical profile measurements (O), continuous recording data sondes (X) during 2005

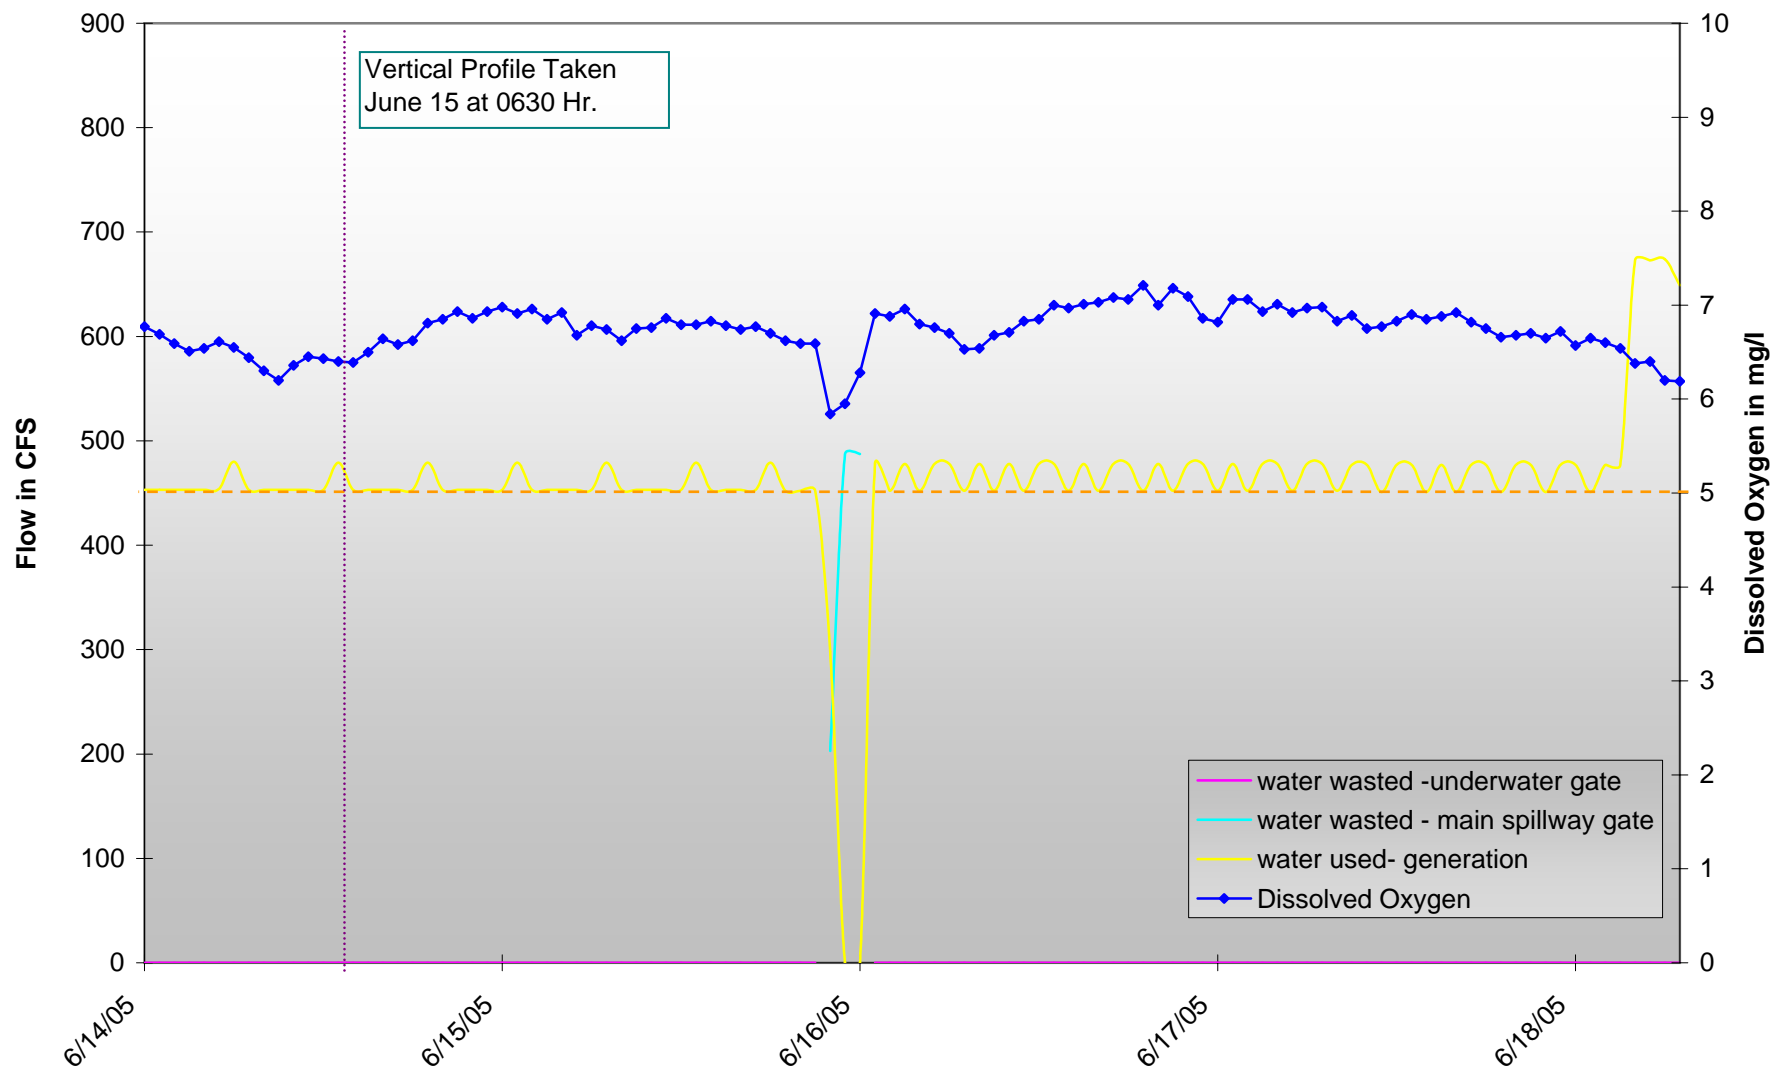
Appendix A, Figure 1
 Way Dam Tailrace DO vs Underwater Gate Flow, Week of June 14, 2005

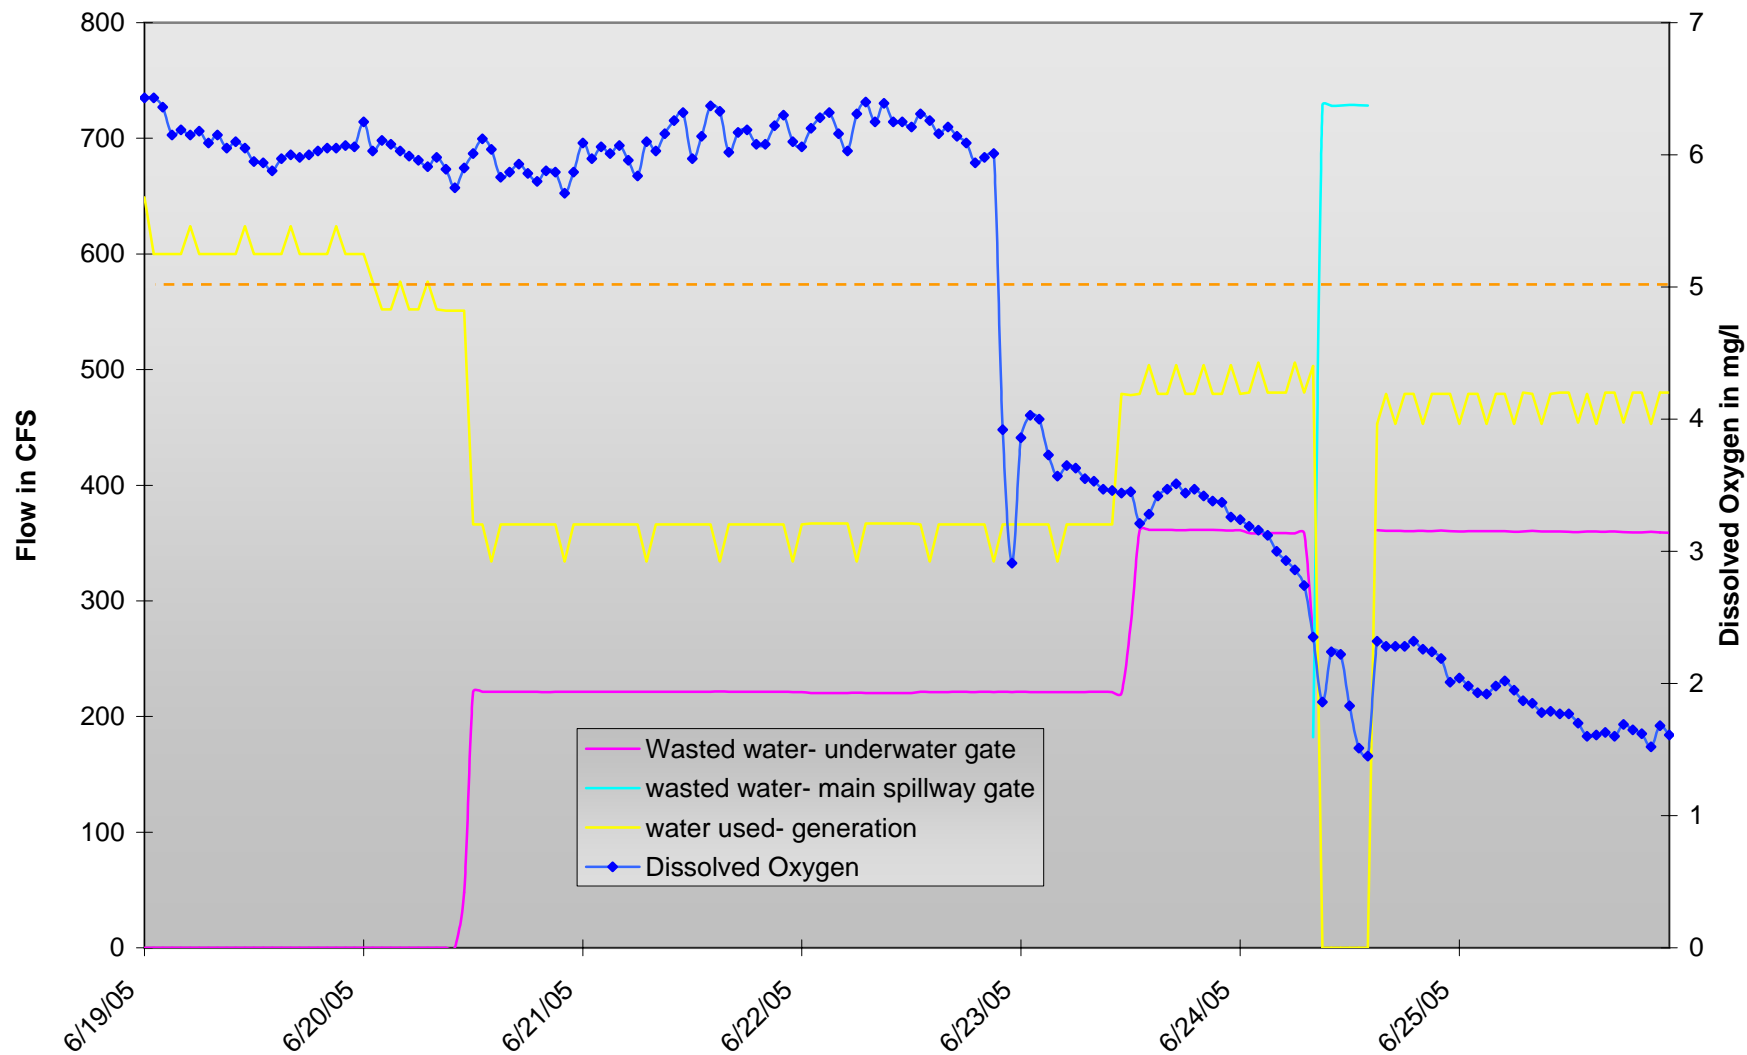
Appendix A, Figure 2
 Way Dam Tailrace DO vs. Underwater Gate Flow, Week of June 19, 2005

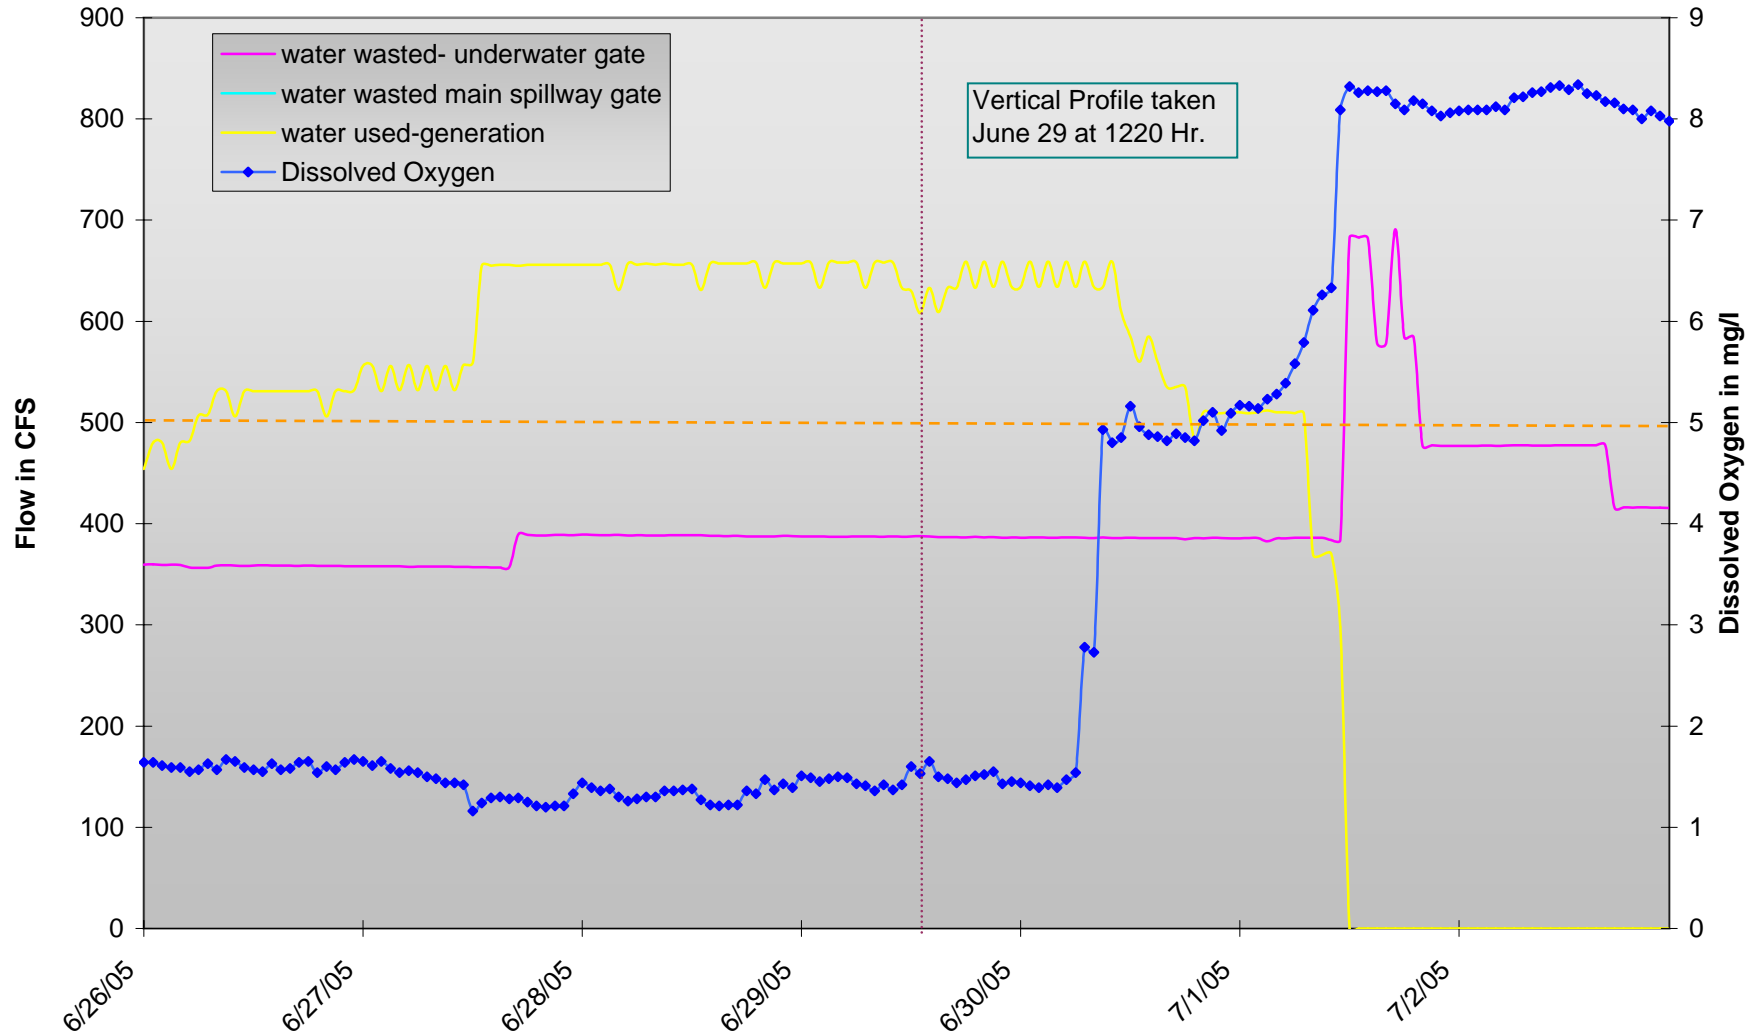
Appendix A, Figure 3
Way Dam Tailrace DO vs Underwater Gate Flow, Week of June 26, 2005

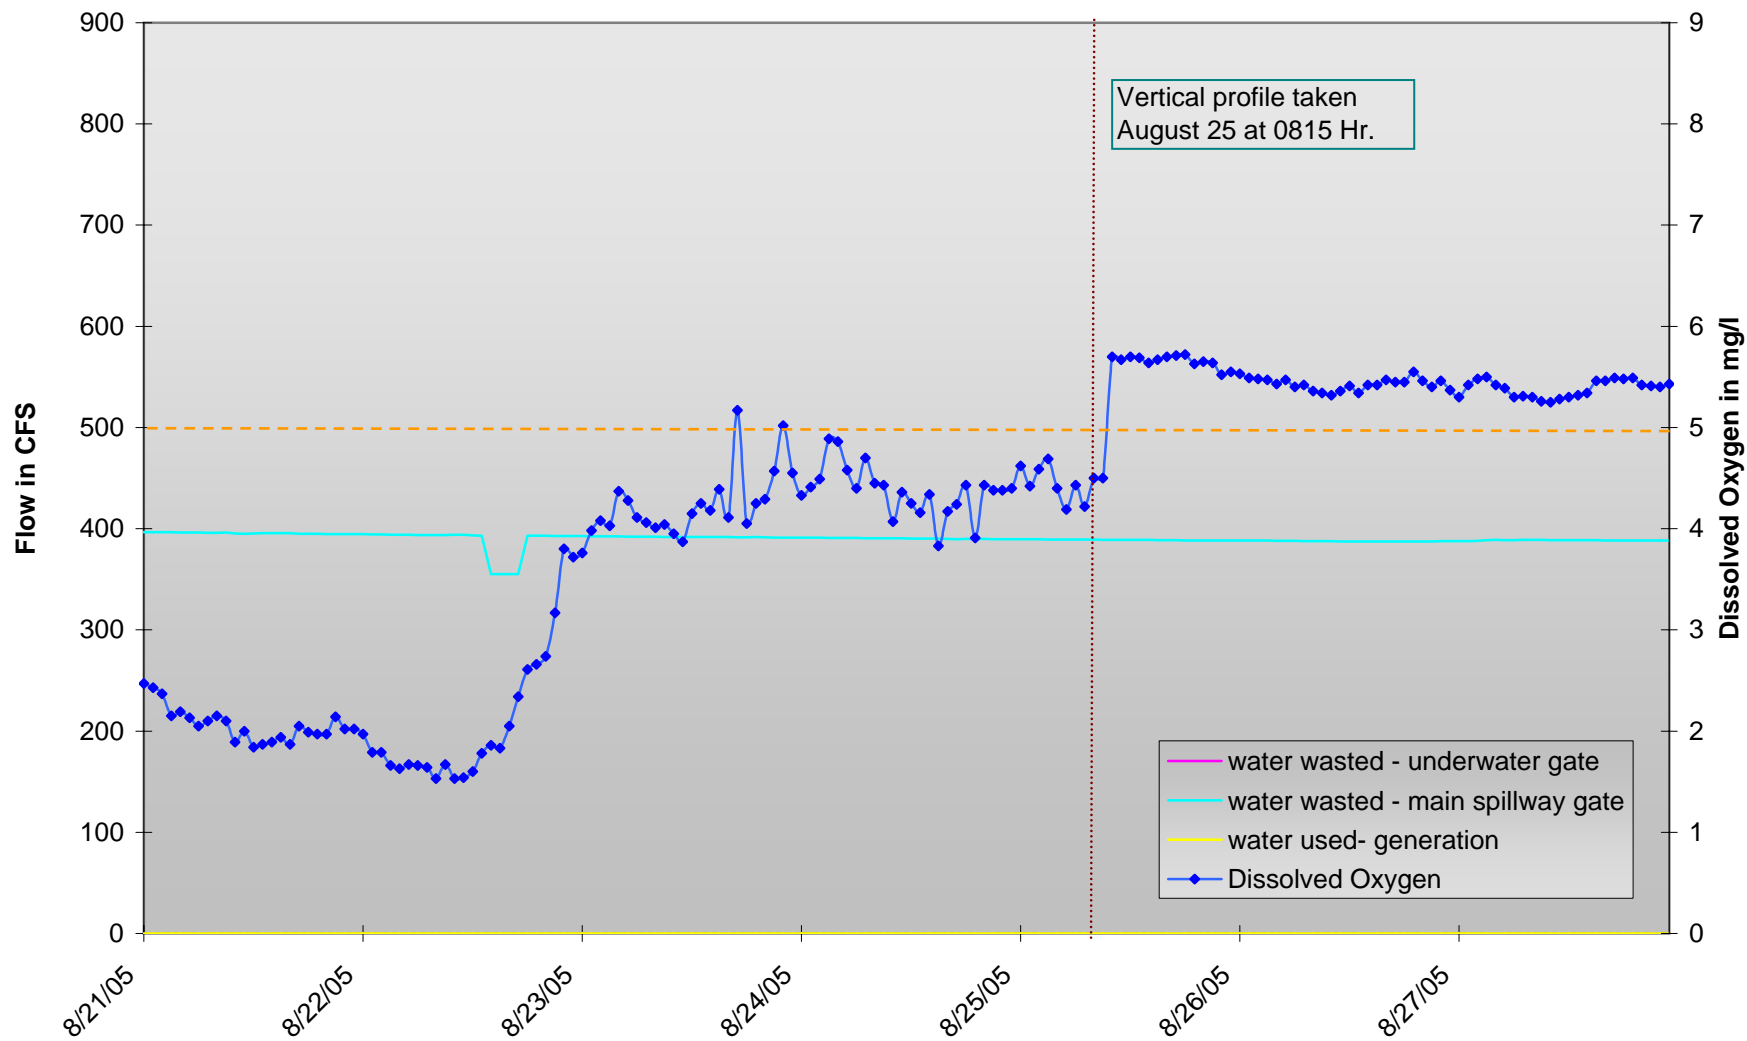
Appendix A, Figure 11
 Way Dam Tailrace DO vs Underwater Gate Flow, Week of August 21, 2005

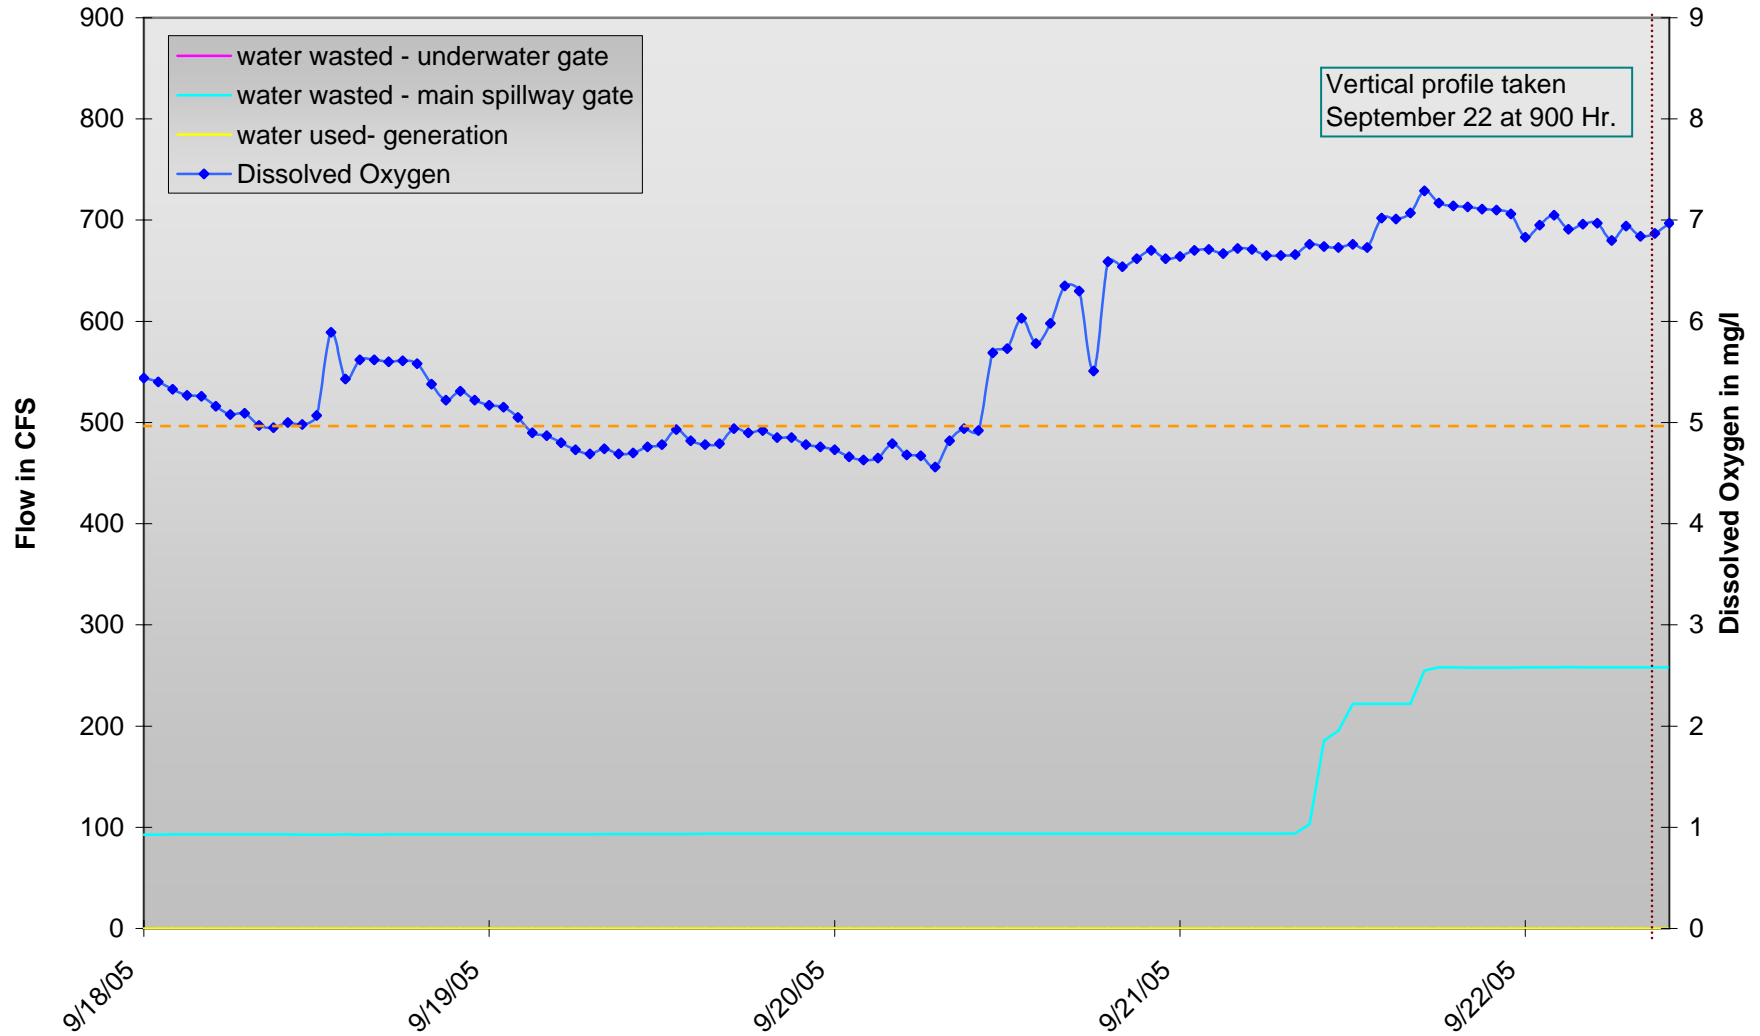
Appendix A, Figure 15
 Way Dam Tailrace DO vs Underwater Gate Flow, Week of September 18, 2005
