SUBJECT: Case Closure with Continuing Obligations Elsinger Property, N4946 County Highway WS, Woodland, WI 53099 BRRTS #: 03-14-219712

#### ENGINEERED CAP BARRIER MAINTENANCE PLAN

Elsinger Property 4946 CTH WS Woodland, Wis. 53099

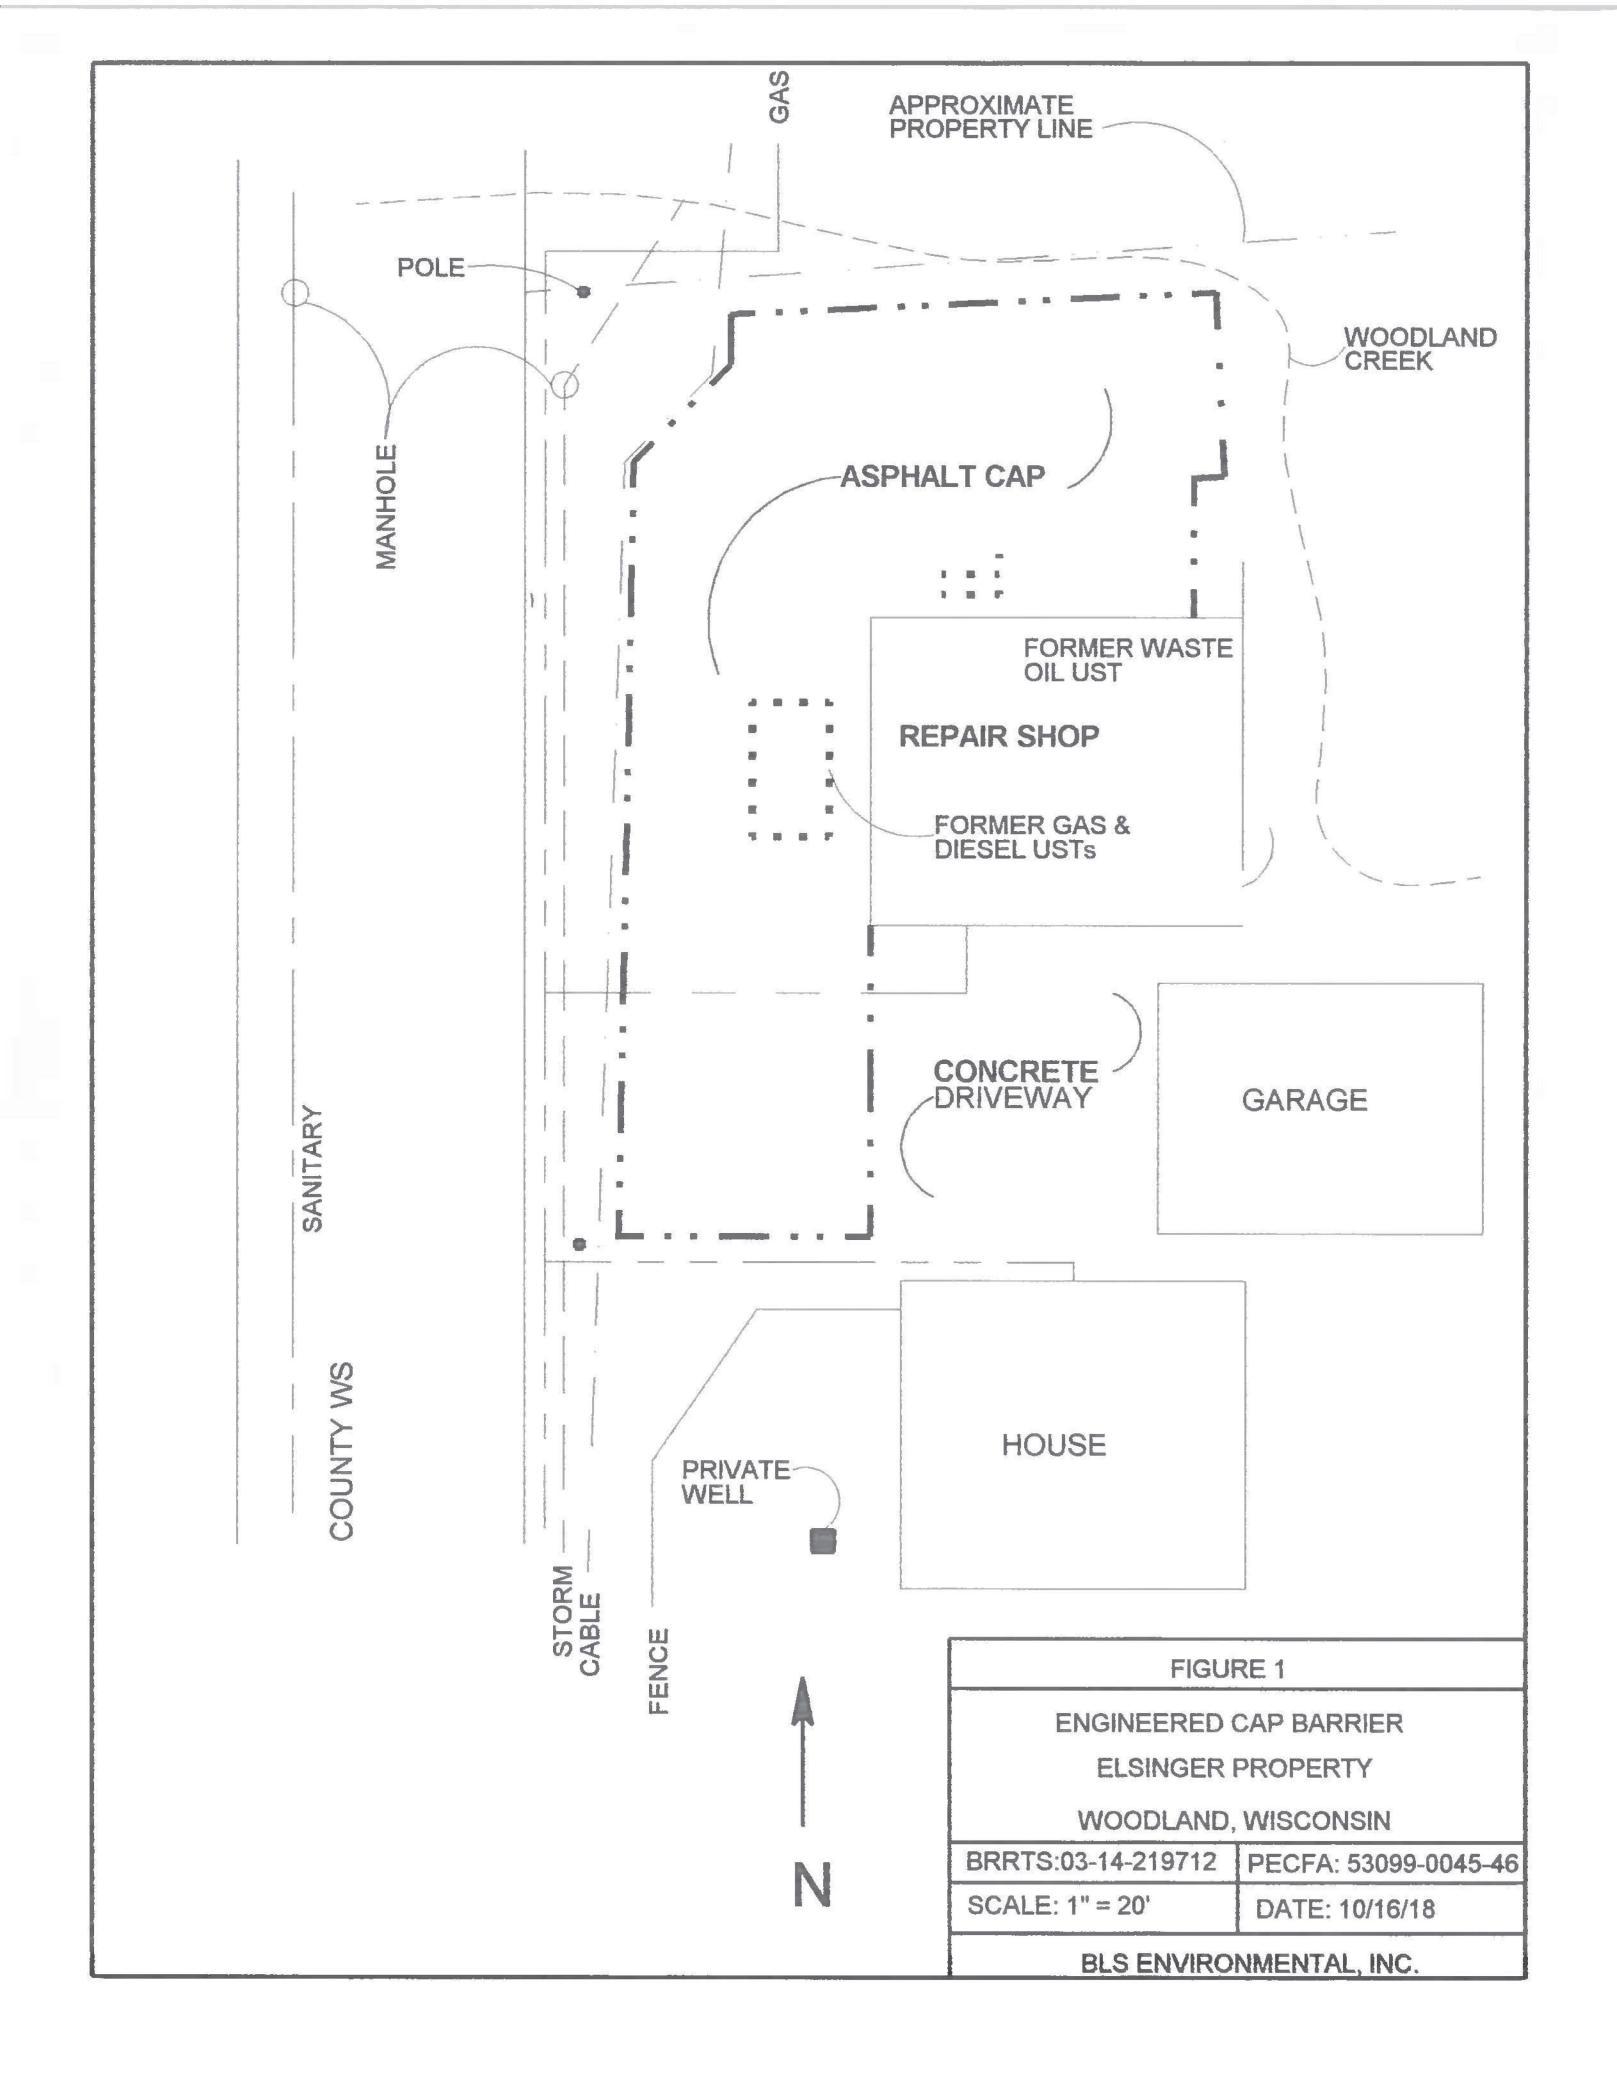
## **EXHIBIT A**

**Engineered Cap Location**

An Asphalt Barrier shall be established and maintained over the Remedial Excavation Area. The Barrier shall be a minimum of three (3) inches thick in the area identified in Exhibit A. Based on the current and future use of the property, the barrier should function as intended unless disturbed.

The Engineered Cap overlying the impacted soil/groundwater and as depicted in Exhibit A will be inspected twice a year, normally in the spring after all snow and ice is gone and late-summer, for deterioration, cracks and other potential problems that can cause additional infiltration into or exposure to underlying

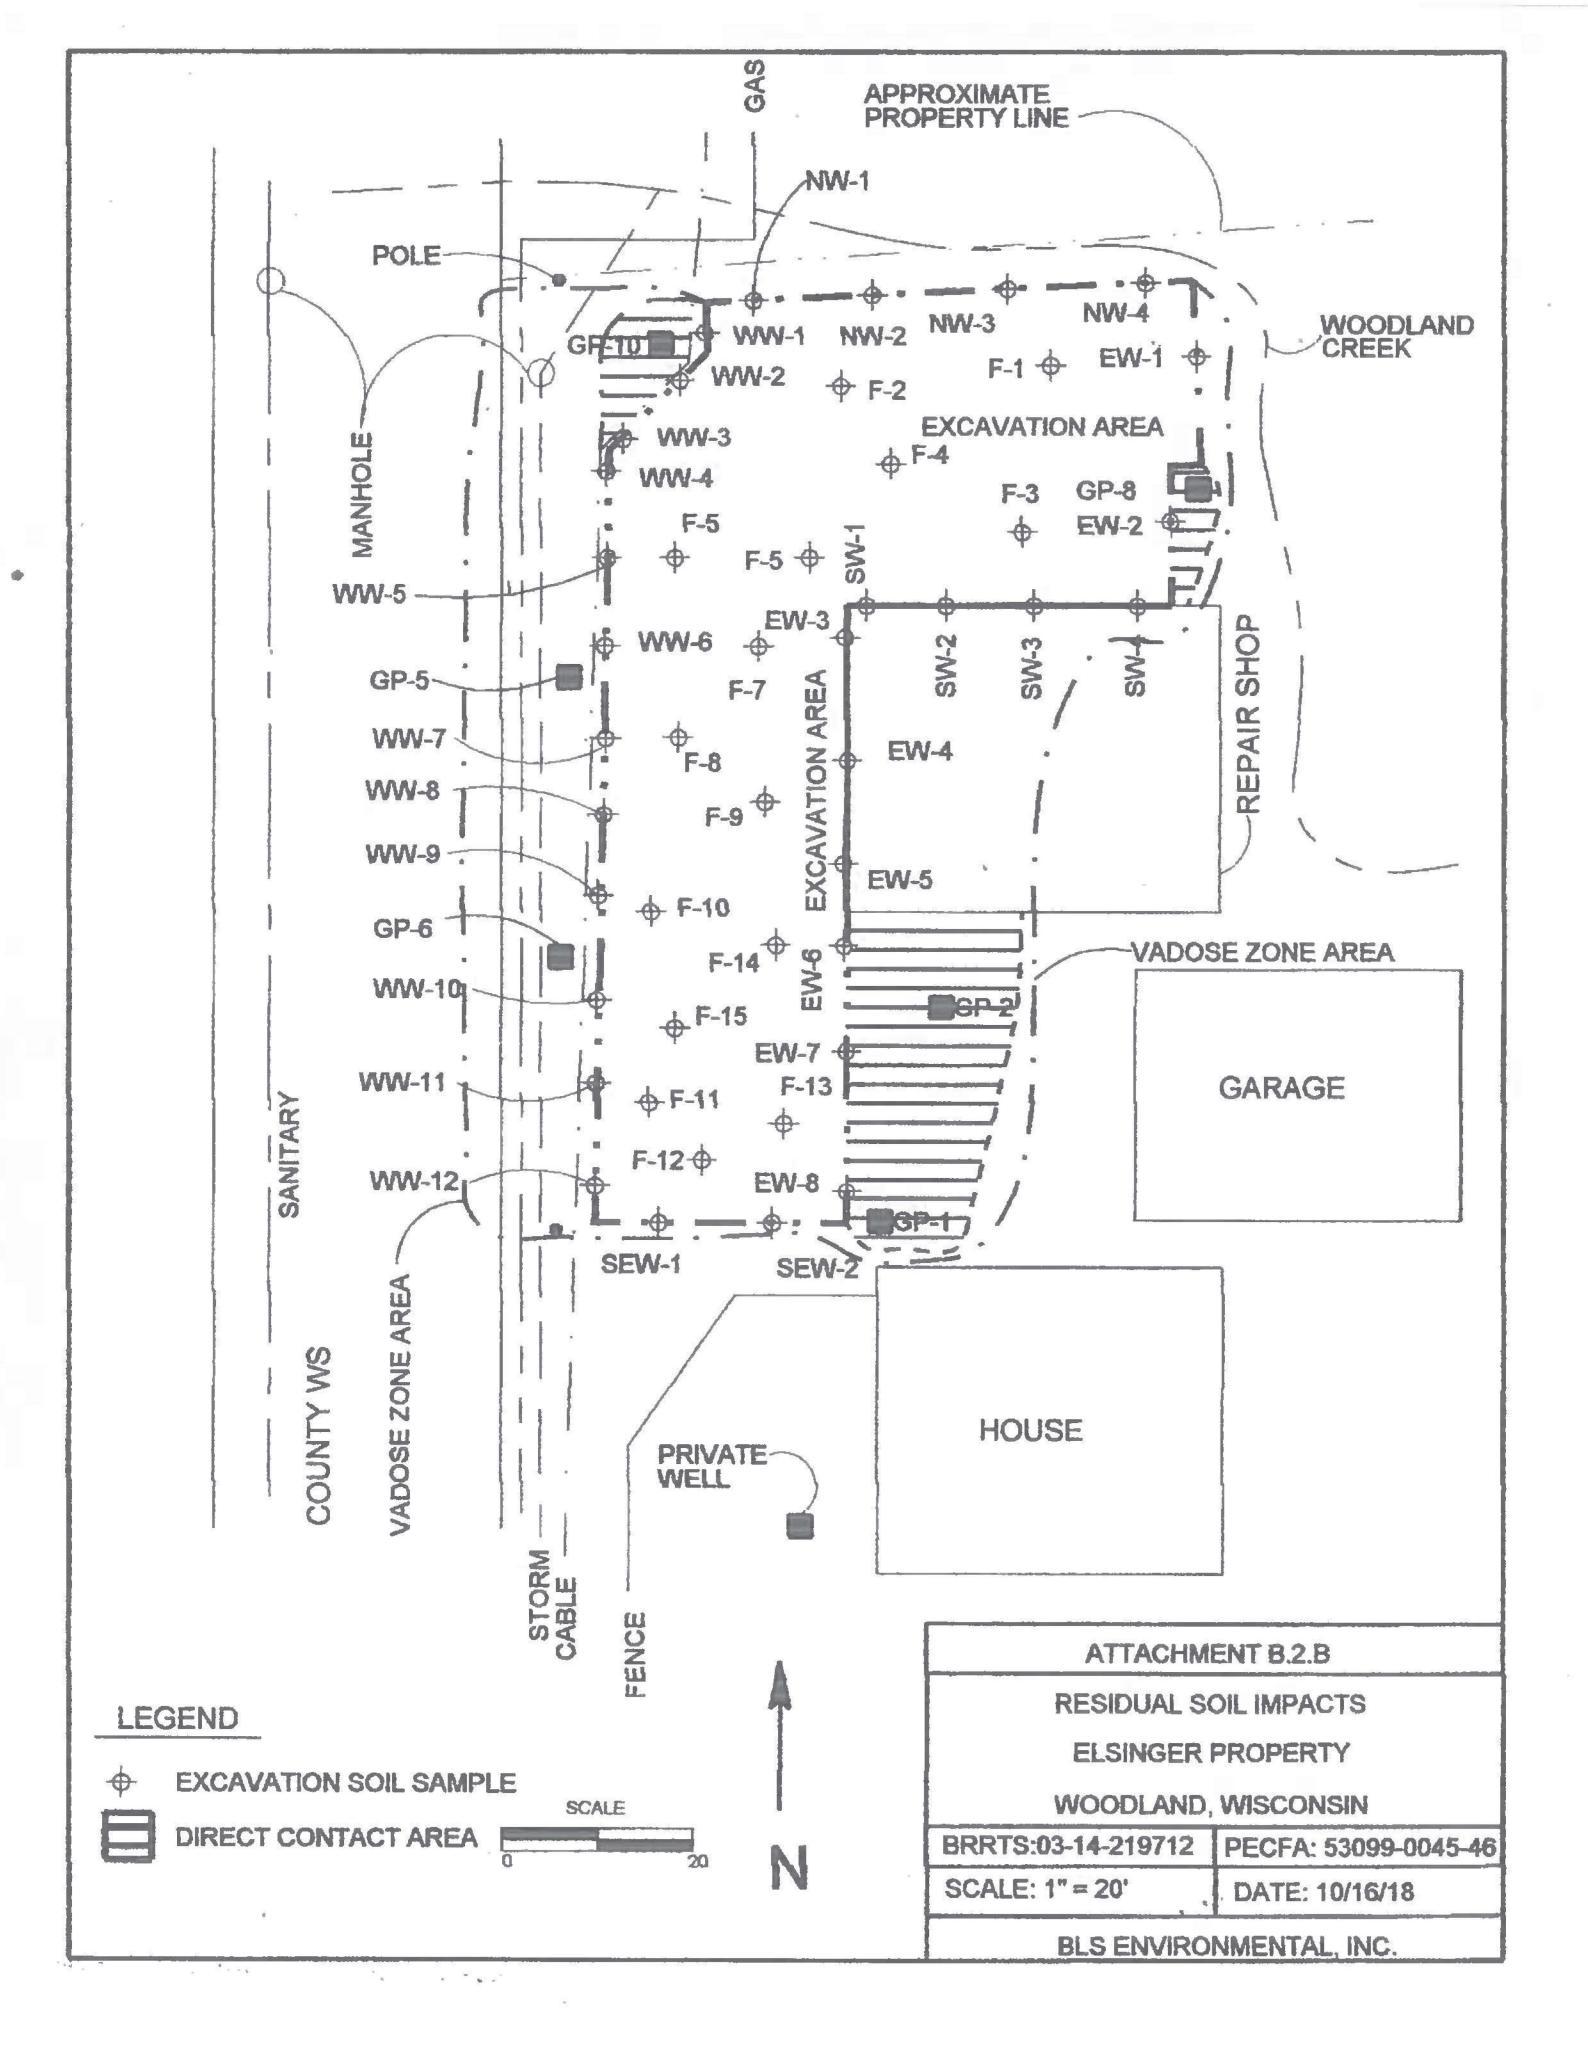
## EXHIBIT B

**Residual Impacted Soil Information**

Lead Ethylbenzene Naphthalene Total Trimethylbenzene Benzene Methyl-tert-butyl-ether Toluene Xylene The location of the Barrier Cap to be maintained in accordance with this Maintenance Plan is presented in Exhibit A (Proposed Cap). The residual impacted soil is presented in Exhibit B, (Residual Direct Contact Soil Impacts and Residual GW Pathway Soil Impacts). Residual impacted soil concentrations are presented on Table 1 (Exhibit B).

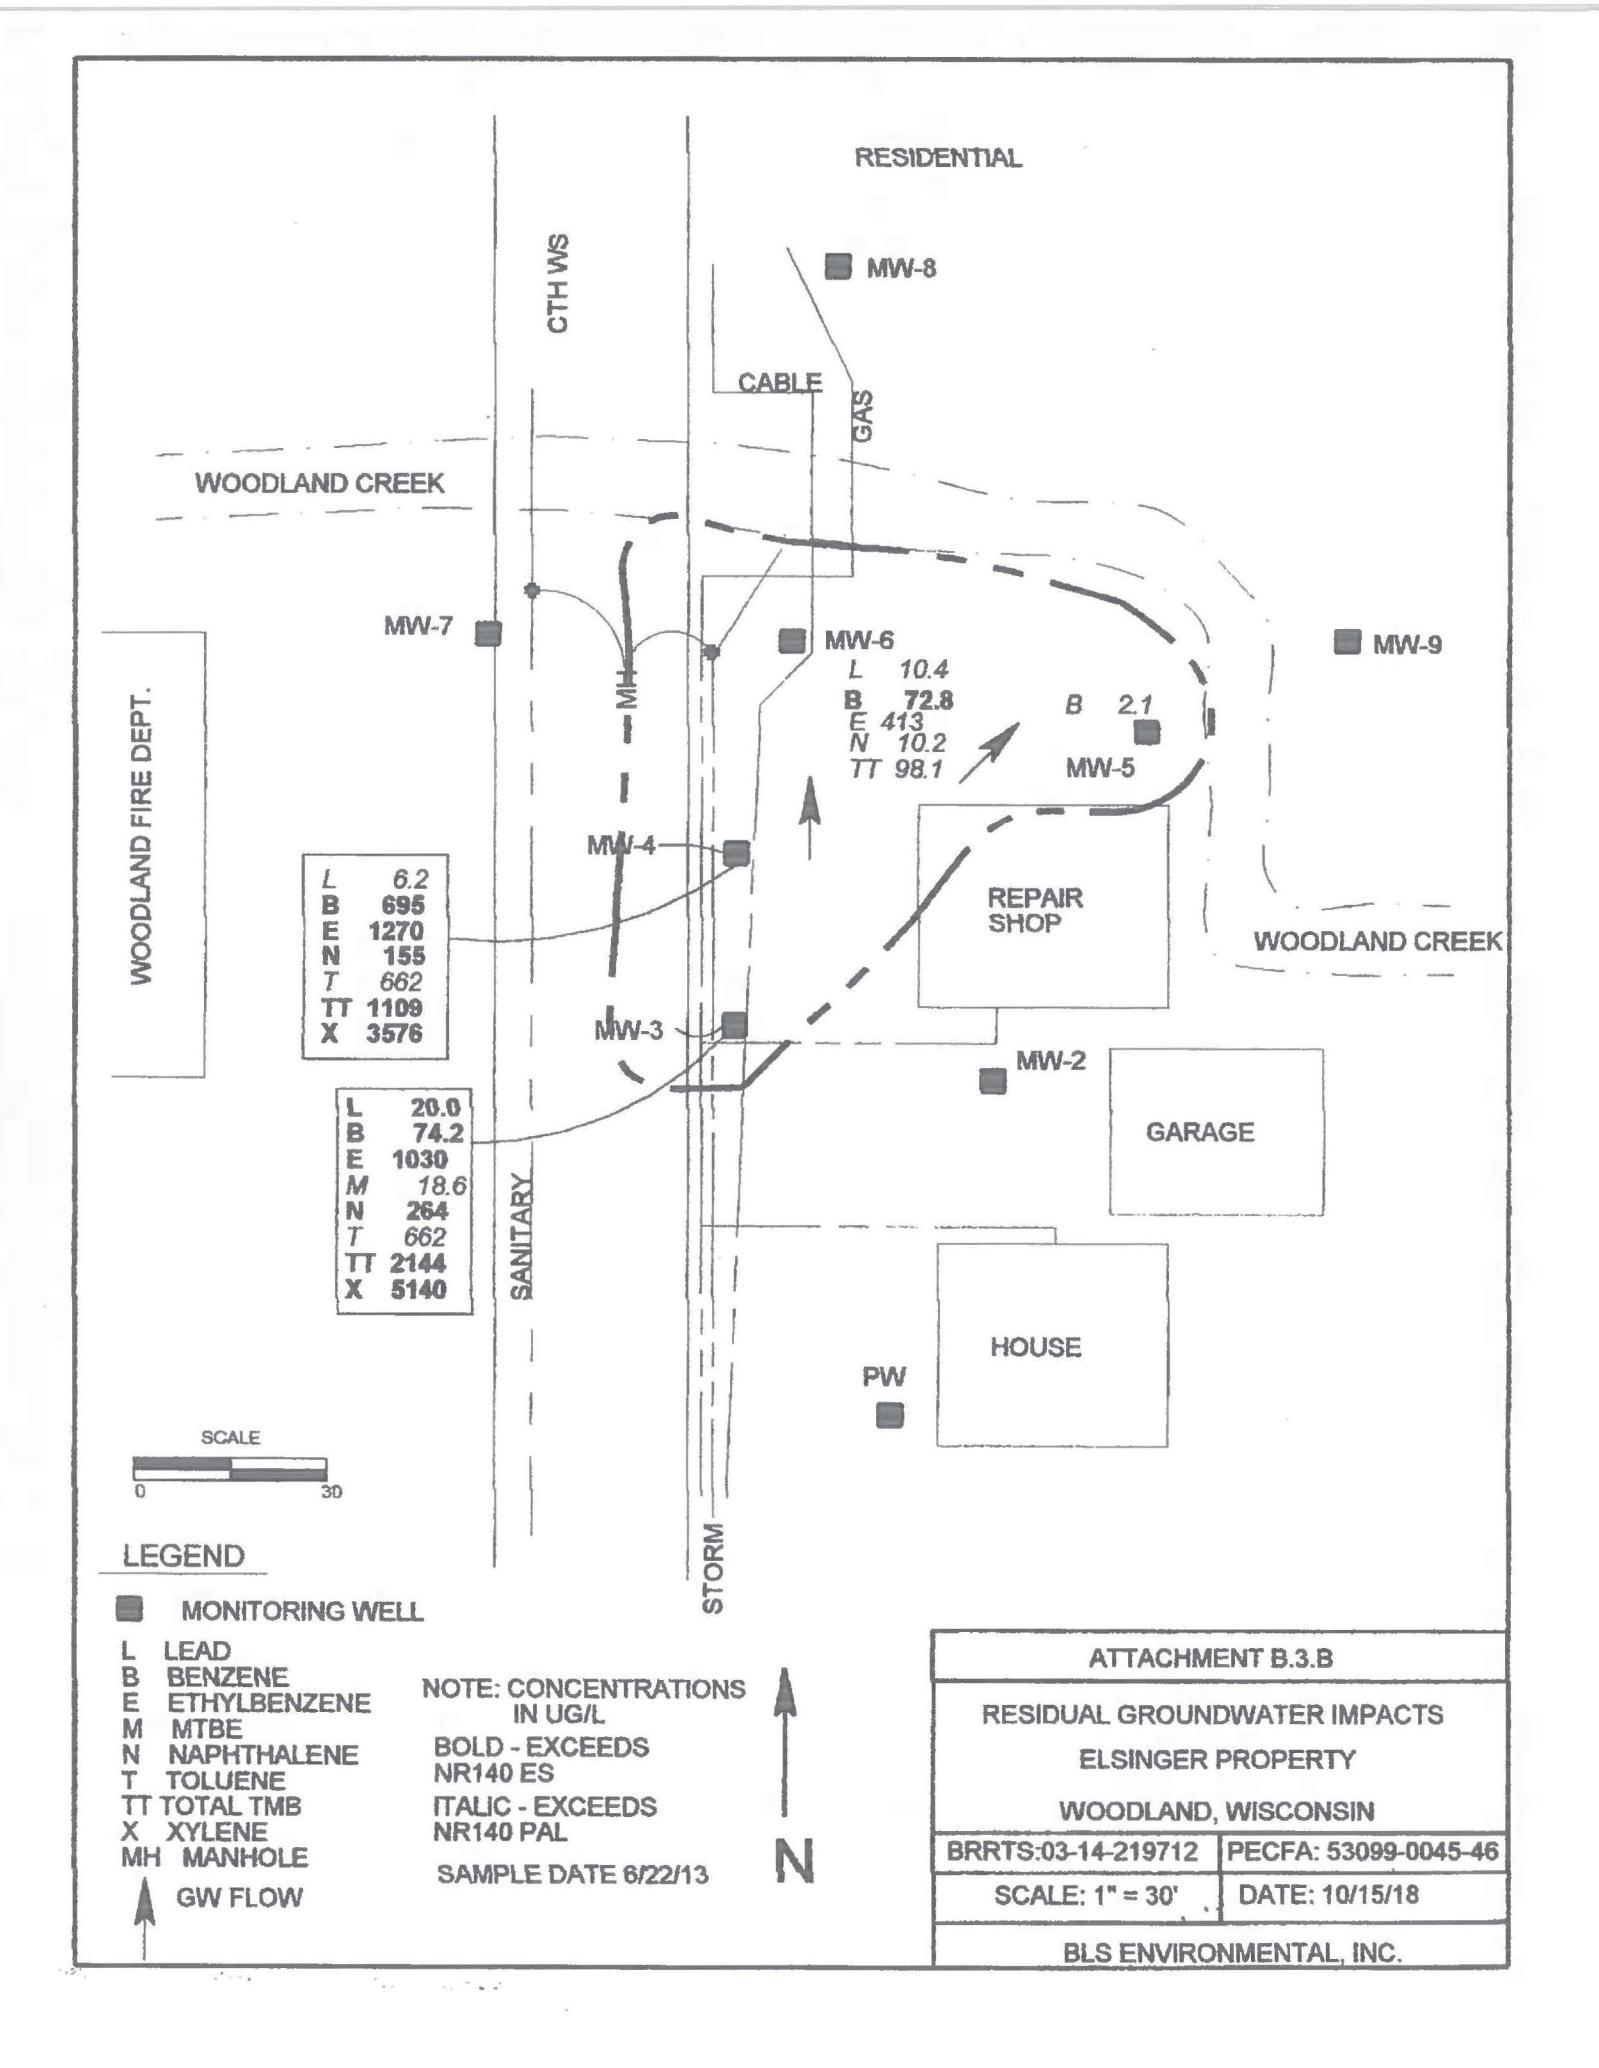
# EXHIBIT C

### **Residual Impacted Groundwater Information**

The impacted groundwater is presented in Exhibit C (Residual Groundwater Impacts), with compound concentrations presented on Table 2.

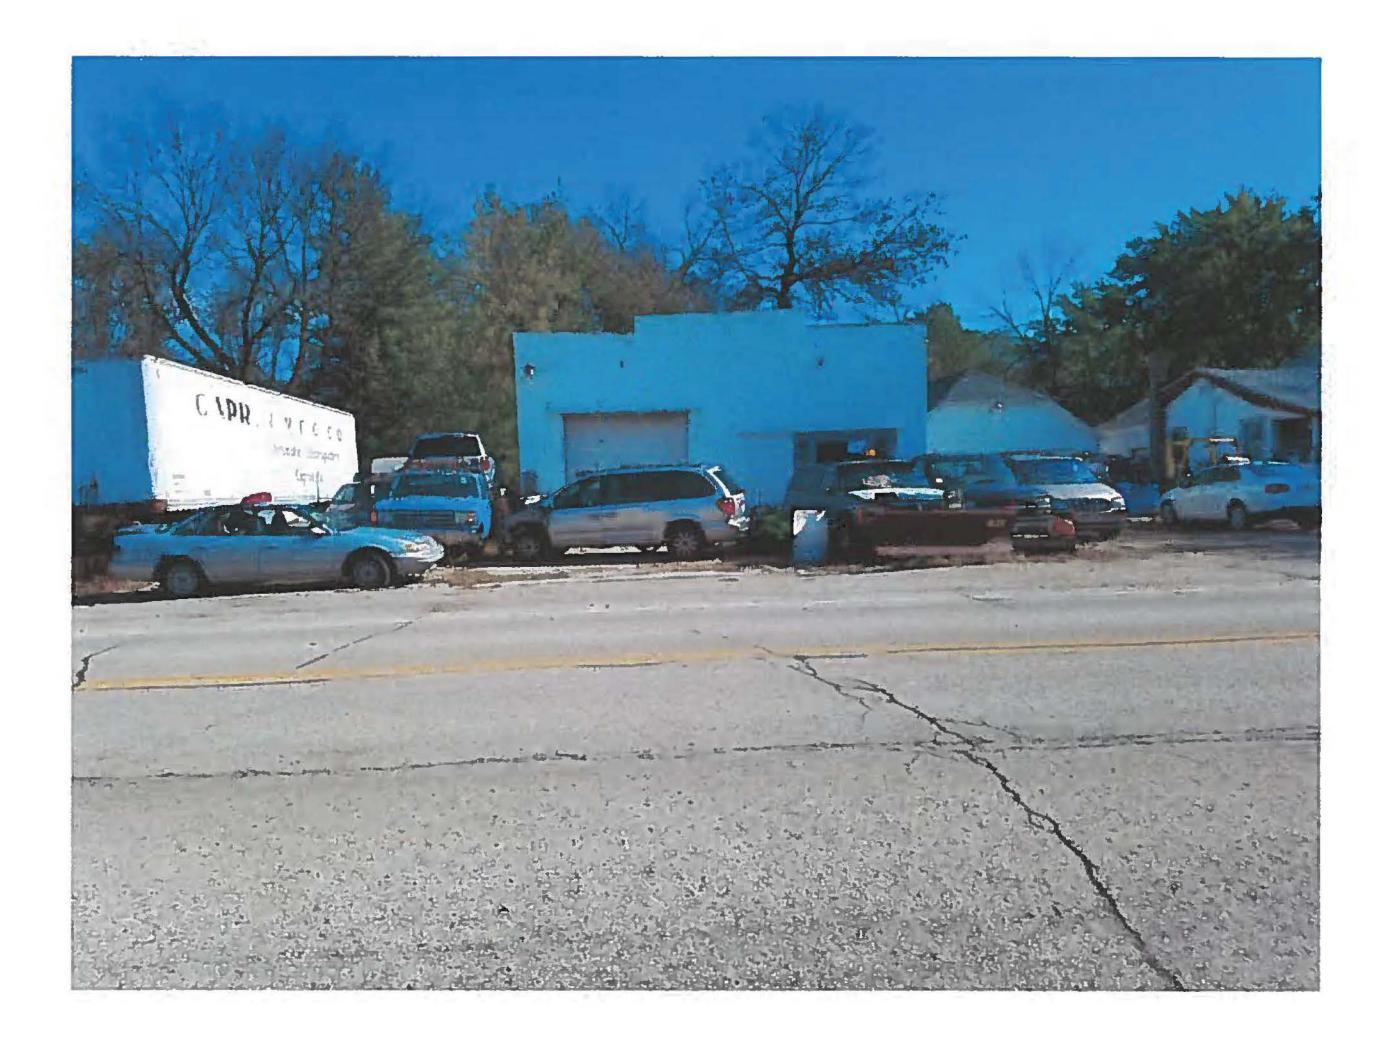
### Photographs of Engineered Cap Barrier Area

Engineered Barrier Cap Area- Cap extends from roadway to the repair shop, and from the house (right) to Woodland Creek (just left of large trailer). The Engineered Barrier Cap would include the area between the repair shop and Woodland Creek for the length of the repair shop (left of repair shop, from front of repair shop to trees at rear of repair shop)

- The cap area extends from the roadway eastward to the repair shop and from the house to north of the repair shop. The cap does not extend across County Highway WS. The attached figure shows the area of the cap.
