Soil Vapor Extraction System: Progress Report and Recommendations

Autostop (former) 119 W. 9th Street North Ladymith, Wisconsin 54848 BRRTS No. 03-55-282548 PECFA No. 54848-1295-19 Meridian No. 05F630

Doug's Tire (former) 811 Lake Ave W. Ladysmith, Wisconsin 54848 BRRTS No. 03-55-000408 PECFA No. 54848-1215-11 Meridian No. 05F786

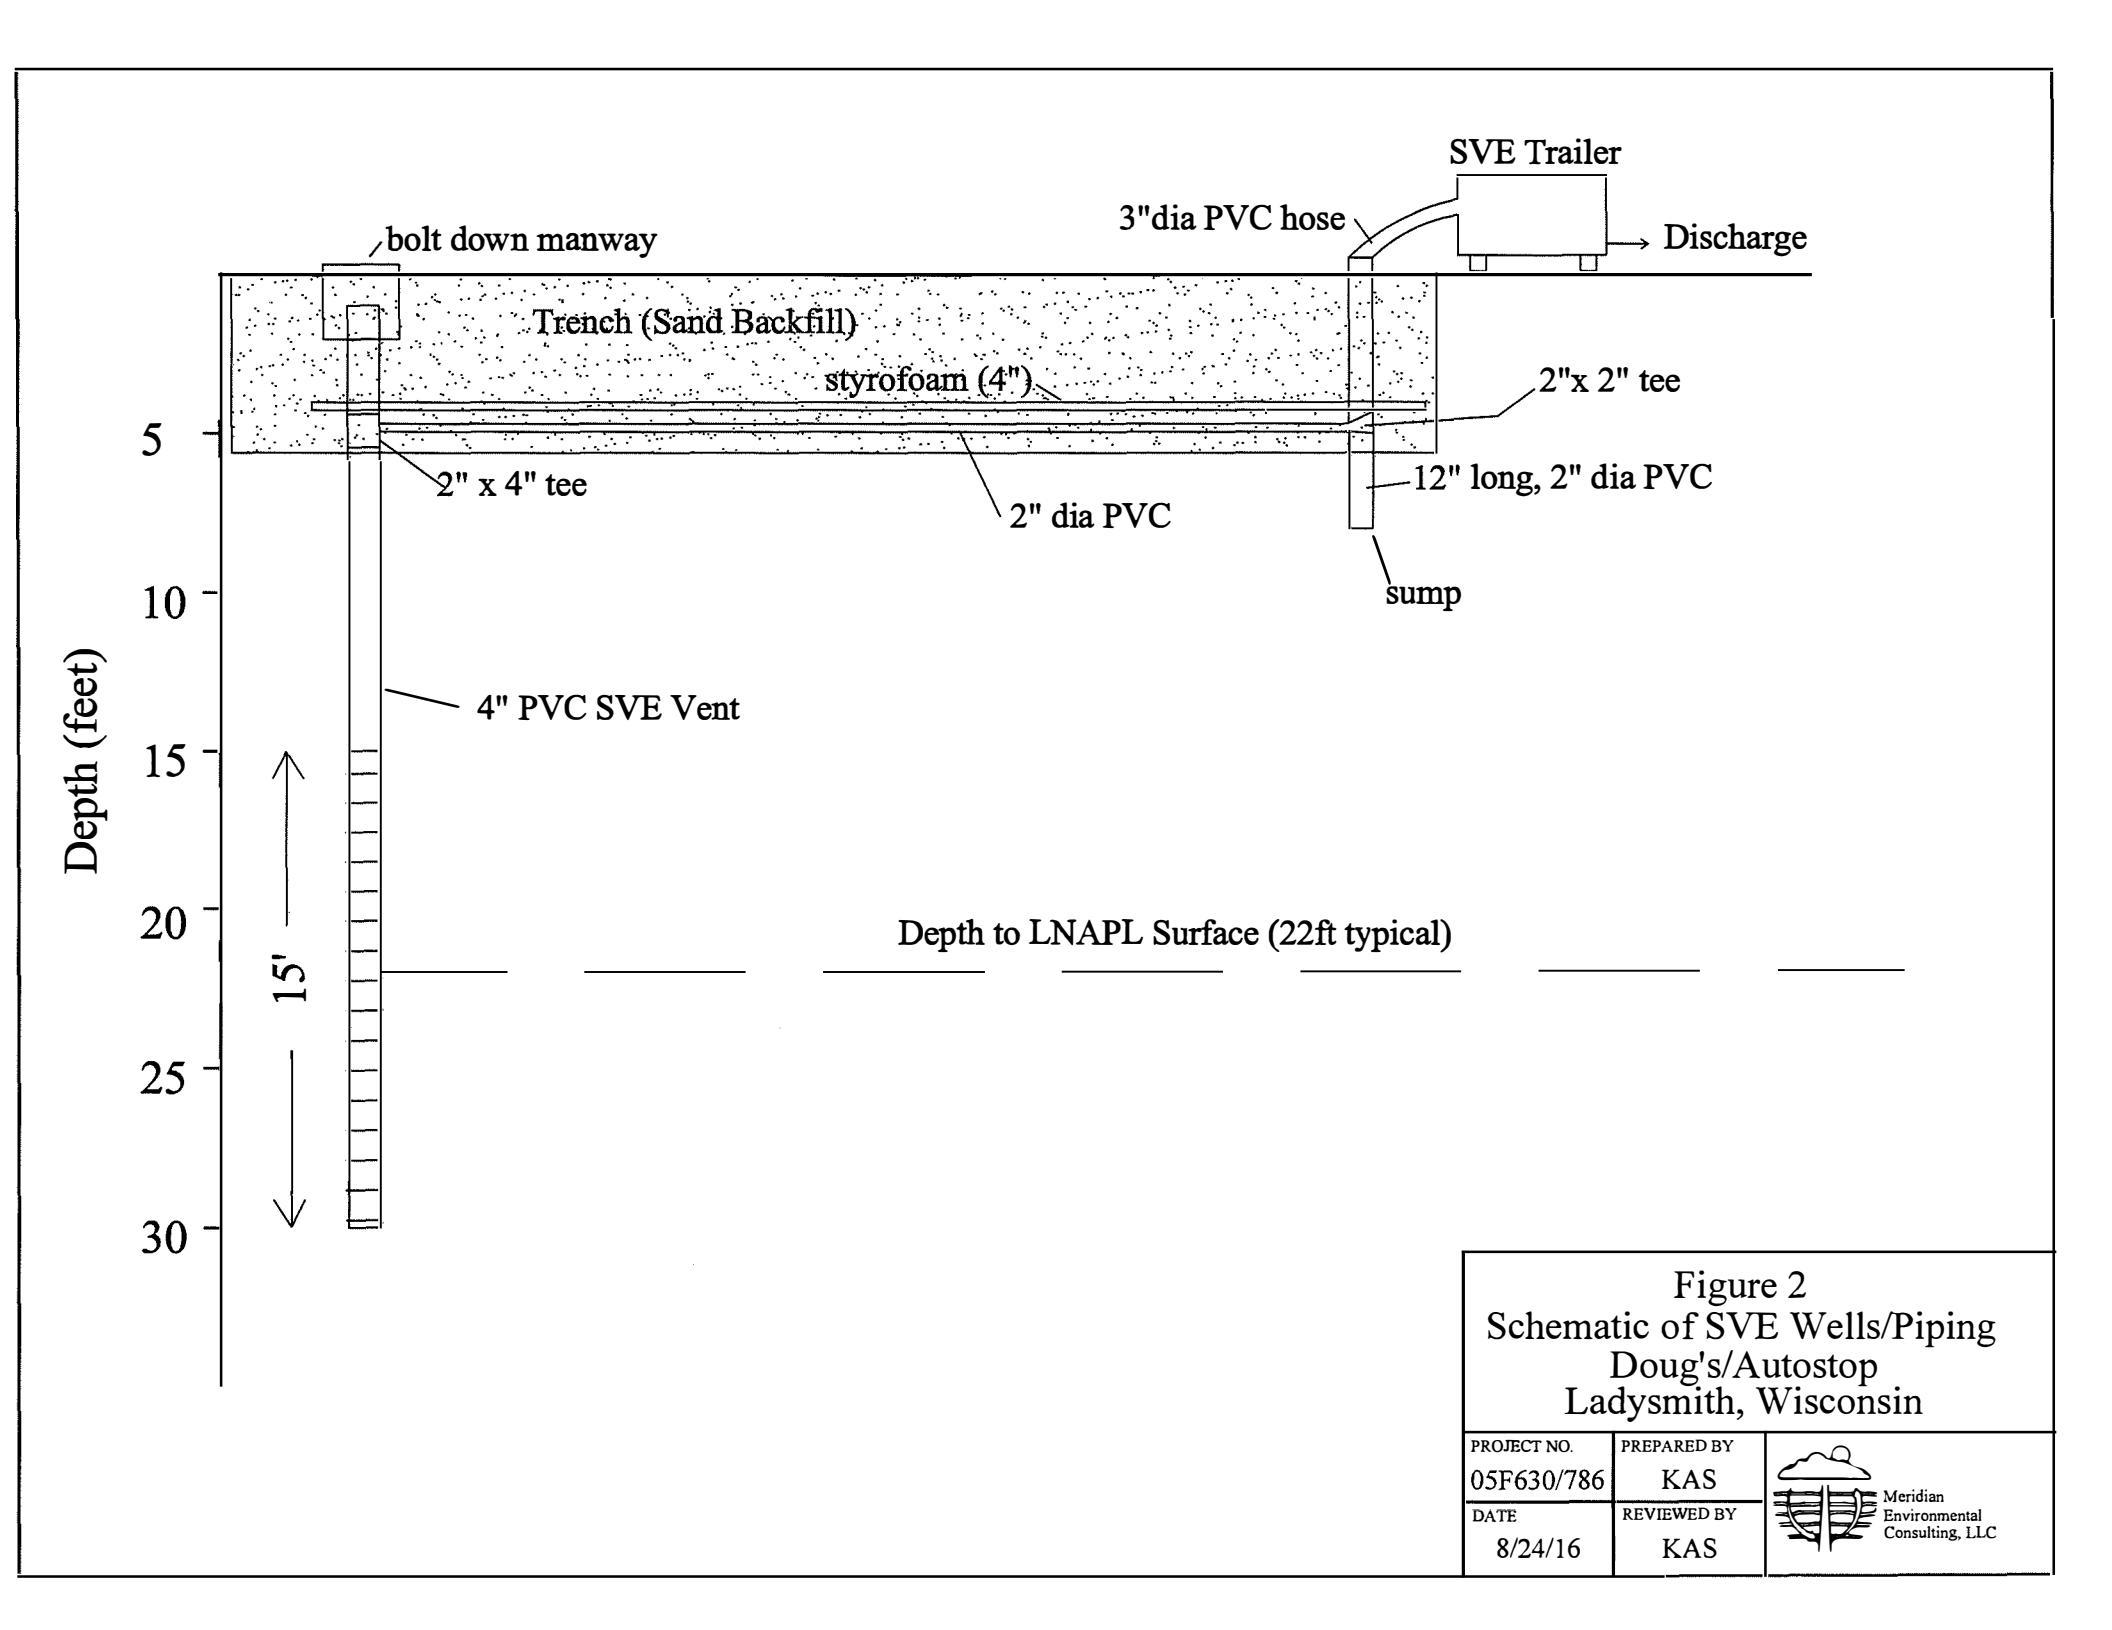
Figure 2 is a schematic diagram of the extraction wells and piping construction.

Due to the layout of the SVE system and surface topography, the piping could not be sloped back to the well and still remain below the frost. Therefore, a small sump was installed in the line at the SVE trailer location. This allows for the removal of condensate.
