Re: UST Closure Assessment, Glorioso's Village Service, 310 E. Brown Deer Road, Bayside, Wisconsin 53217

Environmental Associates, Inc. (Environmental Associates) has completed an Underground Storage Tank (UST) Closure Assessment on one (1) UST formerly located at 310 E. Brown Deer Road, Bayside, Wisconsin. This site will be referred to as the "Property" for the remainder of this report. The legal description defines the Property as being located in the southwest 1/4 of the southwest 1/4 of Section 4, Township 8 North, Range 22 East, Latitude 43° 11' 02", Longitude 87° 54' 18" (Figure 1). Figure 2 depicts the location and general layout of the Property as well as the former location of the UST and associated sampling locations. The UST closure assessment activities outlined in this report generally conform to the Wisconsin Department of Industry, Labor and Human Relations (DILHR) site assessment guidelines for UST Closure (Reference 1). This letter describes the methods used to conduct the study, presents the study findings, and describes the significance of these findings.

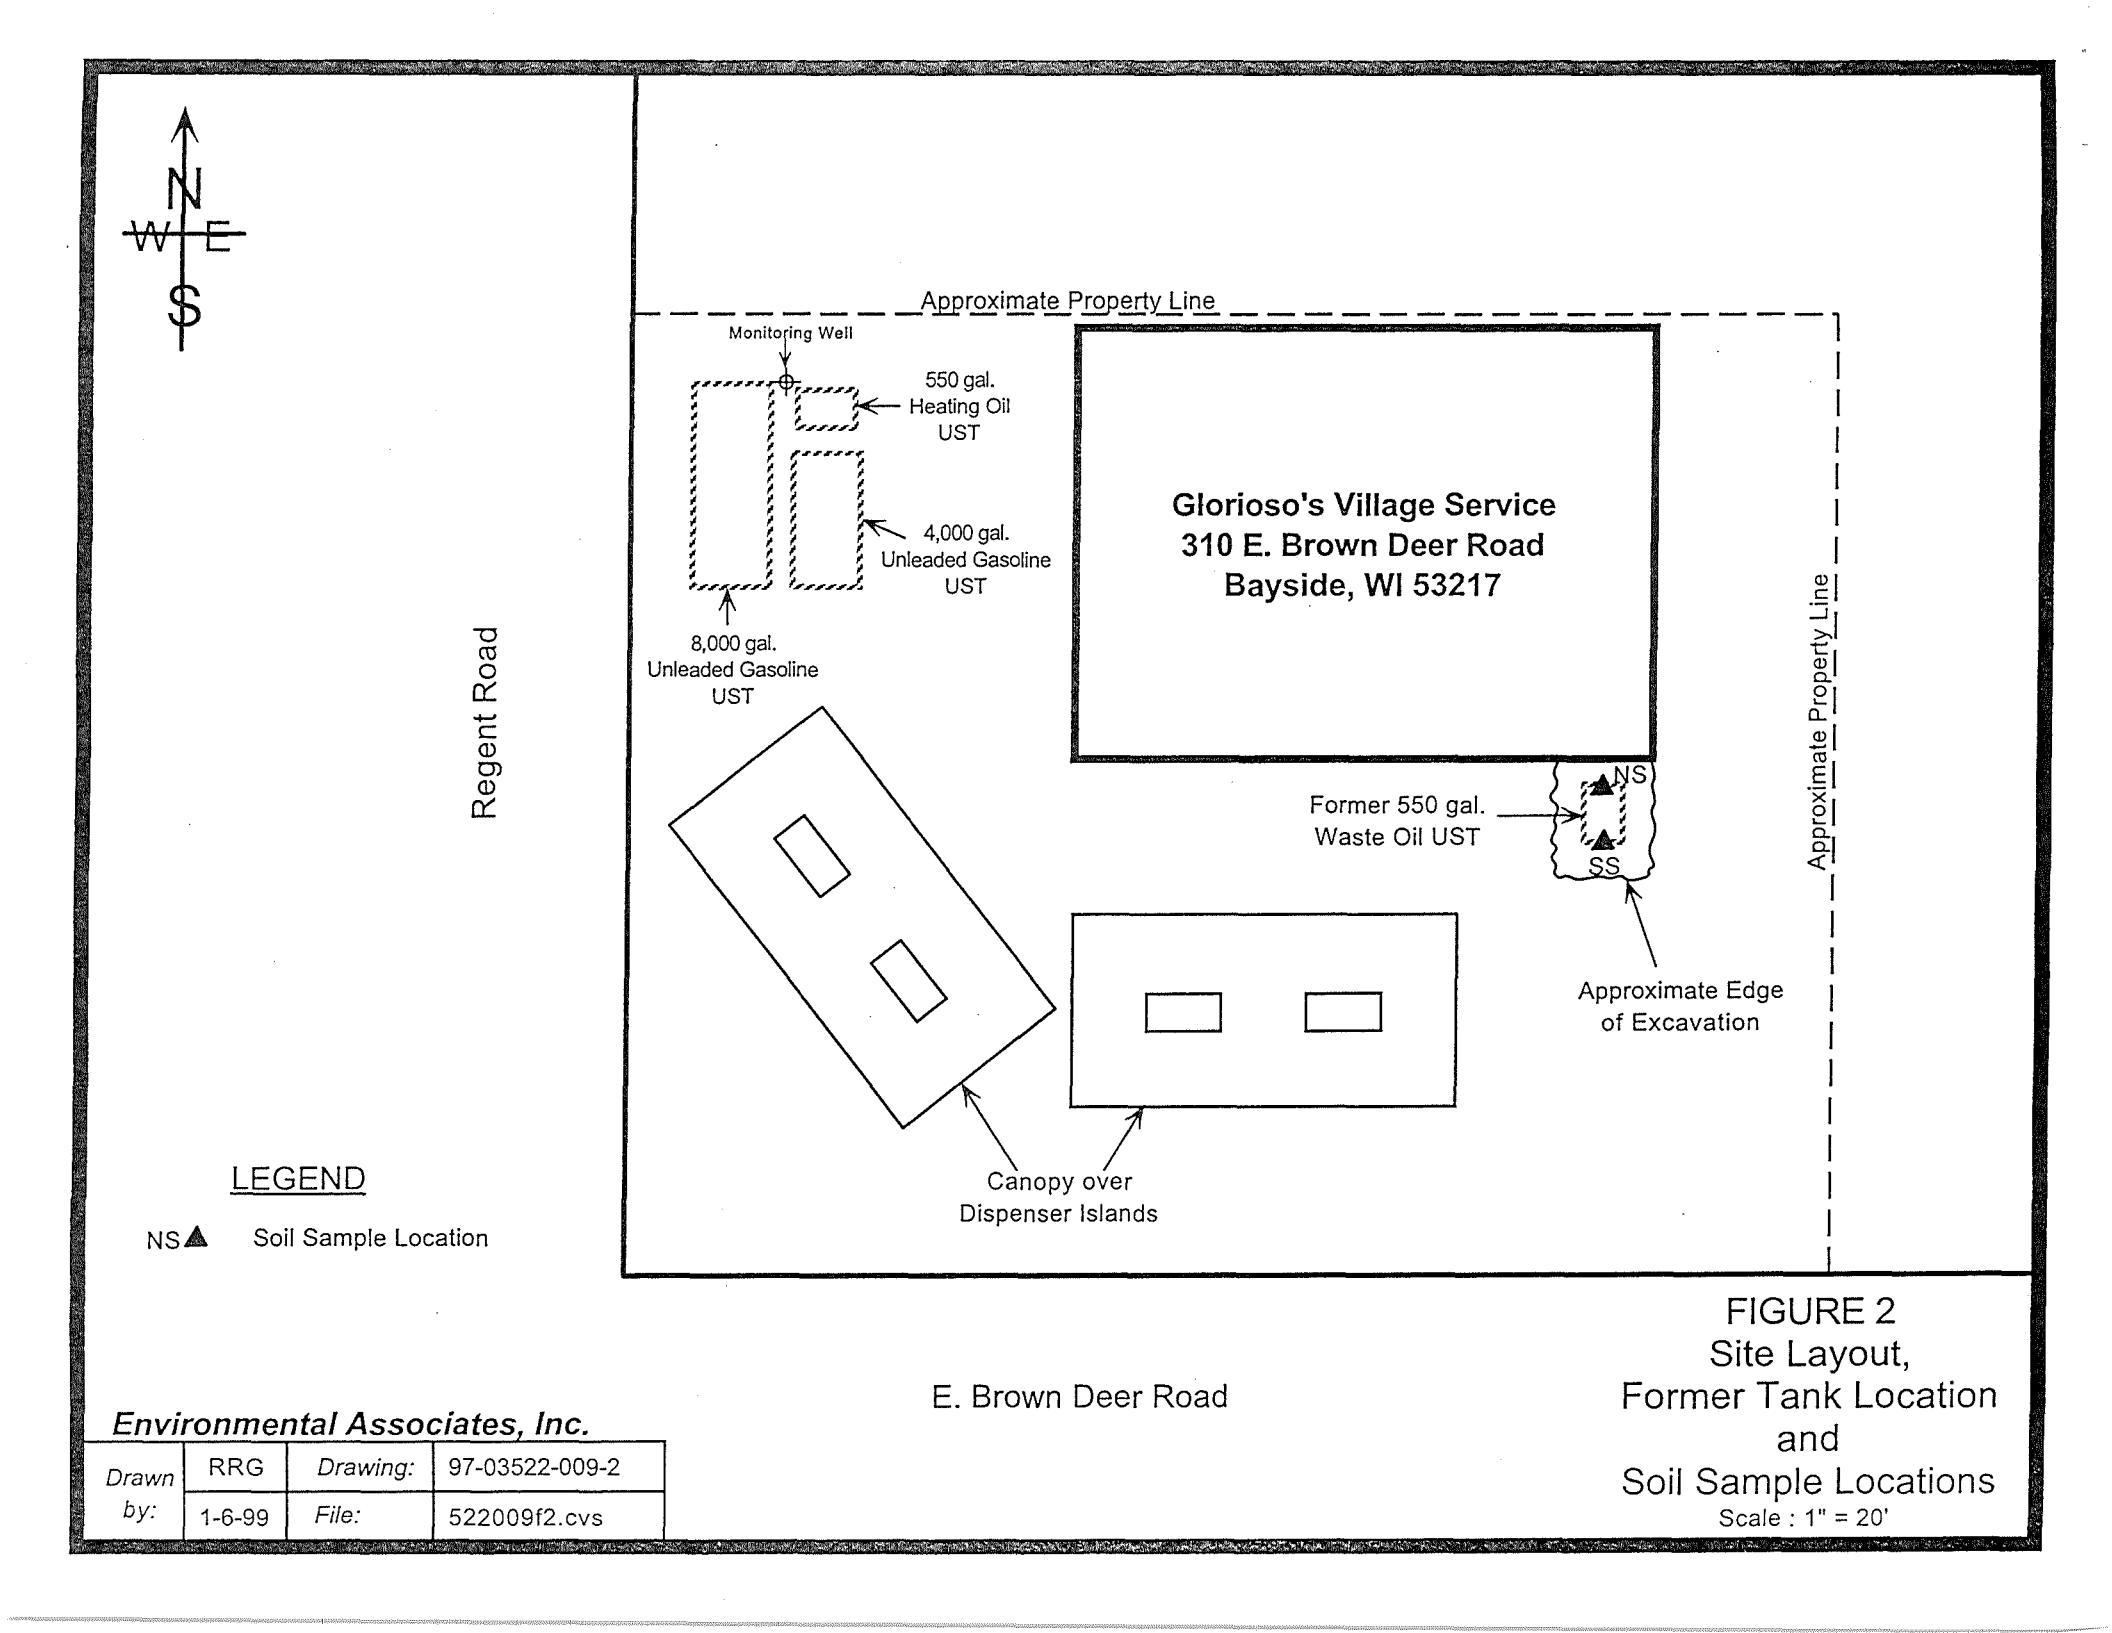
Ionization Detector (PID) headspace screening to identify the potential presence of volatile organic compounds such as those which occur in petroleum fuels. Screening was performed using a Thermo Environmental Instruments Model 580 B Organic Vapor Analyzer calibrated for direct response to 0.0 ppm air and 250 ppm isobutylene span gas. A portion of each sample was transferred into a quart size "Ziploc[™] plastic bag, and allowed to equilibrate in a relatively warm location (i.e. 60°F) for at least one half hour. The PID probe extension was then inserted into the bag and the highest stable reading occurring within 10 to 20 seconds was recorded. Odor and appearance of the soil samples were also noted during screening. PID headspace analysis is summarized in Table 1 and sample locations are depicted in Figure 2.
