DRAFT SITE ASSESSMENT REPORT ECOLAB SITE MEQUON, OZAUKEE COUNTY, WISCONSIN

Date Prepared: February 13, 2004 TDD No.: S05-0311-009 Contract No.: 68-W-00-129 Prepared by: Tetra Tech EM Inc. Tetra TechSTART Project Manager: Lee Christenson Telephone No.: (312) 946-6457 U.S. EPA On-Scene Coordinator: Michael Harris Telephone No.: (312) 886-0760

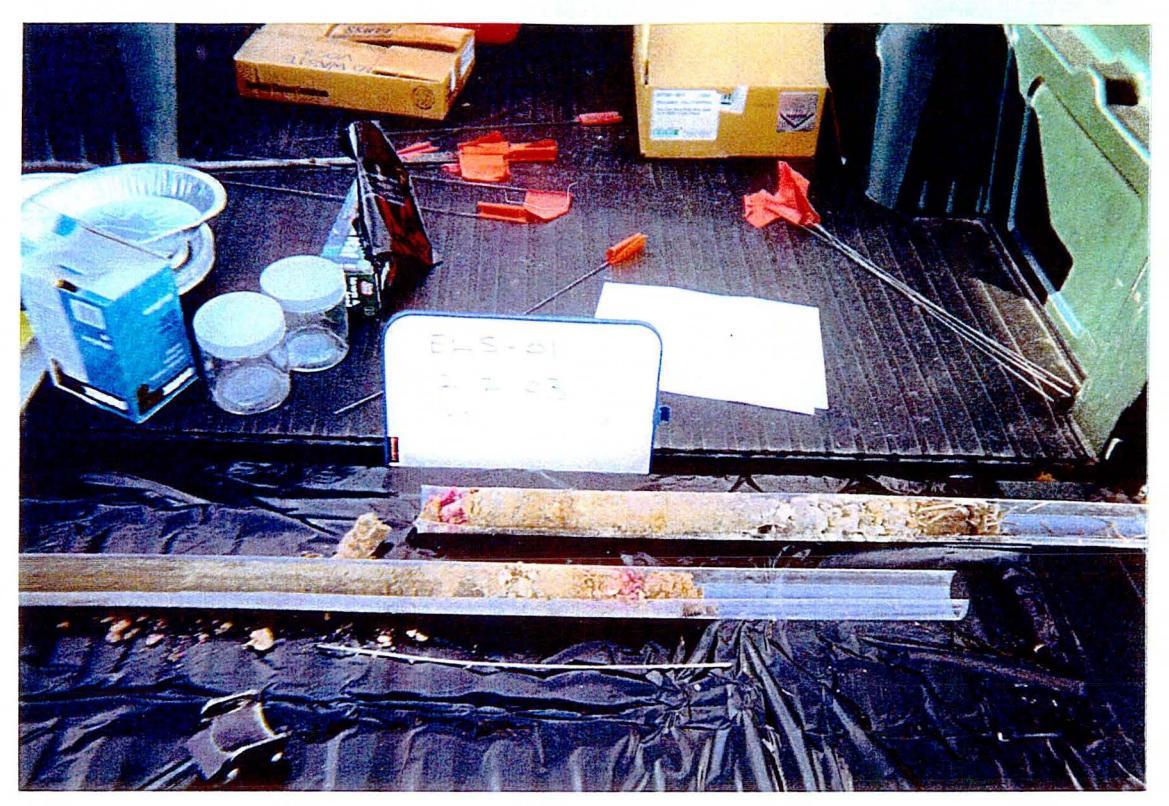
1Orientation: WestS05-0311-009Date: December 2, 2003Ecolab SiteSoil core with pink wax from sampling location ELS-01

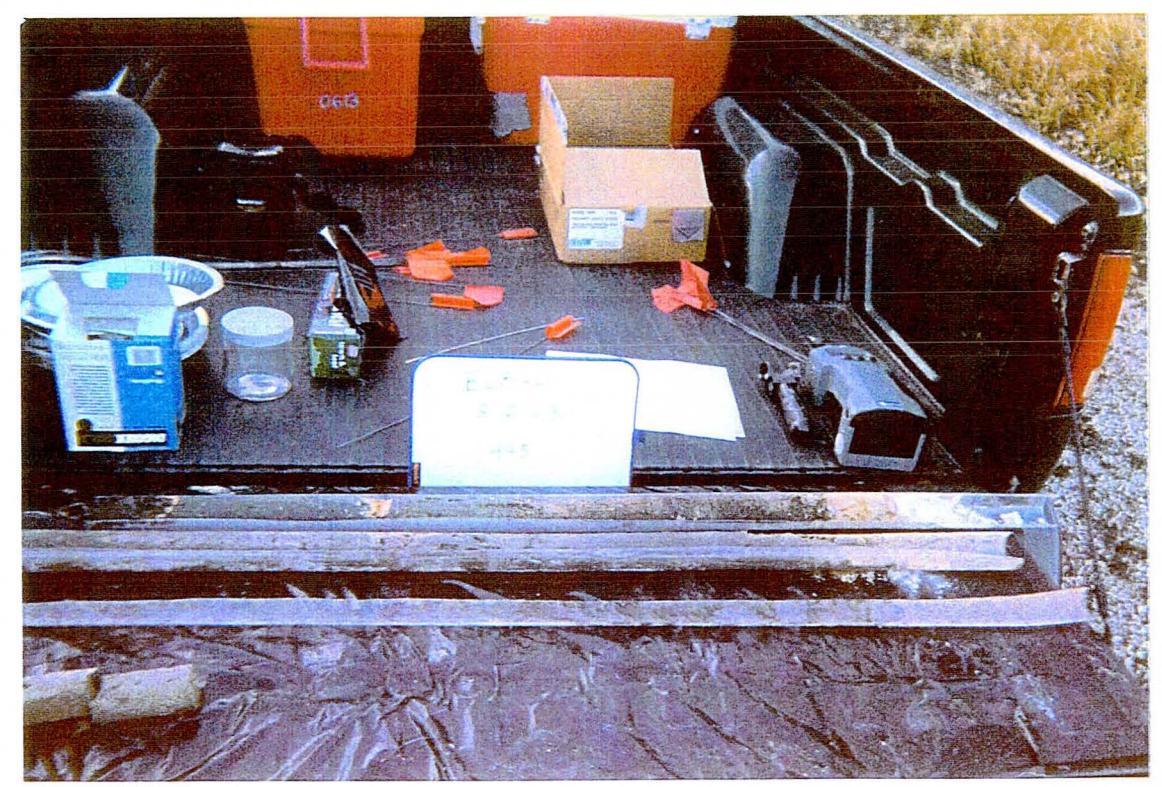
Photograph No.: TDD No.: Location: Subject: 2 Orientation: West S05-0311-009 Date: December 2, 2003 Ecolab Site Soil core from sampling location ELB-01 inside east building

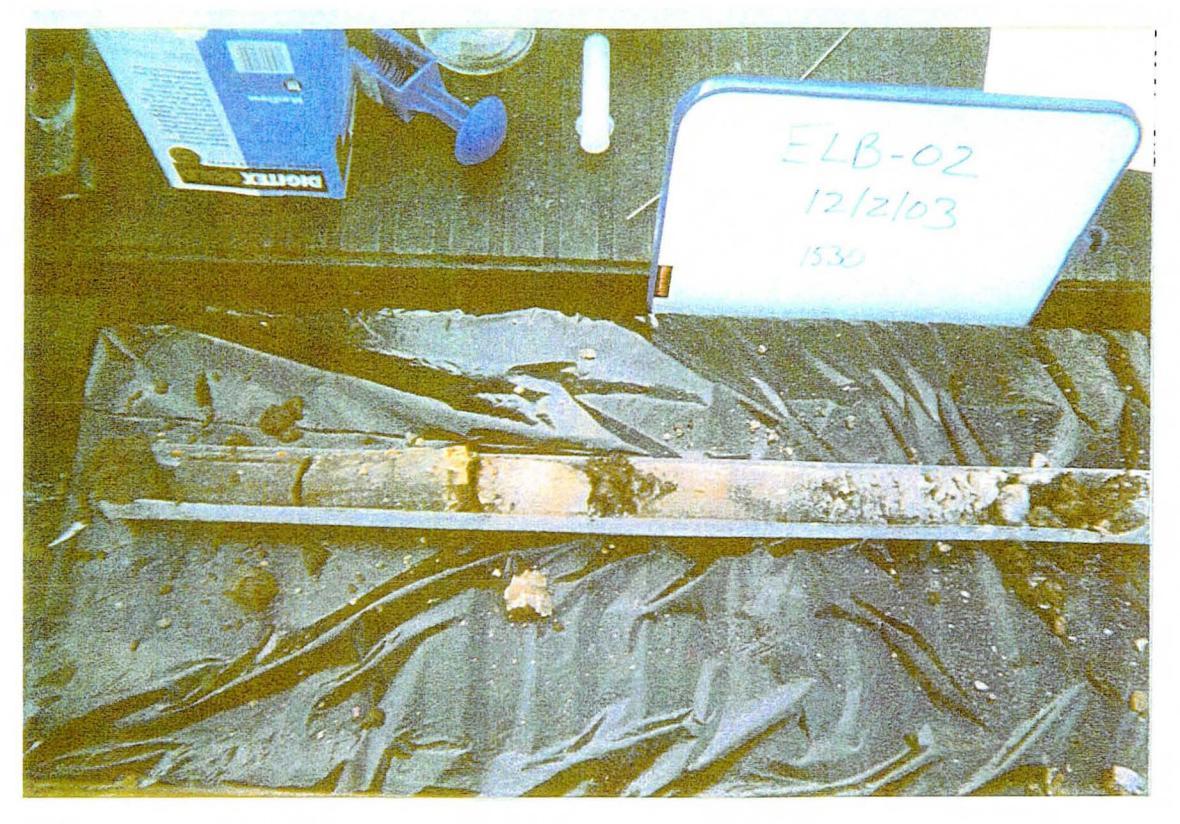
Photograph No.:3Orientation: WestTDD No.:S05-0311-009Date: December 2, 2003Location:Ecolab SiteSubject:Soil core from sampling location ELB-02 inside east building

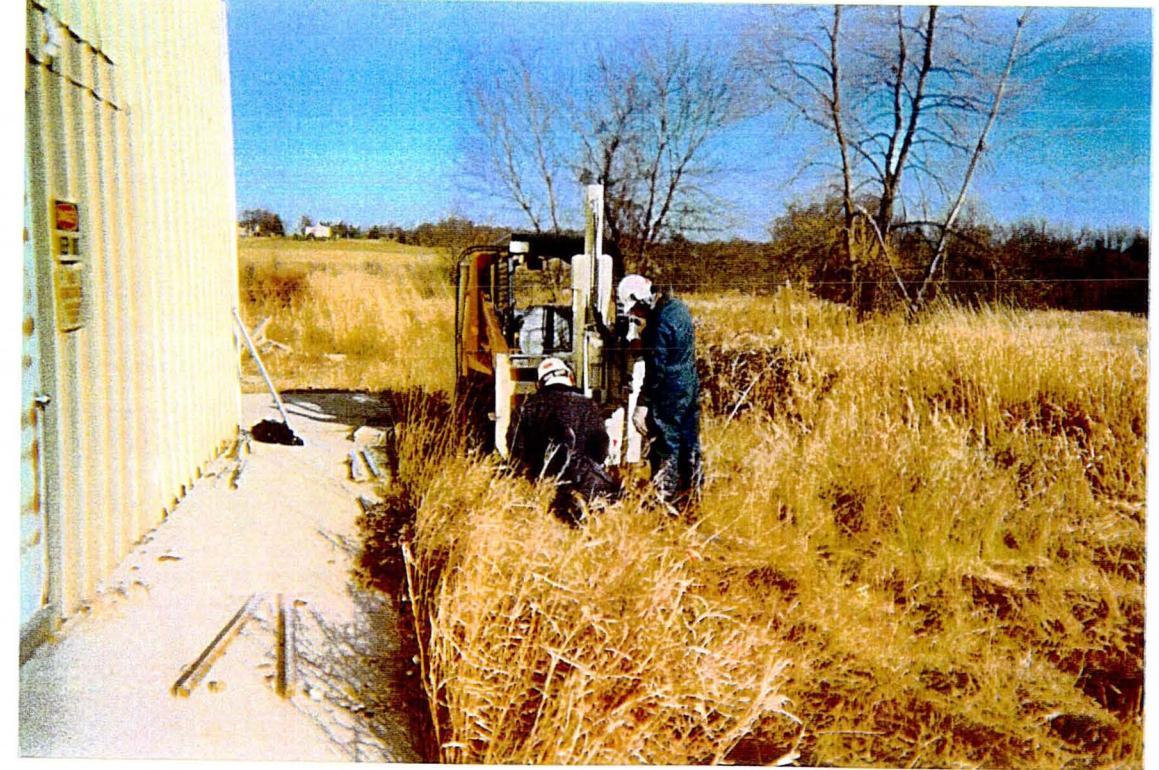
Photograph No.: TDD No.: Location: Subject: 4Orientation: NorthS05-0311-009Date: December 3, 2003Ecolab SiteFIELDS team using Geoprobe at location ELS-02

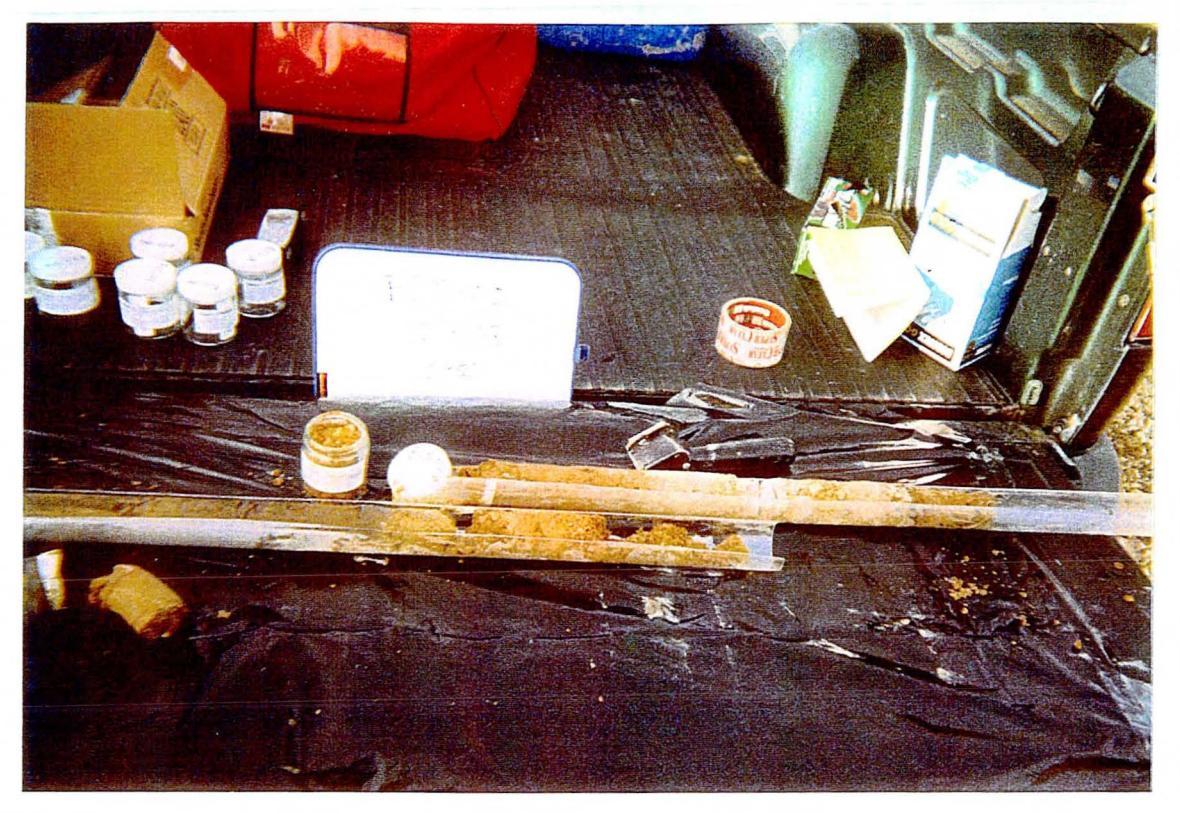
5 S05-0311-009 Ecolab Site Soil sample from location ELS-02 Orientation: West Date: December 3, 2003

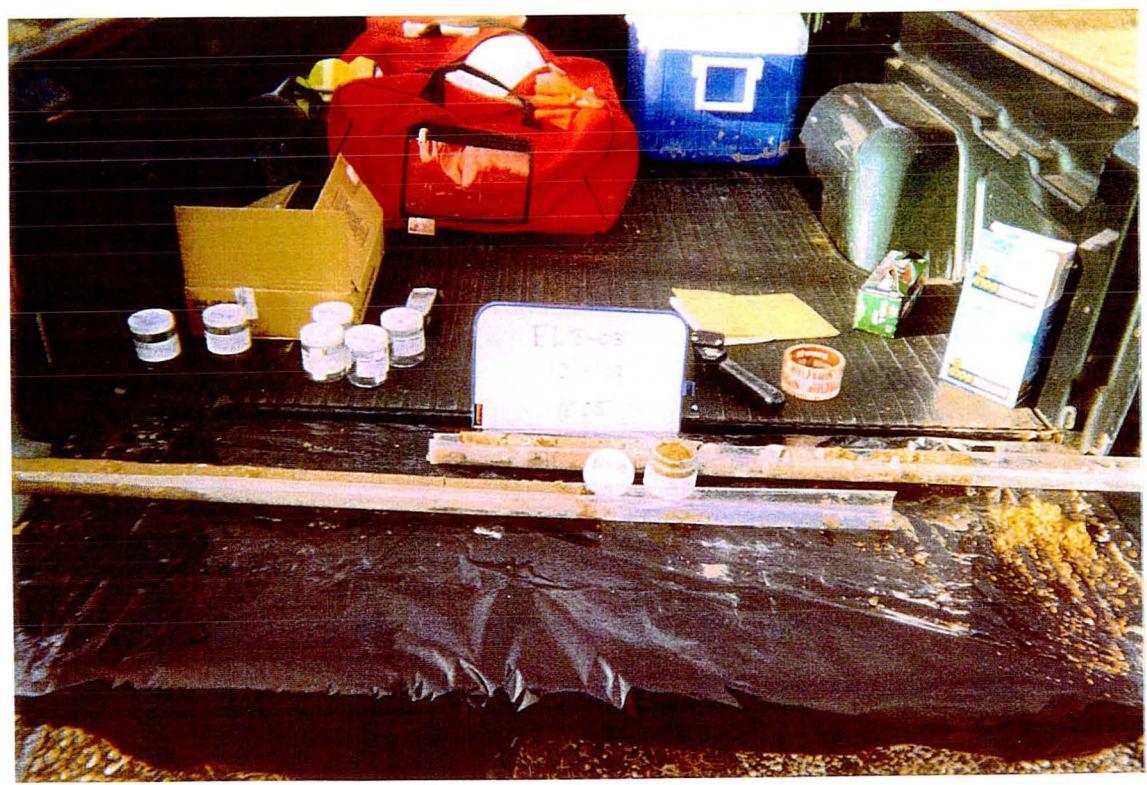
Photograph No.: TDD No.: Location: Subject: 6 S05-0311-009 Ecolab Site Soil sample from location ELS-03 Orientation: West Date: December 3, 2003

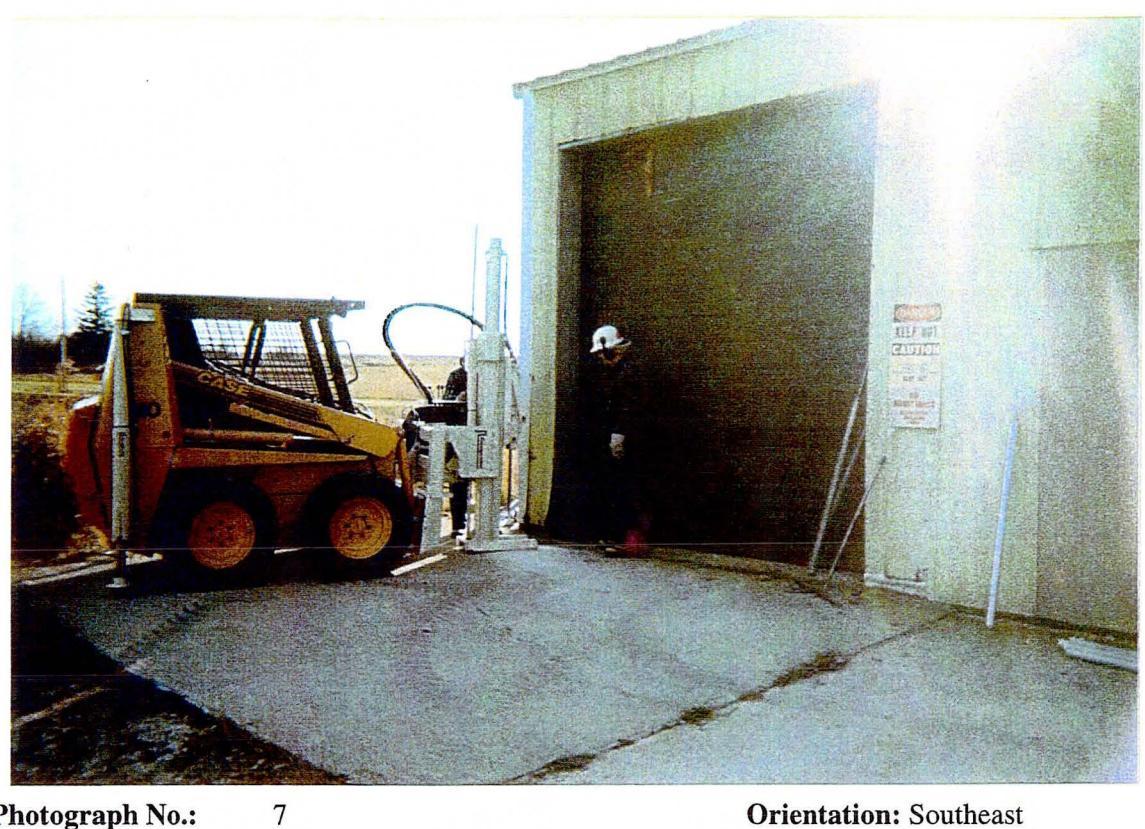
7 Orientation: Southeast S05-0311-009 Date: December 3, 2003 Ecolab Site FIELDS team using Geoprobe at location ELS-04

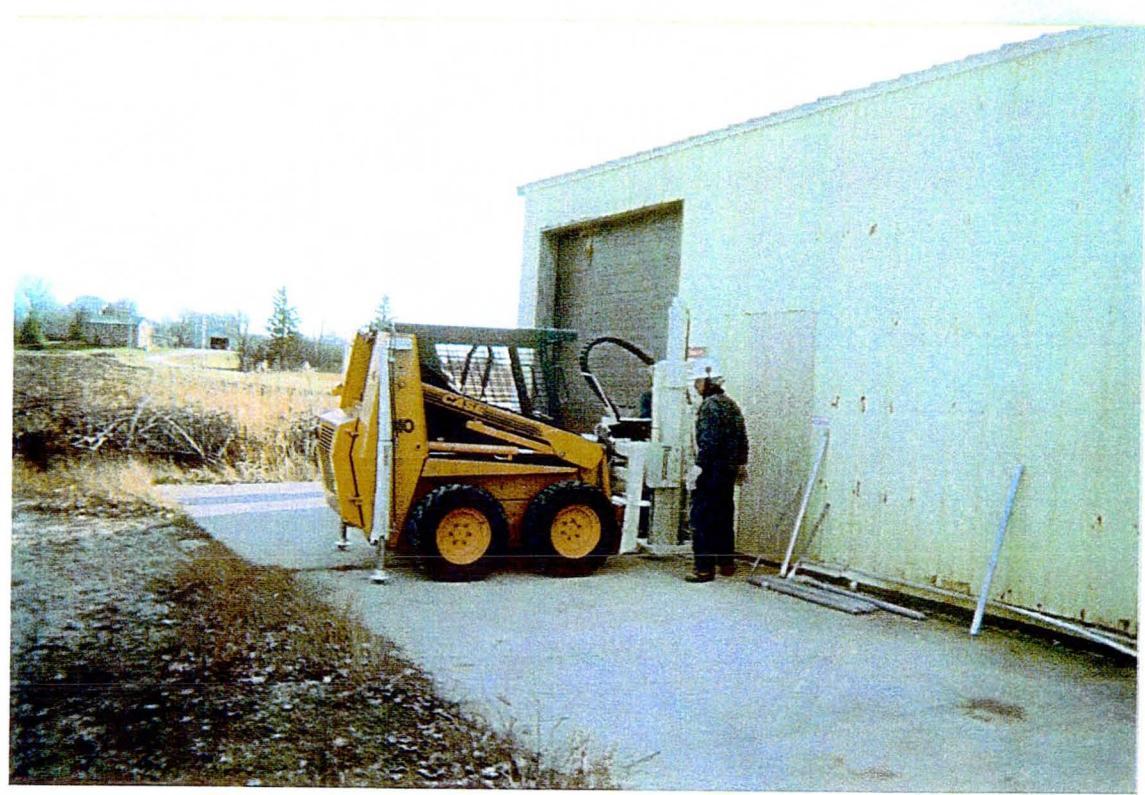
9OrientatS05-0311-009Date: DeEcolab SiteFIELDS team using Geoprobe at location ELS-05

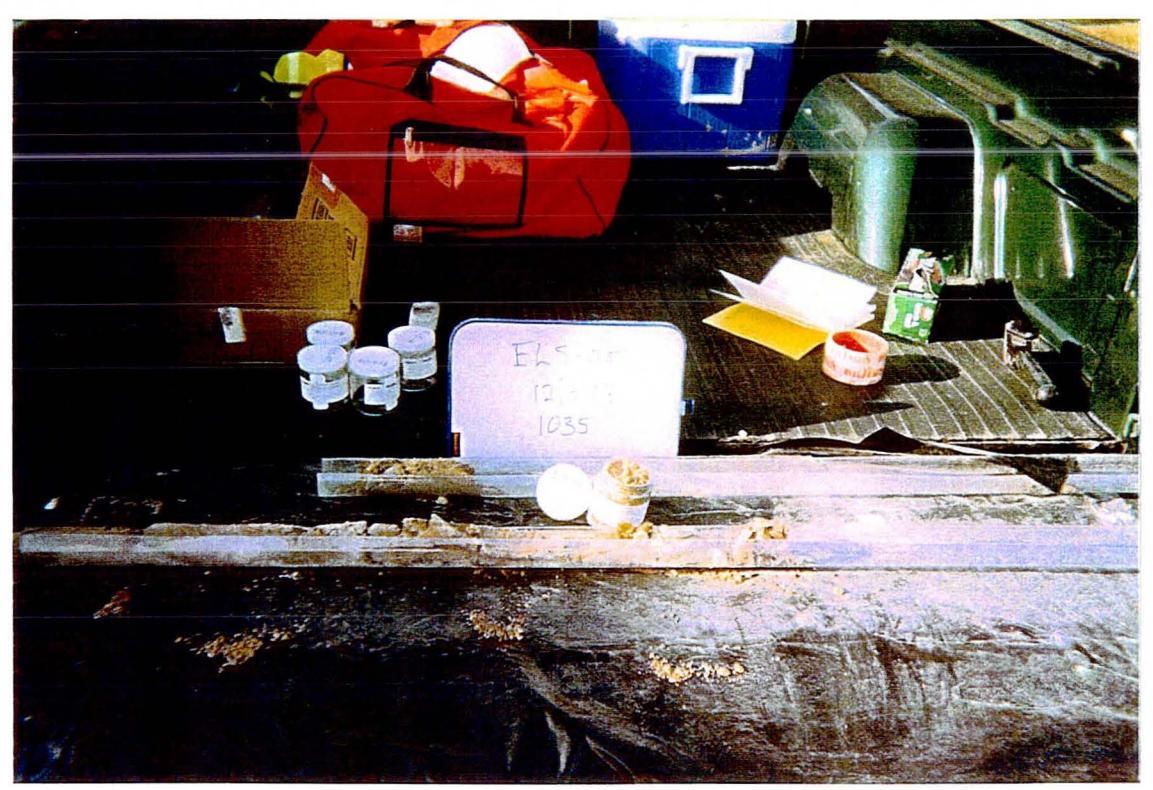
10 S05-0311-009 Ecolab Site Soil sample from location ELS-05 **Orientation:** West **Date:** December 3, 2003

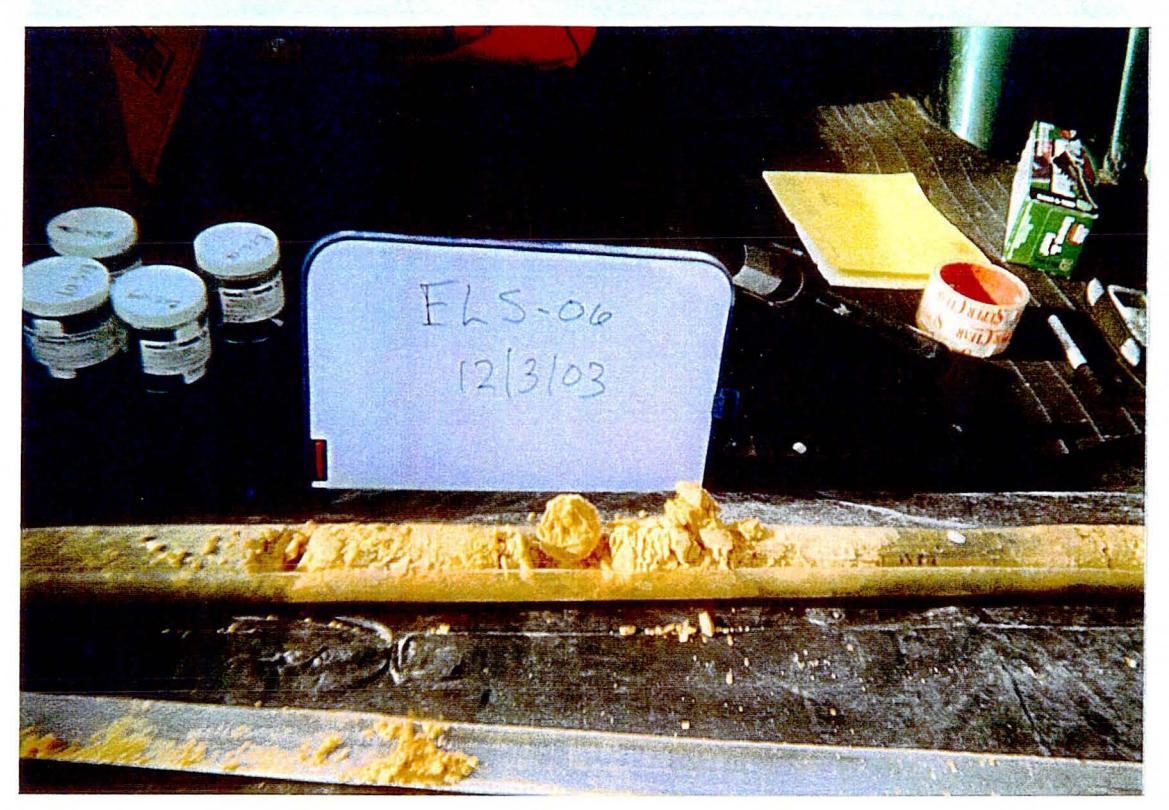
Five more samples, ELS-06 through ELS-10, were collected from five borings advanced in the gravel parking lot north of the concrete pad. The soil core from which sample ELS-06 was collected contained a solid, light brown wax layer throughout the entire 2-to-3 ft bgs interval. Sample ELS-06 was collected from this interval for PCB Aroclor and DCB analyses. U.S. EPA decided that because the wax material had been observed above 4 ft bgs in the soil borings advanced thus far, the remaining borings would be advanced only to 4 ft bgs.

Photograph No.:11Orientation: WestTDD No.:S05-0311-009Date: December 3, 2003Location:Ecolab SiteSubject:Light brown wax in soil core from sampling location ELS-06

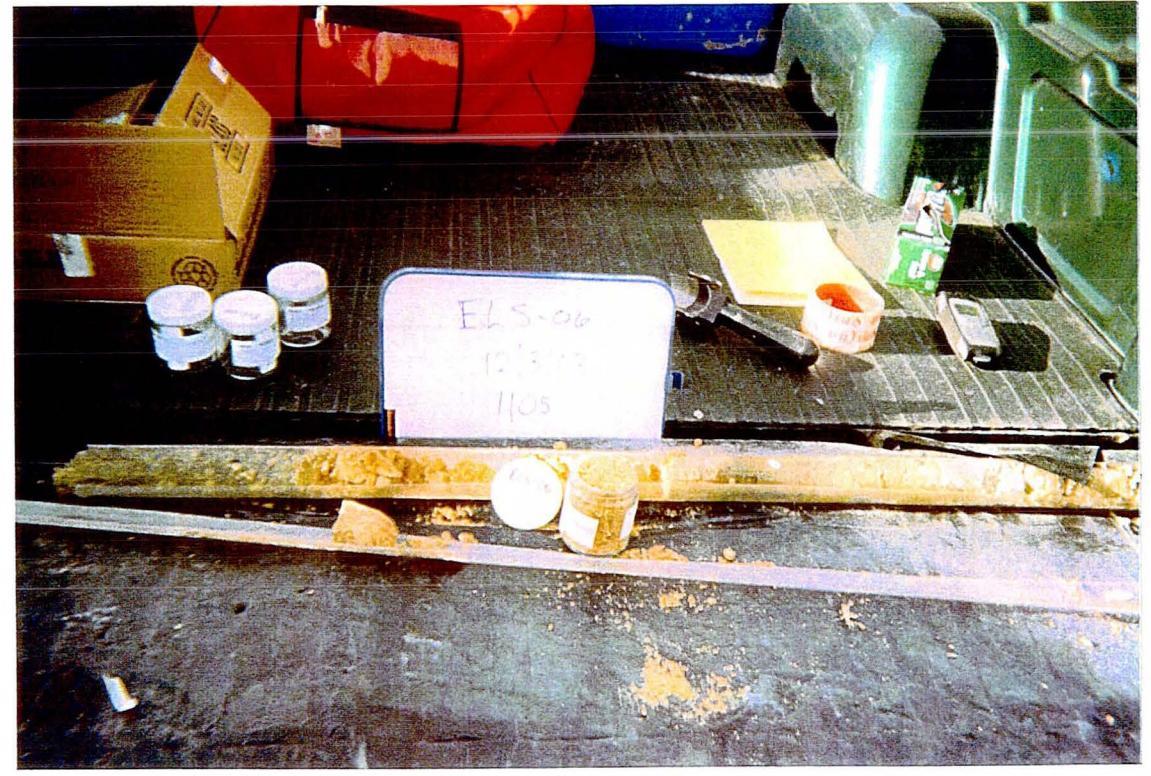
Photograph No.: TDD No.: Location: Subject: 12 S05-0311-009 Ecolab Site Soil sample from location ELS-06 **Orientation:** West **Date:** December 3, 2003

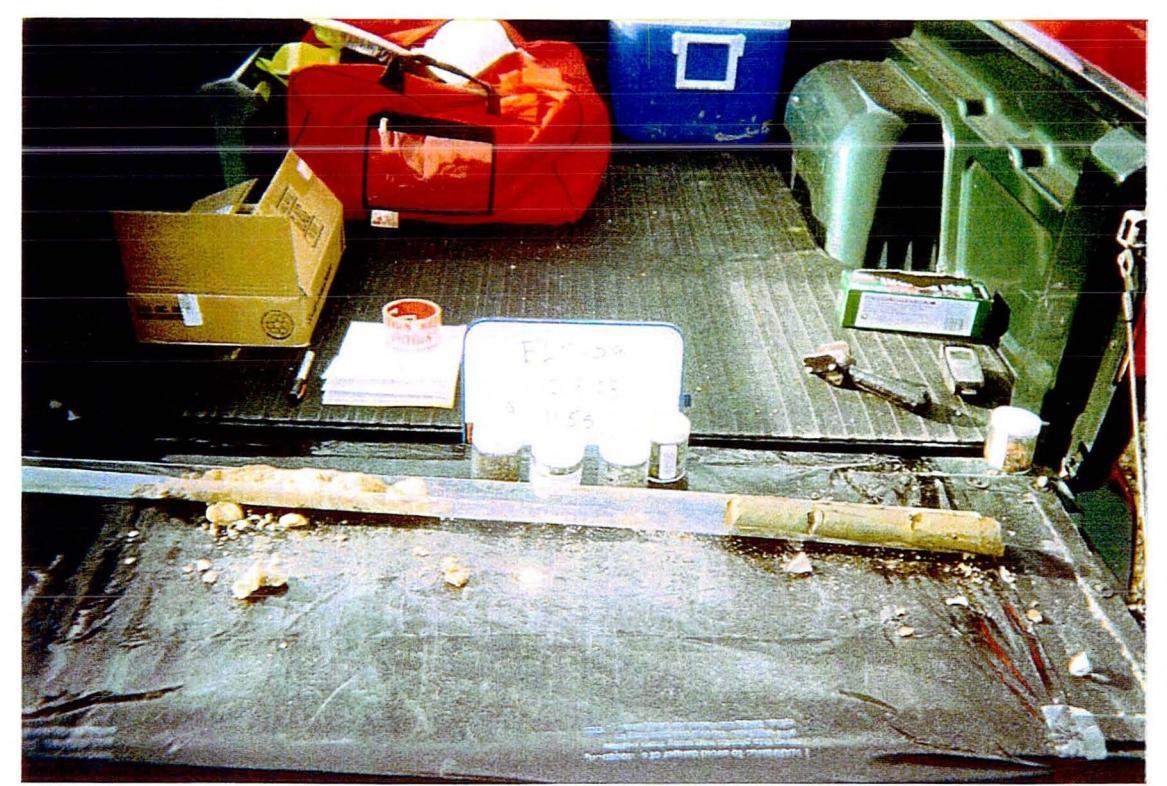
Photograph No.: TDD No.: Location: Subject: 14Orientation: WestS05-0311-009Date: December 3, 2003Ecolab SiteSoil sample from location ELS-09 with duplicate sample and matrix spike/matrixspike duplicate

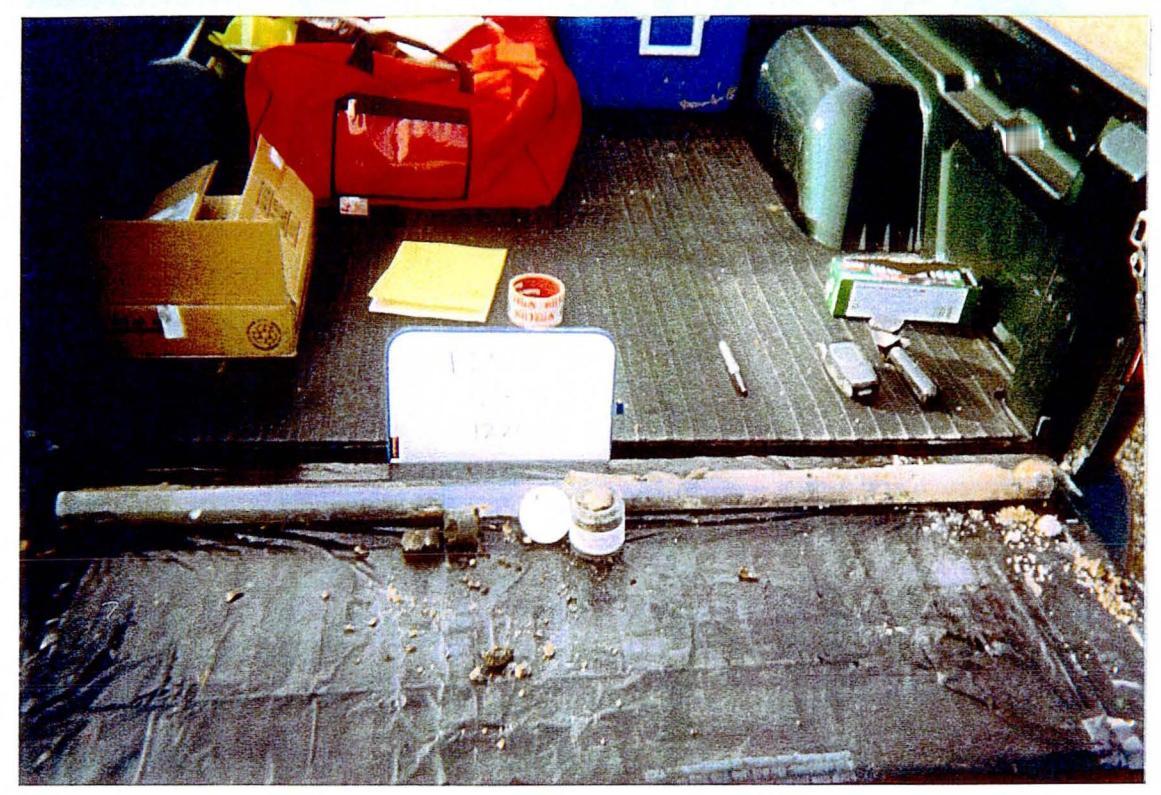
15 S05-0311-009 Ecolab Site Soil sample from location ELS-10

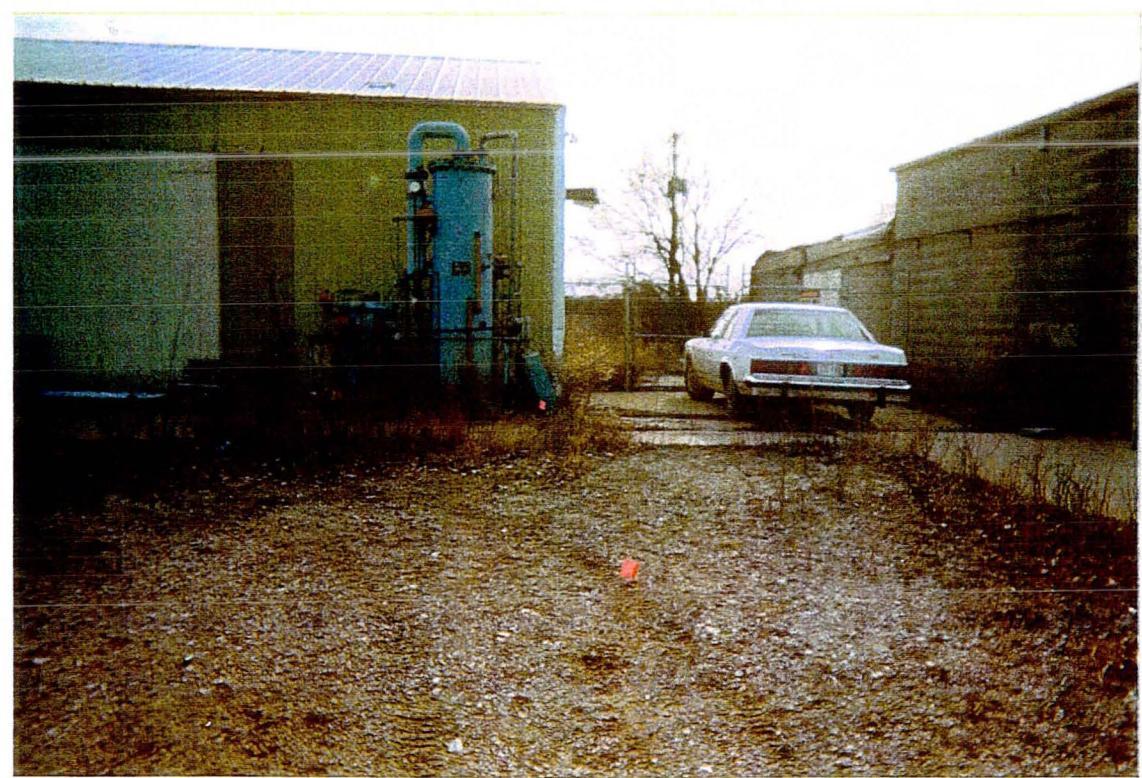
Borings advanced at locations ELS-08 and ELS-09 both contained small amounts of a material resembling the wax material in the 2-to-3 ft bgs intervals. Samples were collected from these intervals for PCB Aroclor and DCB analyses. A duplicate sample and matrix/spike matrix spike duplicate (ELS-09D) was collected at location ELS-09. No wax material was observed in the borings advanced at locations ELS-07 and ELS-10. However, samples were collected from the intervals at these locations because wax material had been observed at this depth in the other borings advanced in the gravel parking lot. Sample analytical results are discussed in Section 4.0.

Photograph No.: TDD No.: Location: Subject: 16OrientaS05-0311-009Date: DEcolab siteView of sampling locations ELS-08 and ELS-09
